WPC.EC.25.11.05 – Play Inspection Reports & Remedial Work

Play Area Inspection Reports & Remedial Work

Wickhambrook. Bury Road

Inspection Ref: 2834689

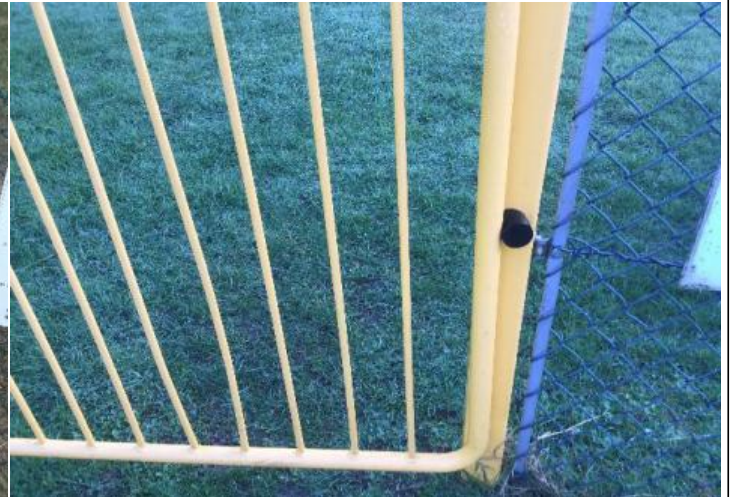
Finding: There is some damage to the item and is slightly out of alignment

Action: Monitor for any further deterioration and repair as required

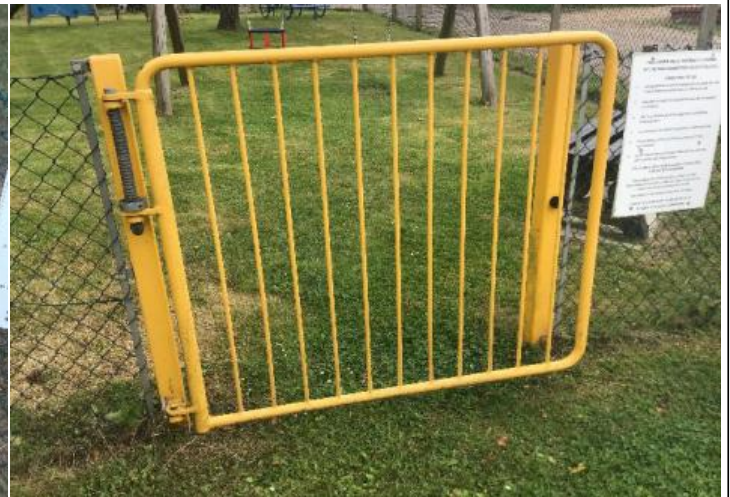
Finding: The gate rebounds when opened quickly and could strike the next user entering the area

Action: Monitor use and adjust/replace as required

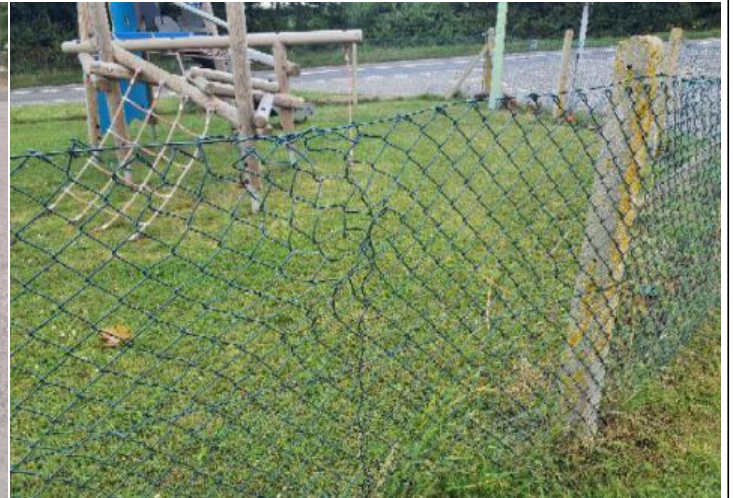
Finding: There is some damage to the fence sections

Action: Monitor for any further deterioration and repair as required

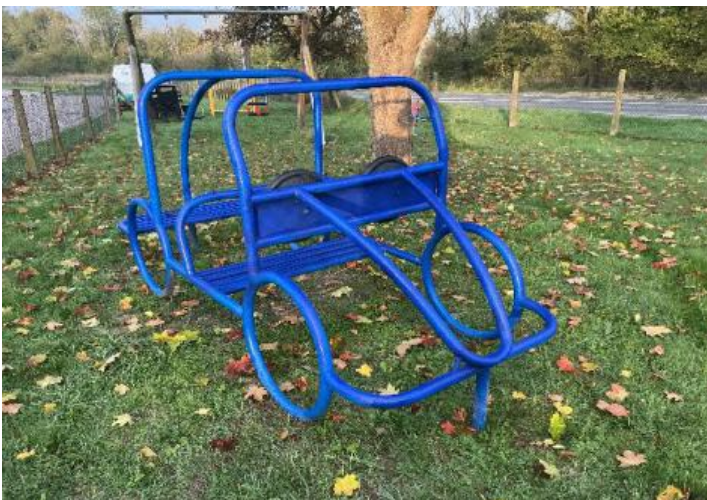
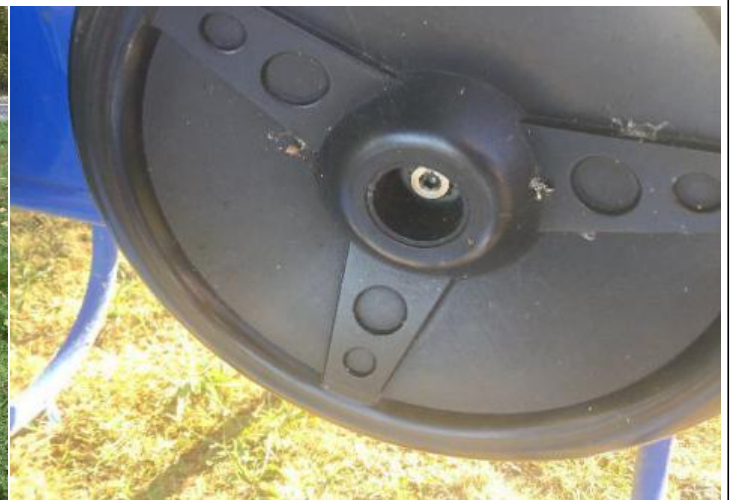
Finding: Cap covers missing

Action: Replace

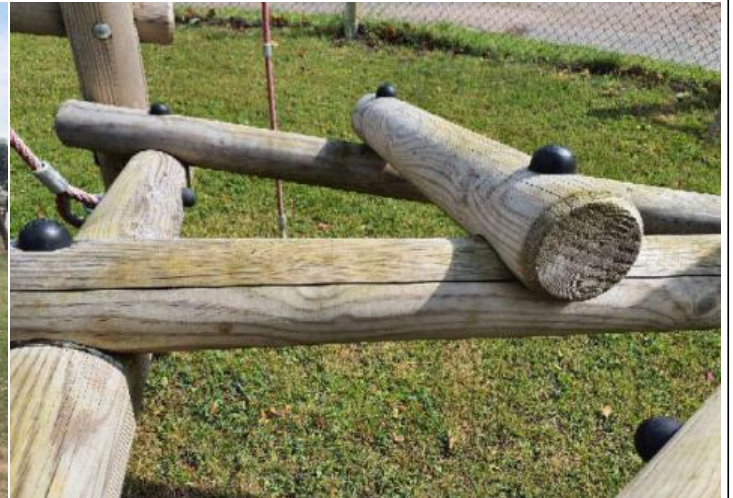
Finding: The timber has a number of splits/shakes or air cracks and this may affect the stability or allow water ingress which will accelerate the rotting process
Action: Monitor to ensure the splits do not cross through fixing points of the structure and/or cause any instability

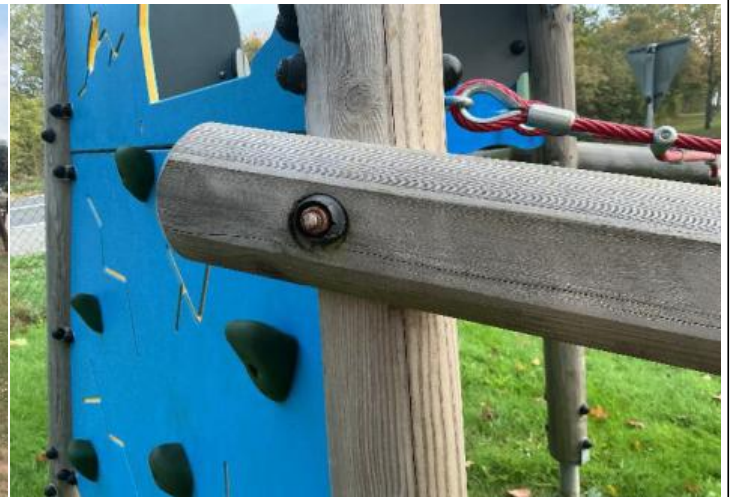
Finding: There is/are bolt cap covers missing or damaged on the item
Action: Replace missing or damaged bolt cap covers

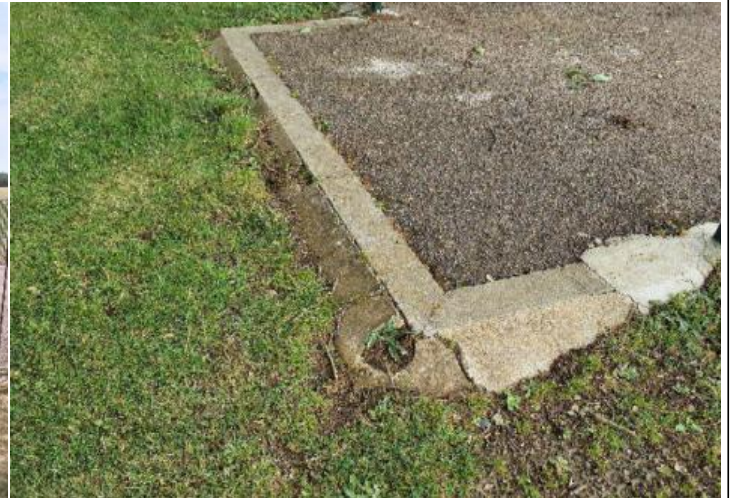
Finding: The concrete is breaking up around the edges of the surface

Action: Repair the damaged concrete

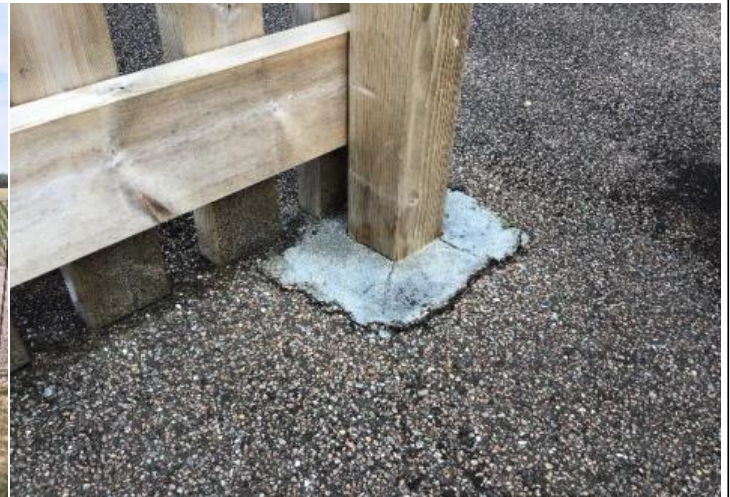
Finding: The concrete foundation around the goal structure is lifting

Action: Repair

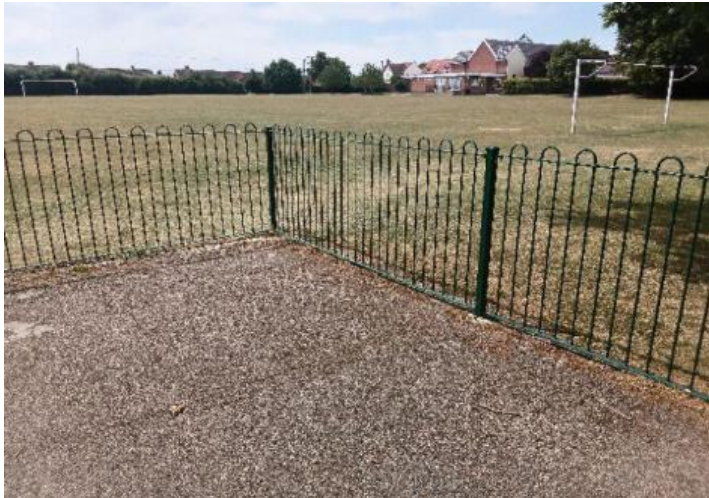
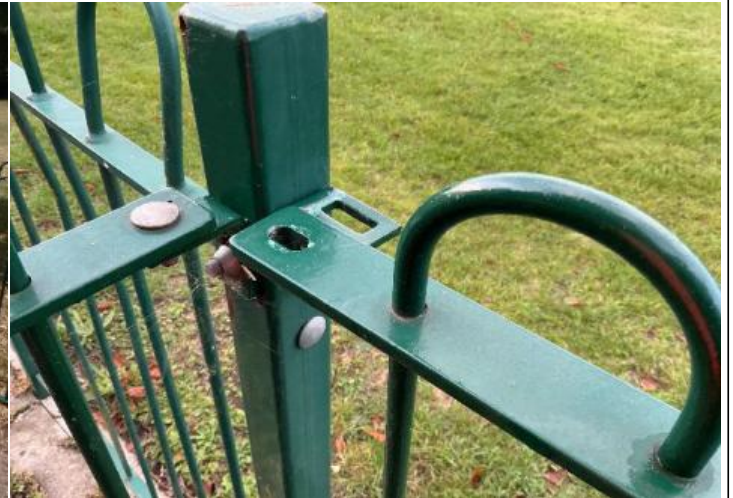
Finding: There are a number of fixings missing from the fence

Action: Replace missing fixings

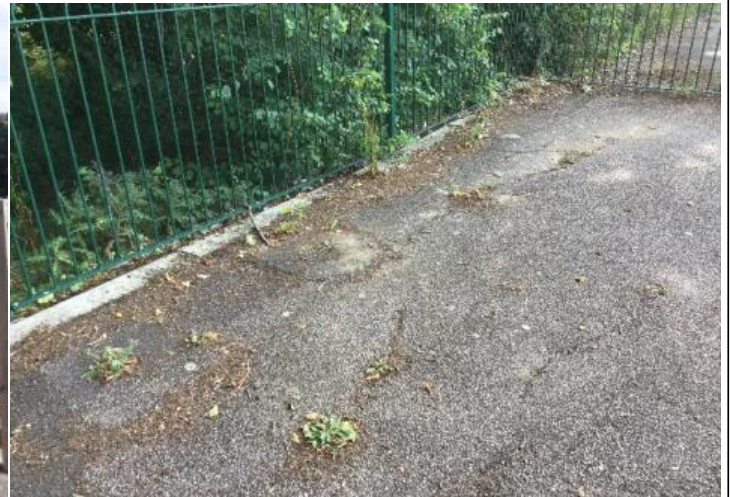
Finding: There is algae, silt or moss growth on the surface resulting in slippery conditions

Action: Clean and treat appropriately

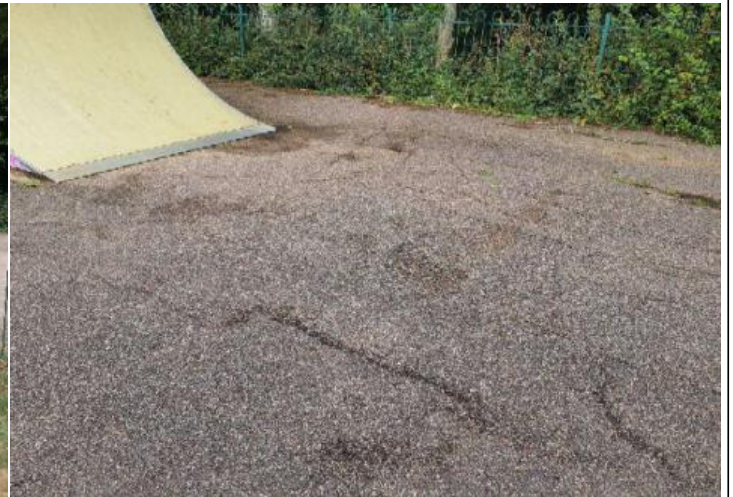
Finding: There is some damage apparent to the riding surface

Action: Monitor for any further deterioration and repair as required

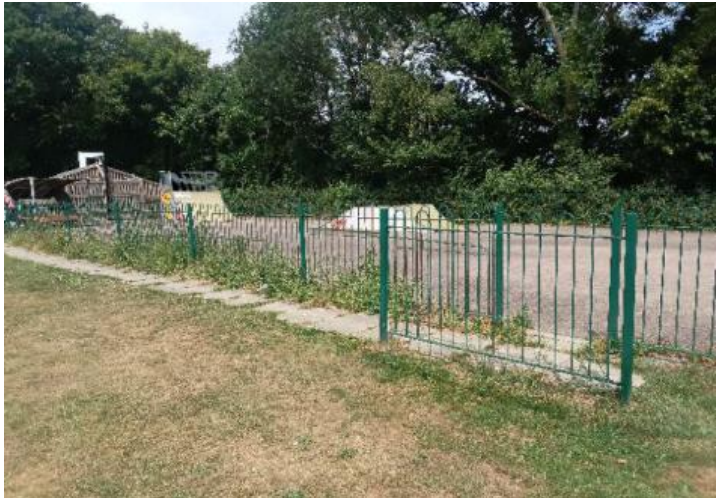
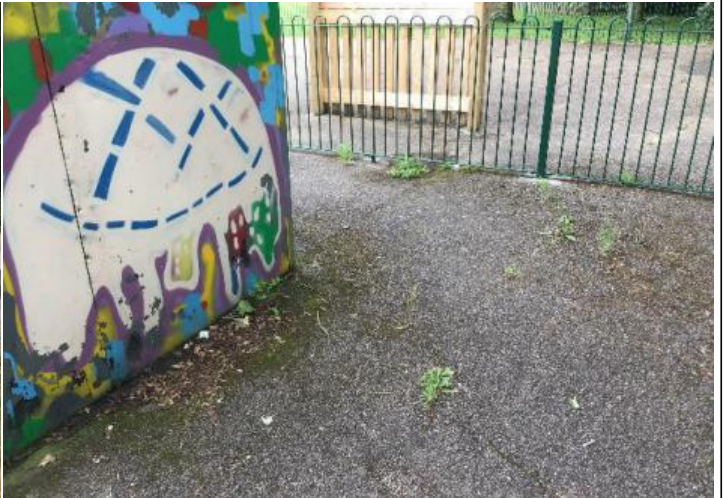
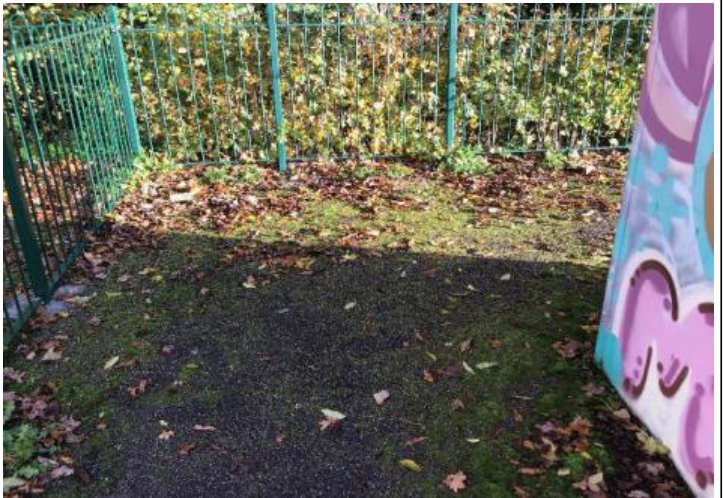
Finding: There is algae, silt or moss growth on the surface resulting in slippery conditions

Action: Clean and treat appropriately

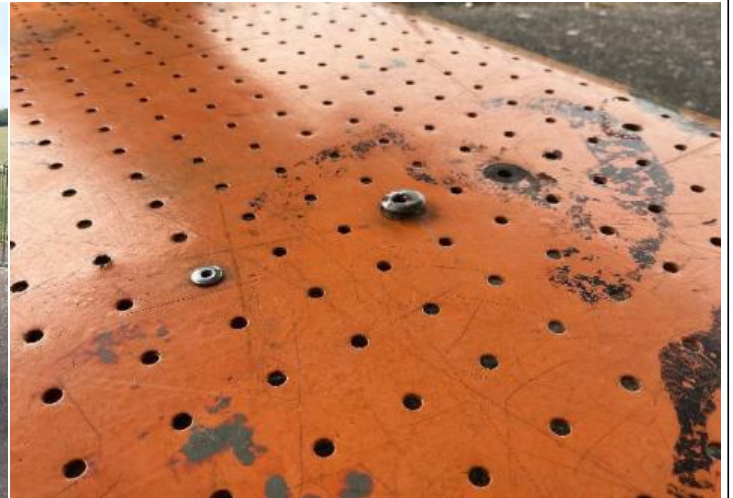
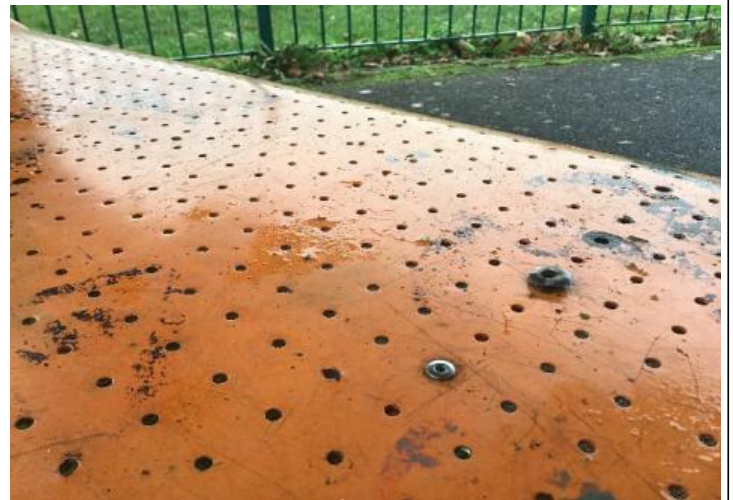
Finding: Pop rivet fixings have failed on the seat

Action: Replace the failed pop rivets

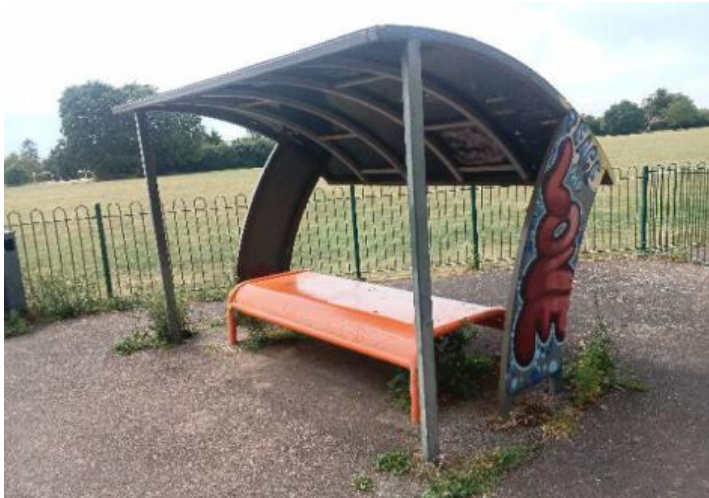
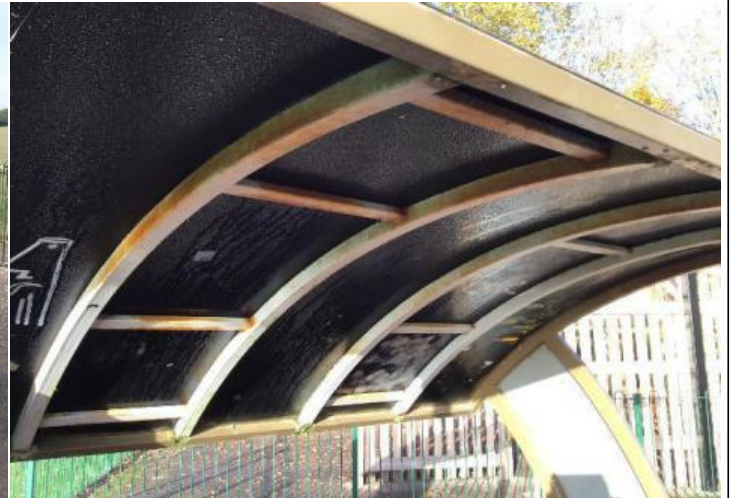
Finding: There is surface corrosion / rust present on the item

Action: Consider treating the item

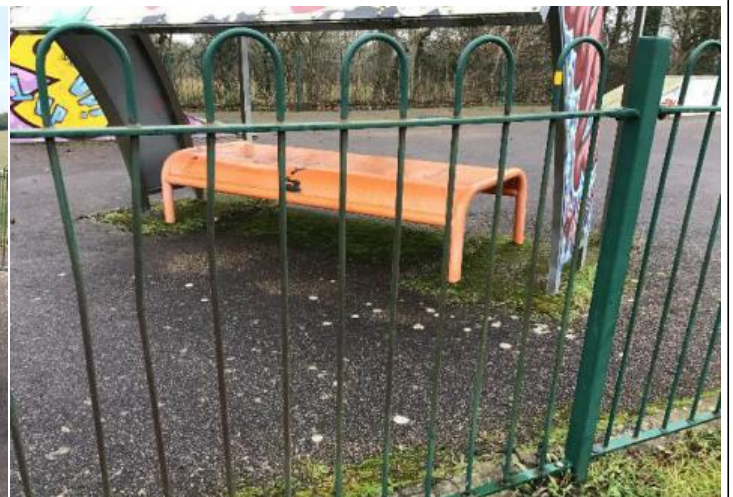
Finding: There is algae, silt or moss growth on the surface resulting in slippery conditions

Action: Clean and treat appropriately

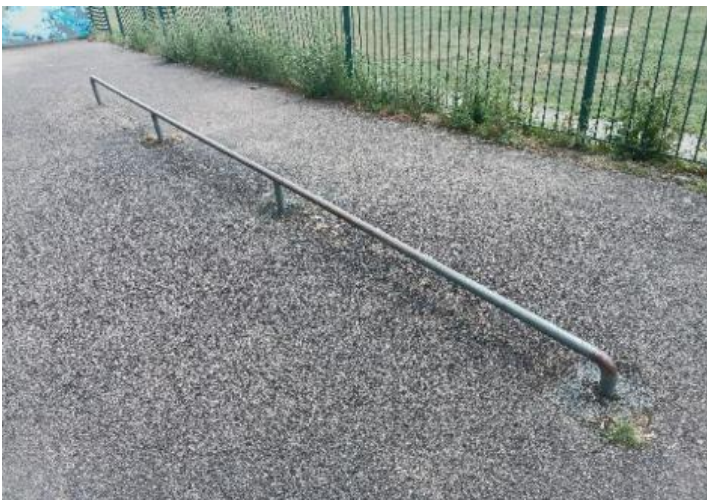
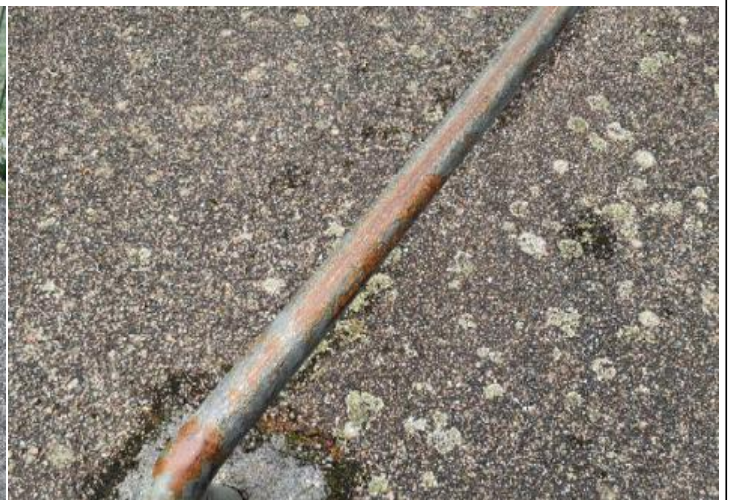
Finding: There is surface corrosion / rust present on the item

Action: Consider treating the item

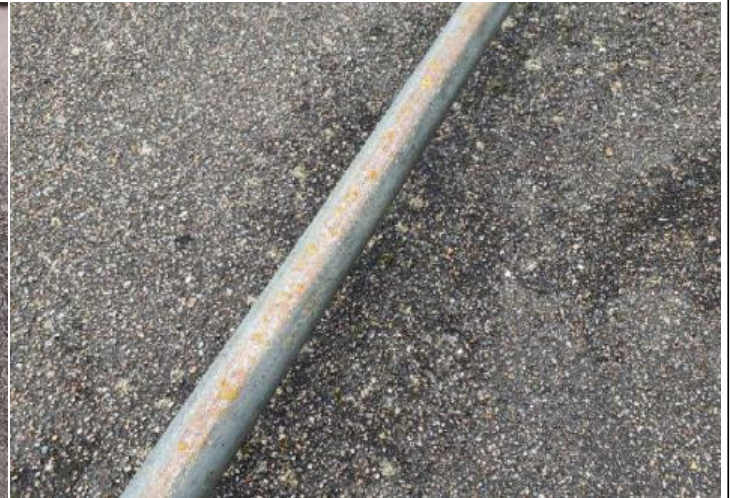
Finding: There is surface corrosion / rust present on the item

Action: Consider treating the item

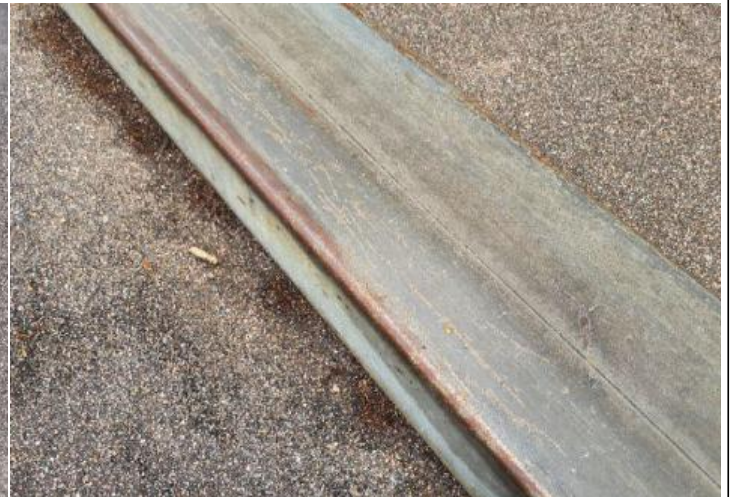
Finding: There is surface corrosion / rust present on the item

Action: Consider treating the item

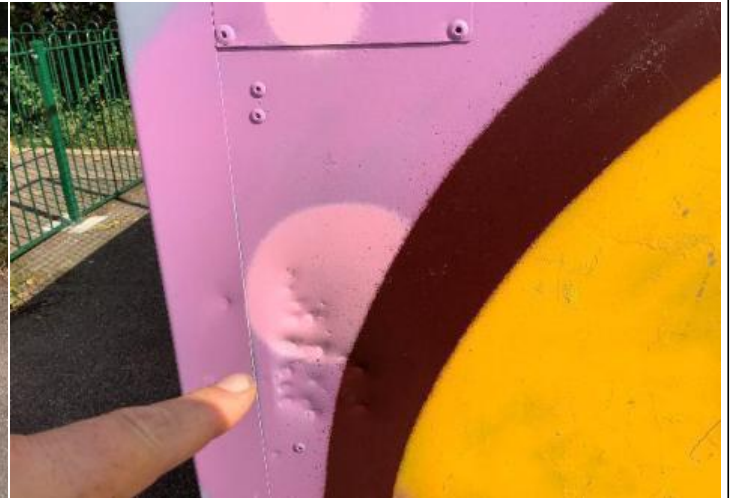
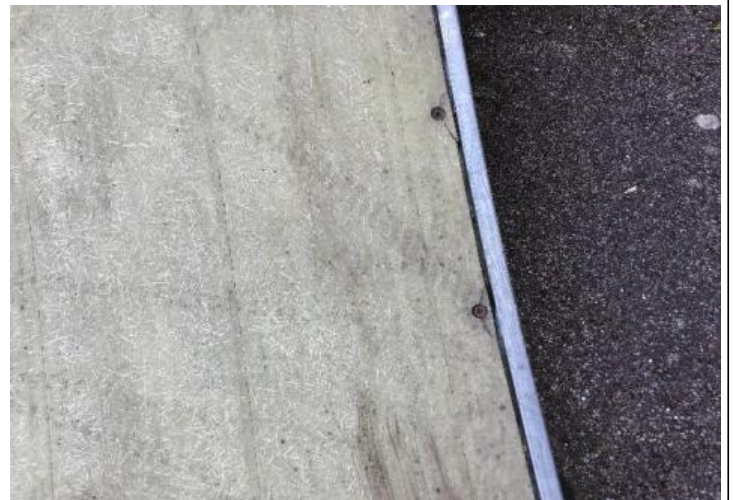
Finding: The item has been damaged

Action: Monitor for any further deterioration and replace as required

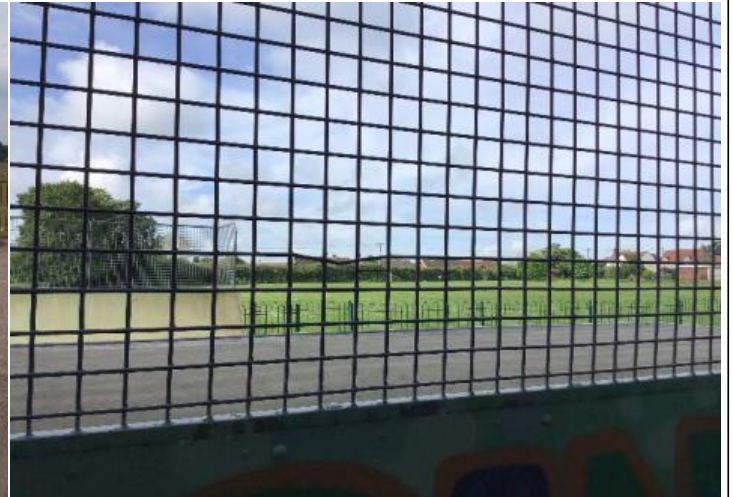
Finding: There is some damage to the fence sections

Action: Monitor for any further deterioration and repair as required

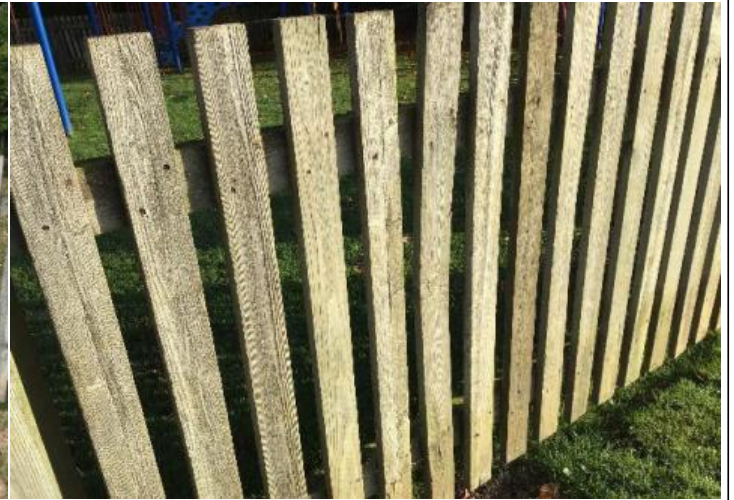
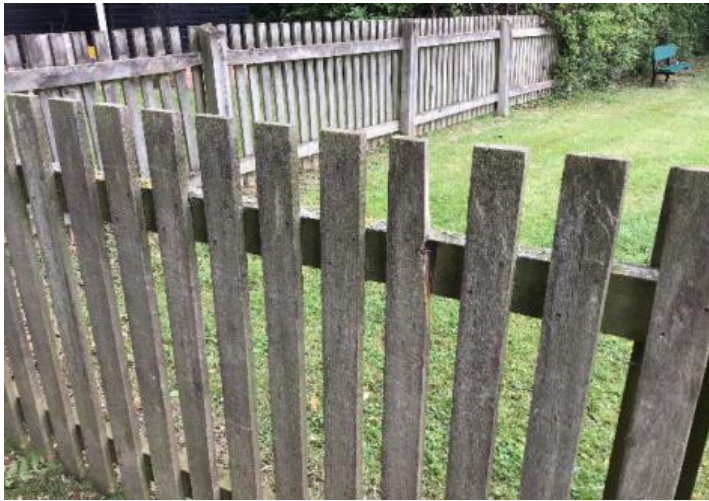
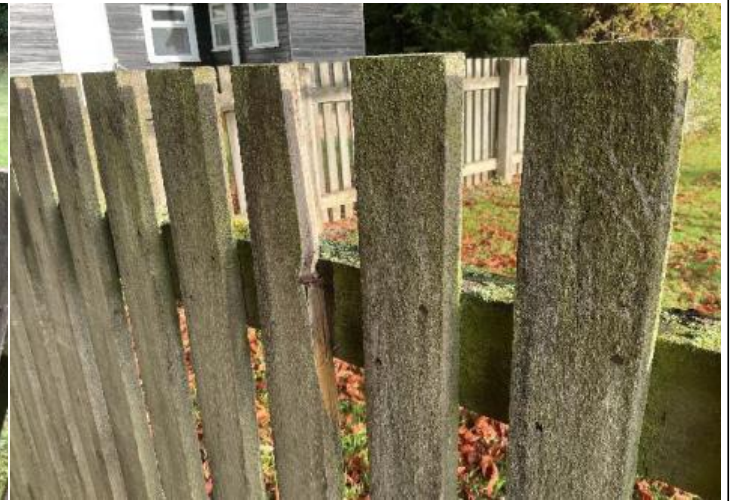
Finding: Slat damaged

Action: Replace damaged slat

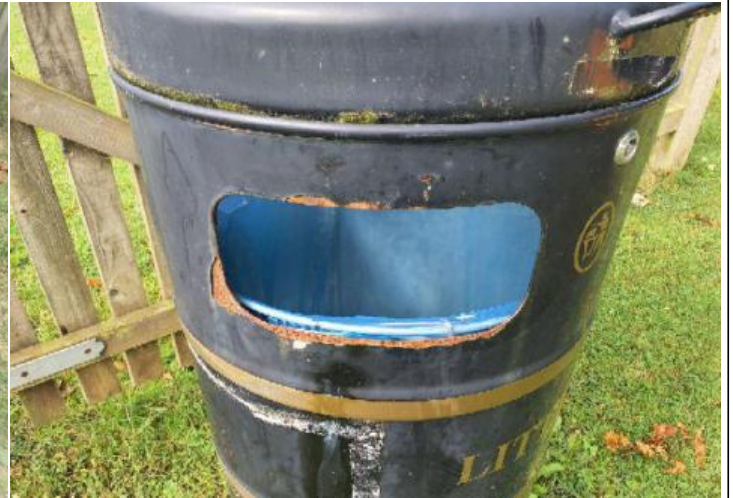
Finding: The paintwork on this item has been damaged or worn exposing the metal underneath which is rusting / corroding

Action: Treat affected areas and repaint

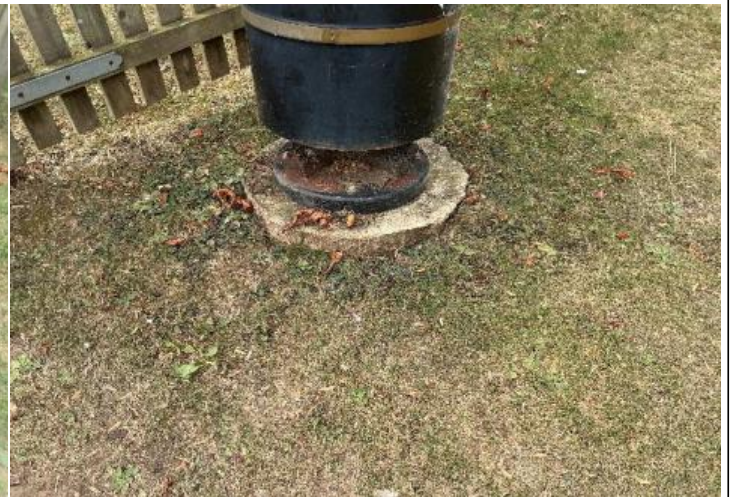
Finding: The foundation is loose

Action: Reinstate the foundation

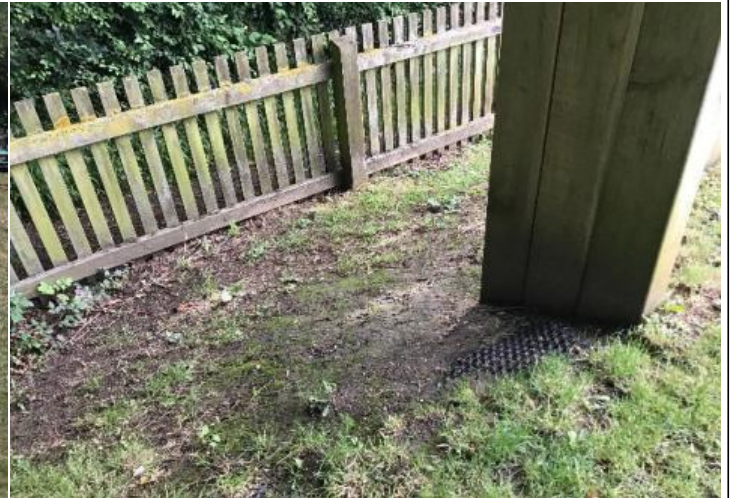
Finding: The surface has eroded in some areas and may be slippery in wet conditions
Action: Reinststate the surface

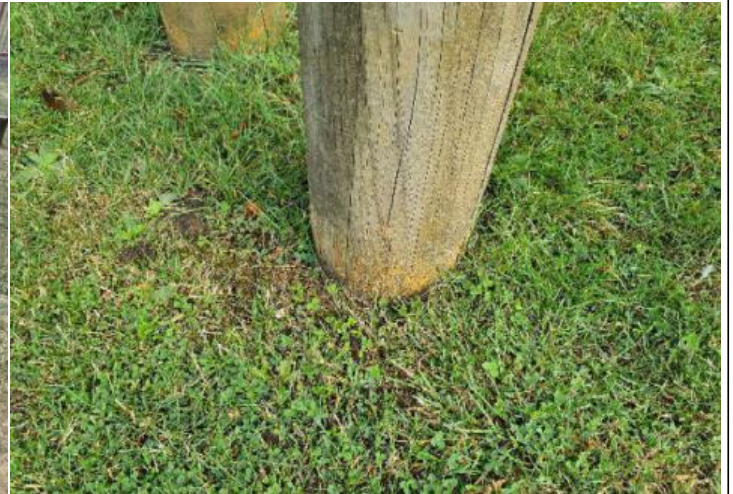
Finding: There is some strimmer / machinery damage apparent on the posts, this can penetrate the preservative applied to the timber and accelerate the rotting process

Action: Monitor for any deterioration (rot) and replace as required

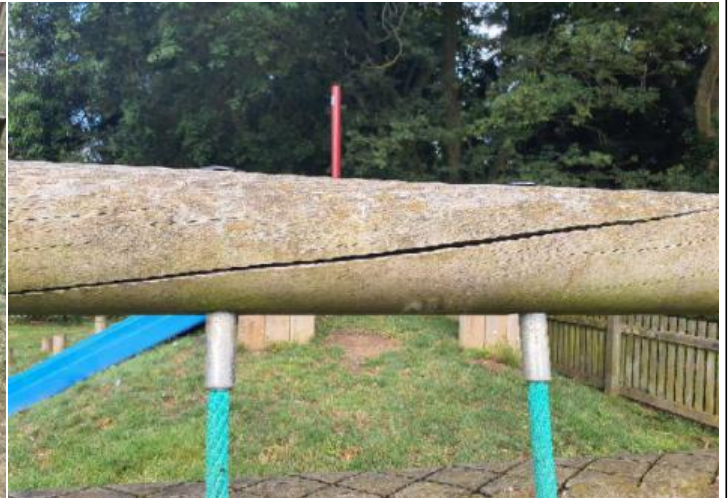
Finding: The timber has a number of splits/shakes or air cracks and this may affect the stability or allow water ingress which will accelerate the rotting process

Action: Monitor to ensure the splits do not cross through fixing points of the structure and/or cause any instability

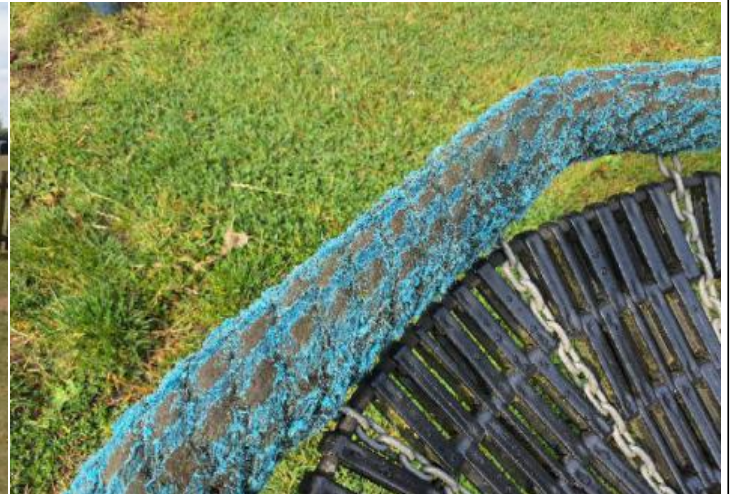
Finding: The seat has minor damage or wear

Action: Monitor for any further deterioration and replace as required

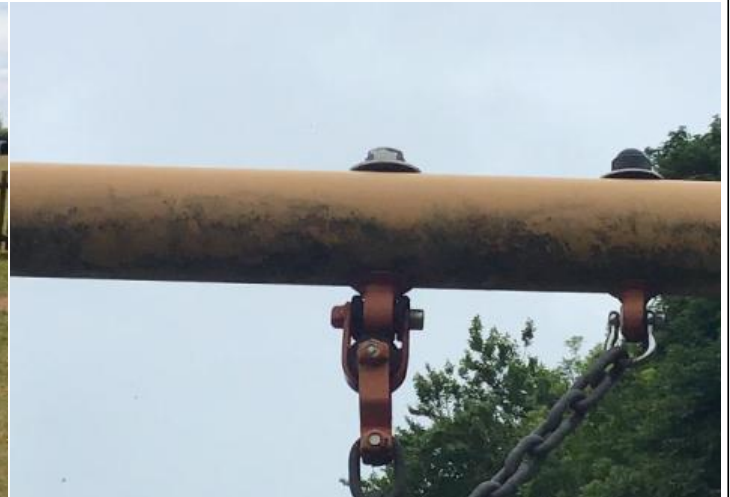
Finding: There is/are bolt cap covers missing or damaged on the item

Action: Replace missing or damaged bolt cap covers

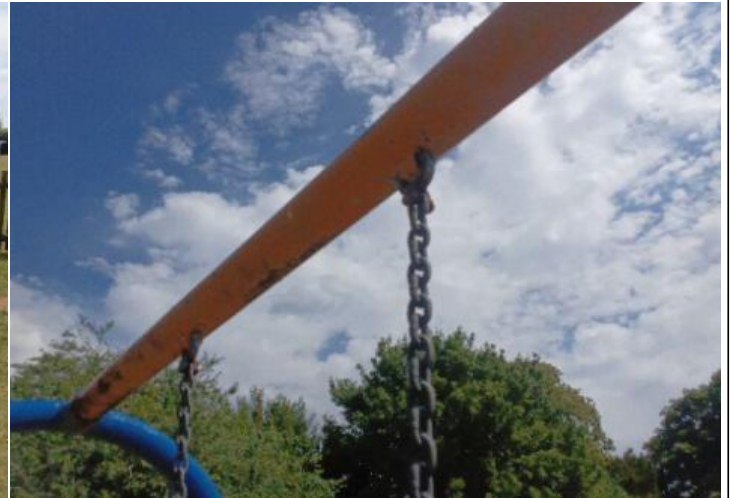
Finding: The bushes are showing signs of wear

Action: Monitor for any further deterioration and replace as required

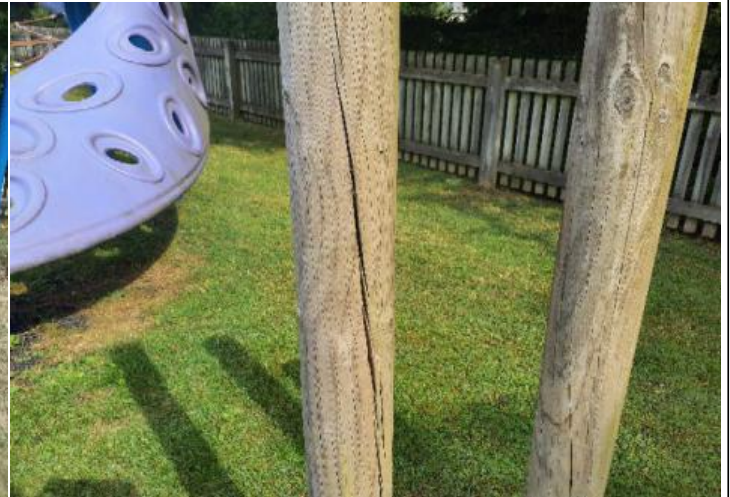
Finding: The timber has a number of splits/shakes or air cracks and this may affect the stability or allow water ingress which will accelerate the rotting process

Action: Monitor to ensure the splits do not cross through fixing points of the structure and/or cause any instability

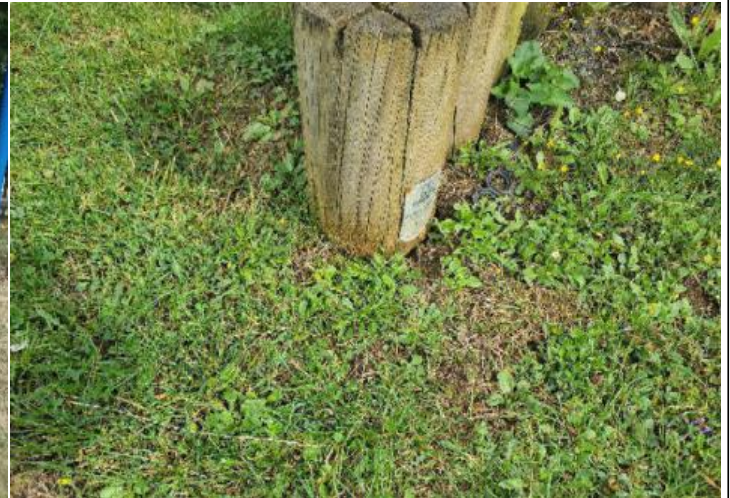
Finding: There is some strimmer / machinery damage apparent on the posts, this can penetrate the preservative applied to the timber and accelerate the rotting process

Action: Monitor for any deterioration (rot) and replace as required

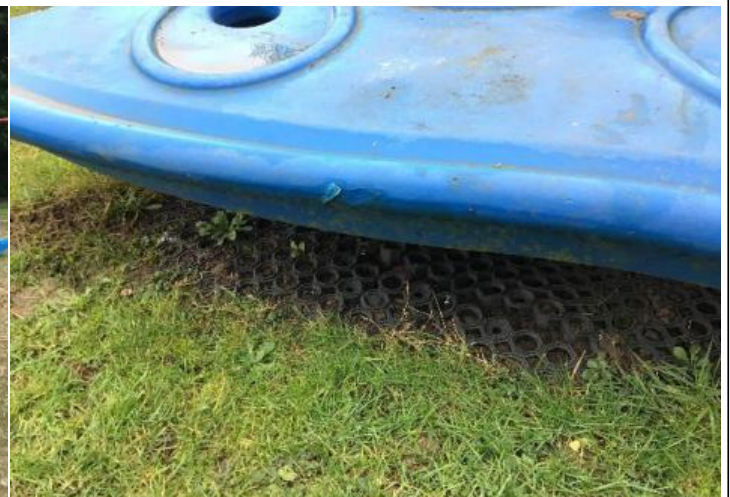
Finding: The item has been damaged

Action: Sand down plastic to remove sharp edge

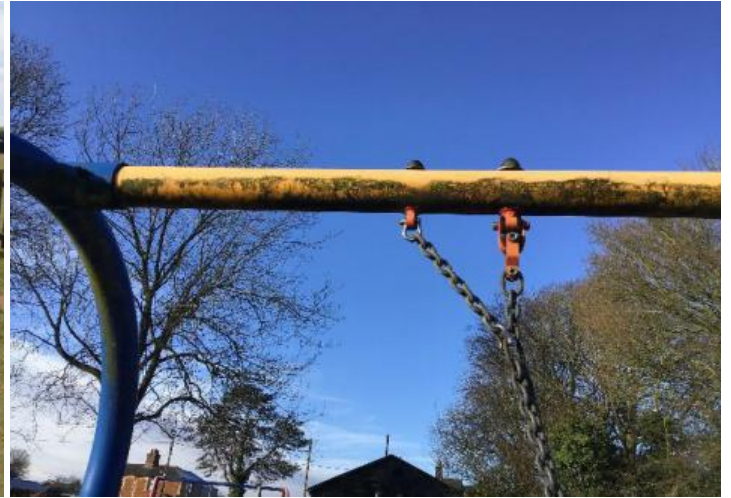
Finding: There is algae or moss on the surface of the equipment

Action: Clean and treat appropriately
