Play Area Inspection Reports & Remedial Work

Wickhambrook. Bury Road

Inspection Ref: 2949094

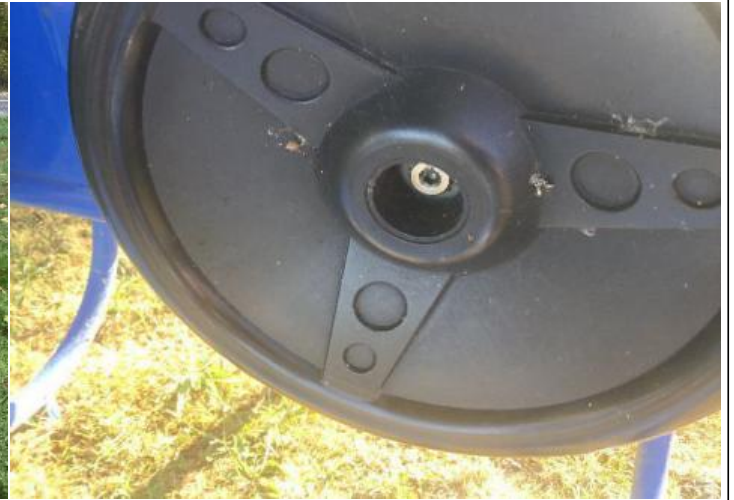
Finding: Cap covers missing

Action: Replace

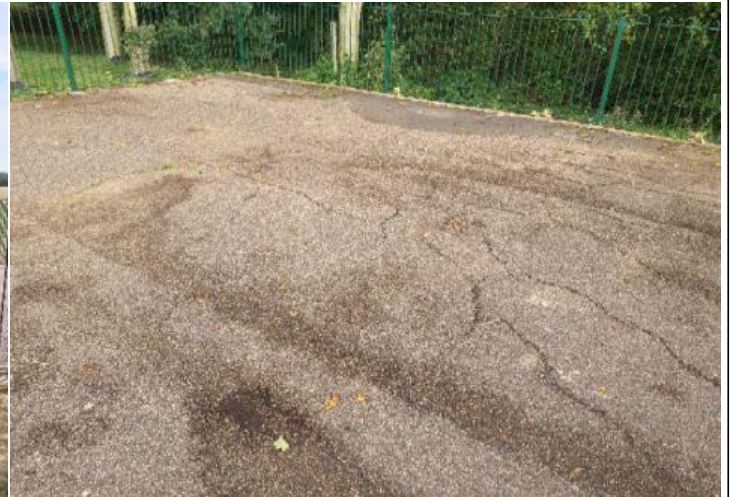
Finding: There is moderate damage to the surface

Action: Repair the damaged areas of surfacing

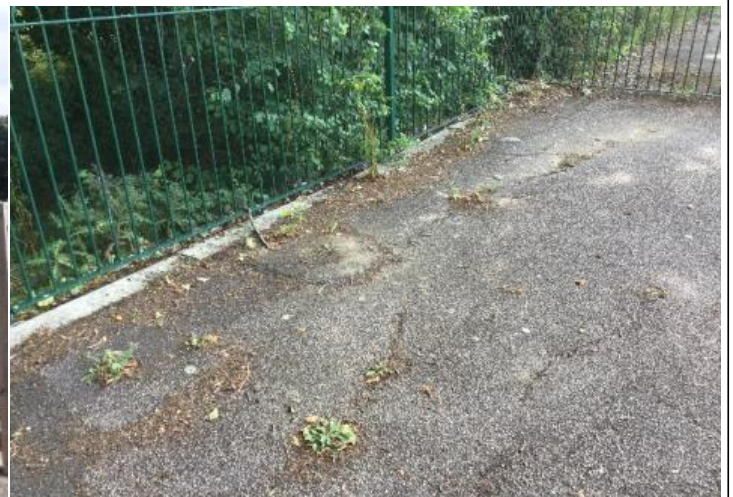
Finding: There is algae, silt or moss growth on the surface resulting in slippery conditions
Action: Clean and treat appropriately

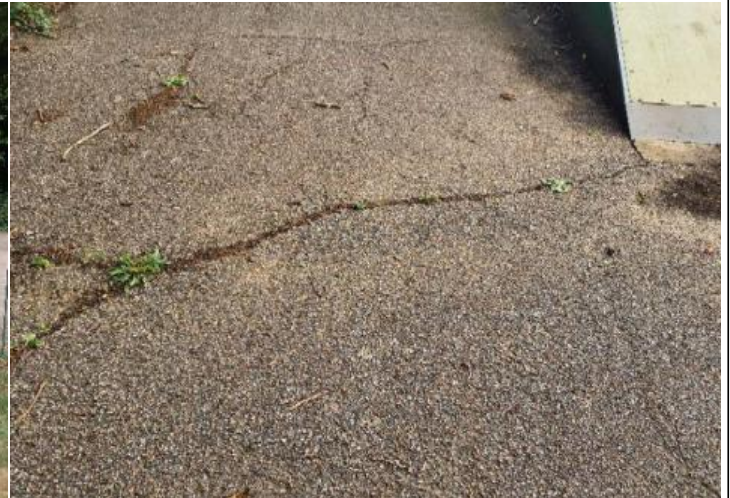
Finding: There is root damage to the surfacing creating unforeseen changes in levels

Action: Repair the damaged areas of tarmac to provide a uniform surface

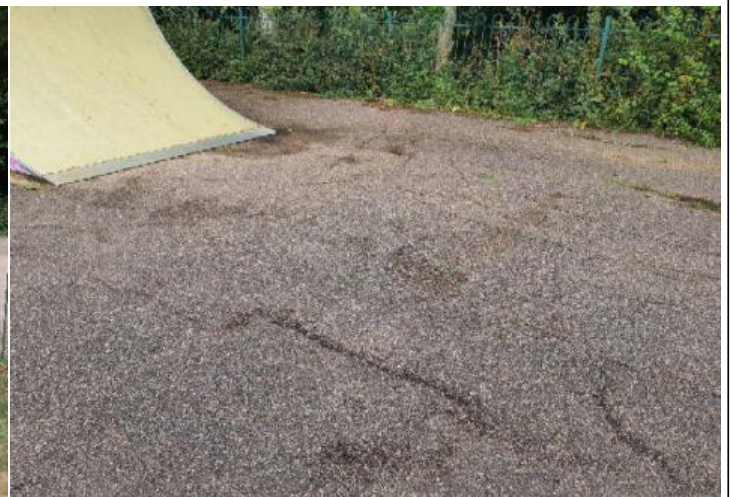
Finding: There is some damage apparent to the riding surface

Action: Monitor for any further deterioration and repair as required

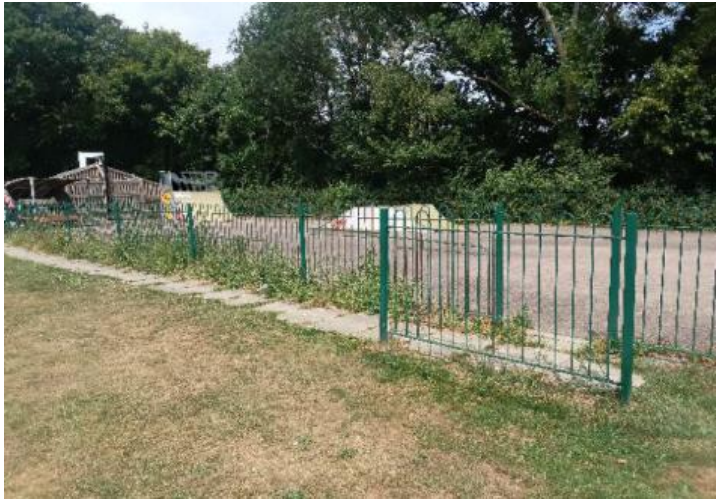
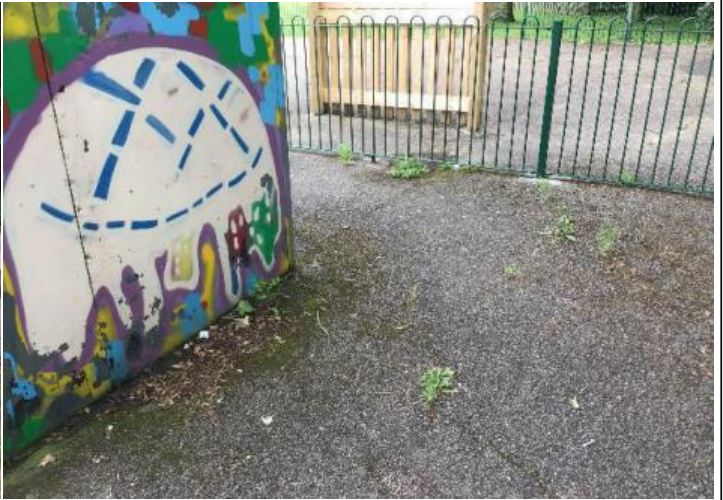
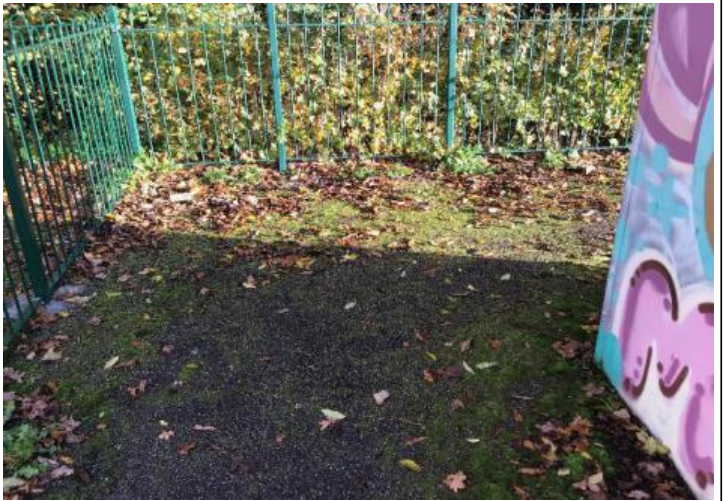
Finding: There is algae, silt or moss growth on the surface resulting in slippery conditions

Action: Clean and treat appropriately

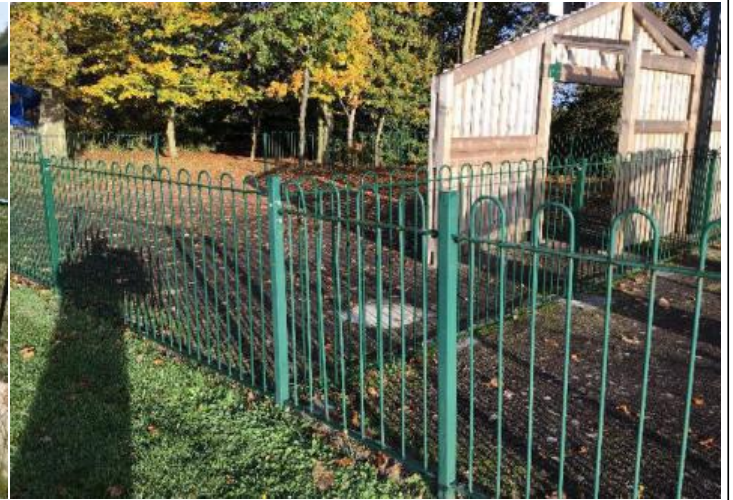
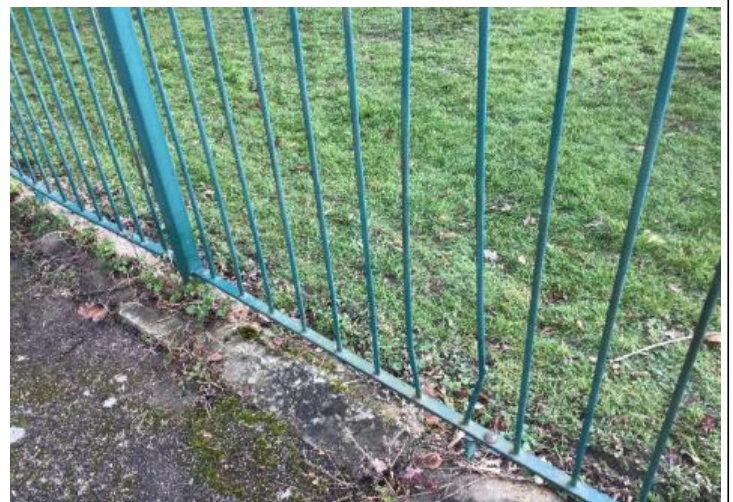
Finding: There is some damage to the fence sections

Action: Monitor for any further deterioration and repair as required

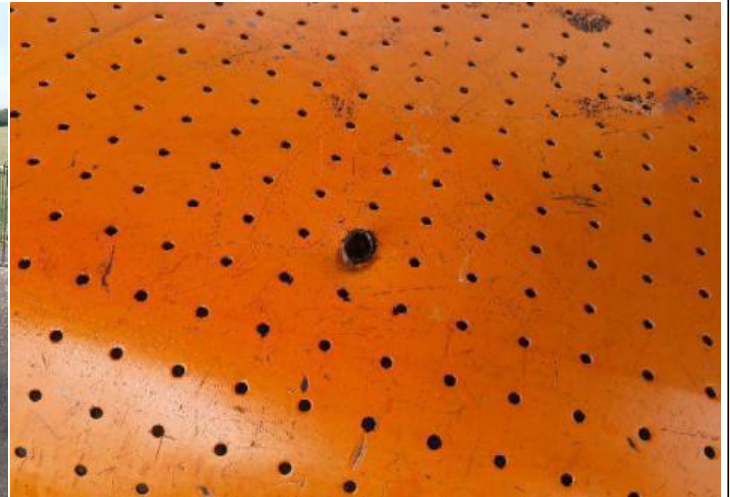
Finding: There is some evidence of fire damage to the item

Action: Monitor for any further deterioration and repair as required

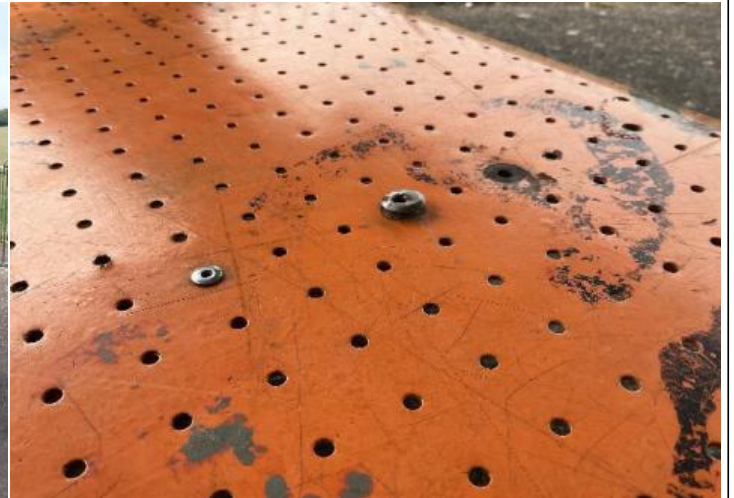
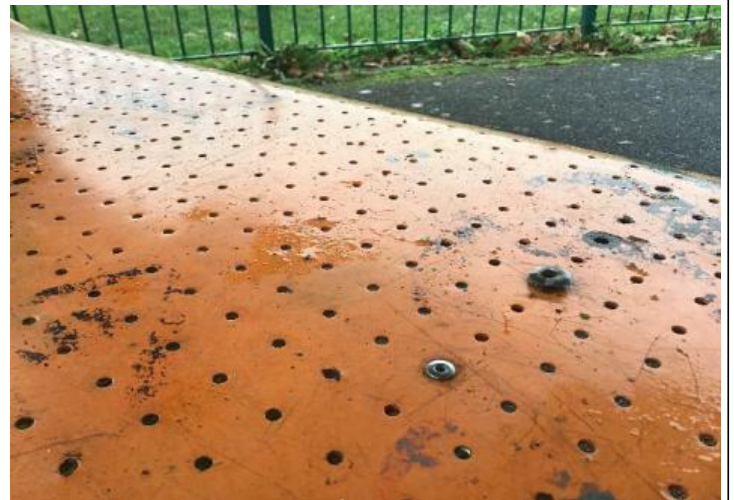
Finding: Pop rivet fixings have failed on the seat

Action: Replace the failed pop rivets

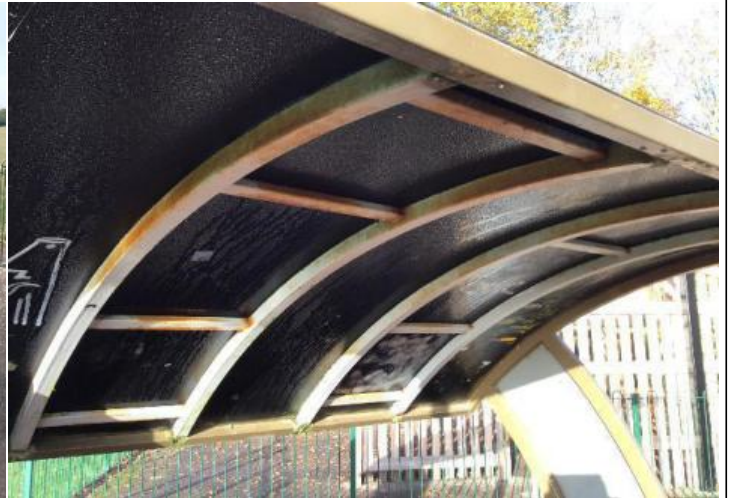
Finding: There is surface corrosion / rust present on the item

Action: Consider treating the item

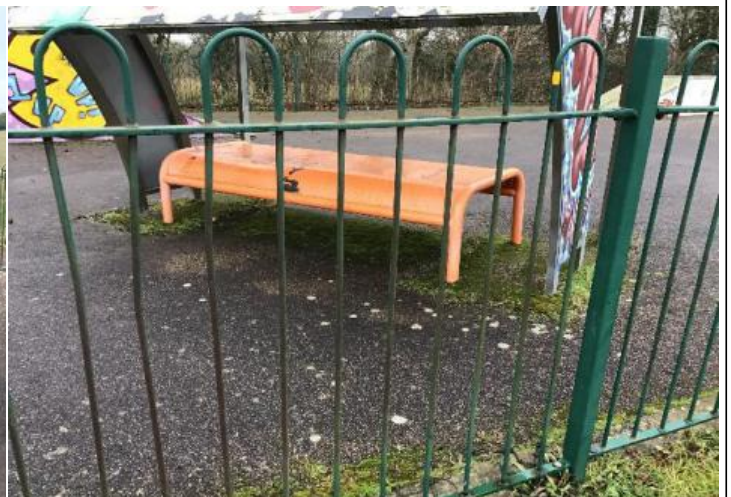
Finding: There is algae, silt or moss growth on the surface resulting in slippery conditions

Action: Clean and treat appropriately

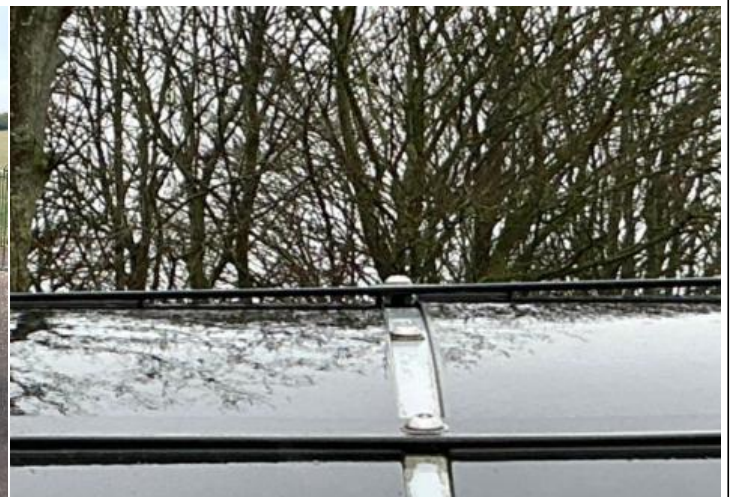
Finding: A number of fixing(s) have worked loose

Action: Secure all loose fixings

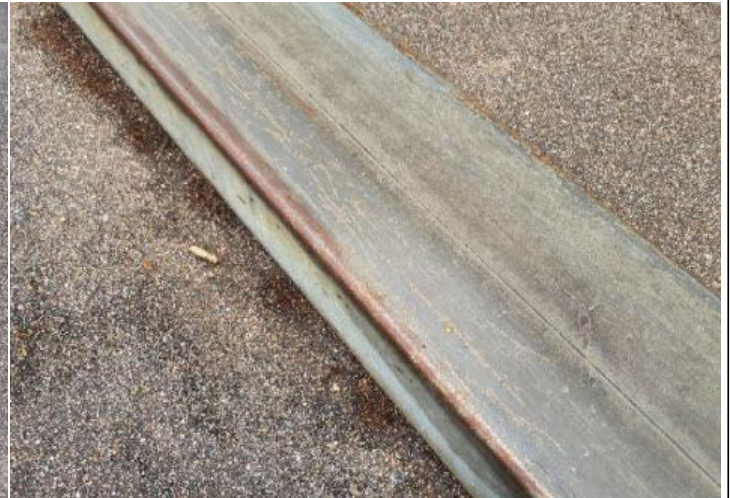
Finding: There is surface corrosion / rust present on the item

Action: Consider treating the item

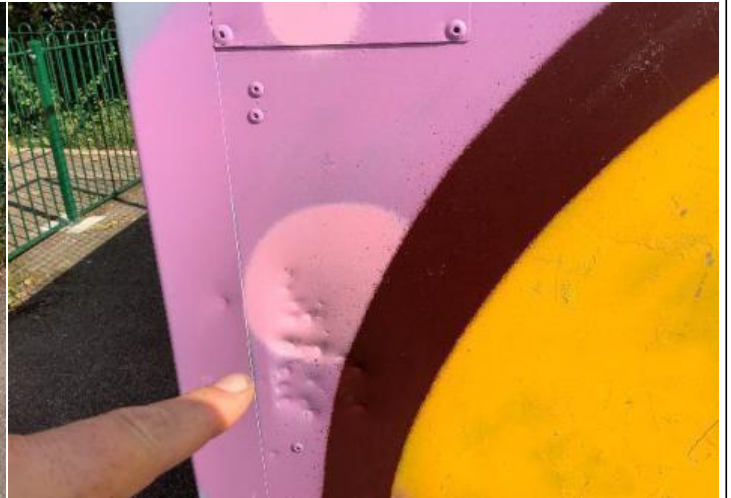
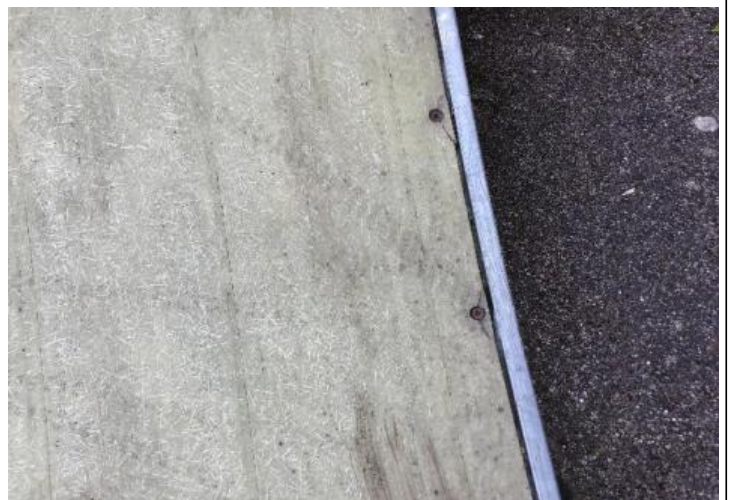
Finding: The item has been damaged

Action: Monitor for any further deterioration and replace as required

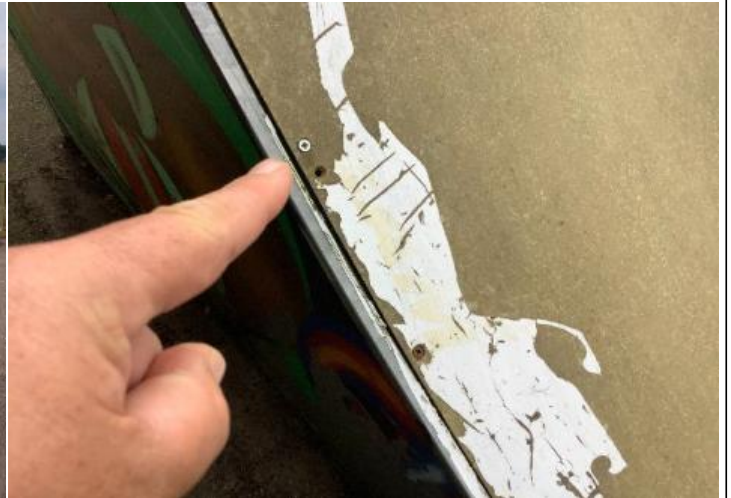
Finding: A number of fixing(s) have worked loose

Action: Secure all loose fixings

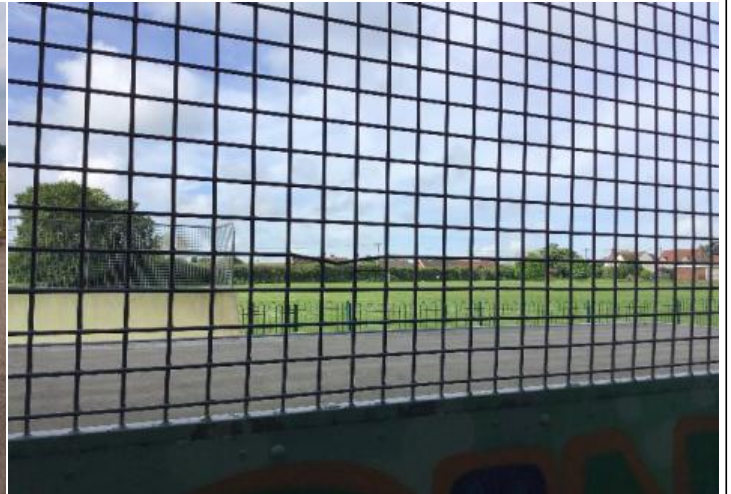
Finding: There is some damage to the fence sections

Action: Monitor for any further deterioration and repair as required

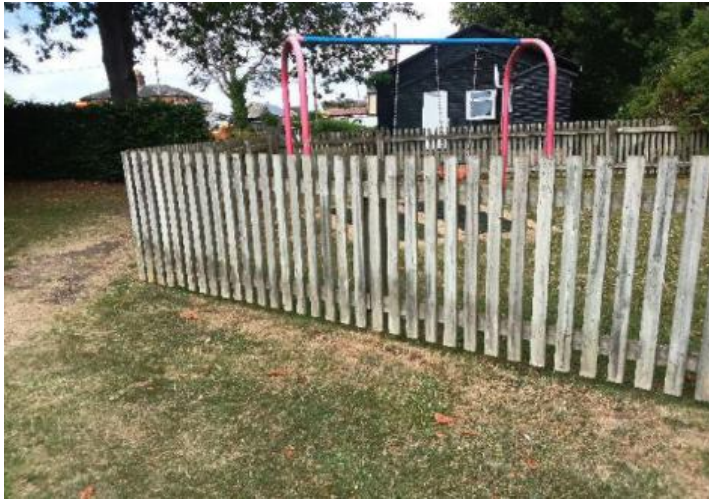
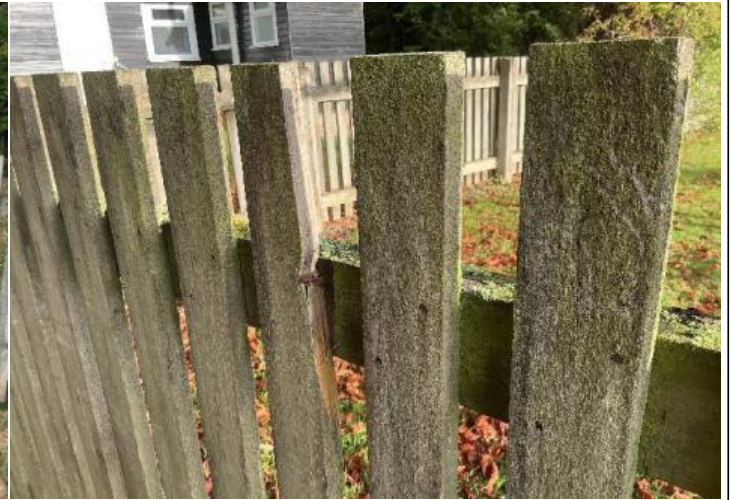
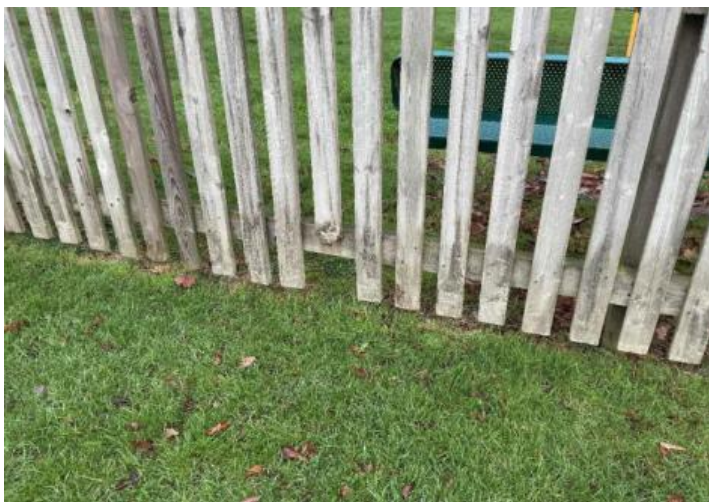
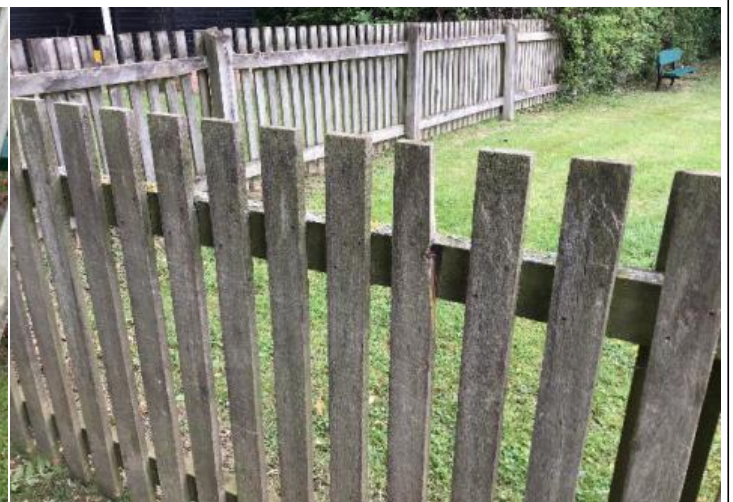
Finding: Slats damaged

Action: Replace damaged slat

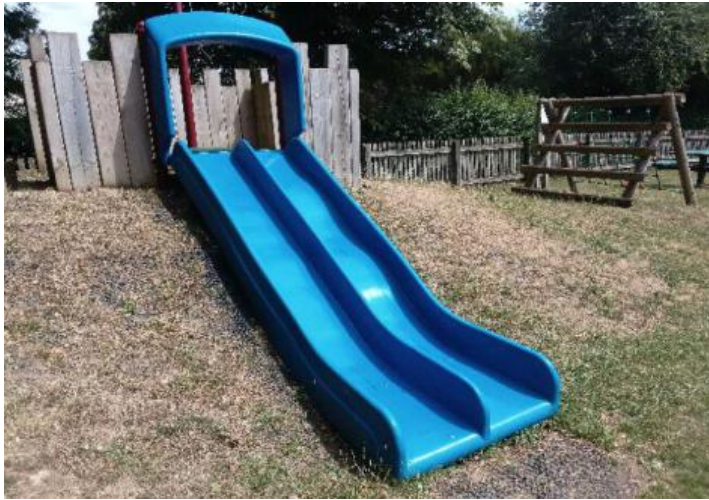
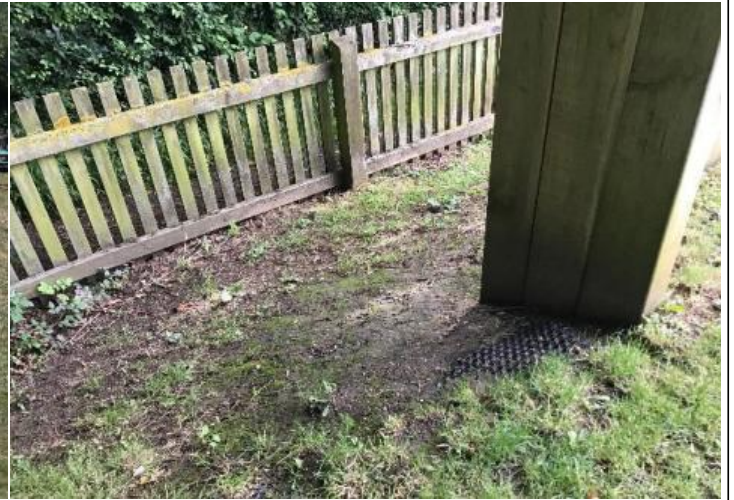
Finding: The surface has eroded in some areas and may be slippery in wet conditions
Action: Reinststate the surface

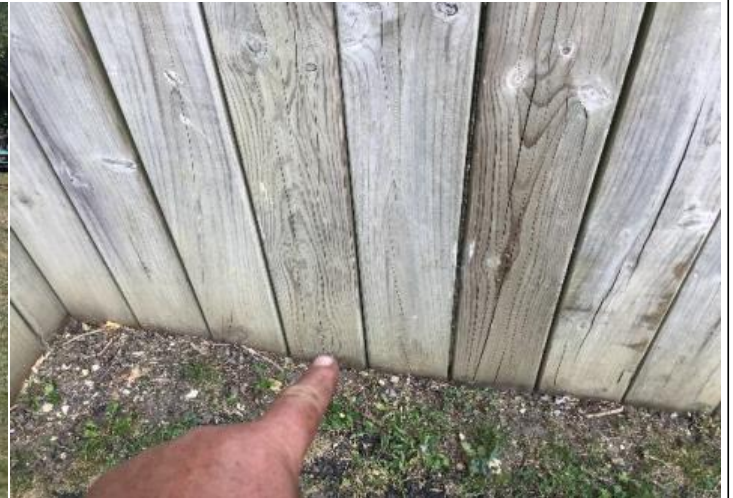
Finding: Some timbers are slightly loose in the foundation

Action: Monitor for deterioration

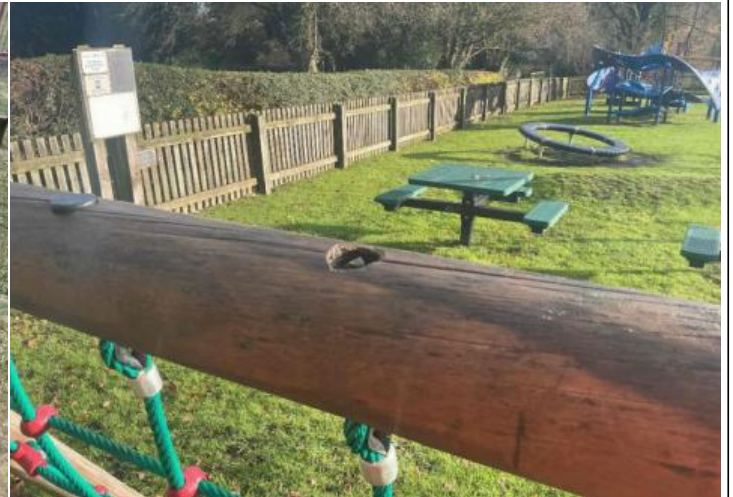
Finding: There is/are bolt cap covers missing or damaged on the item

Action: Replace missing or damaged bolt cap covers

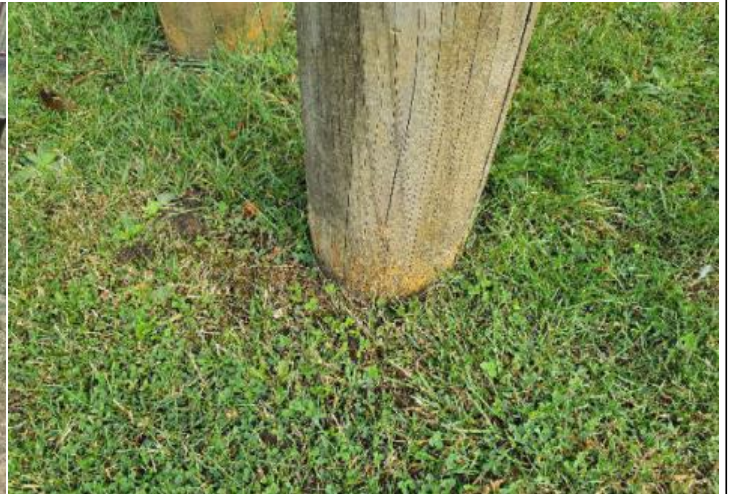
Finding: There is some strimmer / machinery damage apparent on the posts, this can penetrate the preservative applied to the timber and accelerate the rotting process

Action: Monitor for any deterioration (rot) and replace as required

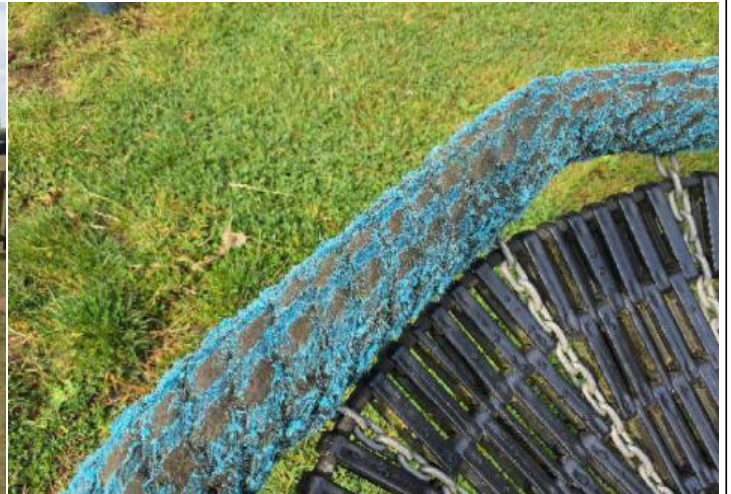
Finding: The seat has minor damage or wear

Action: Monitor for any further deterioration and replace as required

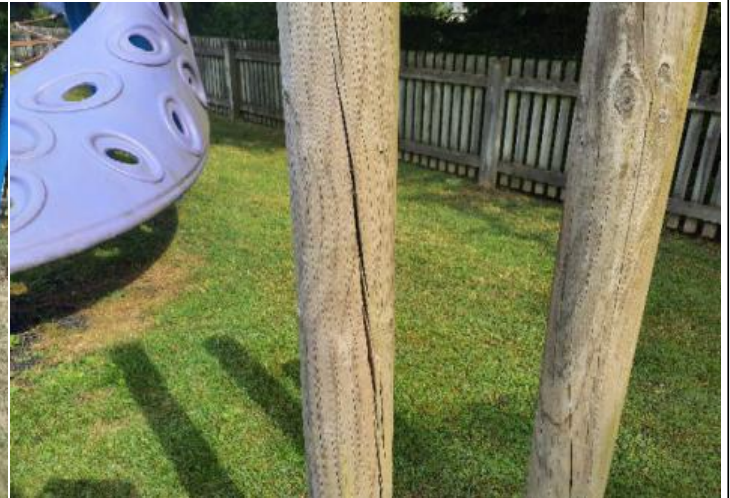
Finding: The timber has a number of splits/shakes or air cracks and this may affect the stability or allow water ingress which will accelerate the rotting process
Action: Monitor to ensure the splits do not cross through fixing points of the structure and/or cause any instability

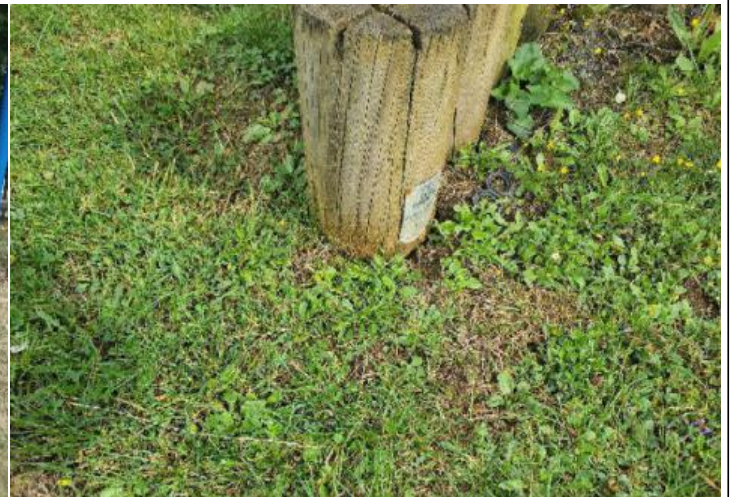
Finding: There is some strimmer / machinery damage apparent on the posts, this can penetrate the preservative applied to the timber and accelerate the rotting process
Action: Monitor for any deterioration (rot) and replace as required

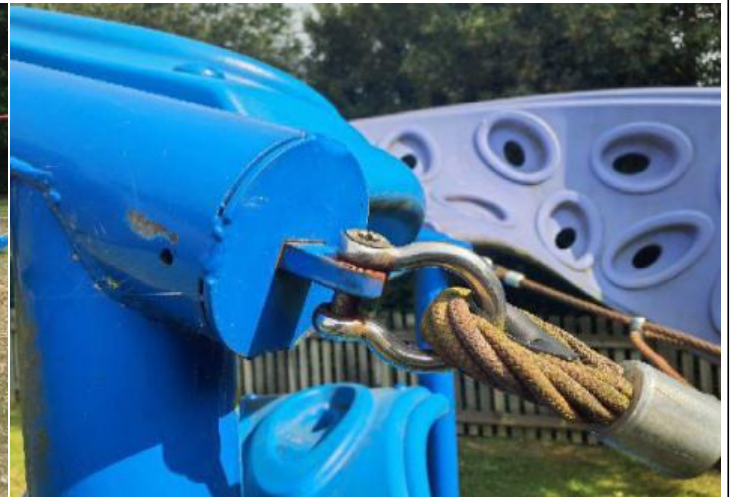
Finding: The connecting lugs are showing signs of wear

Action: Monitor for any further deterioration and repair as required

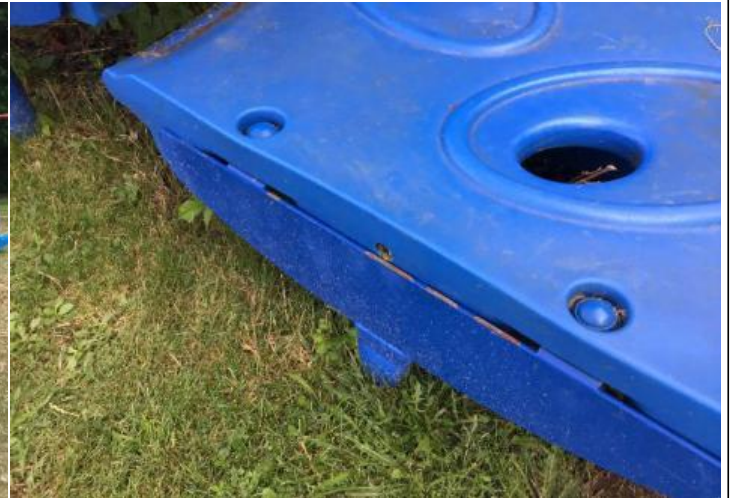
Finding: There is surface corrosion / rust present on the item

Action: Consider treating the item

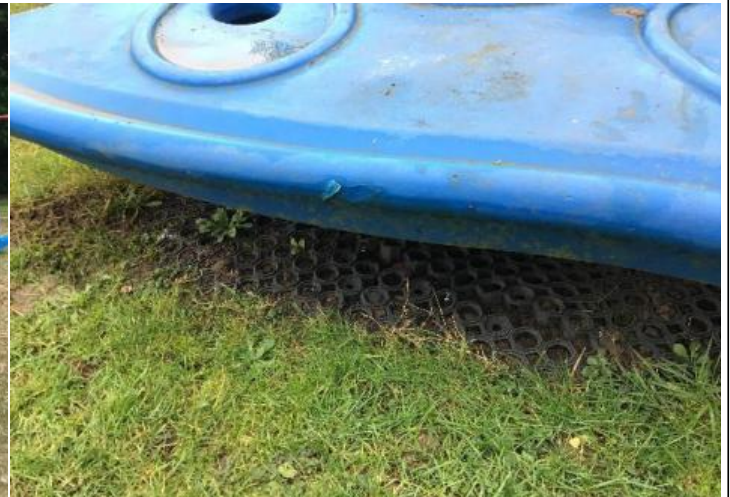
Finding: The item has been damaged

Action: Sand down plastic to remove sharp edge

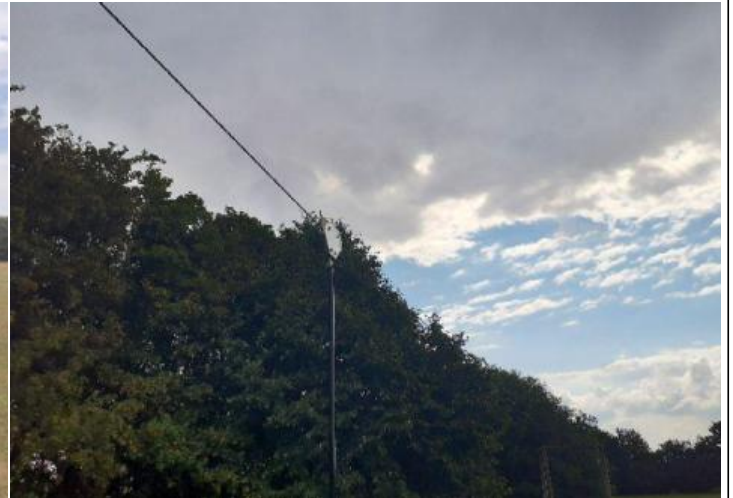
Finding: We have completed a visual inspection of the suspension links, cable and fixing points from ground level, however it is not possible to fully inspect these areas without either hiring equipment to gain access or removing the cable and suspension and inspecting at ground level. We recommend that the main cable and fixing security is thoroughly inspected at least in accordance with the manufacturers recommendations to check for wear, damage, security or internal rusting; this will help to ensure the continued safe use of the equipment

Action: Inspect in accordance with the manufacturers recommendations

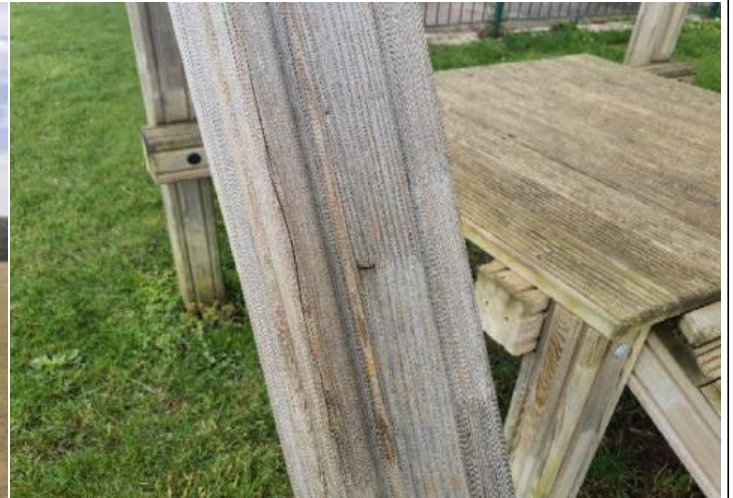
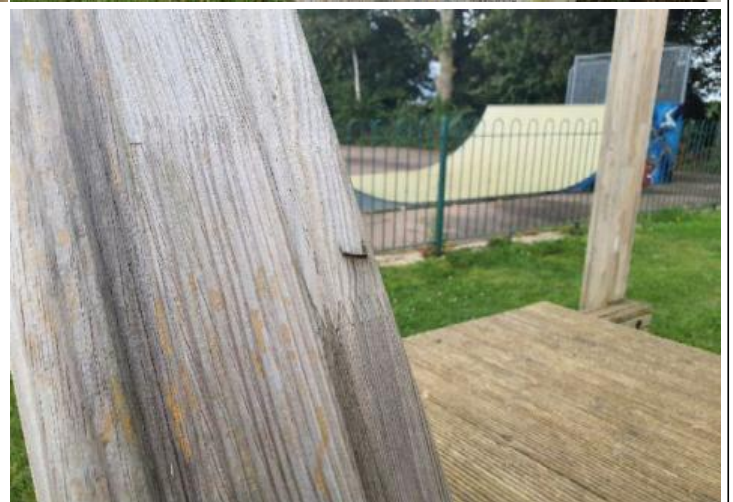
Finding: There are a number of redundant staples attached to the equipment **Action:** Remove redundant staples
