## Play Area Inspection Reports & Remedial Work

## Wickhambrook. Bury Road

Inspection Ref: 2999726

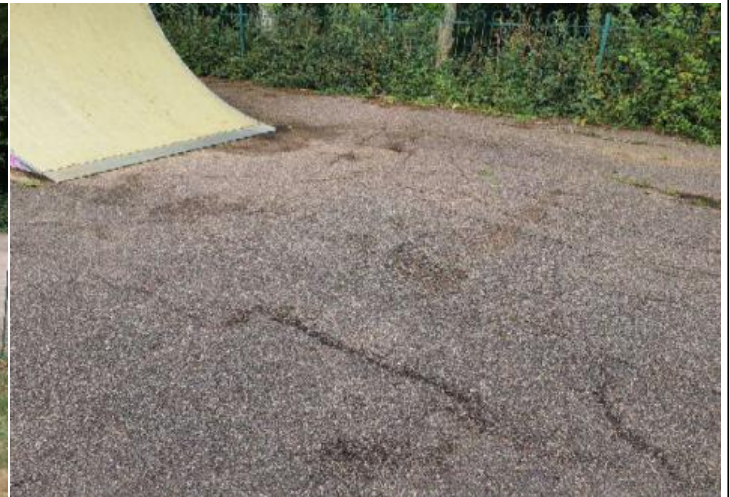
**Finding:** There is some damage apparent to the riding surface

**Action:** Monitor for any further deterioration and repair as required

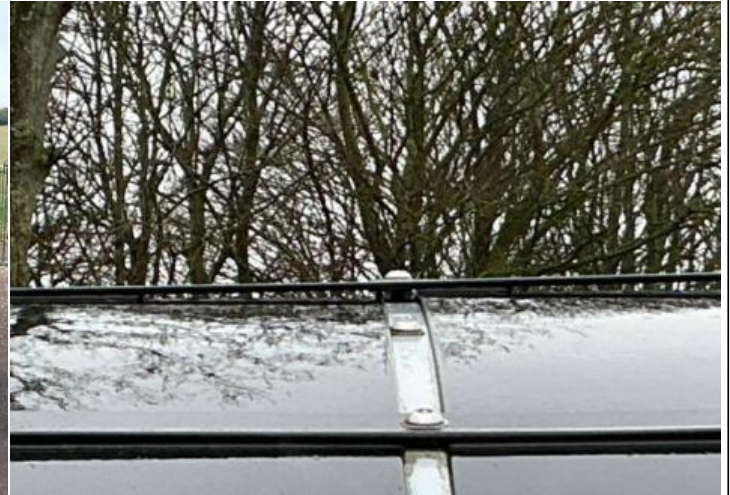
**Finding:** A number of fixing(s) have worked loose

**Action:** Secure all loose fixings

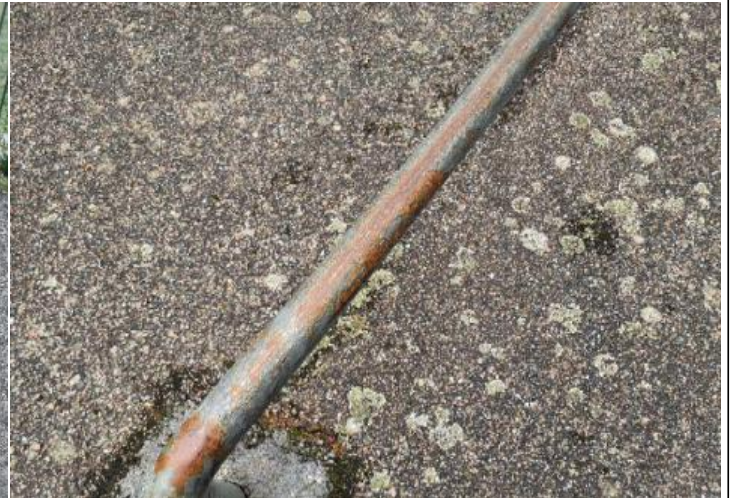
**Finding:** There is surface corrosion / rust present on the item

**Action:** Consider treating the item

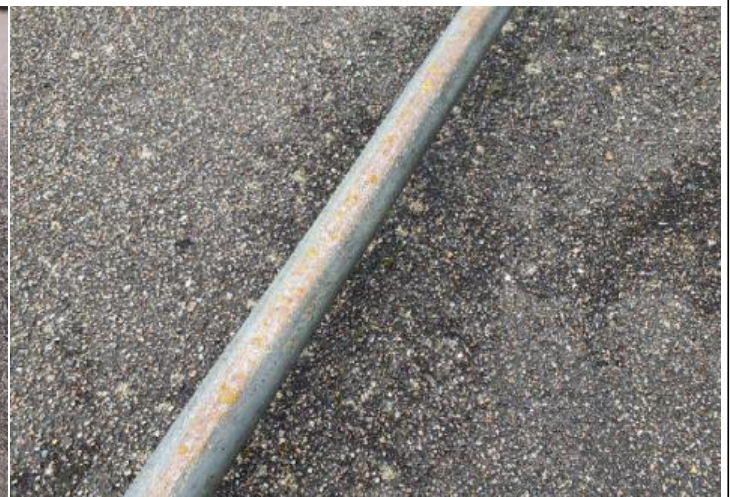
**Finding:** There is surface corrosion / rust present on the item

**Action:** Consider treating the item

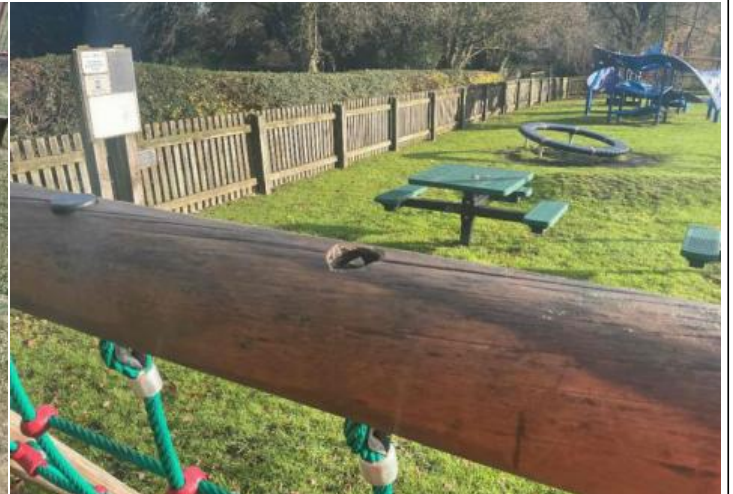
**Finding:** There is/are bolt cap covers missing or damaged on the item

**Action:** Replace missing or damaged bolt cap covers
