## **Play Area Inspection Reports & Remedial Work**

### Playground Maintenance Estimate for Three Site Remedials

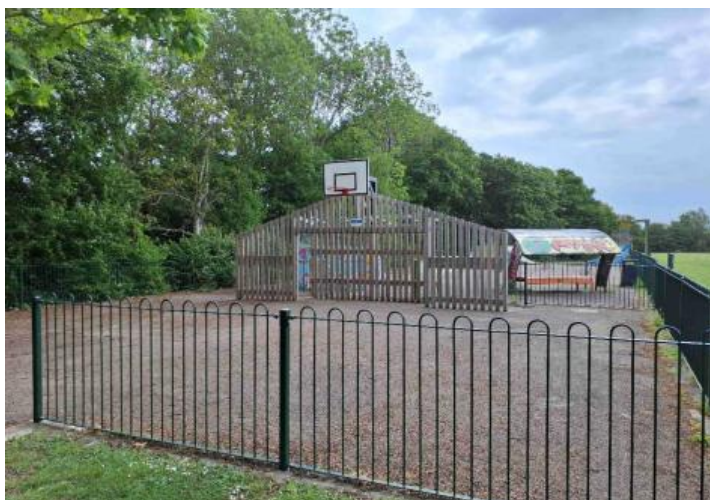
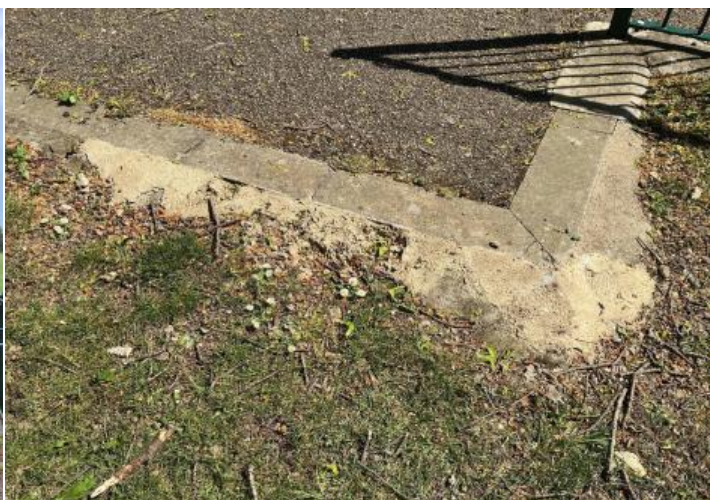
**Finding:** The concrete at site entrance is damaged creating a trip hazard

**Action:** Repair

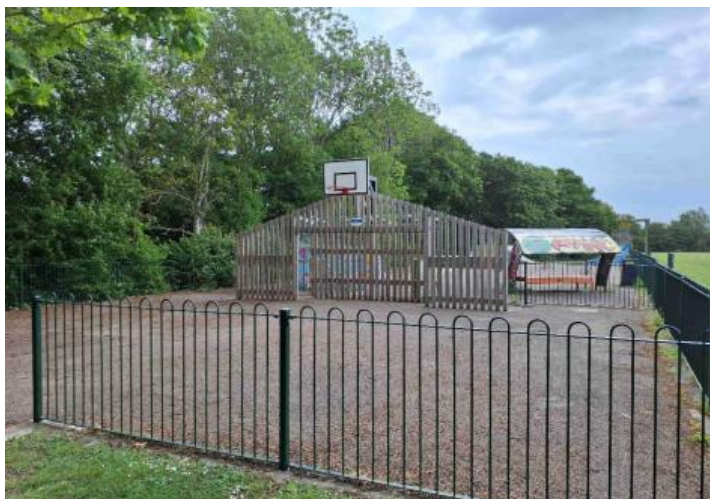
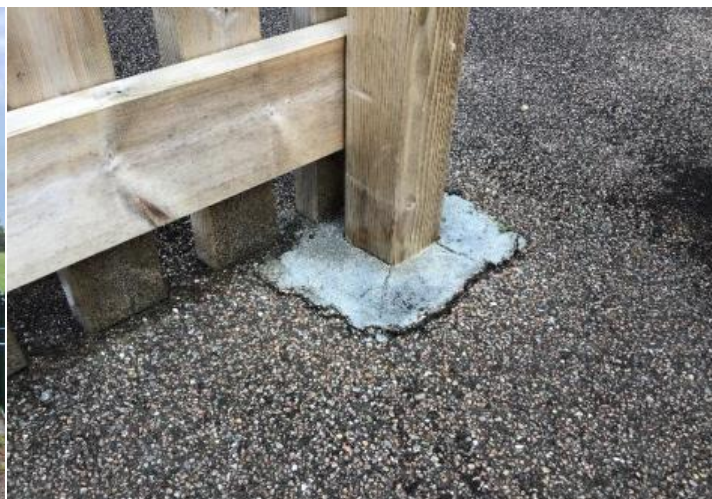
**Finding:** The concrete foundation around the goal structure is lifting

**Action:** Repair

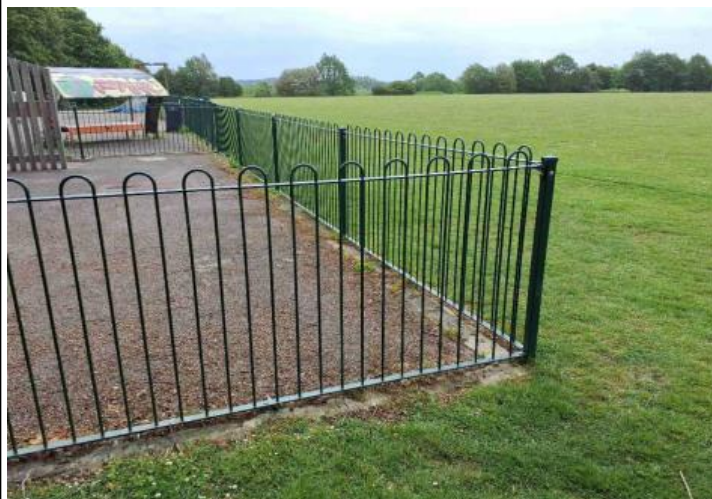
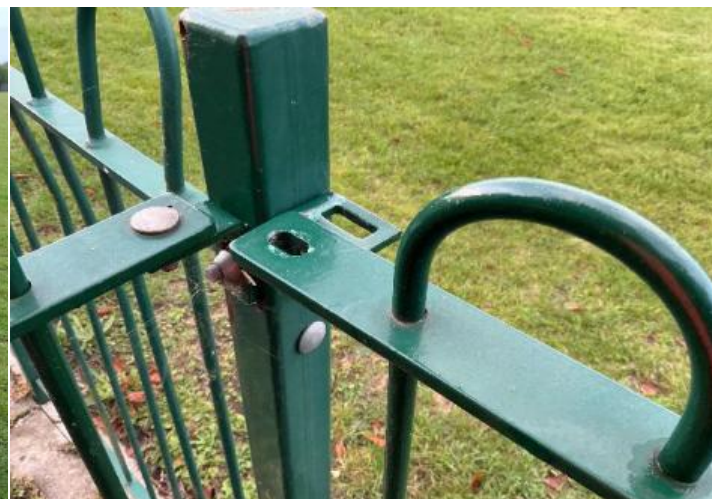
**Finding:** There are a number of fixings missing from the fence

**Action:** Replace missing fixings

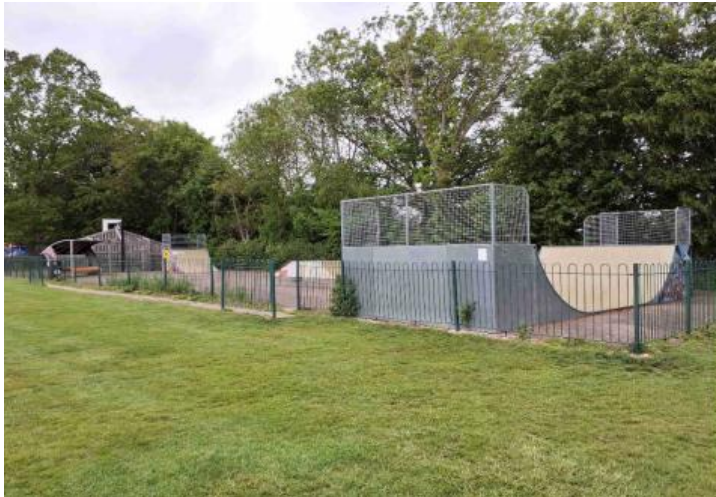
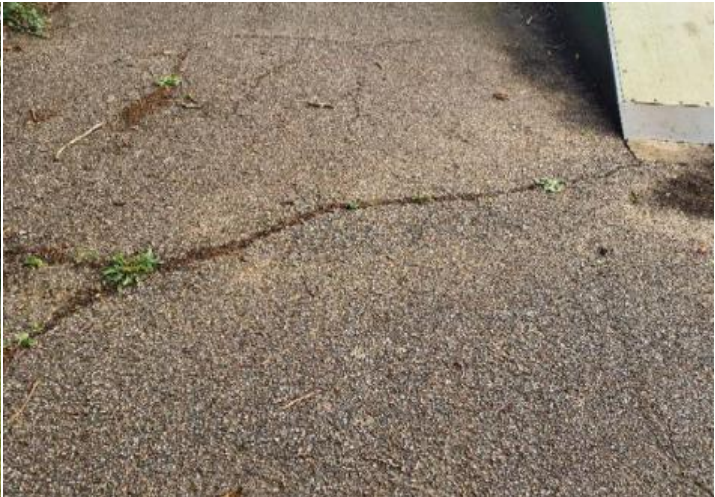
| <div> 8 - Low Risk (Finding 1) </div> | | | |
|---|--|---|--|
| <b>Finding:</b> There is root damage to the surfacing creating unforeseen changes in levels | | <b>Action:</b> Repair the damaged areas of tarmac to provide a uniform surface | |

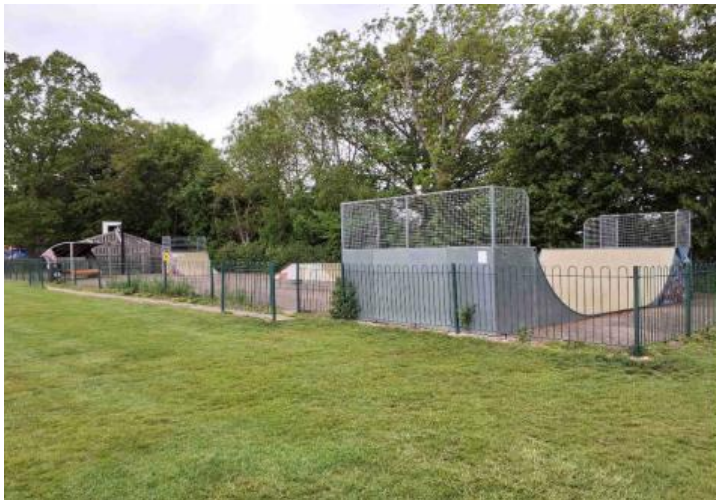
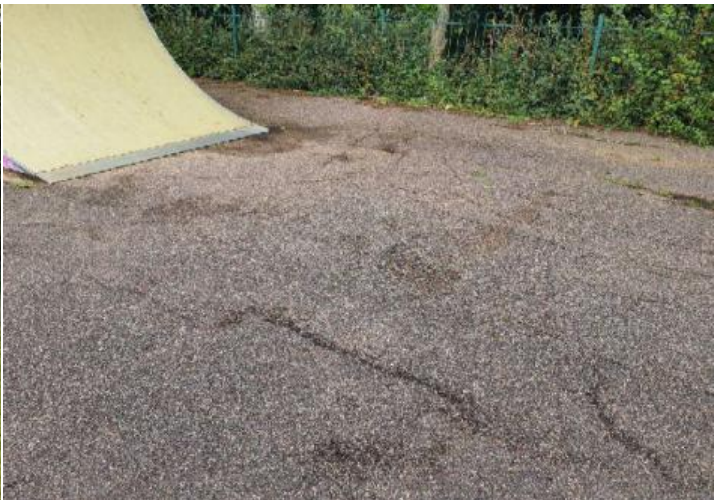
| <div> <div>Finding:</div> <div>There is some damage apparent to the riding surface</div> </div> | | <div> <div>Action:</div> <div>Monitor for any further deterioration and repair as required</div> </div> | |

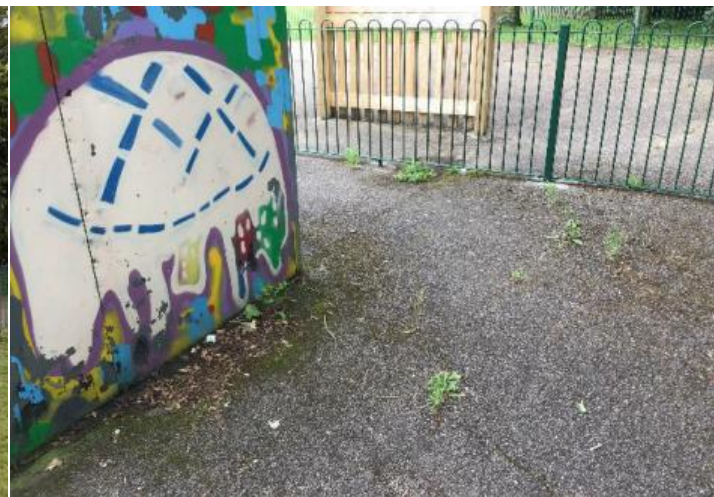
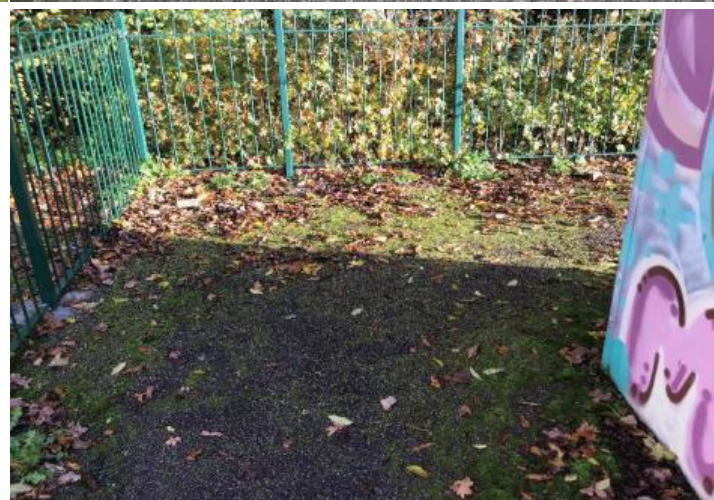
**Finding:** There is algae, silt or moss growth on the surface resulting in slippery conditions

**Action:** Clean and treat appropriately

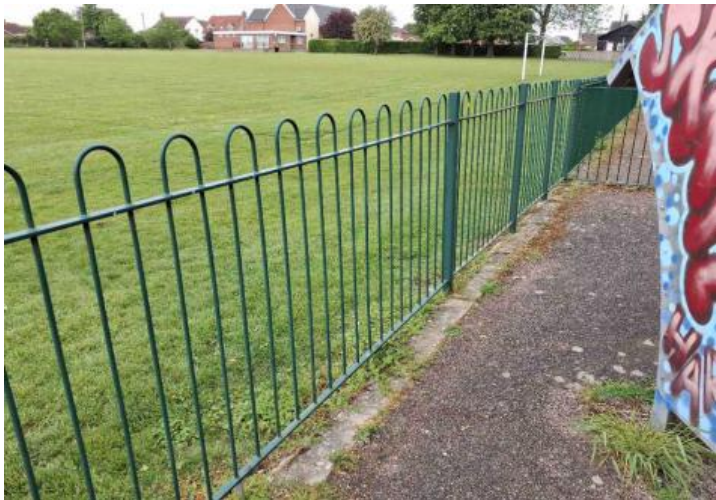
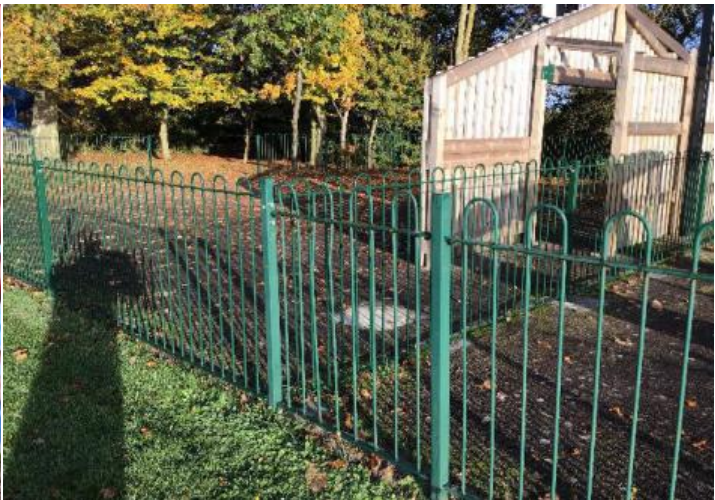
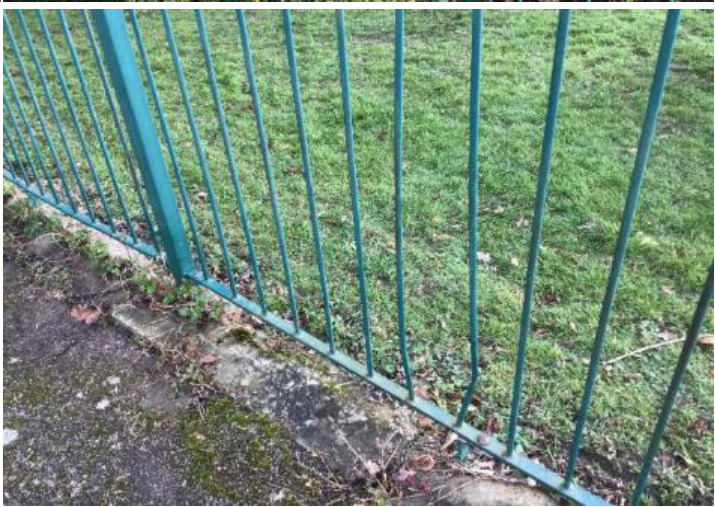
**Finding:** There is some damage to the fence sections

**Action:** Monitor for any further deterioration and repair as required

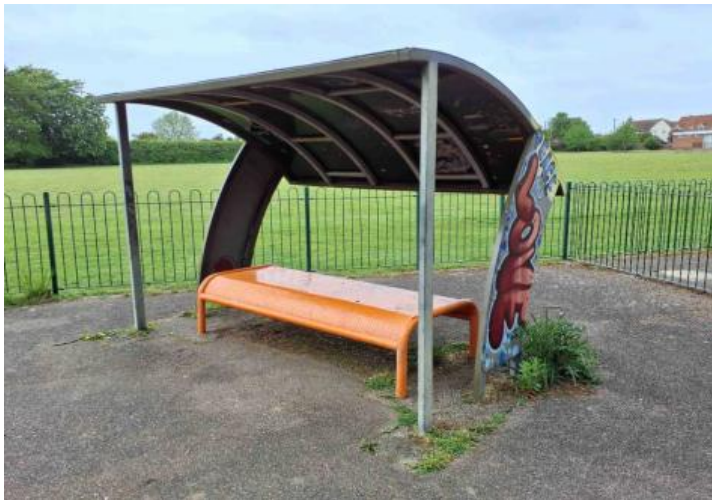
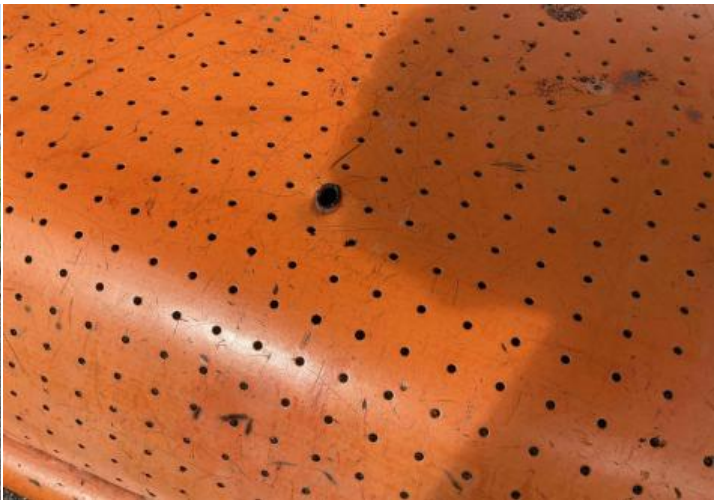
The item has been damaged leaving sharp edges

Repair item

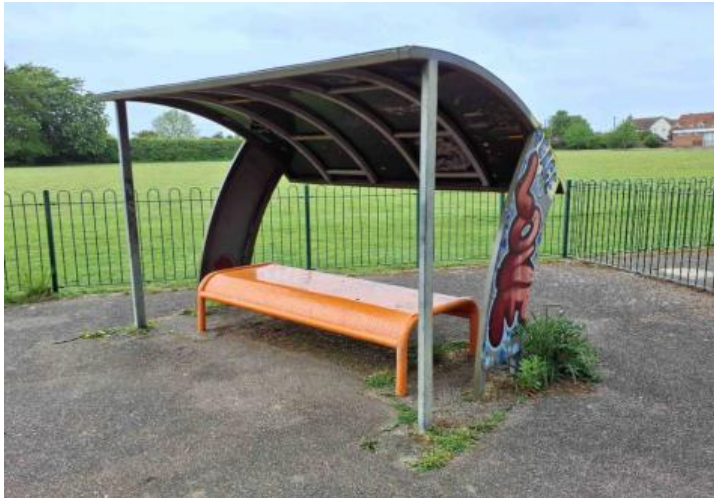
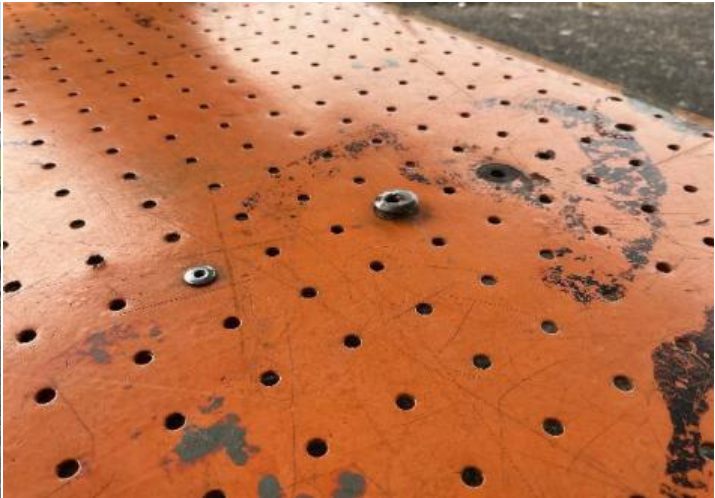
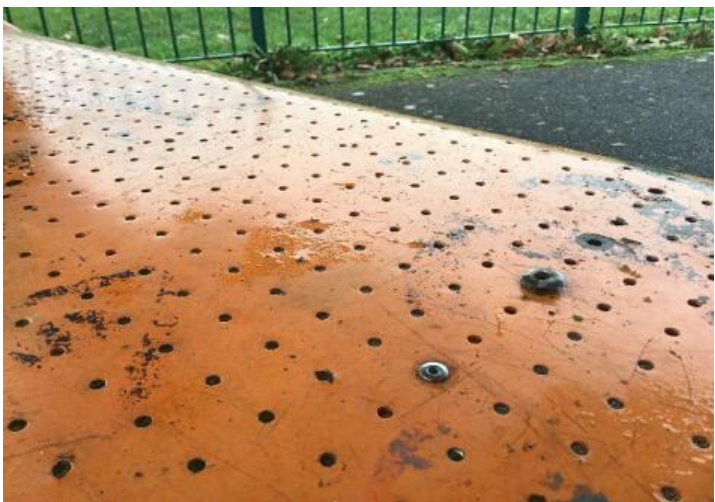
| <div> 6 - Low Risk (Finding 2) </div> | | | |
|---|---|---|---|
| <b>Finding:</b> Pop rivet fixings have failed on the seat | | <b>Action:</b> Replace the failed pop rivets | |

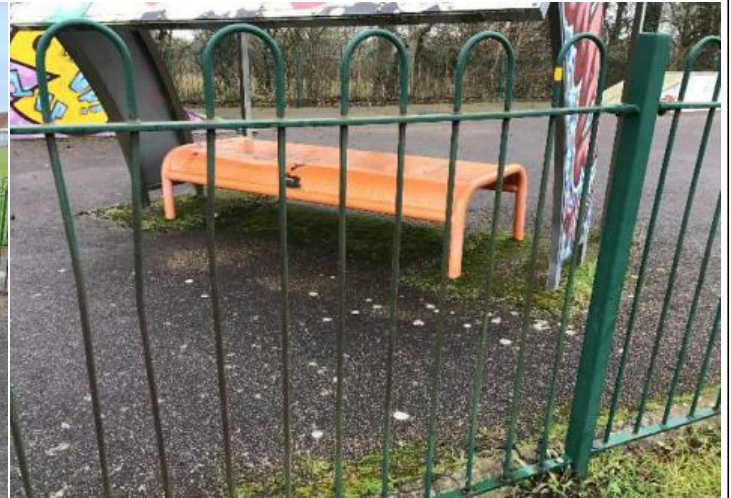
**Finding:** There is algae, silt or moss growth on the surface resulting in slippery conditions

**Action:** Clean and treat appropriately

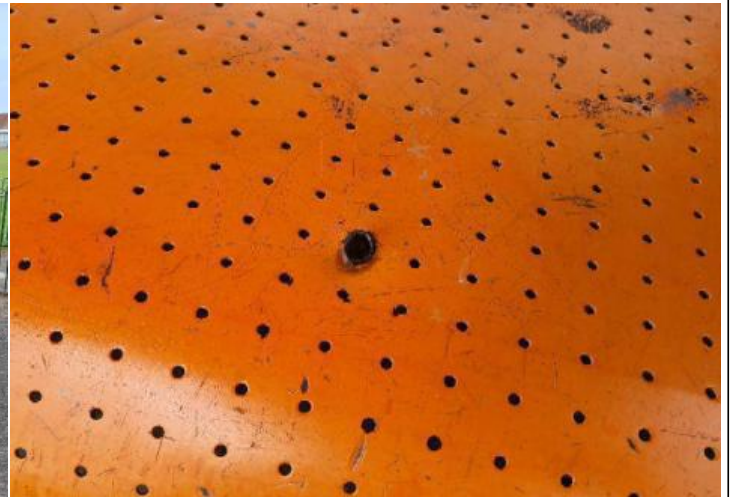
**Finding:** There is some evidence of fire damage to the item

**Action:** Monitor for any further deterioration and repair as required

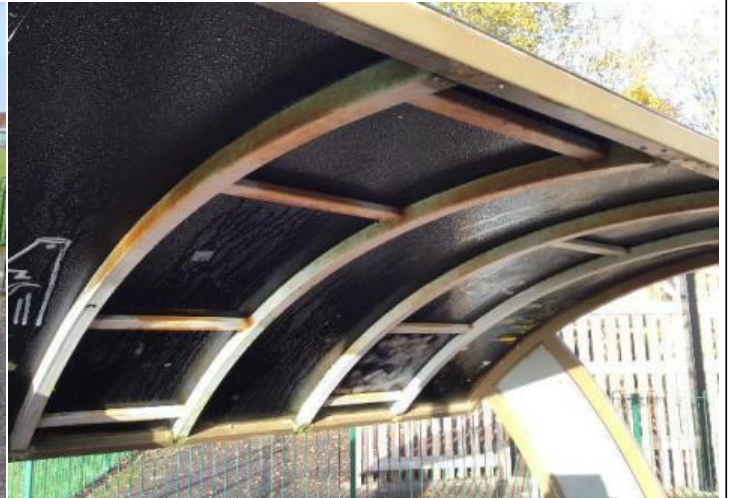
**Finding:** There is surface corrosion / rust present on the item

**Action:** Consider treating the item

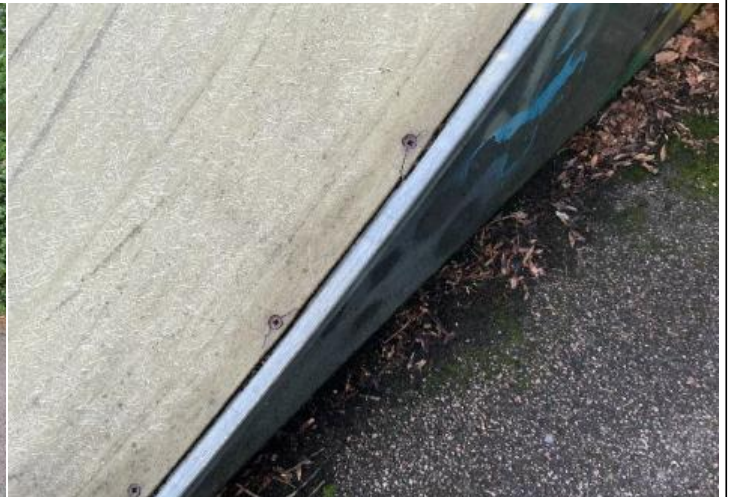
**Finding:** Minor damage to surface

**Action:** Monitor for deterioration

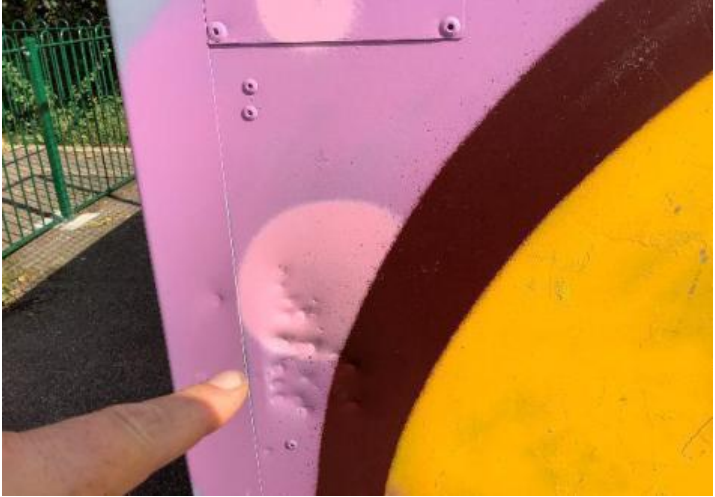
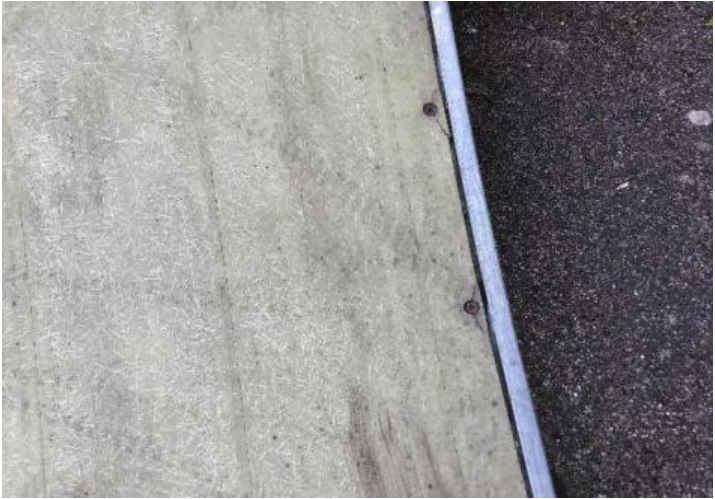
| <div> 6 - Low Risk (Finding 2) </div> | | | |
|---|--|---|--|
| | | <b>Finding:</b> The item has been damaged | |

| <div> 6 - Low Risk (Finding 2) </div> | | | |
|---|--|---|--|
| | | <b>Action:</b> Monitor for any further deterioration and replace as required | |

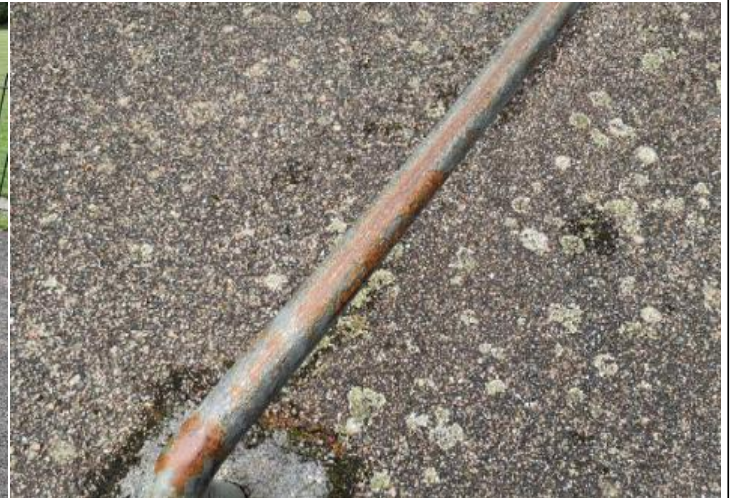
**Finding:** There is surface corrosion / rust present on the item

**Action:** Consider treating the item

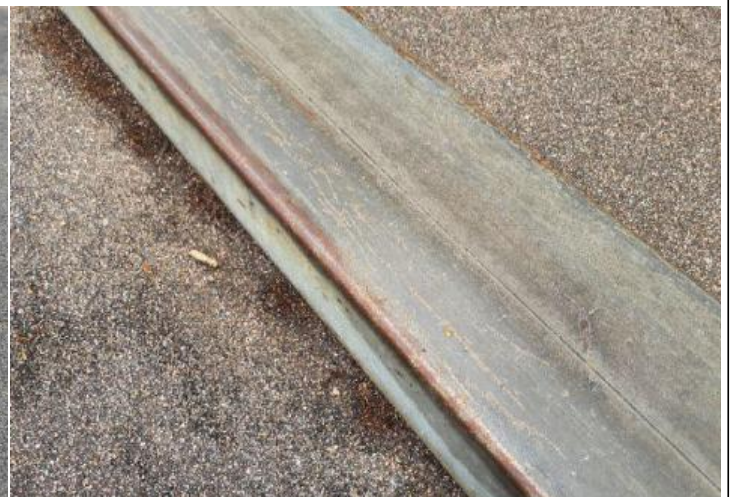
**Finding:** There is surface corrosion / rust present on the item

**Action:** Consider treating the item

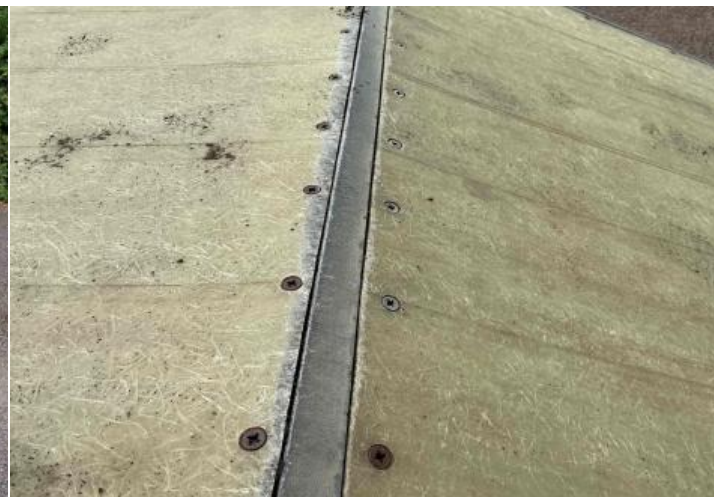
**Finding:** The riding surface has minor damage apparent

**Action:** Monitor for any further deterioration and repair as required

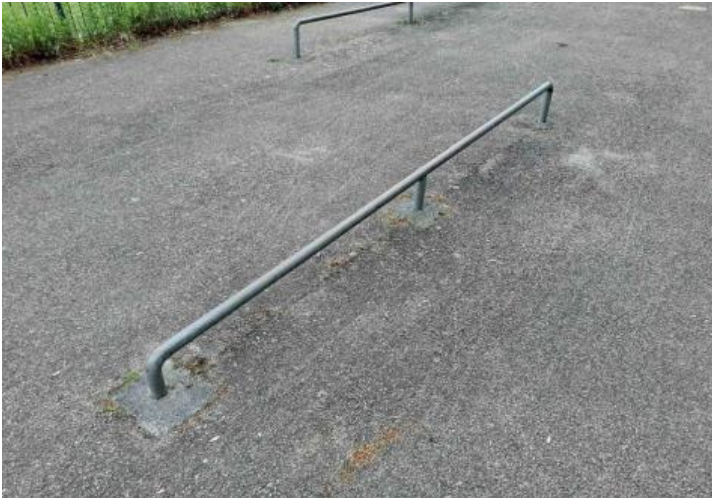
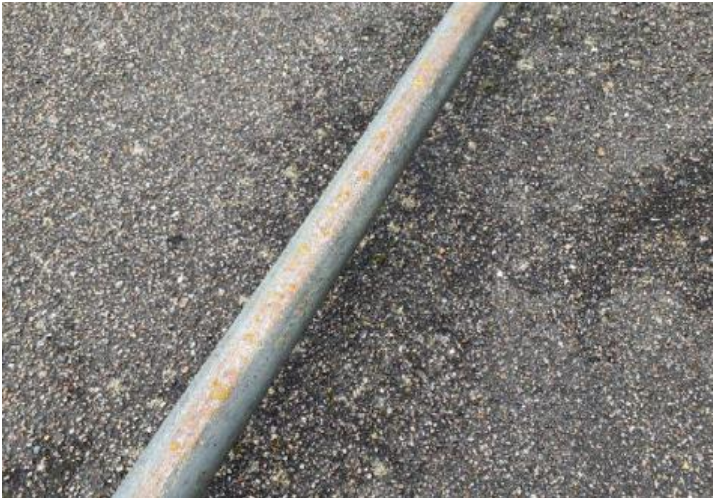
| <div> 6 - Low Risk (Finding 1) </div> | | | |
|---|--|---|--|
| <b>Finding:</b> There is surface corrosion / rust present on the item | | <b>Action:</b> Consider treating the item | |

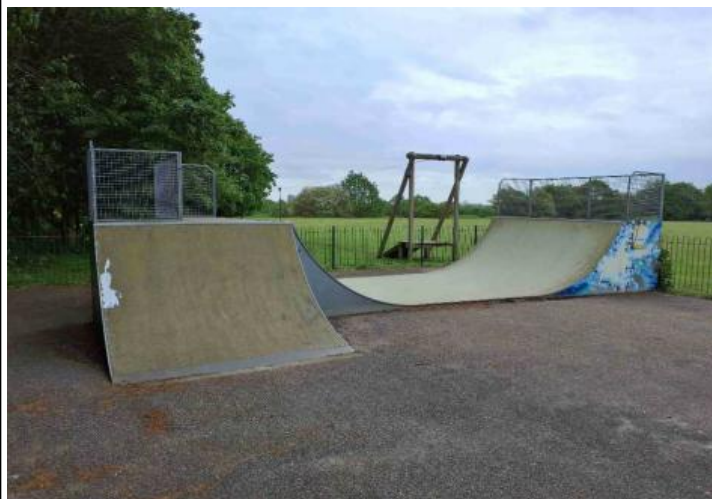
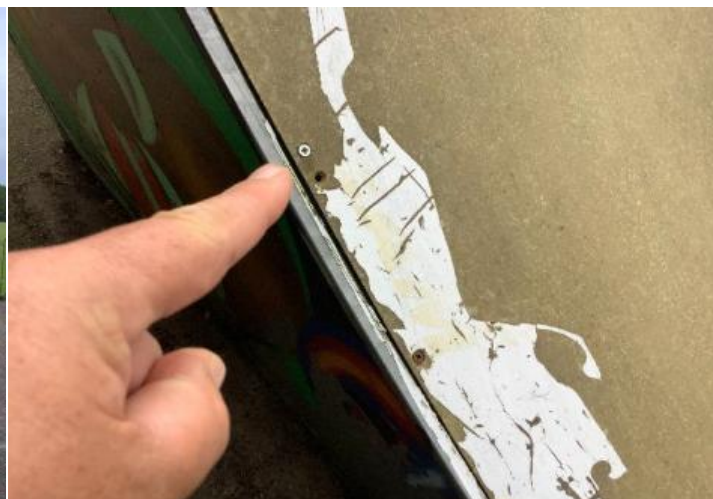
**Finding:** A number of fixing(s) have worked loose

**Action:** Secure all loose fixings

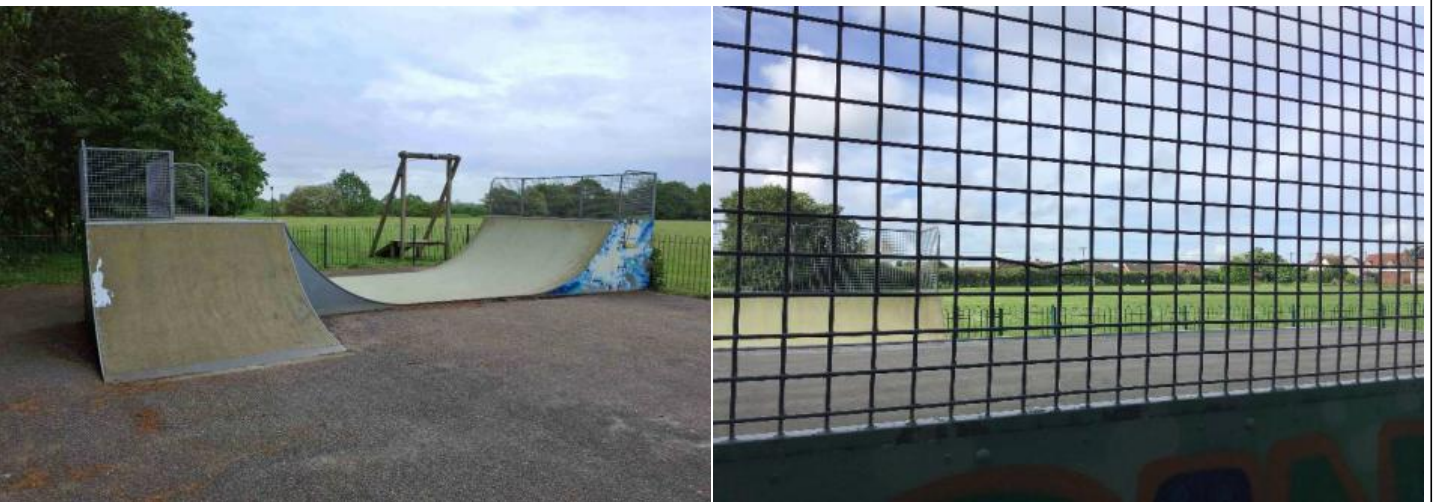
| <b>Finding:</b> There is some damage to the fence sections | <b>Action:</b> Monitor for any further deterioration and repair as required |

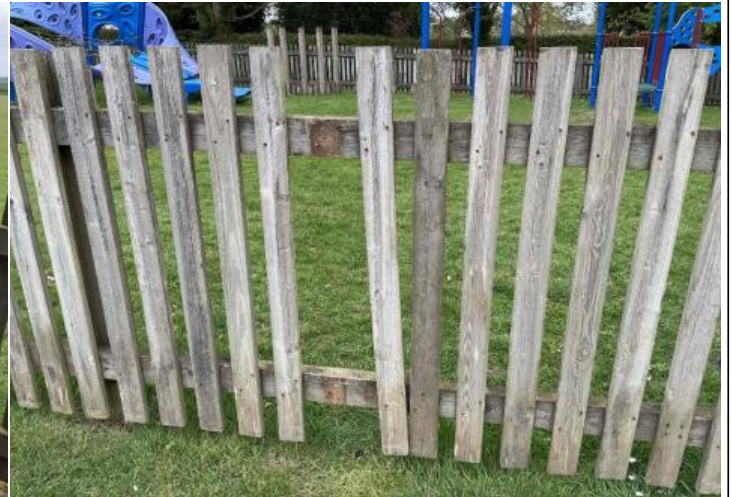
**Finding:** There are a number of fixings missing from the fence

**Action:** Replace missing fixings

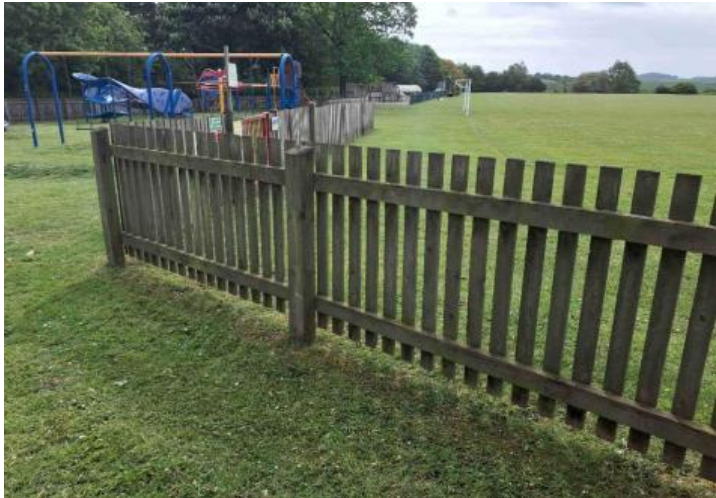
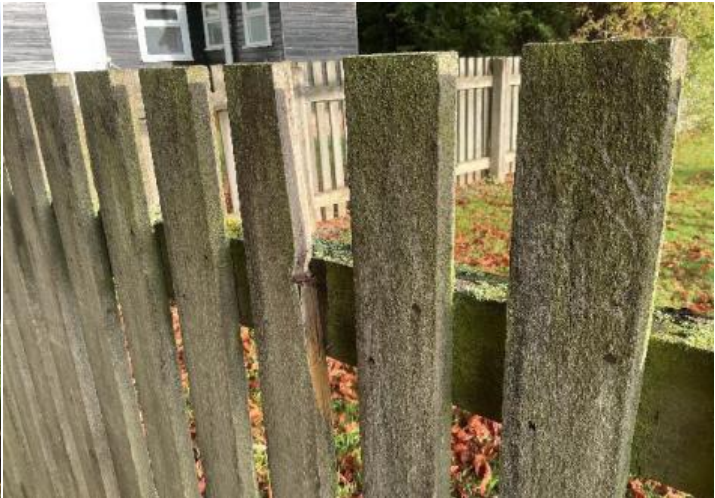
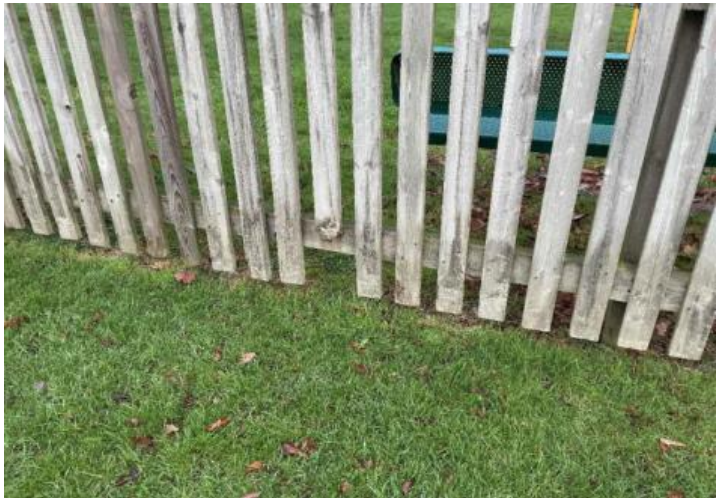
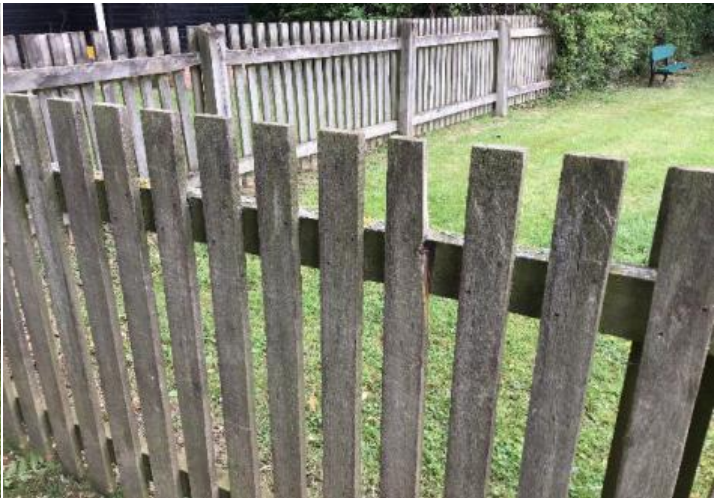
**Finding:** Slats damaged

**Action:** Replace damaged slat

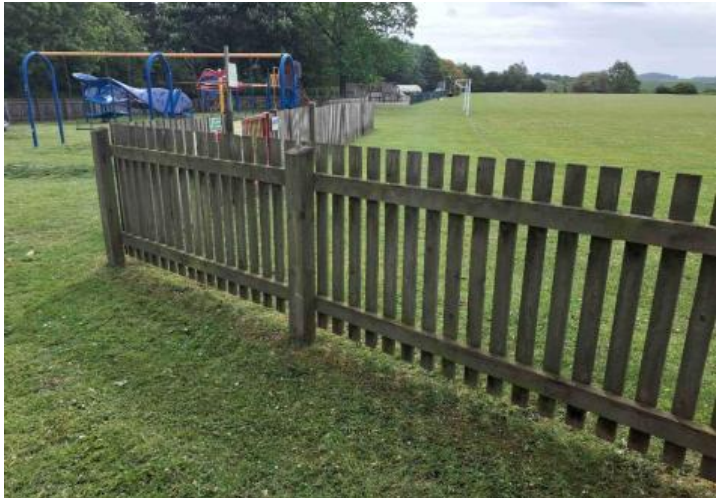
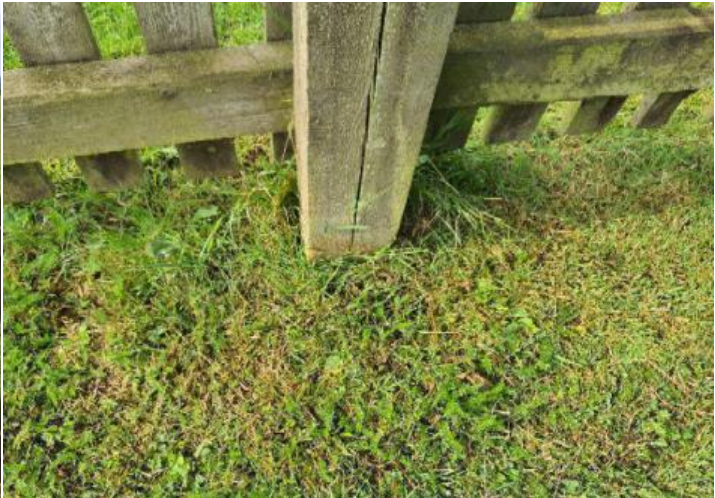
**Finding:** There is some strimmer / machinery damage apparent on the posts, this can penetrate the preservative applied to the timber and accelerate the rotting process

**Action:** Monitor for any deterioration (rot) and replace as required

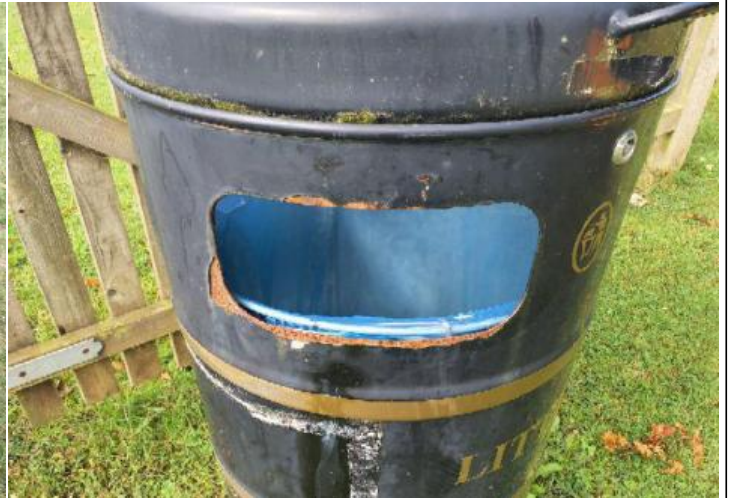
**Finding:** The paintwork on this item has been damaged or worn exposing the metal underneath which is rusting / corroding

**Action:** Treat affected areas and repaint

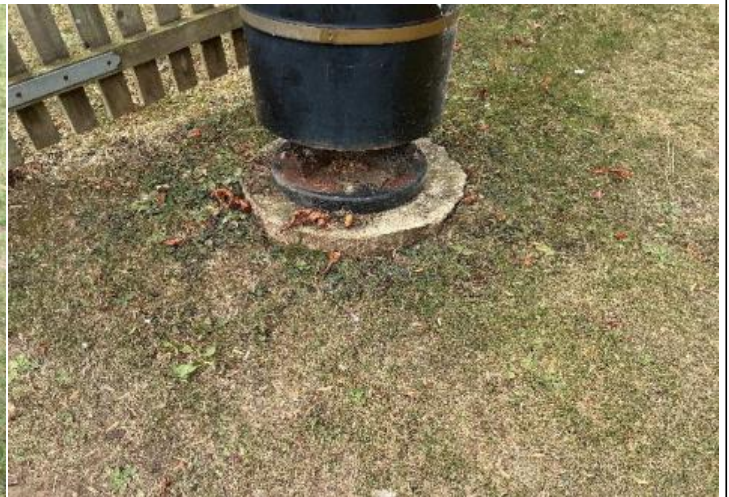
**Finding:** The foundation is loose

**Action:** Reinstate the foundation

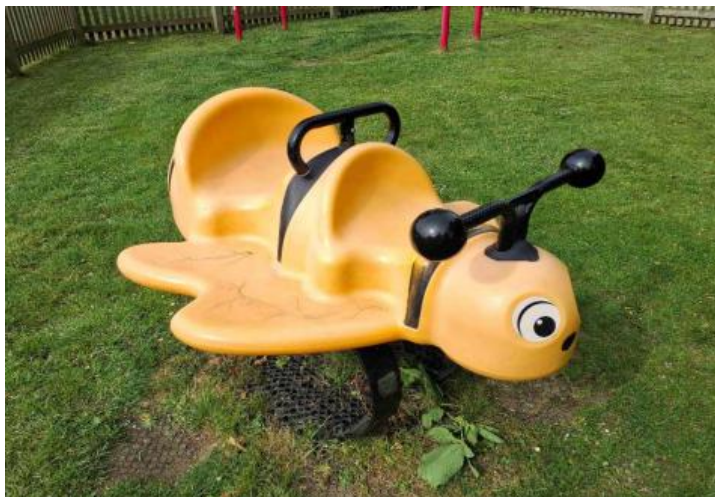
**Finding:** There is or are fixings missing on the item

**Action:** Replace all missing fixings

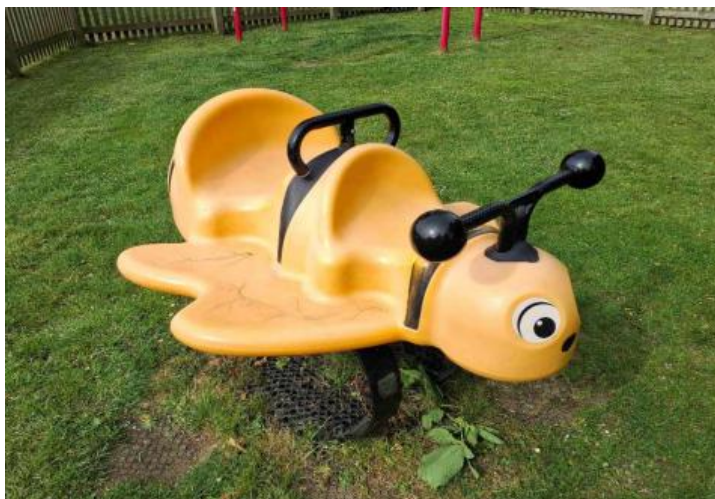
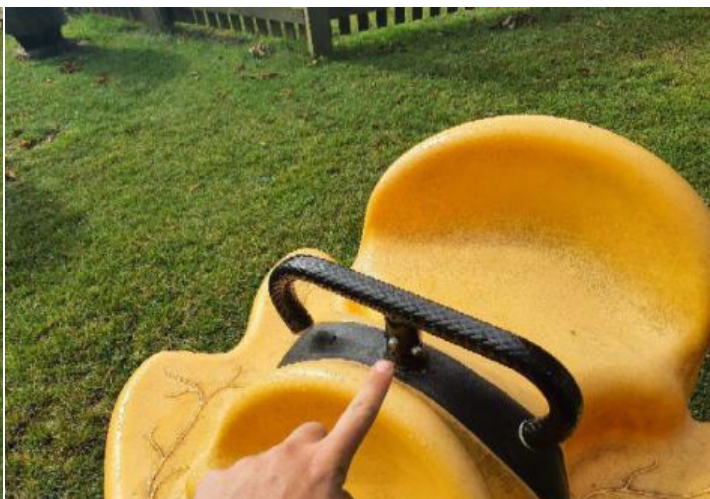
**Finding:** A number of fixing(s) have worked loose

**Action:** Secure all loose fixings

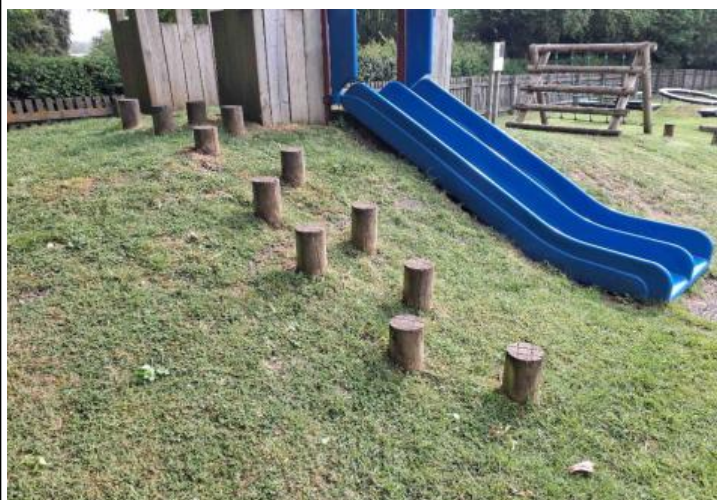
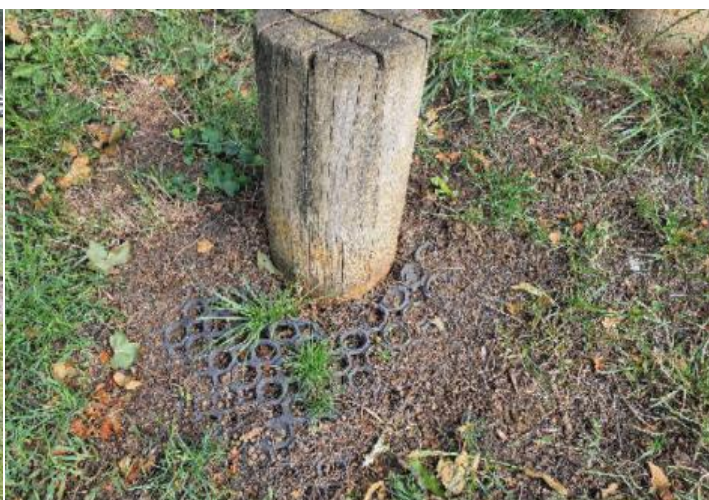
**Finding:** There is some strimmer / machinery damage apparent on the posts, this can penetrate the preservative applied to the timber and accelerate the rotting process  
**Action:** Monitor for any deterioration (rot) and replace as required

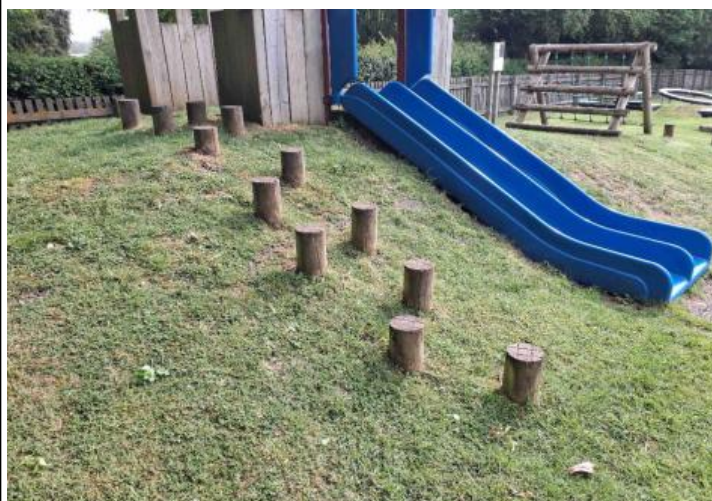
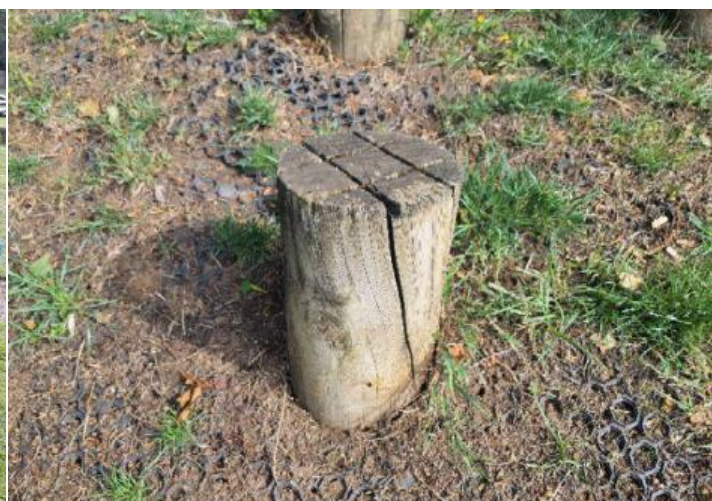
**Finding:** The timber has a number of splits/shakes or air cracks and this may affect the stability or allow water ingress which will accelerate the rotting process  
**Action:** Monitor to ensure the splits do not cross through fixing points of the structure and/or cause any instability

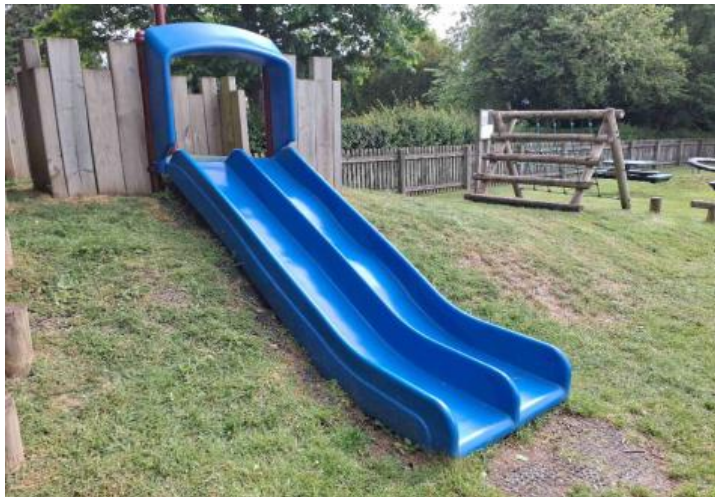
**Finding:** There are trip hazards at the edges of the surface

**Action:** Reinstall surrounding surface levels to remove the trip points

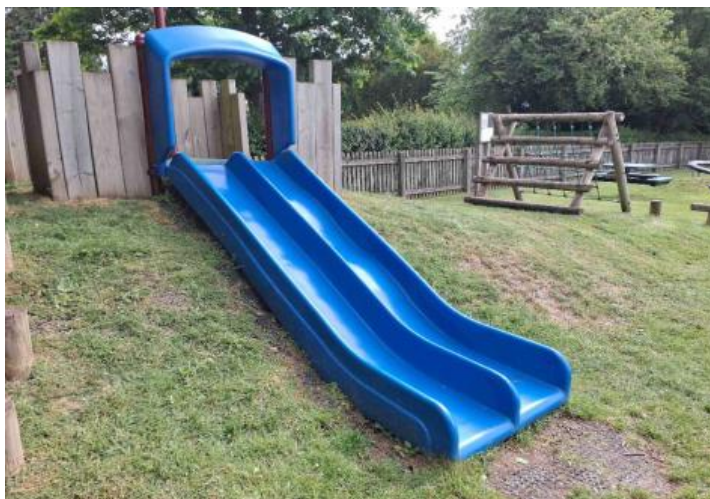
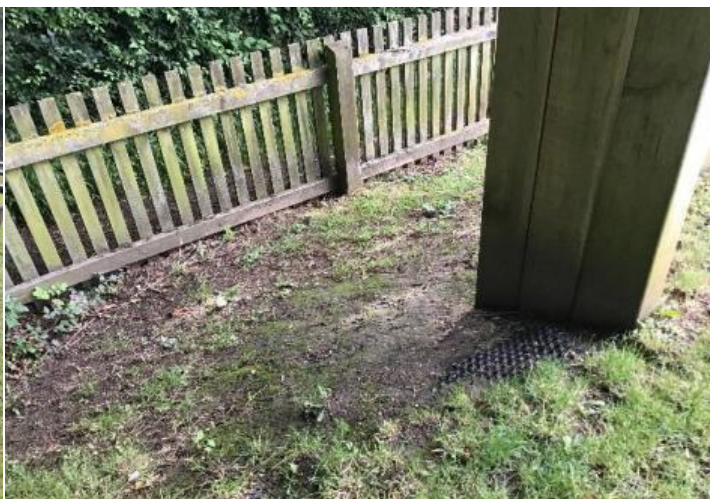
**Finding:** The surface has eroded in some areas and may be slippery in wet conditions

**Action:** Reinstate the surface

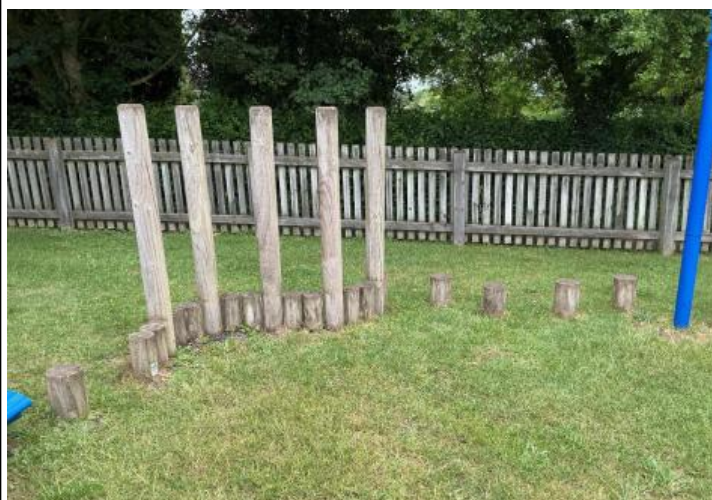
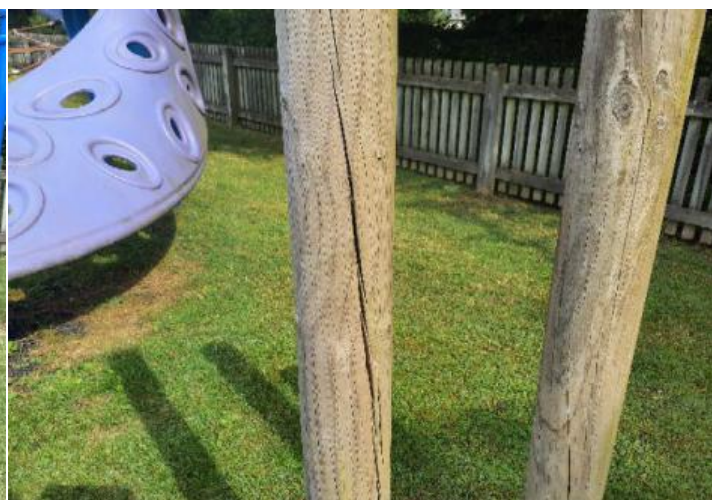
**Finding:** The timber has a number of splits/shakes or air cracks and this may affect the stability or allow water ingress which will accelerate the rotting process

**Action:** Monitor to ensure the splits do not cross through fixing points of the structure and/or cause any instability

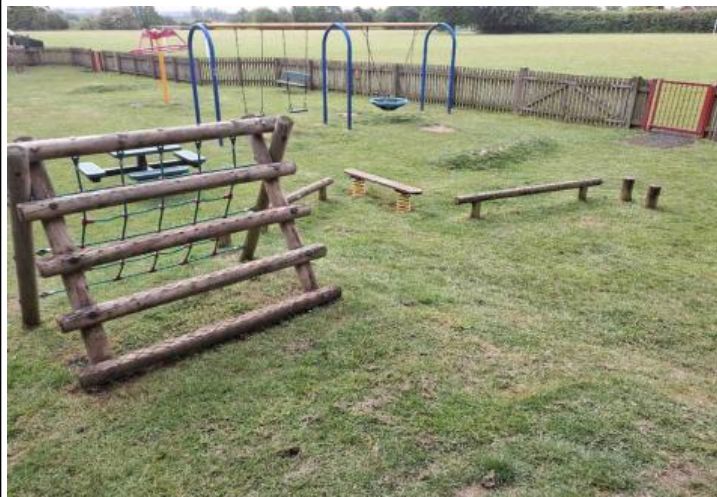
**Finding:** There is some strimmer / machinery damage apparent on the posts, this can penetrate the preservative applied to the timber and accelerate the rotting process

**Action:** Monitor for any deterioration (rot) and replace as required

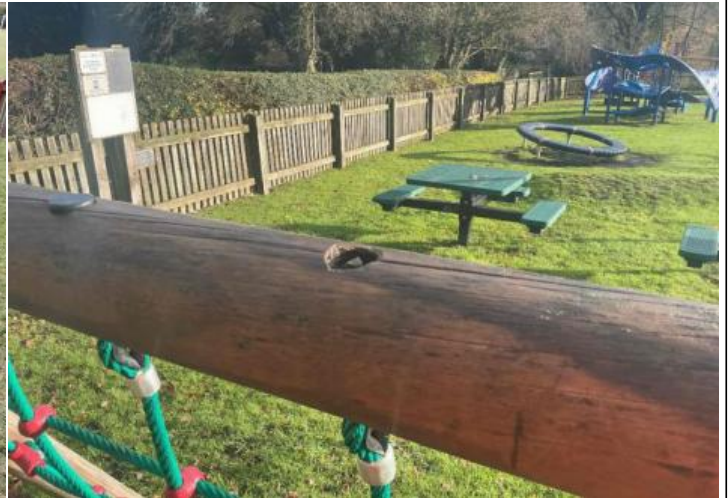
**Finding:** There is/are bolt cap covers missing or damaged on the item

**Action:** Replace missing or damaged bolt cap covers

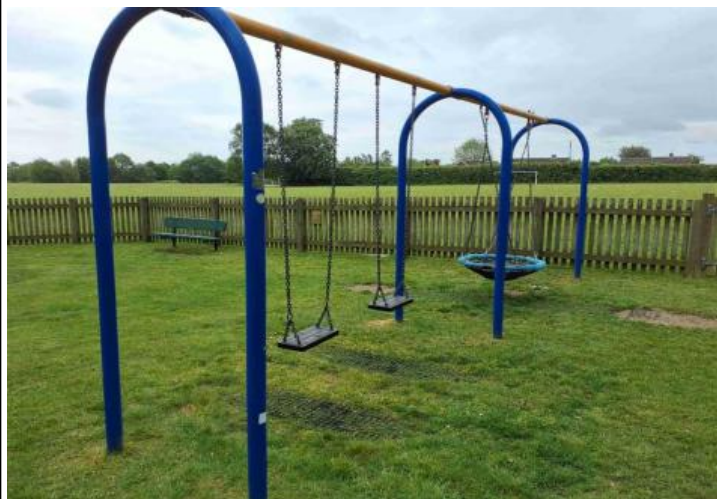
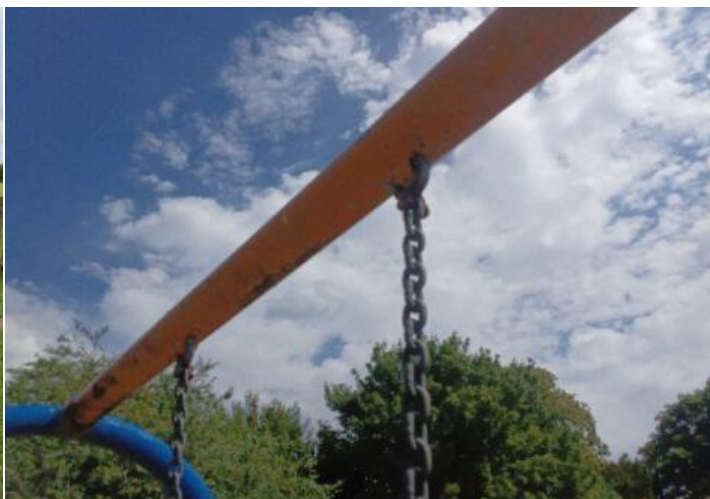
**Finding:** The bushes are showing signs of wear

**Action:** Monitor for any further deterioration and replace as required
