## **Play Area Inspection Reports & Remedial Work**

### Playground Maintenance Estimate for Three Site Remedials

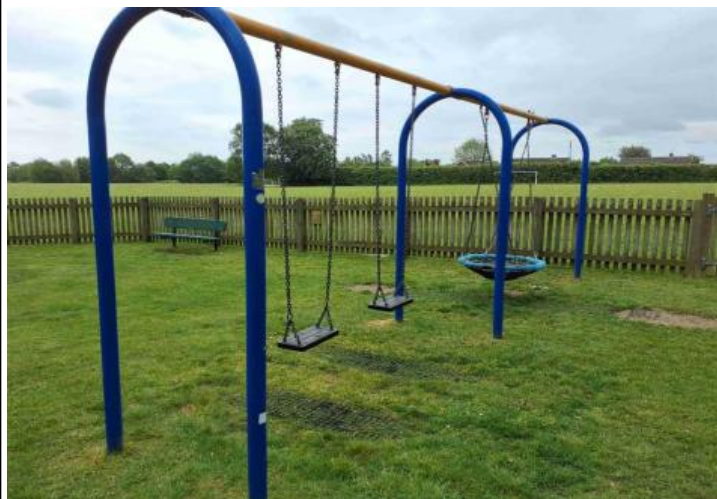
**Finding:** There is some wear to the shackles

**Action:** Monitor for any further deterioration and replace when 40% worn

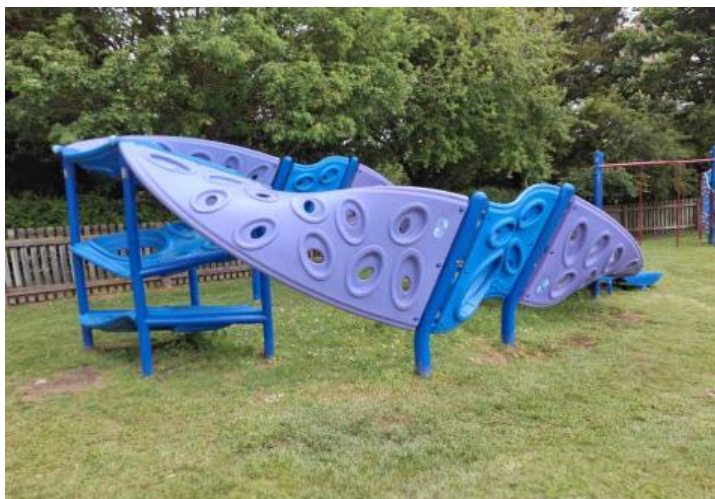
**Finding:** The connecting lugs are showing signs of wear

**Action:** Monitor for any further deterioration and repair as required

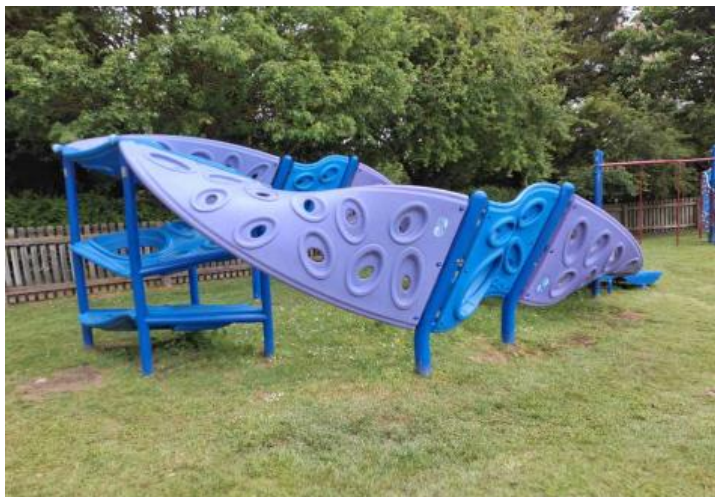
**Finding:** The item has been damaged

**Action:** Sand down plastic to remove sharp edge

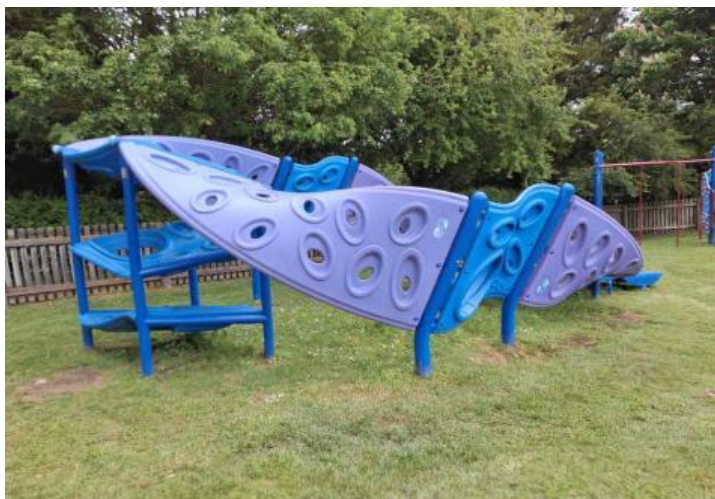
**Finding:** The ropes/nets are worn/damaged in places

**Action:** Monitor for any further deterioration and repair or replace as required

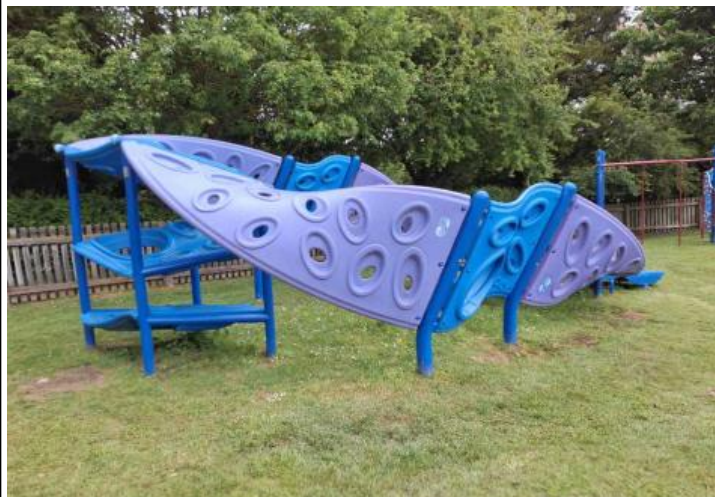
**Finding:** There is surface corrosion / rust present on the item

**Action:** Consider treating the item

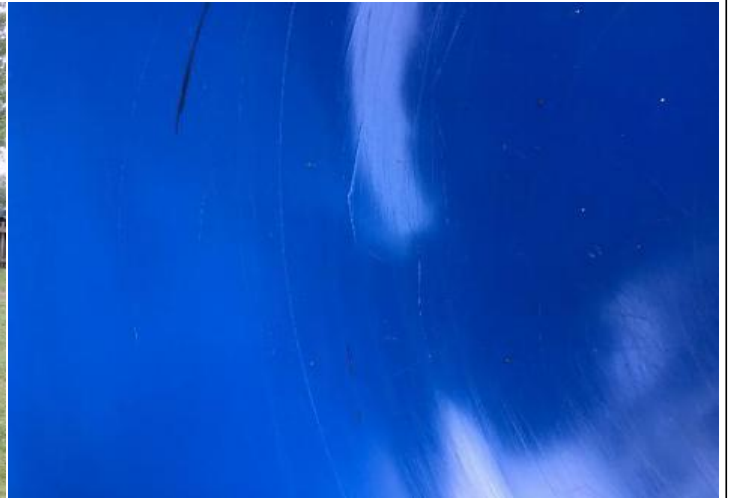
**Finding:** There are a number of dents in the slide surface

**Action:** Monitor for any further deterioration and repair as required

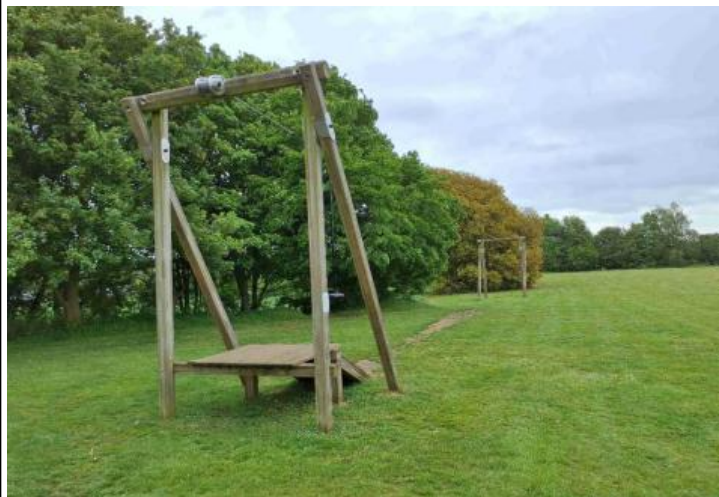
**Finding:** We have completed a visual inspection of the suspension links, cable and fixing points from ground level, however it is not possible to fully inspect these areas without either hiring equipment to gain access or removing the cable and suspension and inspecting at ground level. We recommend that the main cable and fixing security is thoroughly inspected at least in accordance with the manufacturers recommendations to check for wear, damage, security or internal rusting; this will help to ensure the continued safe use of the equipment

**Action:** Inspect in accordance with the manufacturers recommendations

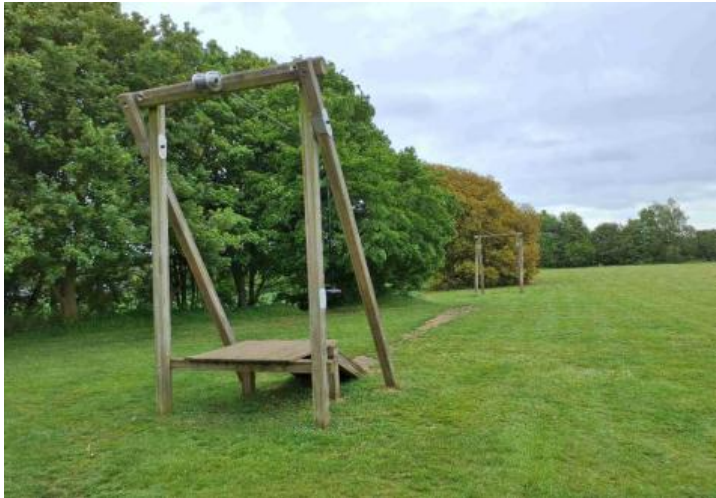
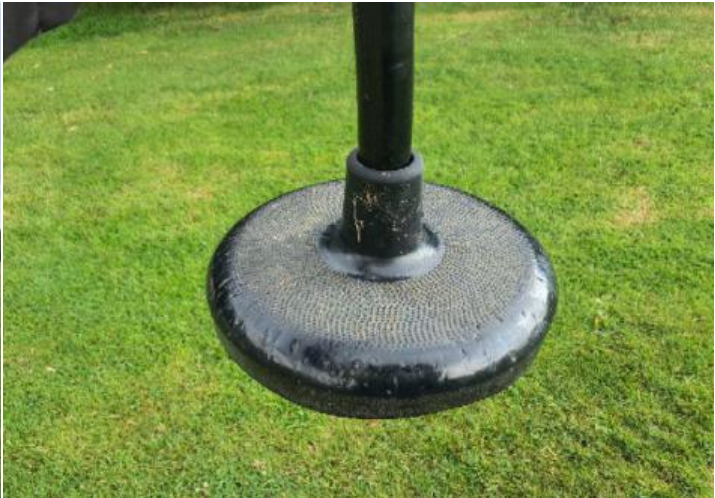
| <div> 0 - Risk Assessment not Undertaken (Finding 3) </div> | | | |
|---|--|---|--|
| <b>Finding:</b> The seat connection cannot be inspected without dismantling the seat | | <b>Action:</b> Dismantle the seat to inspect the seat connection for wear | |

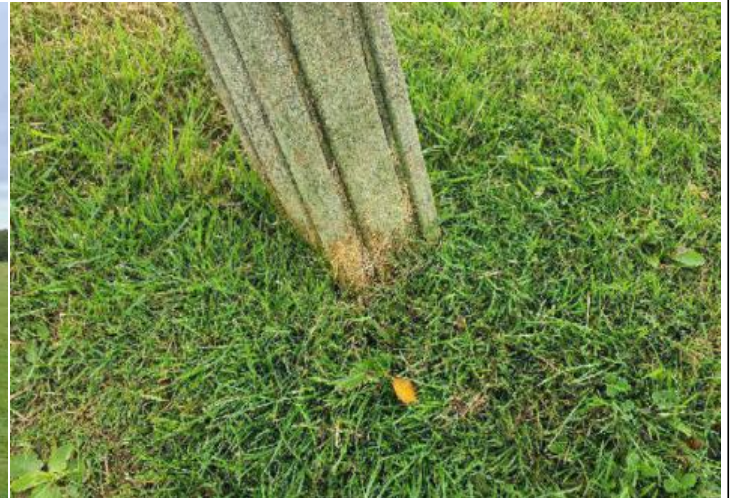
**Finding:** There is some strimmer / machinery damage apparent on the posts, this can penetrate the preservative applied to the timber and accelerate the rotting process

**Action:** Monitor for any deterioration (rot) and replace as required

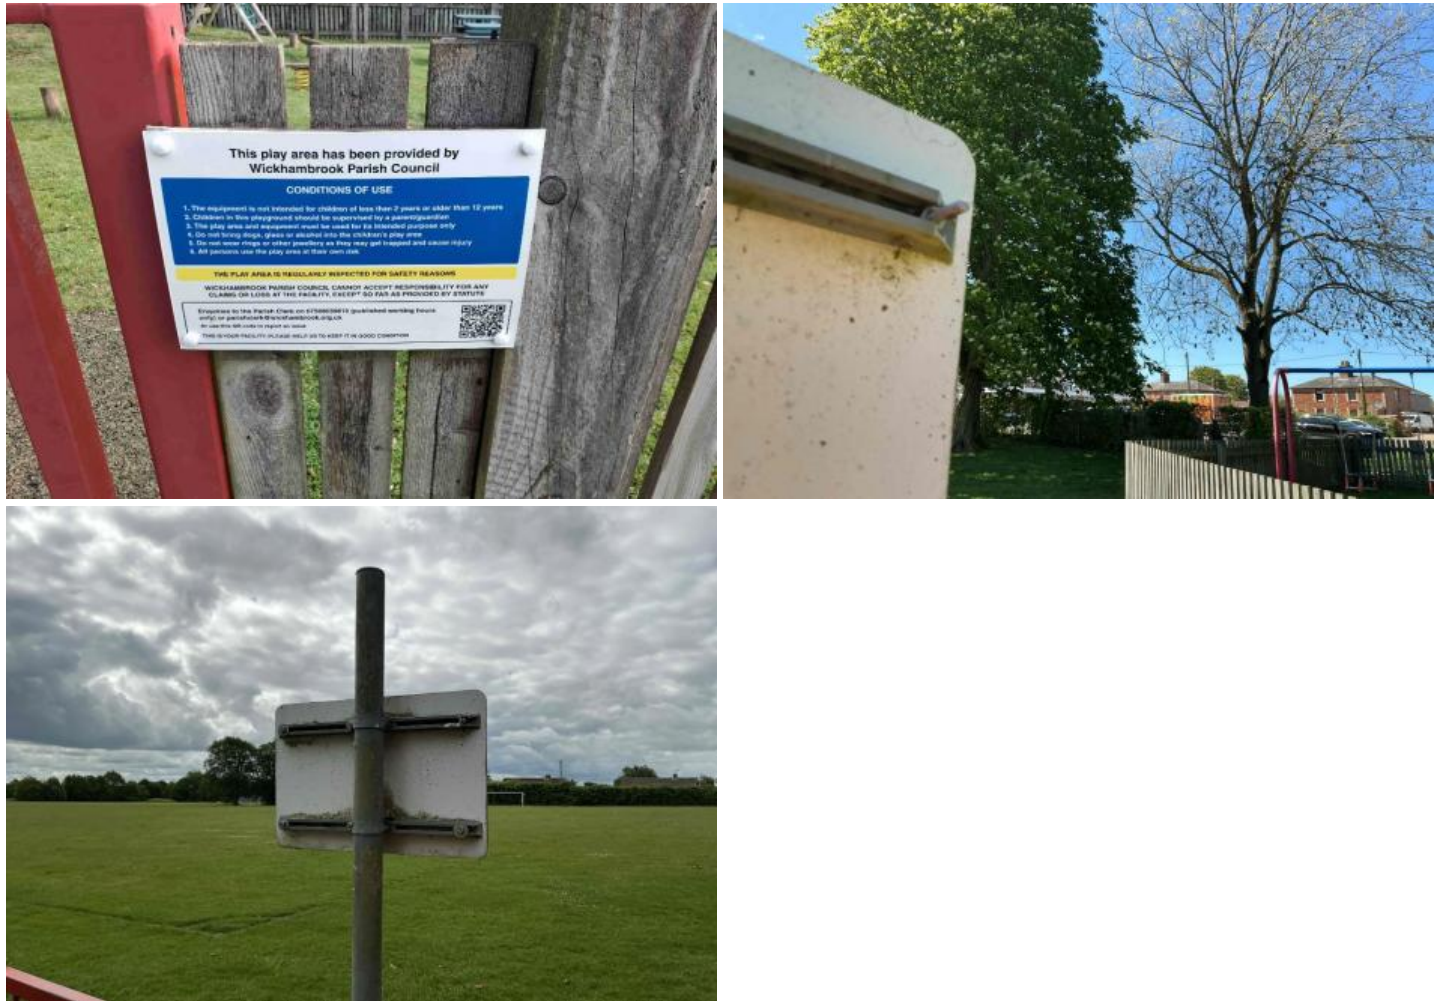
Finding: There is or are fixings missing on the item

Action: Replace all missing fixings
