## **Play Area Inspection Reports & Remedial Work**

## Wickhambrook. Bury Road

Inspection Ref: 3230454

Operational Inspection - 8-October-2026 - 08:11 Inspector Philip Smith

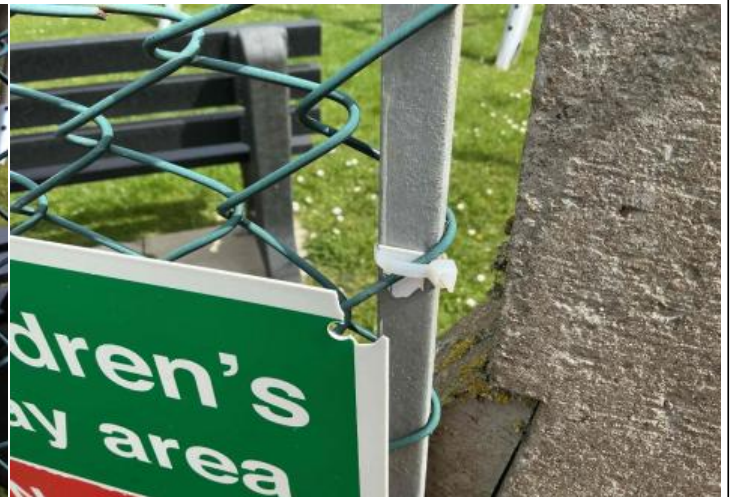
**Finding:** Cable tie has become detached from sign due to damage to sign leaving a sharp edge on the cable tie

**Action:** Repair

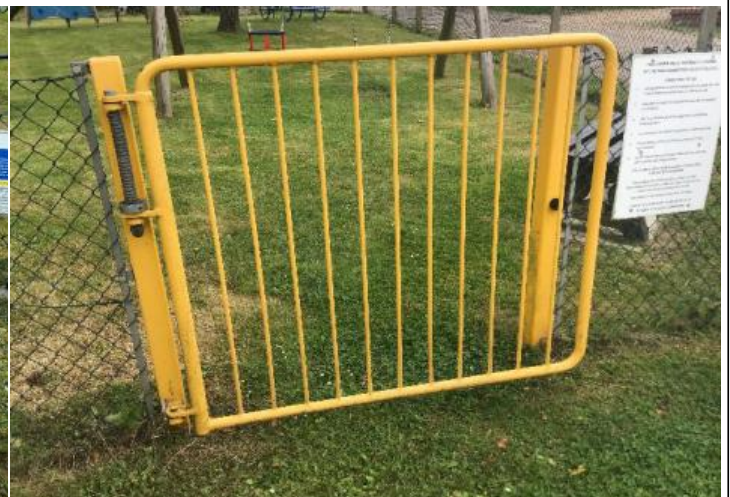
**Finding:** The gate rebounds when opened quickly and could strike the next user entering the area

**Action:** Monitor use and adjust/replace as required

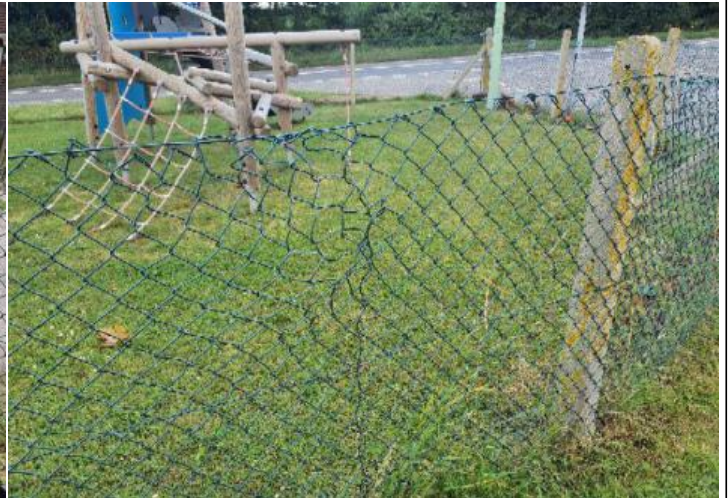
**Finding:** There is some damage to the fence sections

**Action:** Monitor for any further deterioration and repair as required

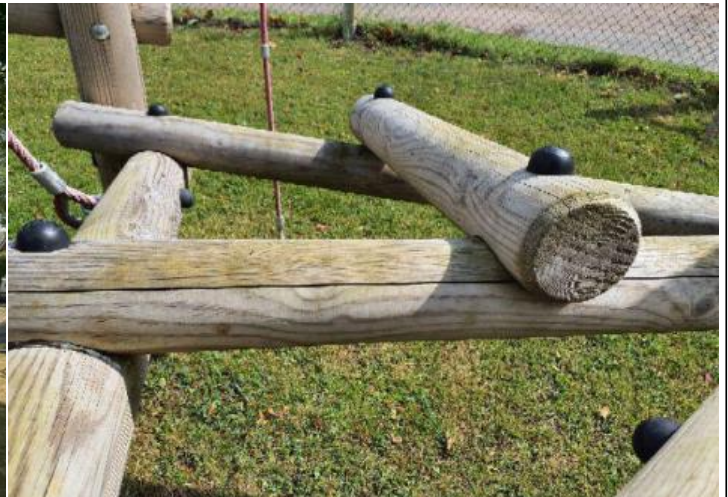
**Finding:** The timber has a number of splits/shakes or air cracks and this may affect the stability or allow water ingress which will accelerate the rotting process

**Action:** Monitor to ensure the splits do not cross through fixing points of the structure and/or cause any instability

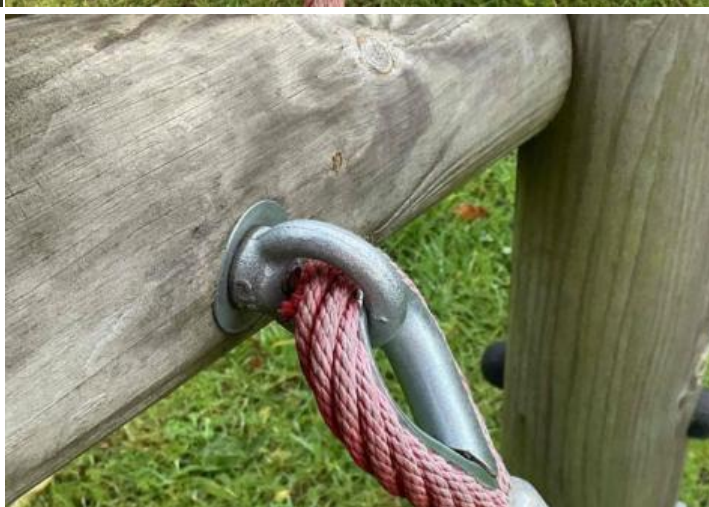
**Finding:** The ropes/nets are worn/damaged in places

**Action:** Monitor for any further deterioration and repair or replace as required

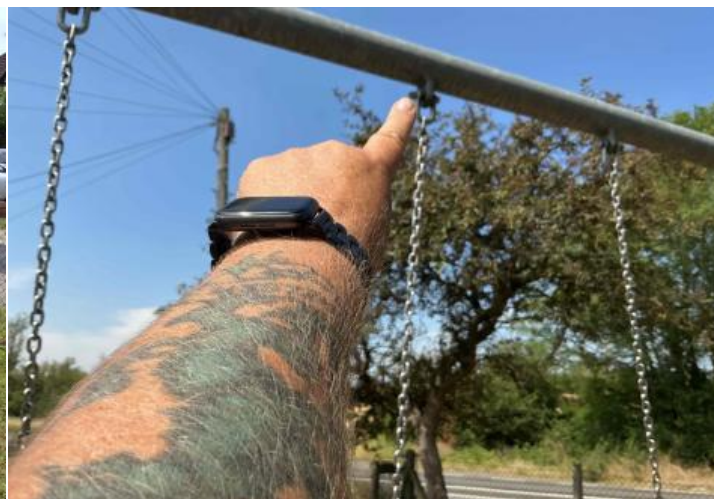
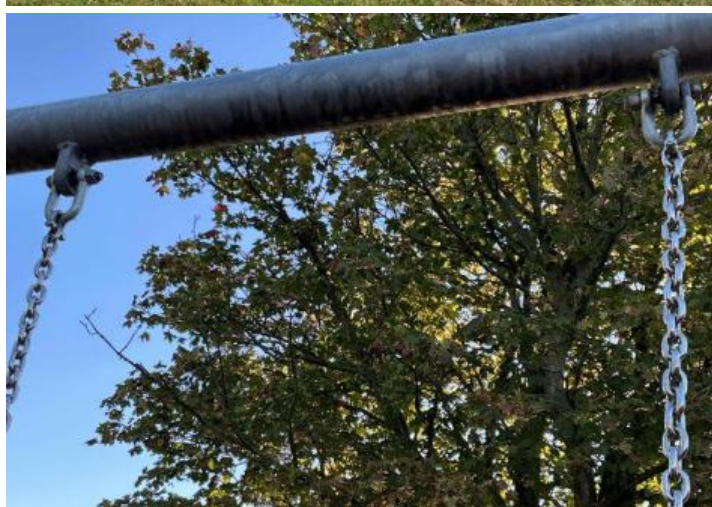
**Finding:** The bushes are showing signs of wear

**Action:** Monitor for any further deterioration and replace as required

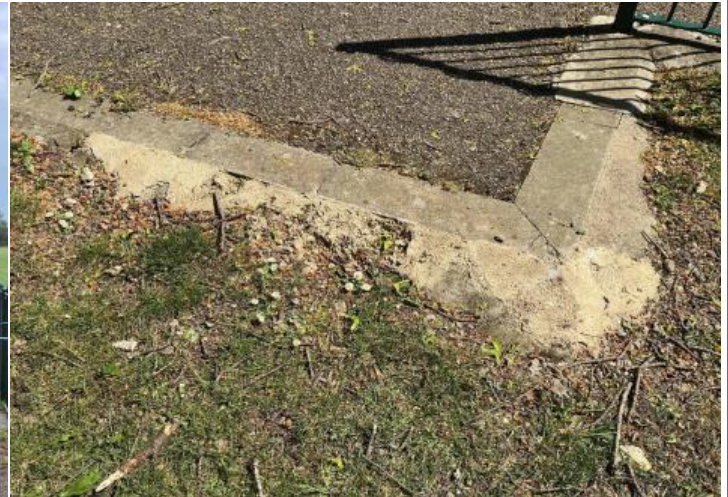
**Finding:** The concrete at site entrance is damaged creating a trip hazard  
**Action:** Repair

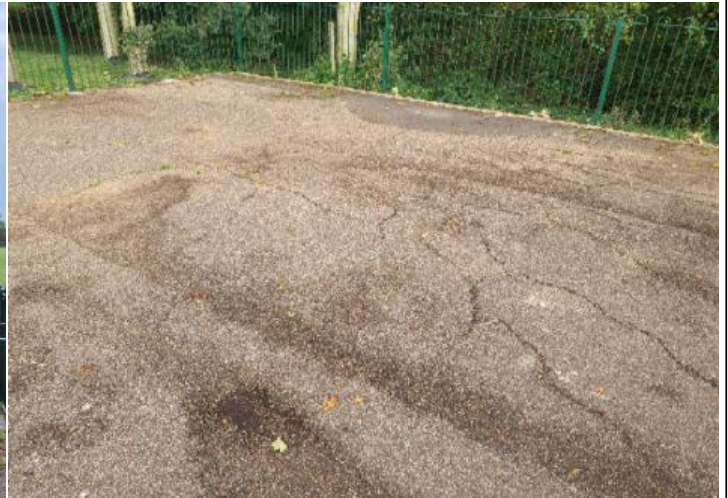
**Finding:** There is moderate damage to the surface

**Action:** Repair the damaged areas of surfacing

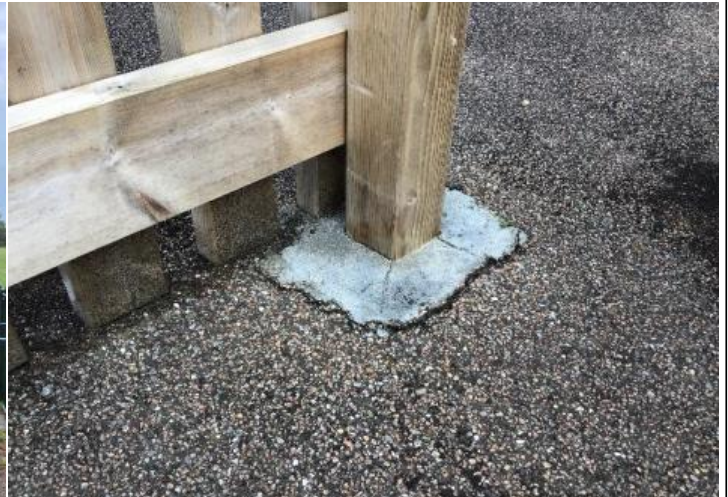
**Finding:** The concrete foundation around the goal structure is lifting

**Action:** Repair

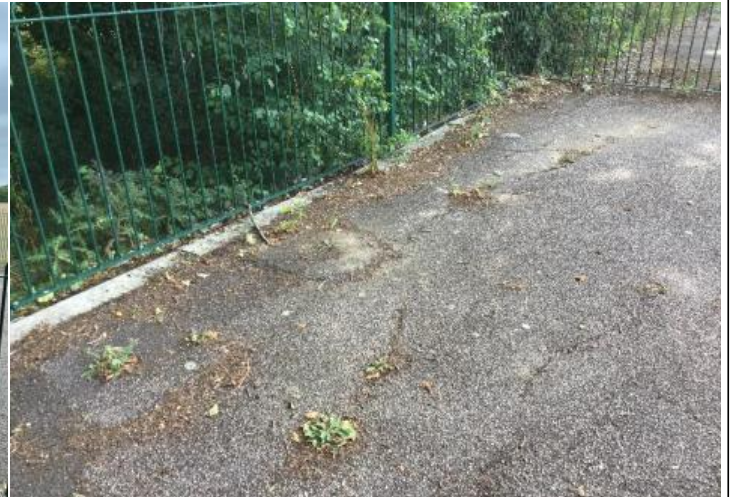
**Finding:** There is algae, silt or moss growth on the surface resulting in slippery conditions

**Action:** Clean and treat appropriately

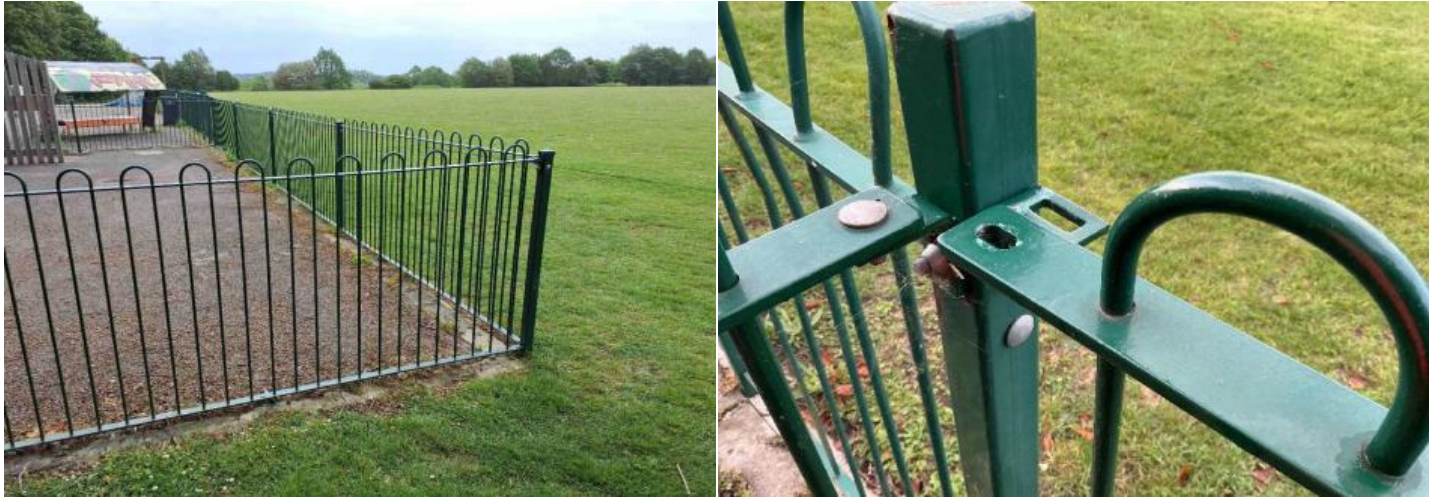
| Finding: | There are a number of fixings missing from the fence | Action: | Replace missing fixings |

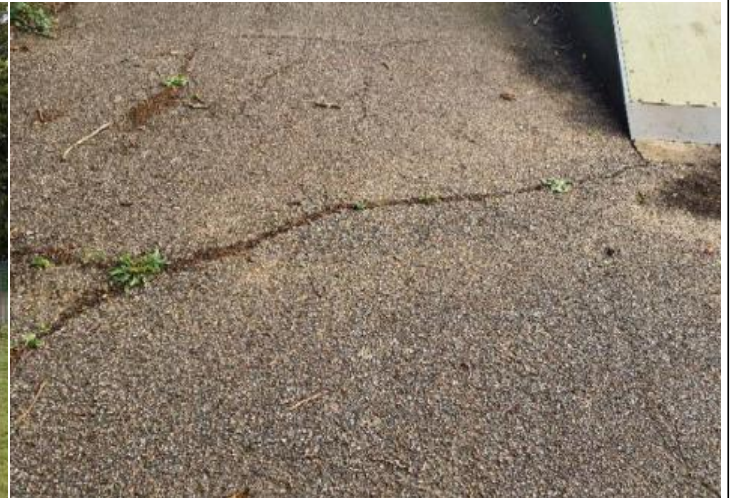
**Finding:** There is root damage to the surfacing creating unforeseen changes in levels

**Action:** Repair the damaged areas of tarmac to provide a uniform surface

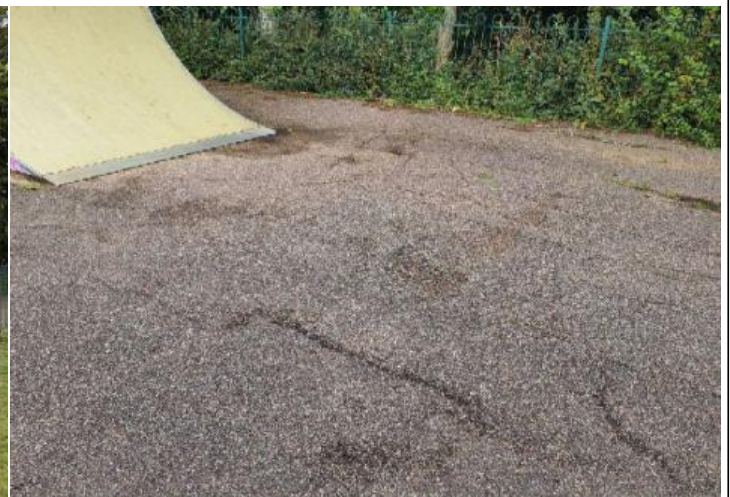
**Finding:** There is some damage apparent to the riding surface

**Action:** Monitor for any further deterioration and repair as required

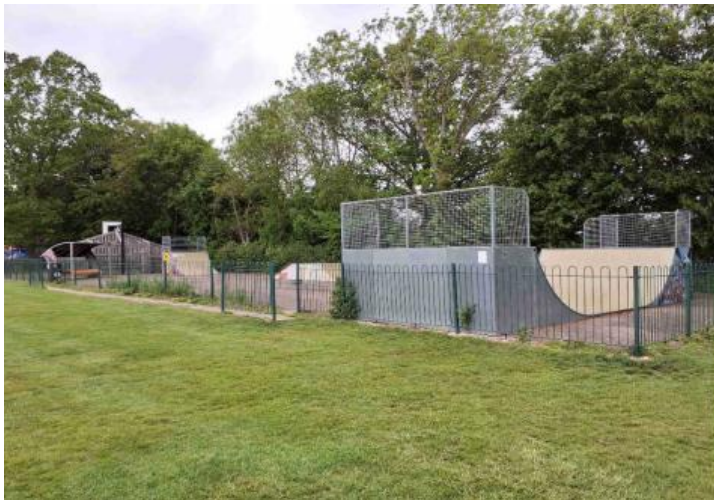
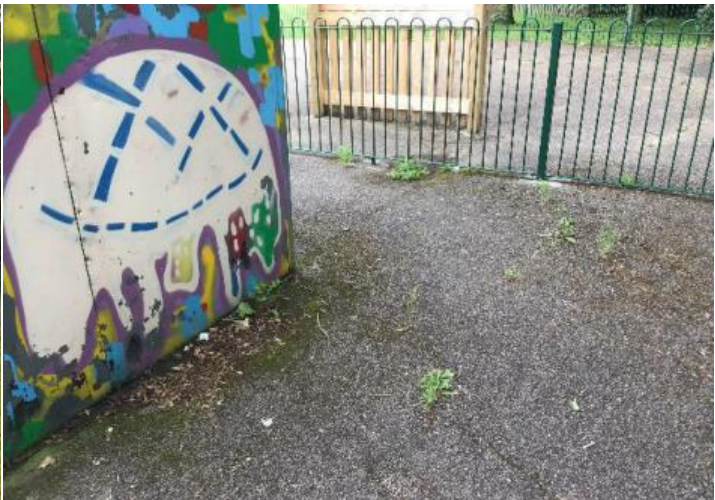
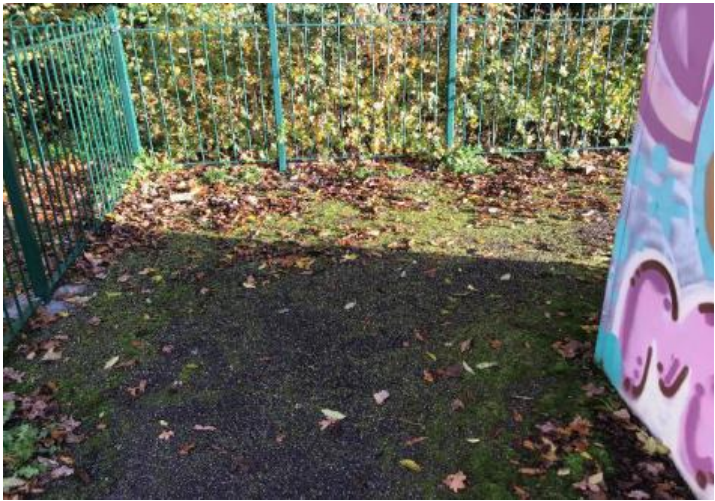
**Finding:** There is algae, silt or moss growth on the surface resulting in slippery conditions

**Action:** Clean and treat appropriately

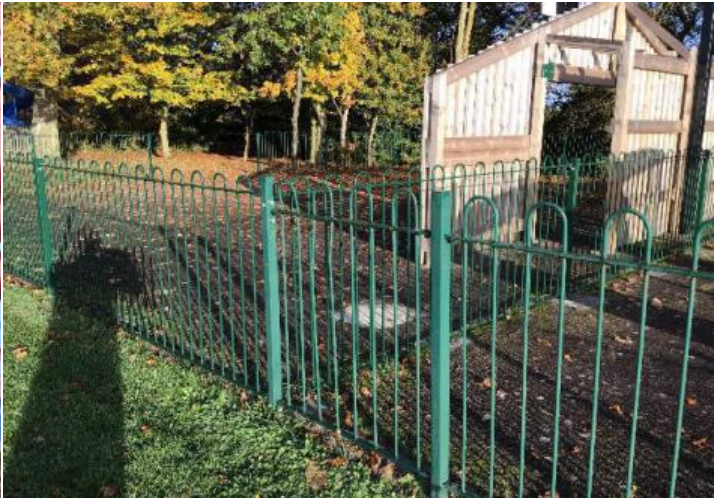
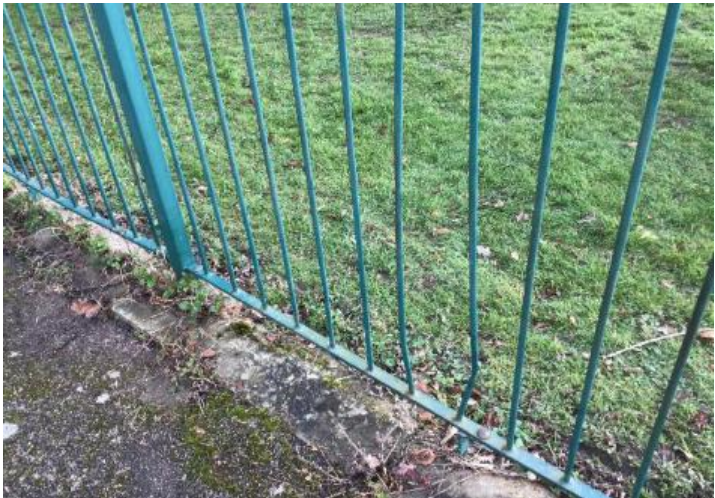
**Finding:** There is some damage to the fence sections

**Action:** Monitor for any further deterioration and repair as required

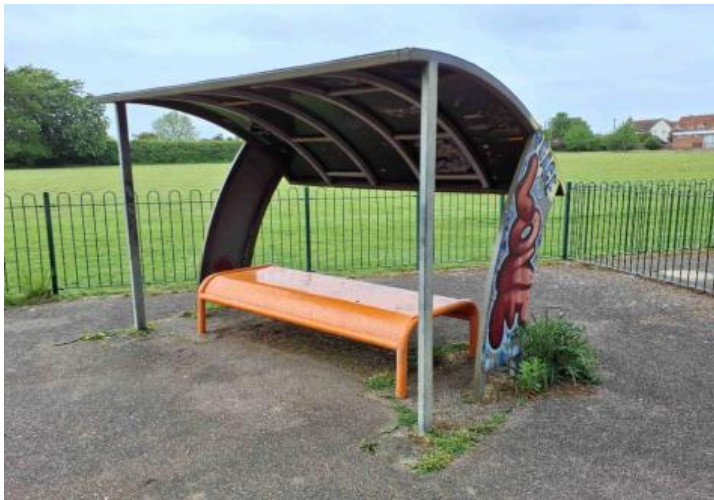
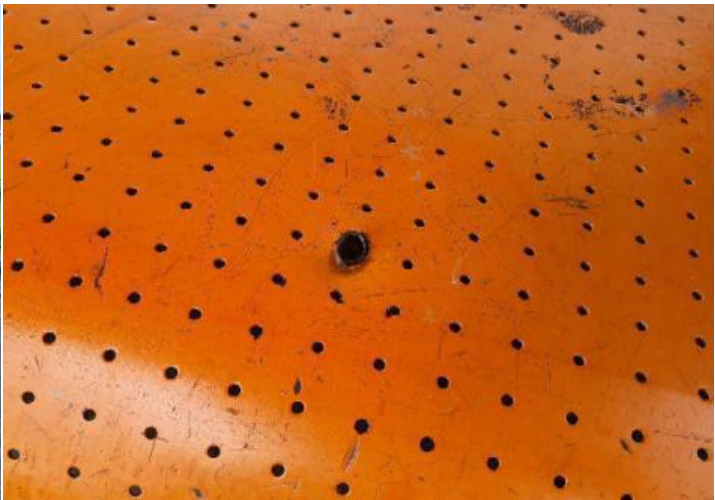
**Finding:** There is some evidence of fire damage to the item **Action:** Monitor for any further deterioration and repair as required

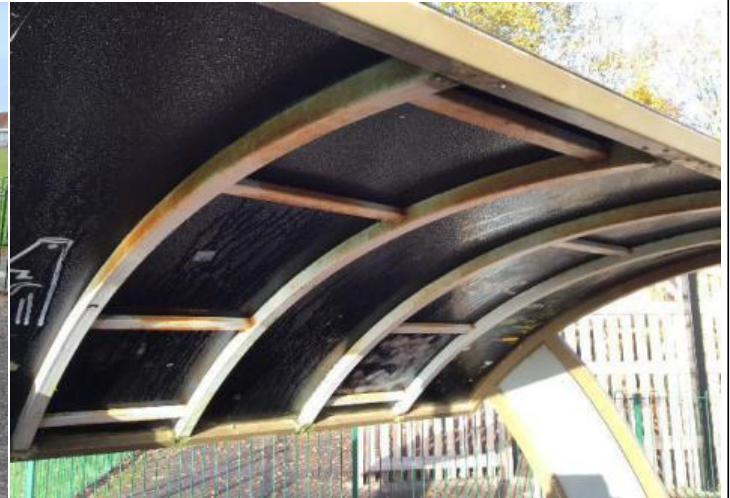
**Finding:** There is surface corrosion / rust present on the item

**Action:** Consider treating the item

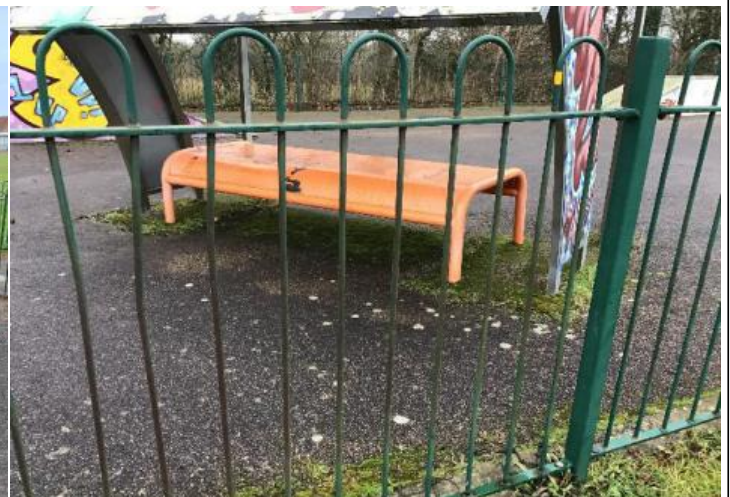
**Finding:** There is algae, silt or moss growth on the surface resulting in slippery conditions

**Action:** Clean and treat appropriately

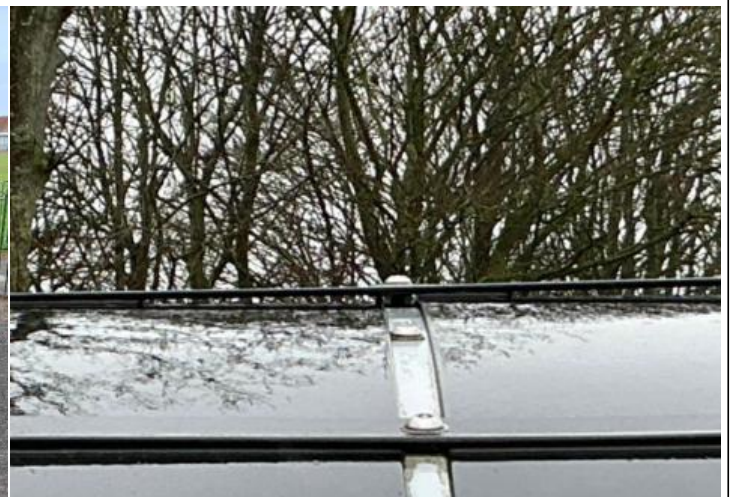
**Finding:** A number of fixing(s) have worked loose

**Action:** Secure all loose fixings

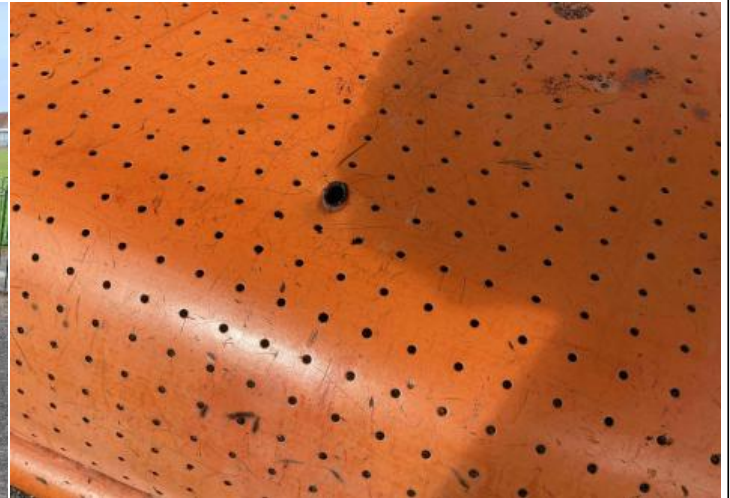
**Finding:** The item has been damaged leaving sharp edges **Action:** Repair item

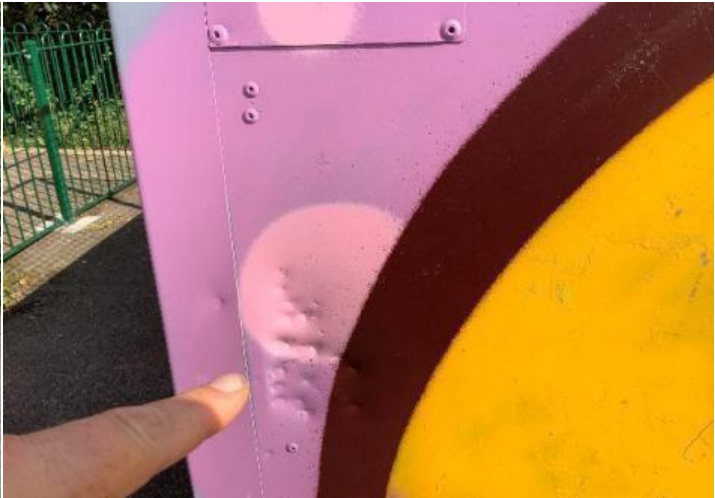
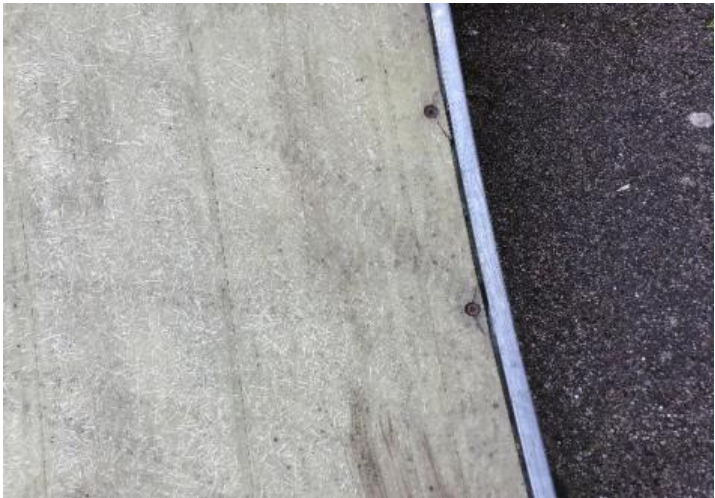
**Finding:** The item has been damaged

**Action:** Monitor for any further deterioration and replace as required

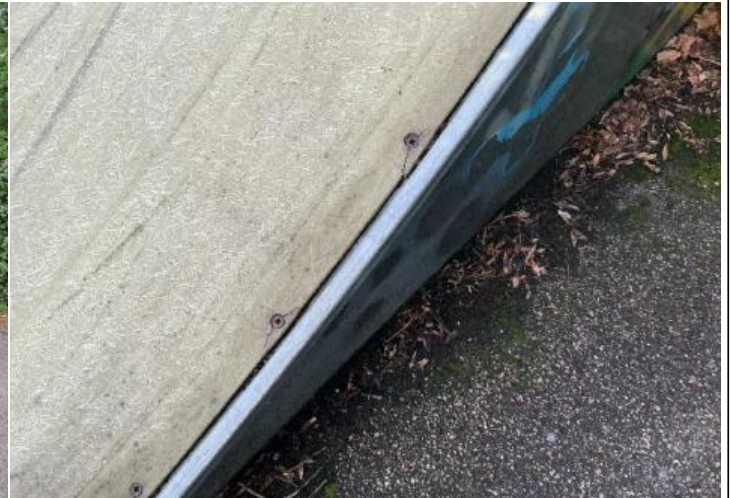
**Finding:** Minor damage to surface

**Action:** Monitor for deterioration

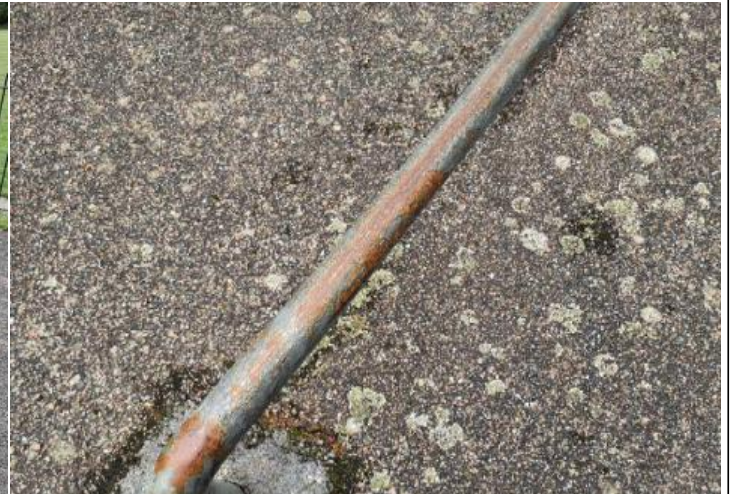
**Finding:** There is surface corrosion / rust present on the item

**Action:** Consider treating the item

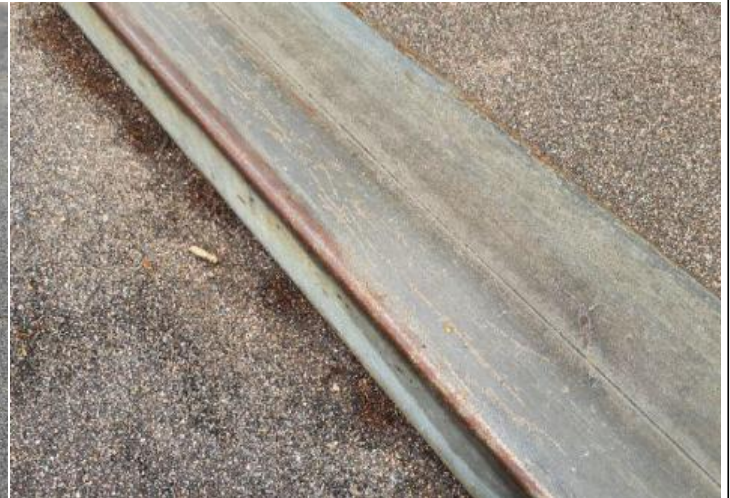
**Finding:** There is surface corrosion / rust present on the item

**Action:** Consider treating the item

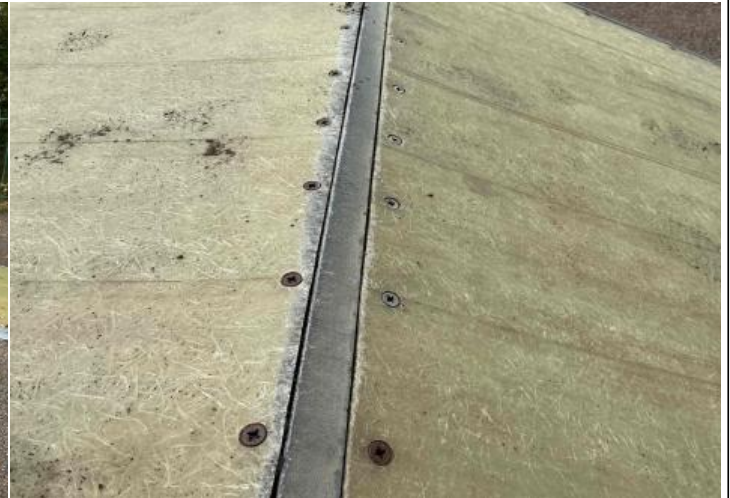
**Finding:** The riding surface has minor damage apparent

**Action:** Monitor for any further deterioration and repair as required

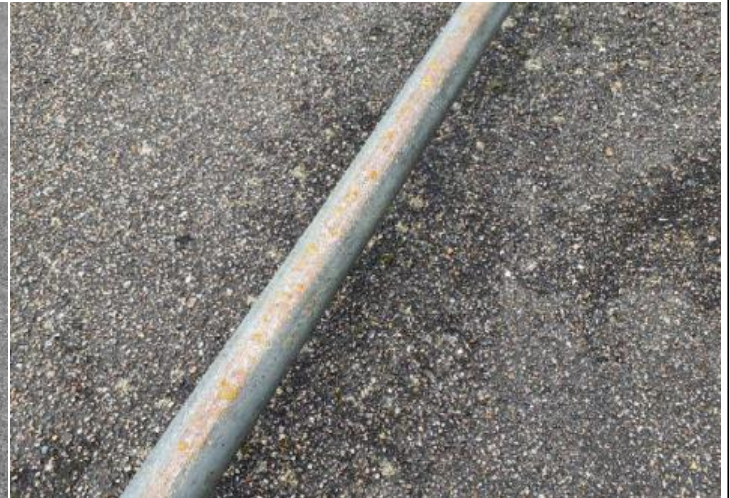
**Finding:** There is surface corrosion / rust present on the item

**Action:** Consider treating the item

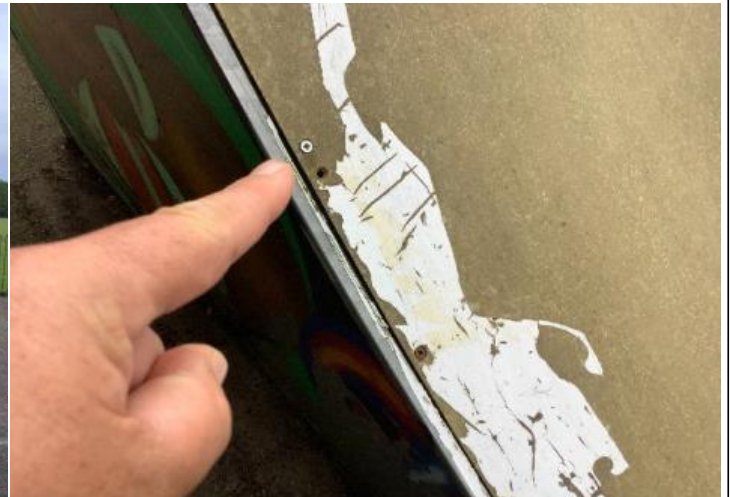
**Finding:** A number of fixing(s) have worked loose

**Action:** Secure all loose fixings

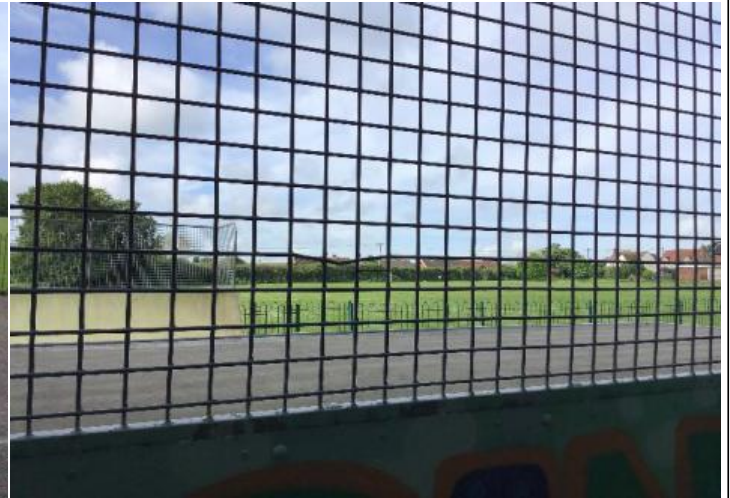
**Finding:** There is some damage to the fence sections

**Action:** Monitor for any further deterioration and repair as required

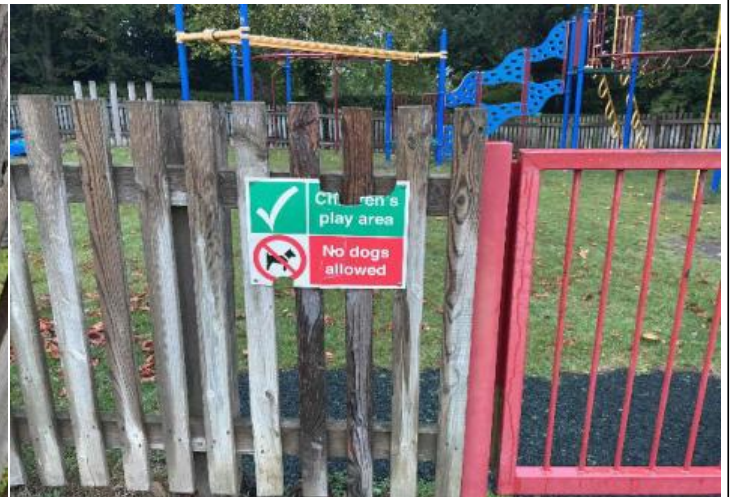
**Finding:** The item has been damaged

**Action:** Monitor for any further deterioration and replace as required

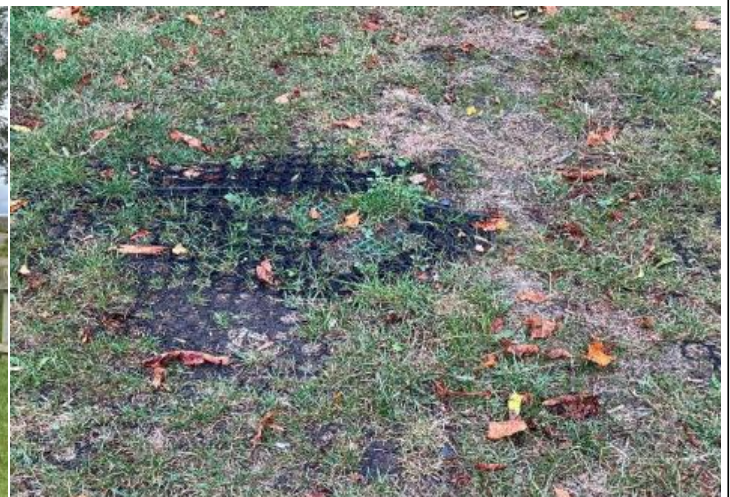
**Finding:** There is moderate damage to the surface

**Action:** Repair the damaged areas of surfacing

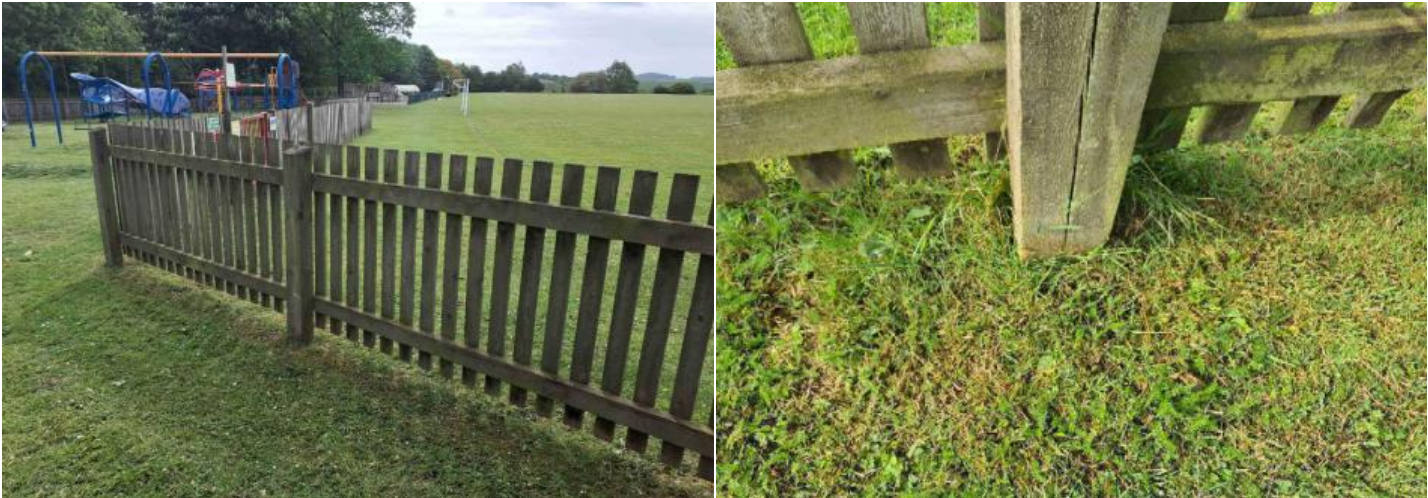
| <b>Finding:</b> There is some strimmer / machinery damage apparent on the posts, this can penetrate the preservative applied to the timber and accelerate the rotting process | <b>Action:</b> Monitor for any deterioration (rot) and replace as required |

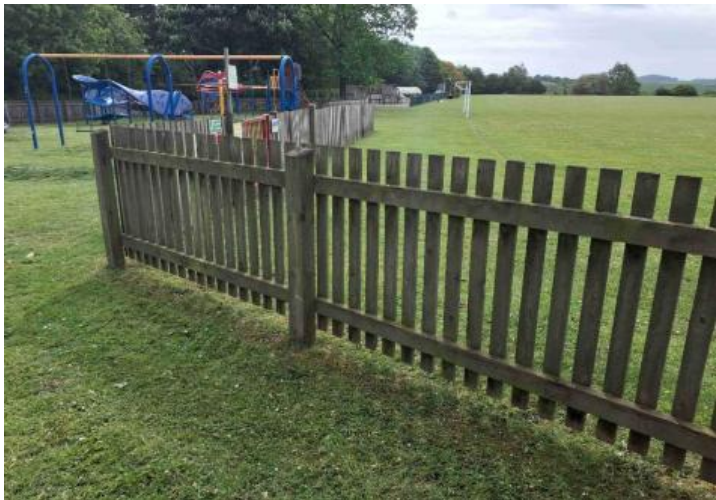
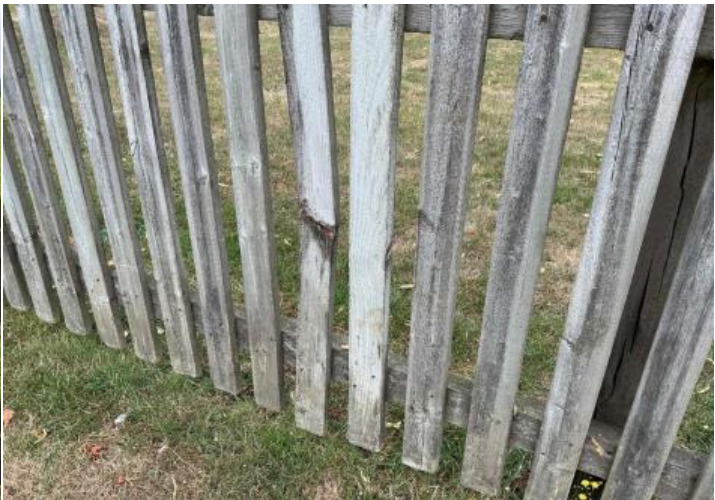
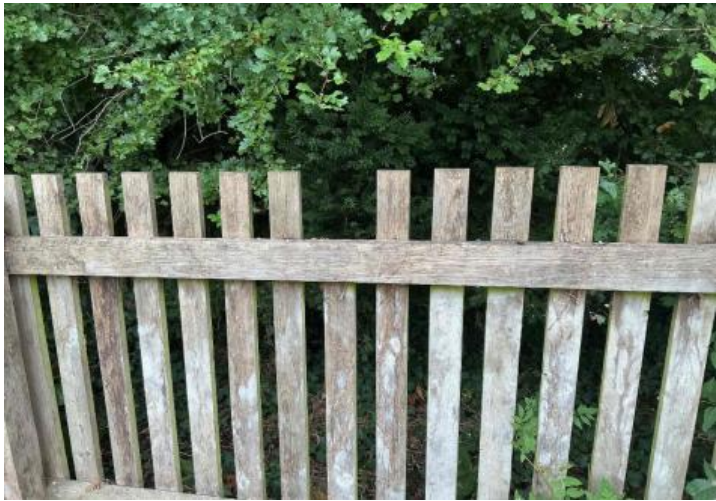
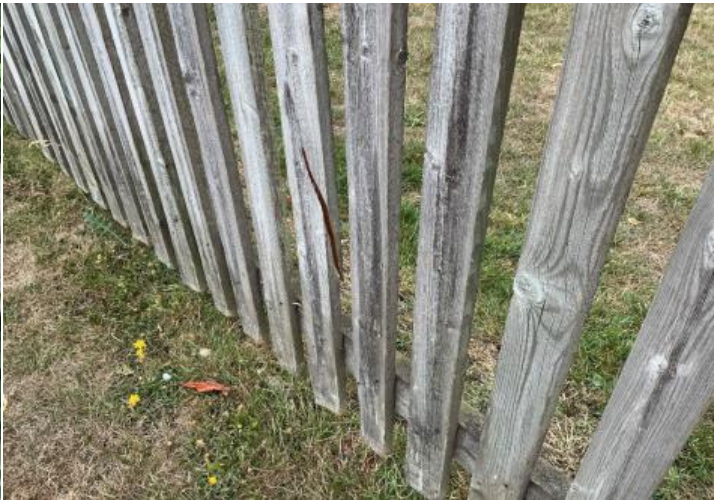
**Finding:** Slats damaged

**Action:** Replace damaged slat

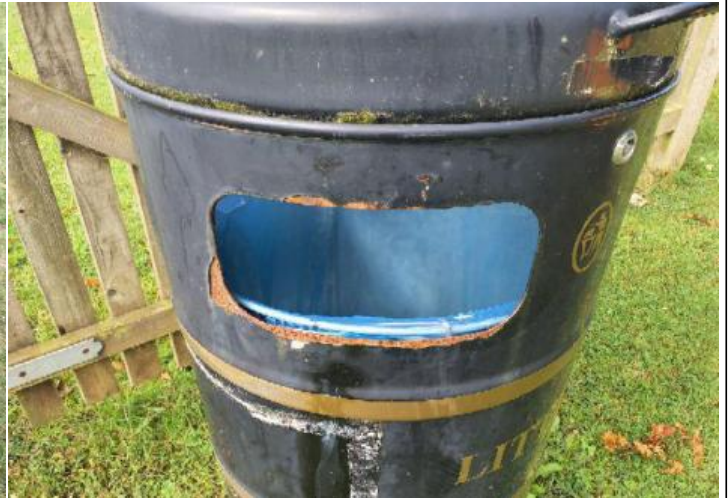
**Finding:** The paintwork on this item has been damaged or worn exposing the metal underneath which is rusting / corroding

**Action:** Treat affected areas and repaint

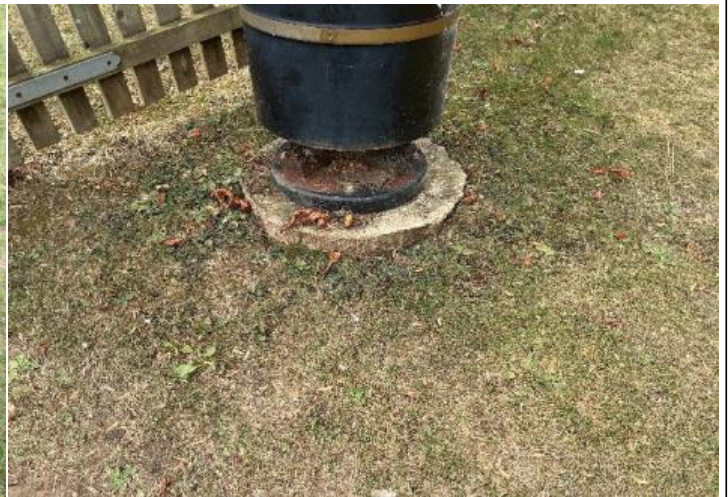
**Finding:** The foundation is loose

**Action:** Reinstate the foundation

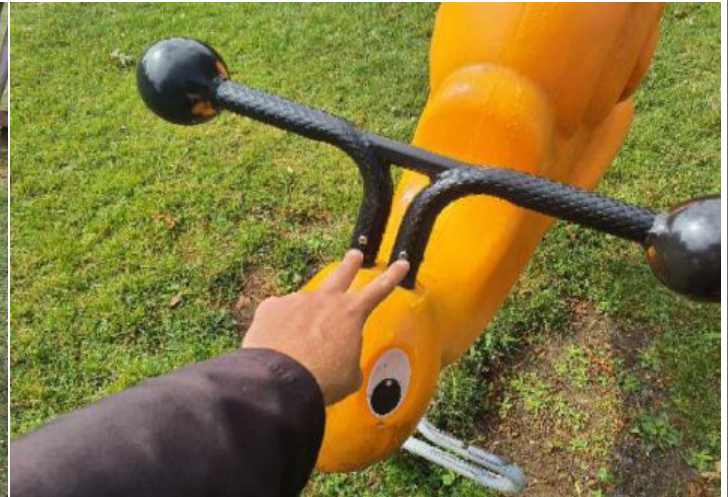
**Finding:** A number of fixing(s) have worked loose

**Action:** Secure all loose fixings

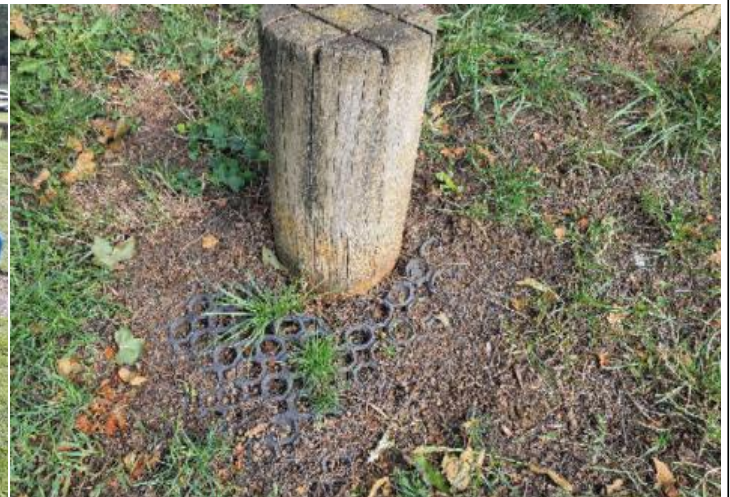
**Finding:** There is some strimmer / machinery damage apparent on the posts, this can penetrate the preservative applied to the timber and accelerate the rotting process

**Action:** Monitor for any deterioration (rot) and replace as required

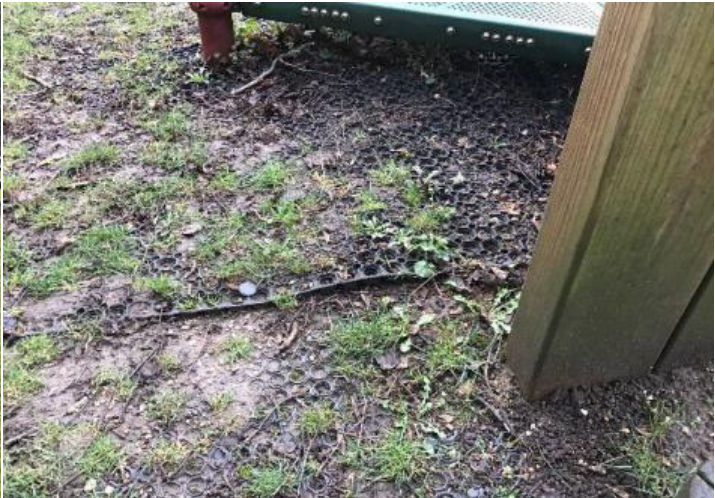
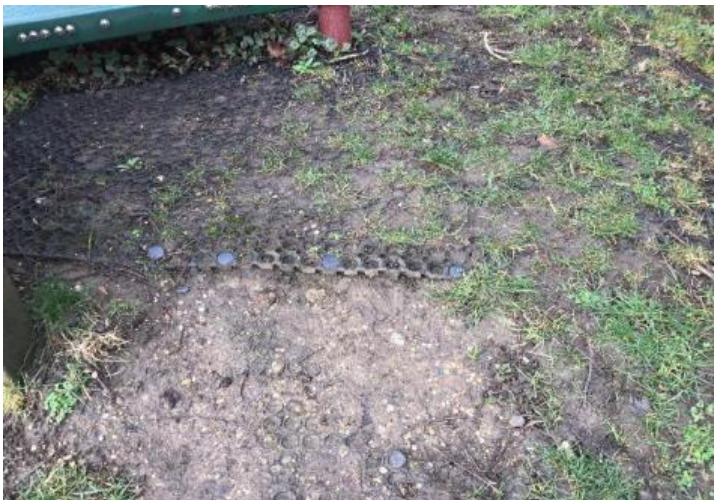
**Finding:** There are trip hazards at the edges of the surface

**Action:** Reinstate surrounding surface levels to remove the trip points

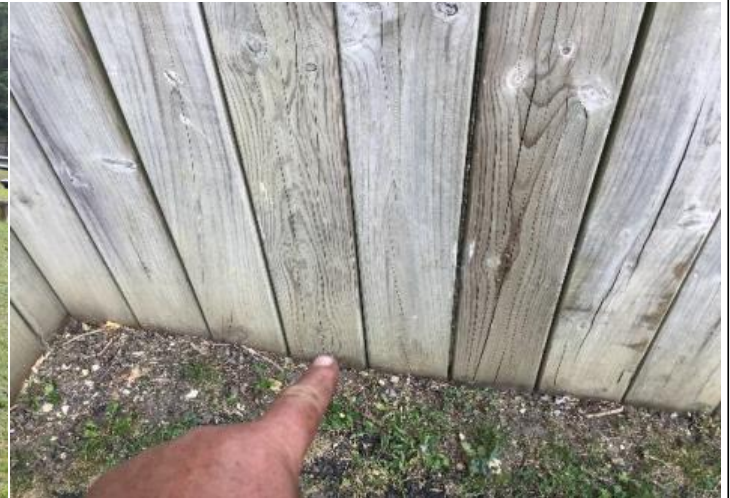
**Finding:** Some timbers are slightly loose in the foundation

**Action:** Monitor for deterioration

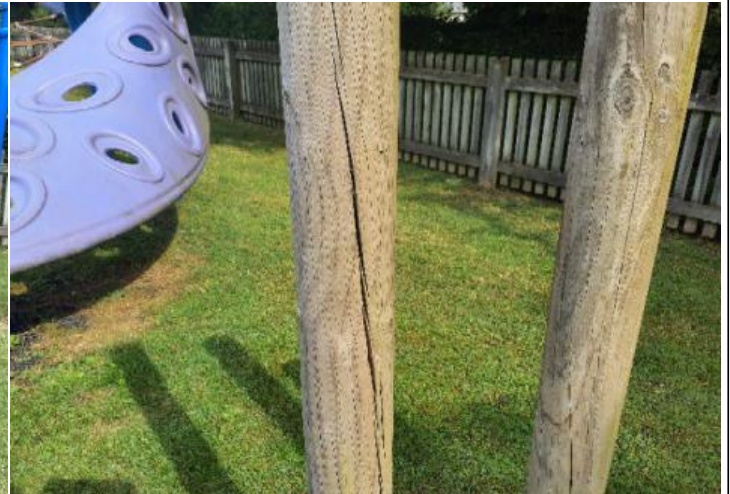
**Finding:** The timber has a number of splits/shakes or air cracks and this may affect the stability or allow water ingress which will accelerate the rotting process

**Action:** Monitor to ensure the splits do not cross through fixing points of the structure and/or cause any instability

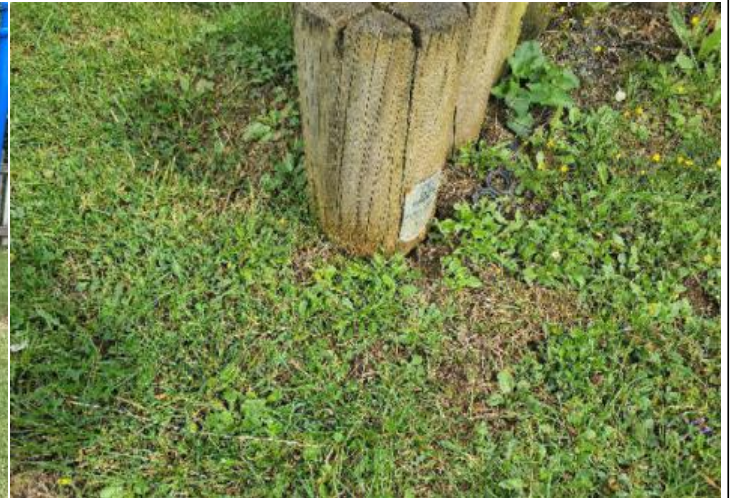
**Finding:** There is some strimmer / machinery damage apparent on the posts, this can penetrate the preservative applied to the timber and accelerate the rotting process

**Action:** Monitor for any deterioration (rot) and replace as required

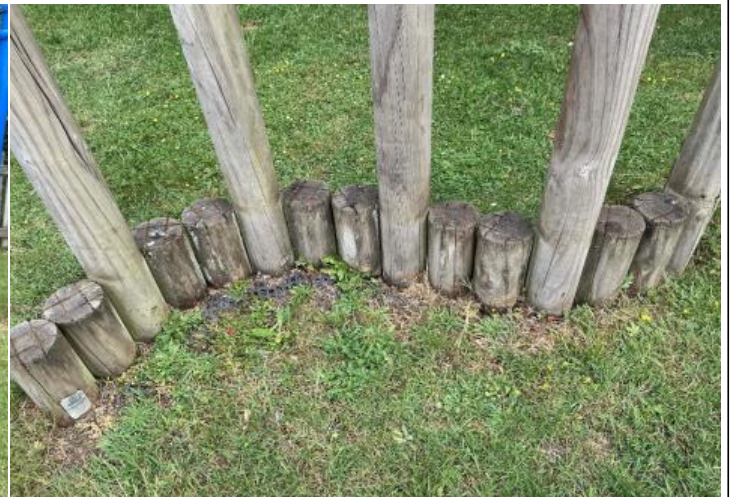
**Finding:** There is some evidence of rot in the timber

**Action:** Monitor for any further deterioration and replace as required

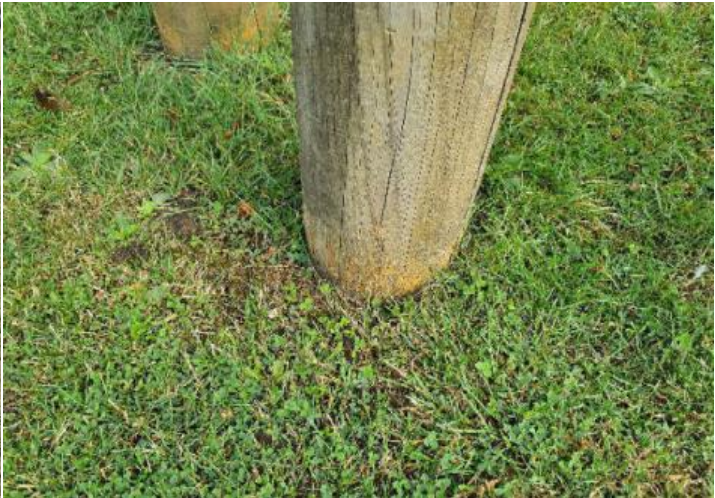
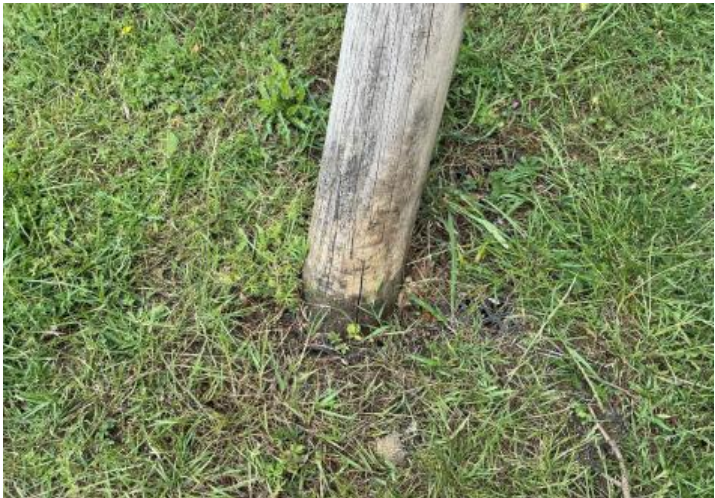
**Finding:** There is some strimmer / machinery damage apparent on the posts, this can penetrate the preservative applied to the timber and accelerate the rotting process

**Action:** Monitor for any deterioration (rot) and replace as required

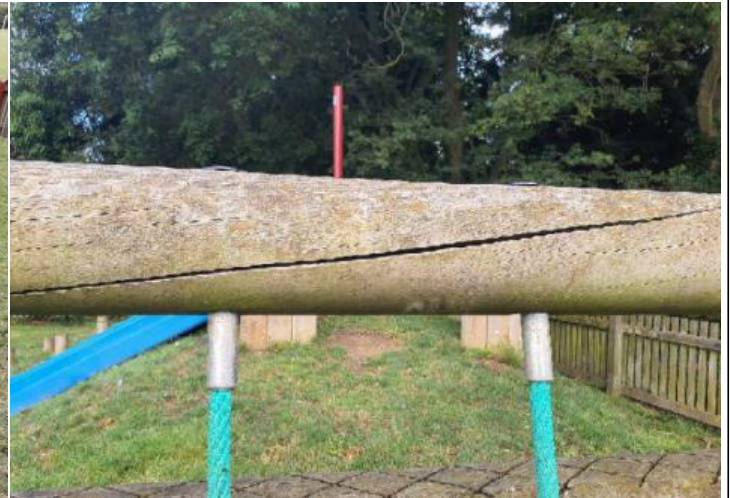
**Finding:** The timber has a number of splits/shakes or air cracks and this may affect the stability or allow water ingress which will accelerate the rotting process

**Action:** Monitor to ensure the splits do not cross through fixing points of the structure and/or cause any instability

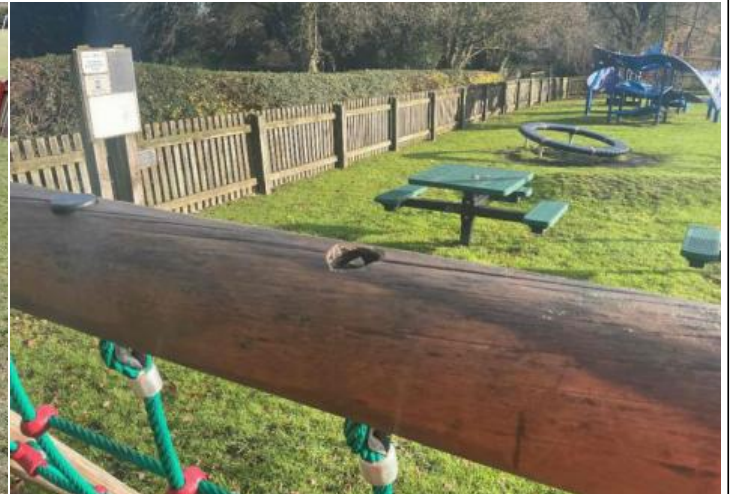
**Finding:** There is/are bolt cap covers missing or damaged on the item

**Action:** Replace missing or damaged bolt cap covers

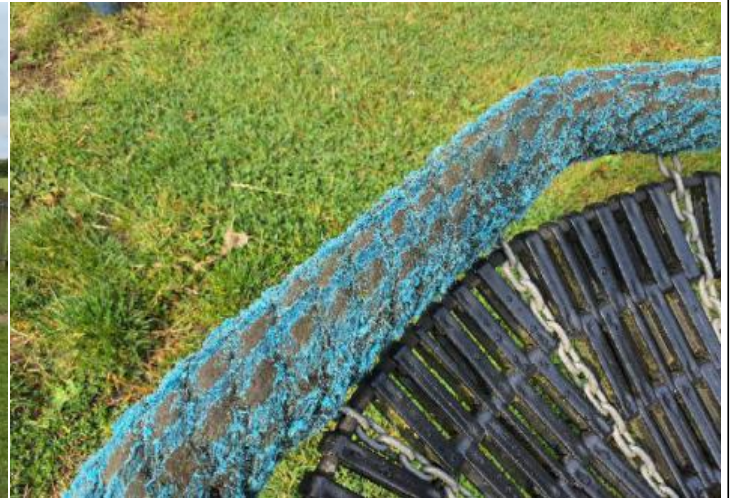
**Finding:** The seat has minor damage or wear

**Action:** Monitor for any further deterioration and replace as required

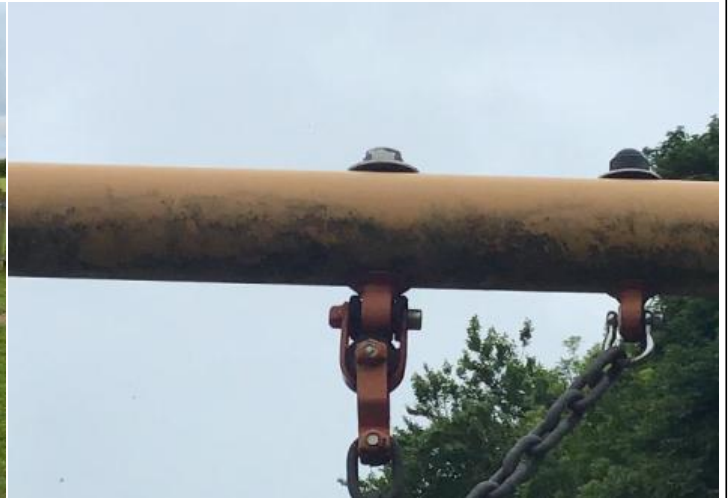
**Finding:** There is/are bolt cap covers missing or damaged on the item

**Action:** Replace missing or damaged bolt cap covers
