## **Play Area Inspection Reports & Remedial Work**

## Wickhambrook. Bury Road

Inspection Ref: 3230454

Operational Inspection - 8-October-2026 - 08:11 Inspector Philip Smith

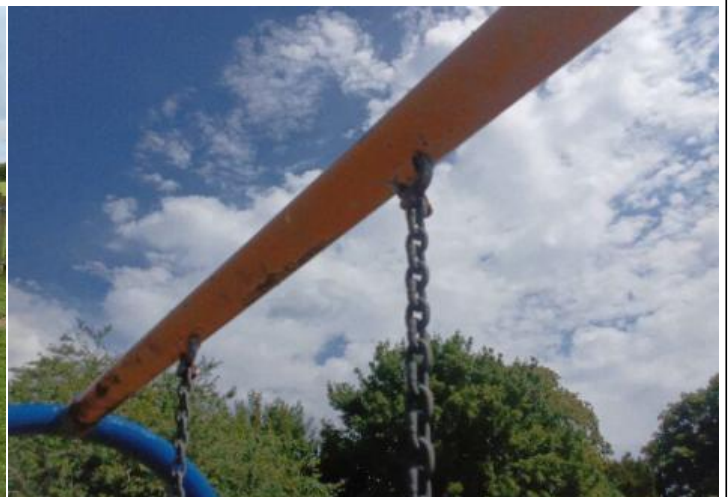
**Finding:** The bushes are showing signs of wear

**Action:** Monitor for any further deterioration and replace as required

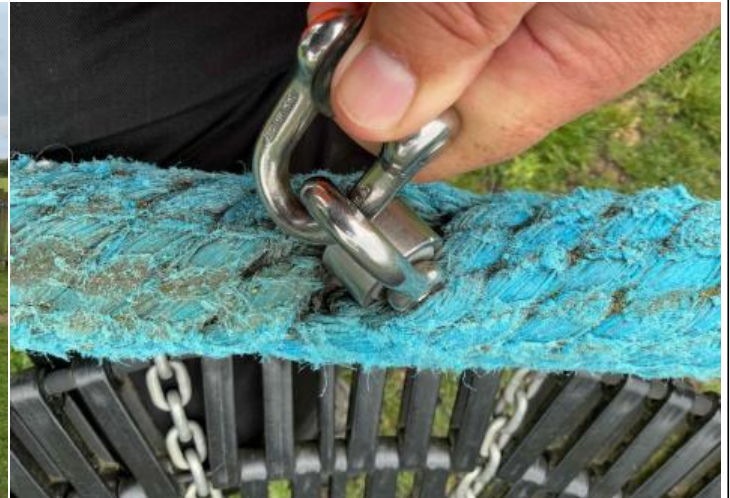
**Finding:** There is some wear to the shackles

**Action:** Monitor for any further deterioration and replace when 40% worn

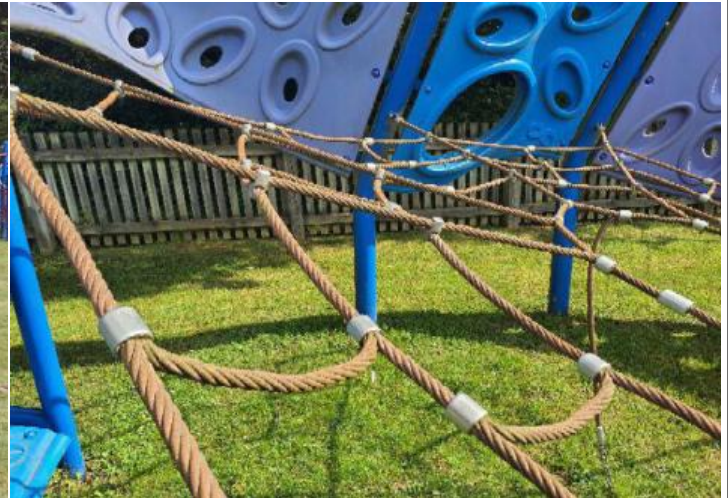
**Finding:** The ropes/nets are worn/damaged in places

**Action:** Monitor for any further deterioration and repair or replace as required

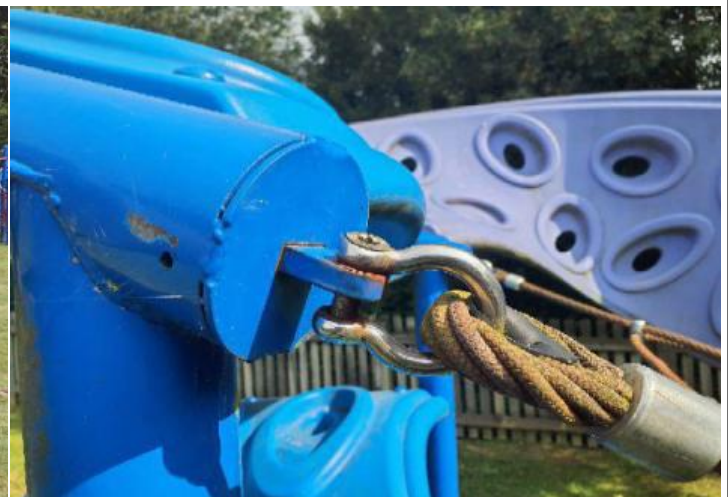
**Finding:** The connecting lugs are showing signs of wear

**Action:** Monitor for any further deterioration and repair as required

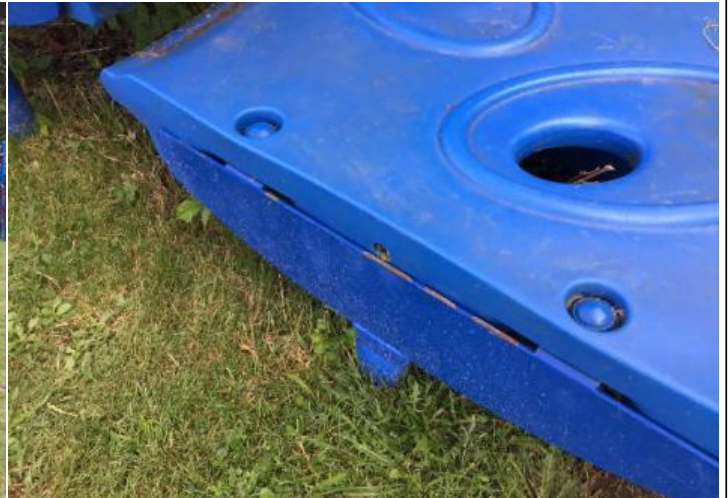
**Finding:** There is surface corrosion / rust present on the item

**Action:** Consider treating the item

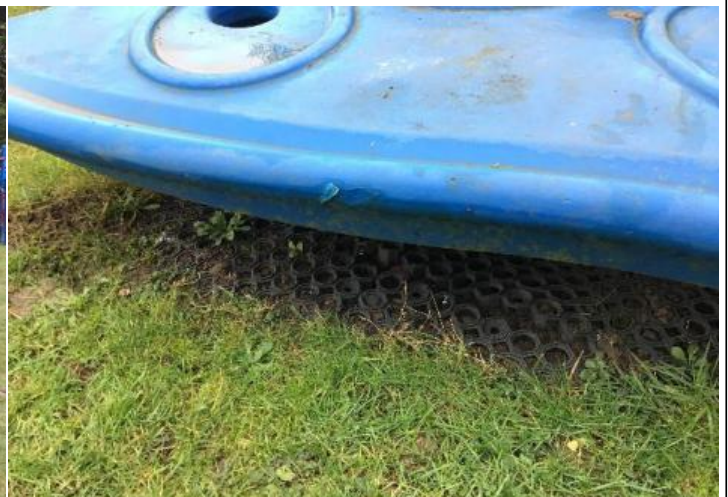
**Finding:** The item has been damaged

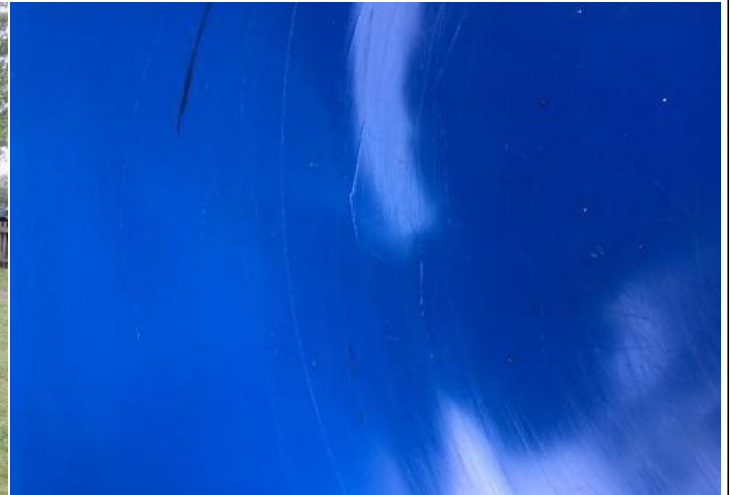
**Finding:** There are a number of dents in the slide surface

**Action:** Monitor for any further deterioration and repair as required

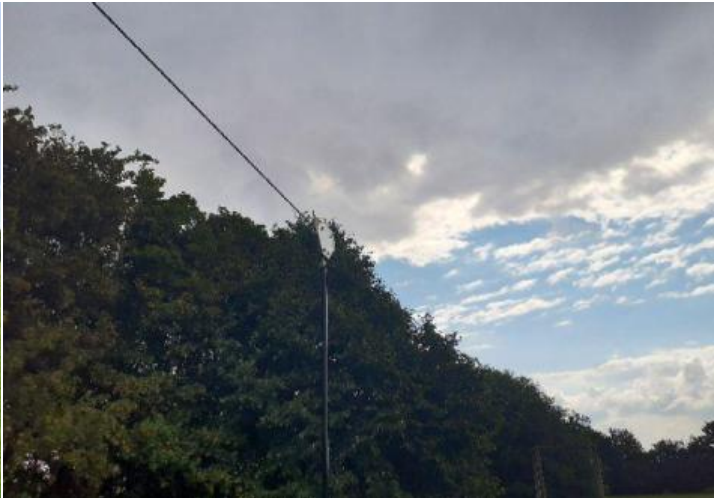
| <b>Finding:</b> We have completed a visual inspection of the suspension links, cable and fixing points from ground level, however it is not possible to fully inspect these areas without either hiring equipment to gain access or removing the cable and suspension and inspecting at ground level. We recommend that the main cable and fixing security is thoroughly inspected at least in accordance with the manufacturers recommendations to check for wear, damage, security or internal rusting; this will help to ensure the continued safe use of the equipment | | <b>Action:</b> Inspect in accordance with the manufacturers recommendations | |

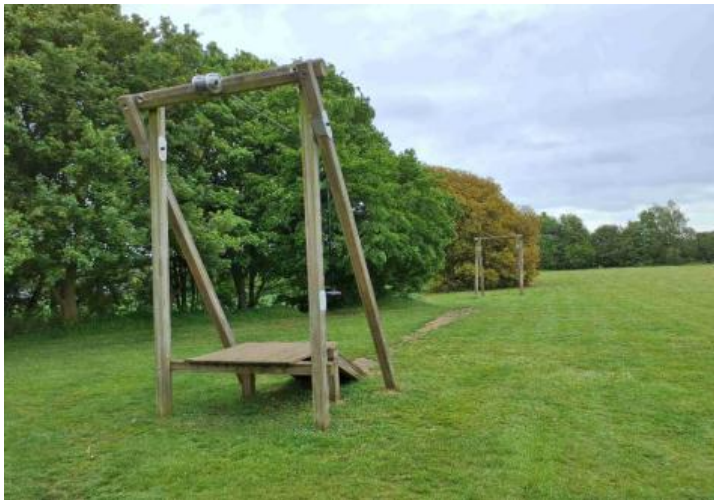
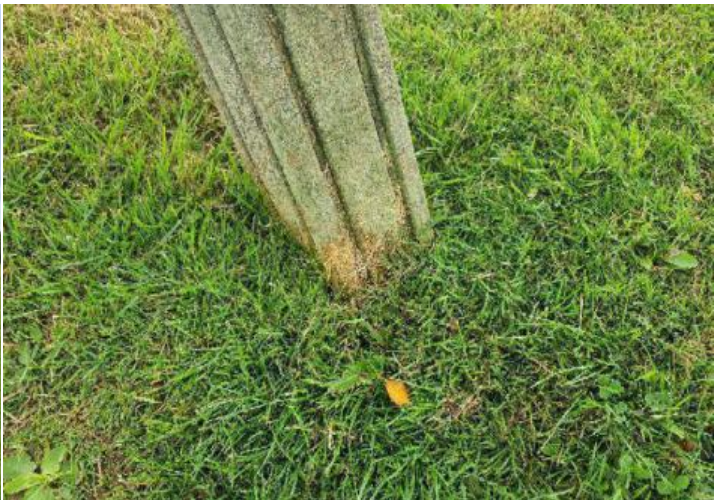
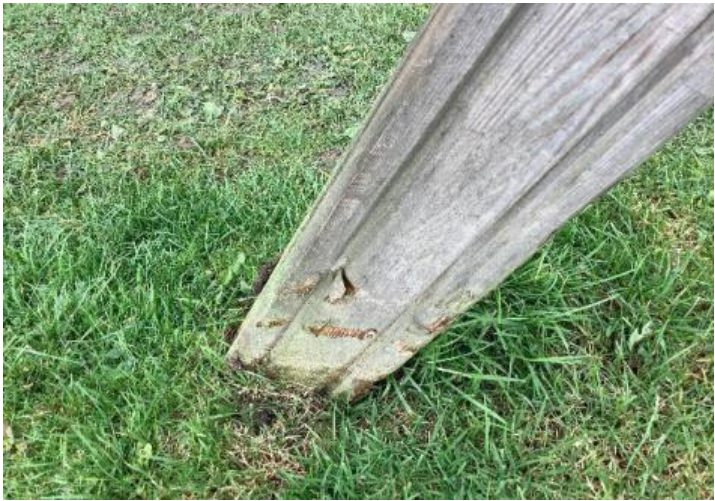
**Finding:** There is some strimmer / machinery damage apparent on the posts, this can penetrate the preservative applied to the timber and accelerate the rotting process

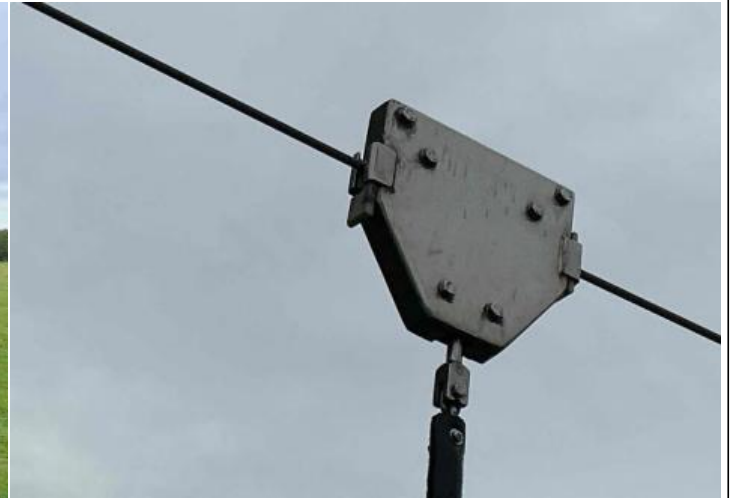
**Finding:** The nylon inserts are worn or missing at the point the cable enters the traveller

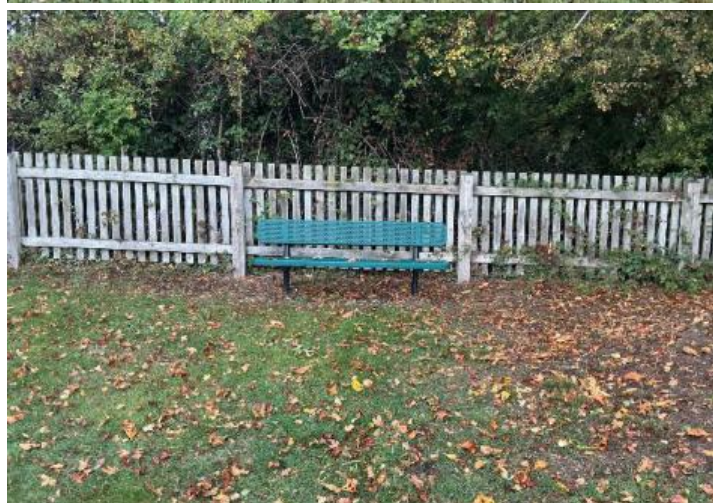
**Finding:** A number of fixing(s) have worked loose
