## **Play Area Inspection Reports & Remedial Work**

A copy of the March inspection reports is attached as **Appendix A**, and a summary of work identified is attached as **Appendix B**.

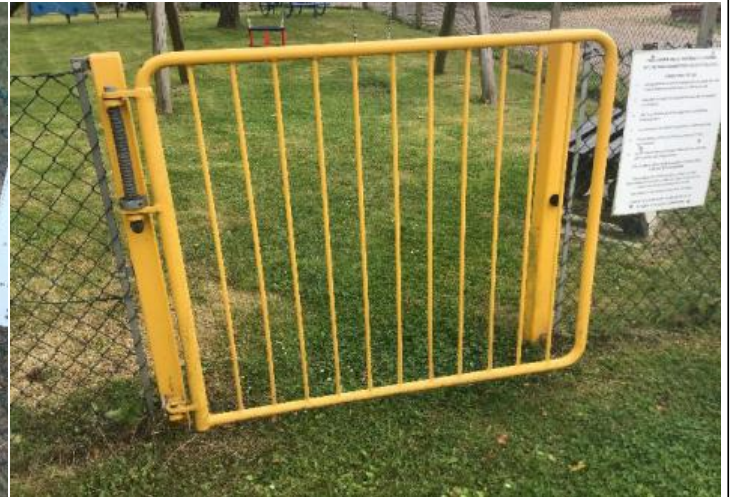
The gate rebounds when opened quickly and could strike the next user entering the area - Monitor use and adjust/replace as required

**Finding:** The gate rebounds when opened quickly and could strike the next user entering the area  
**Action:** Monitor use and adjust/replace as required

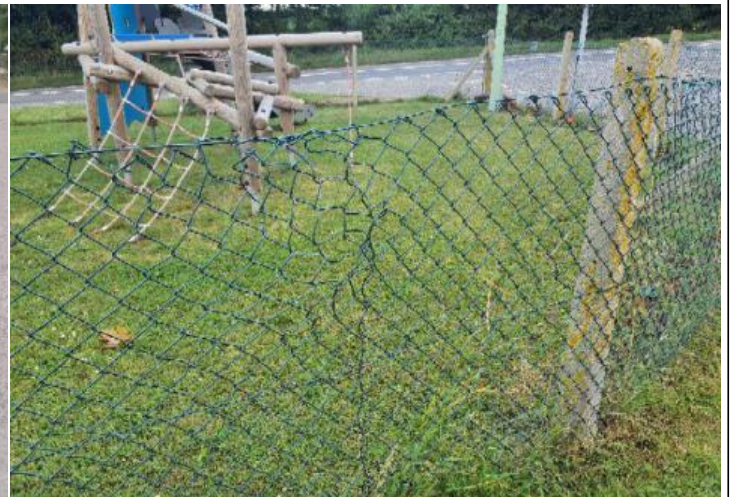
There is some damage to the fence sections - Monitor for any further deterioration and repair as required

**Finding:** There is some damage to the fence sections

**Action:** Monitor for any further deterioration and repair as required

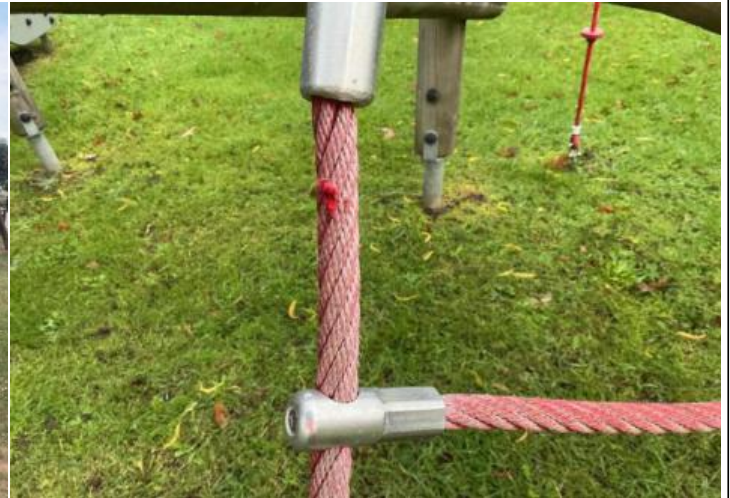
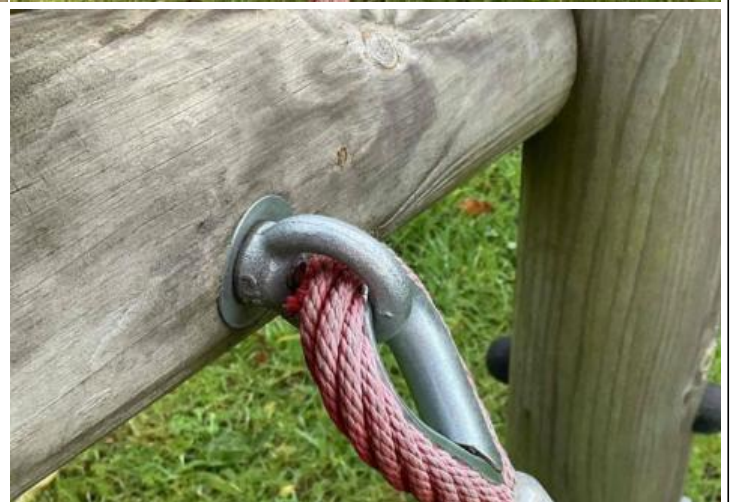
The ropes/nets are worn/damaged in places - Monitor for any further deterioration and repair or replace as required

**Finding:** The ropes/nets are worn/damaged in places

**Action:** Monitor for any further deterioration and repair or replace as required

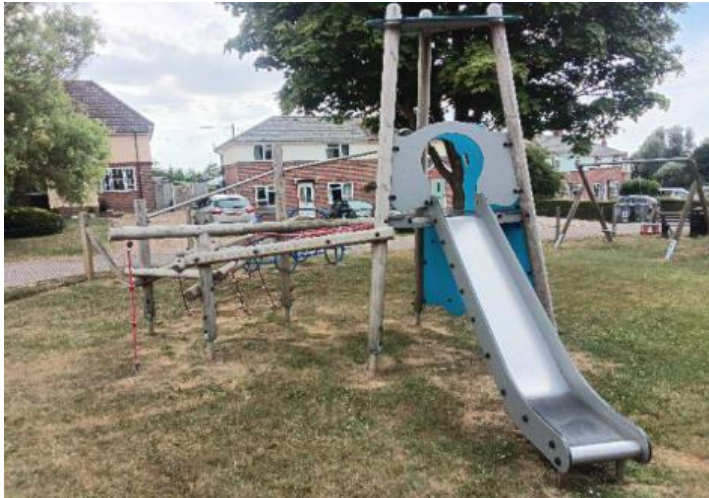
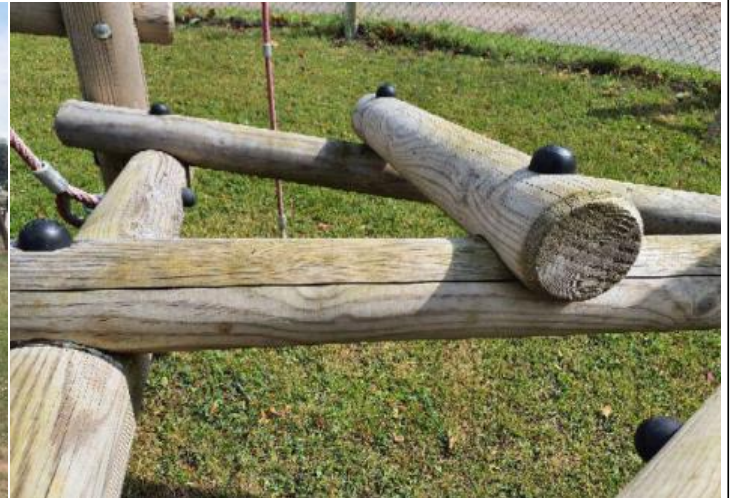
The timber has a number of splits/shakes or air cracks and this may affect the stability or allow water ingress which will accelerate the rotting process - Monitor to ensure the splits do not cross through fixing points of the structure and/or cause any instability

**Finding:** The timber has a number of splits/shakes or air cracks and this may affect the stability or allow water ingress which will accelerate the rotting process  
**Action:** Monitor to ensure the splits do not cross through fixing points of the structure and/or cause any instability

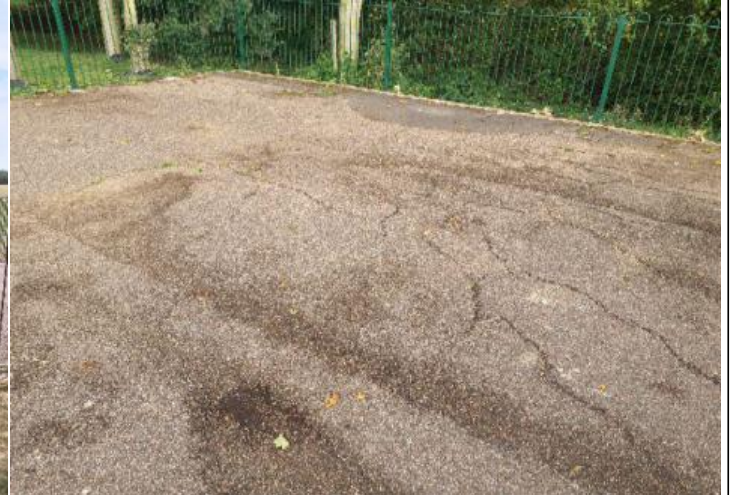
There is moderate damage to the surface - Repair the damaged areas of surfacing

**Finding:** There is moderate damage to the surface

**Action:** Repair the damaged areas of surfacing

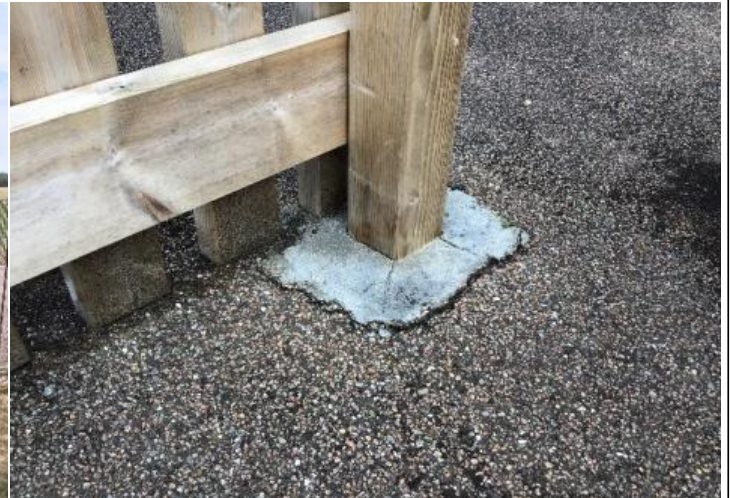
The concrete foundation around the goal structure is lifting - Repair

**Finding:** The concrete foundation around the goal structure is lifting  
**Action:** Repair

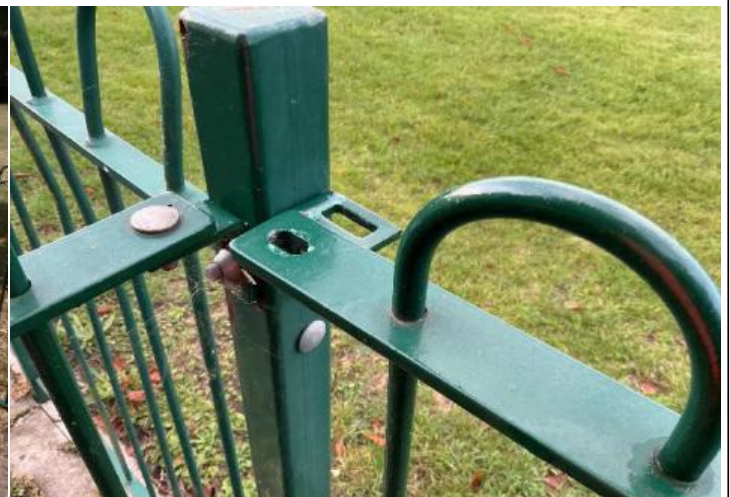
There are a number of fixings missing from the fence - Replace missing fixings

**Finding:** There are a number of fixings missing from the fence  
**Action:** Replace missing fixings

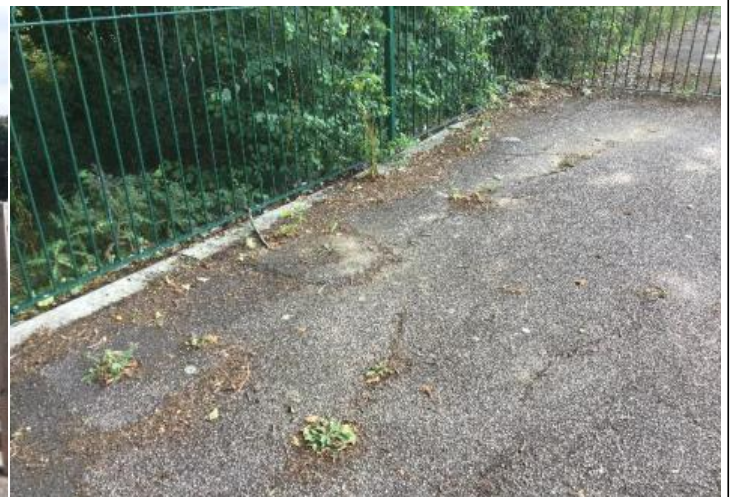
There is algae, silt or moss growth on the surface resulting in slippery conditions - Clean and treat appropriately

**Finding:** There is algae, silt or moss growth on the surface resulting in slippery conditions

**Action:** Clean and treat appropriately

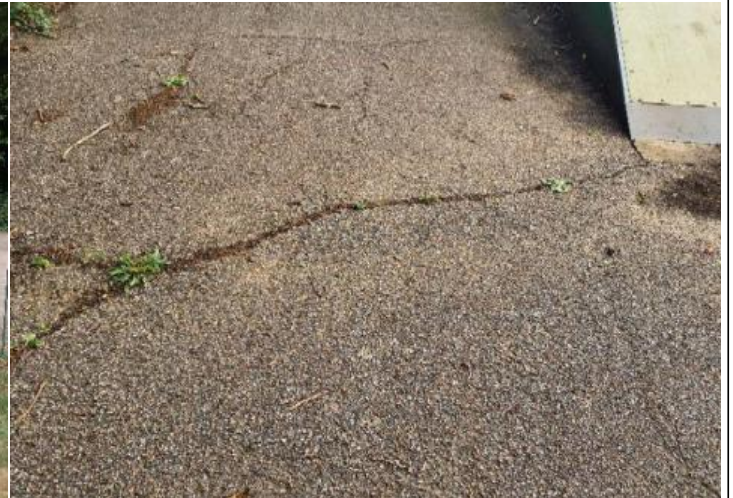
There is root damage to the surfacing creating unforeseen changes in levels - Repair the damaged areas of tarmac to provide a uniform surface

**Finding:** There is root damage to the surfacing creating unforeseen changes in levels

**Action:** Repair the damaged areas of tarmac to provide a uniform surface

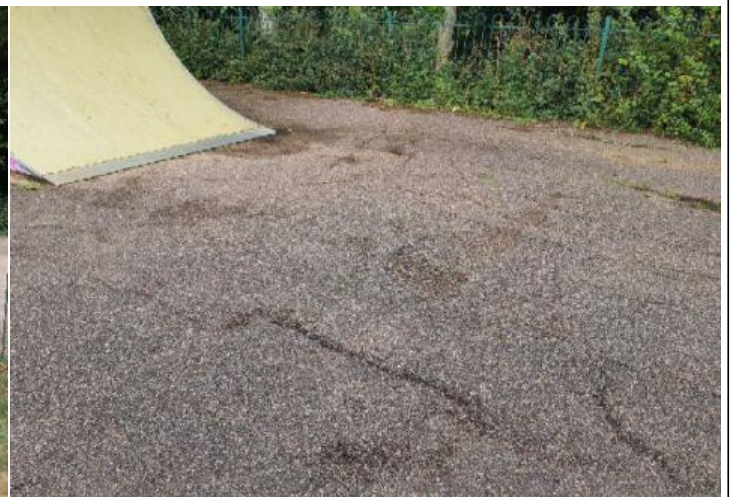
There is some damage apparent to the riding surface - Monitor for any further deterioration and repair as required

**Finding:** There is some damage apparent to the riding surface

**Action:** Monitor for any further deterioration and repair as required

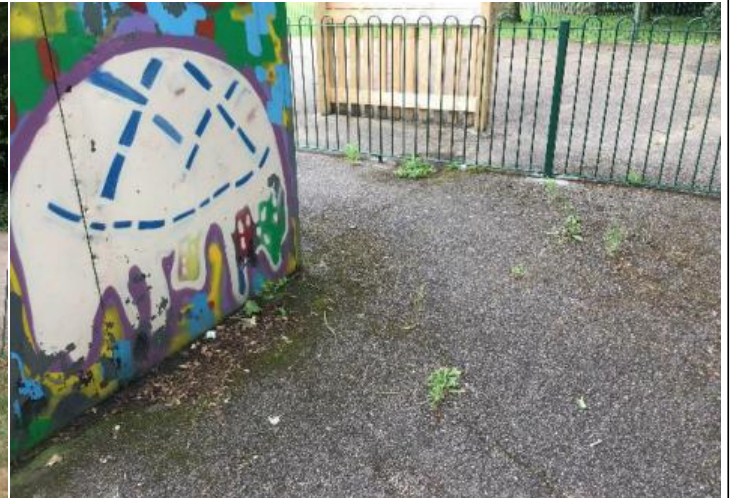
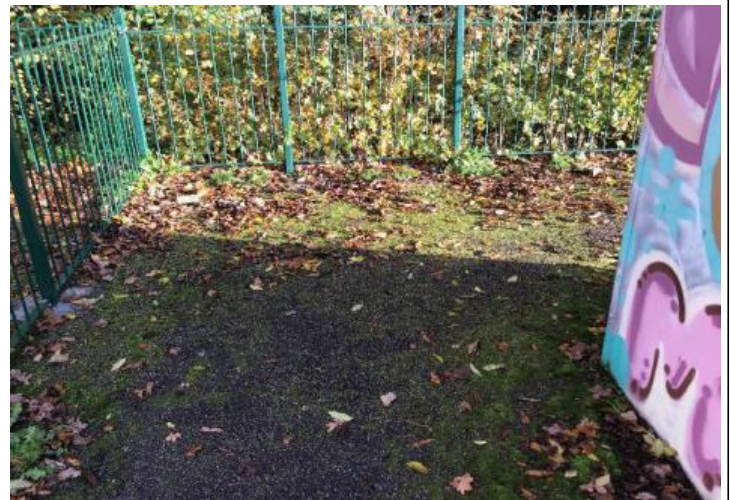
There is algae, silt or moss growth on the surface resulting in slippery conditions - Clean and treat appropriately

**Finding:** There is algae, silt or moss growth on the surface resulting in slippery conditions

**Action:** Clean and treat appropriately

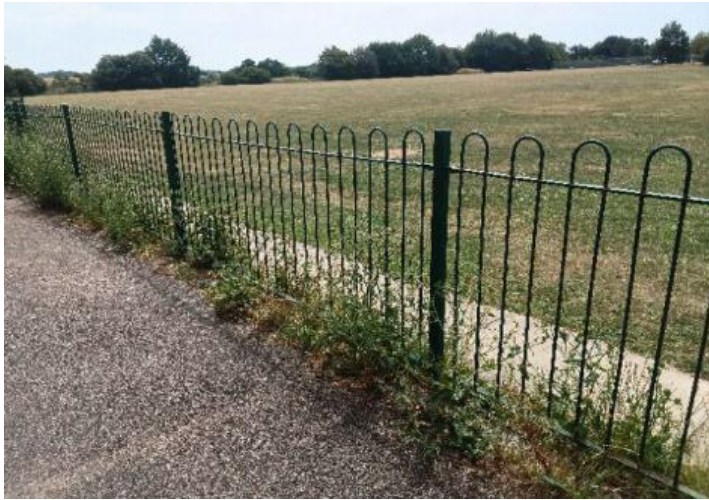
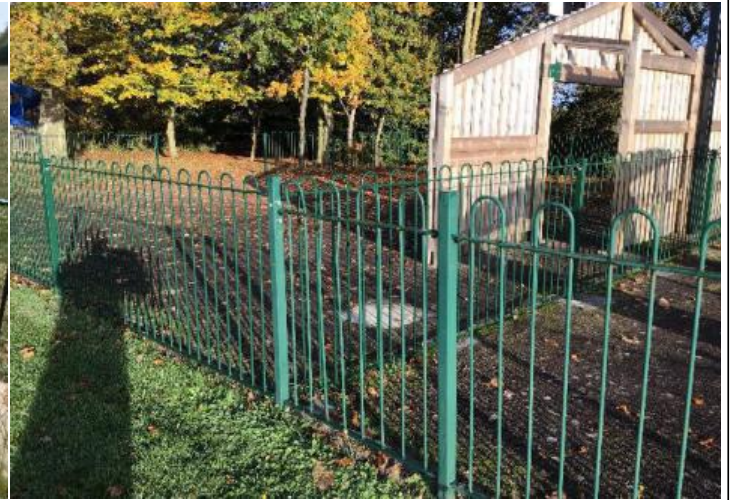
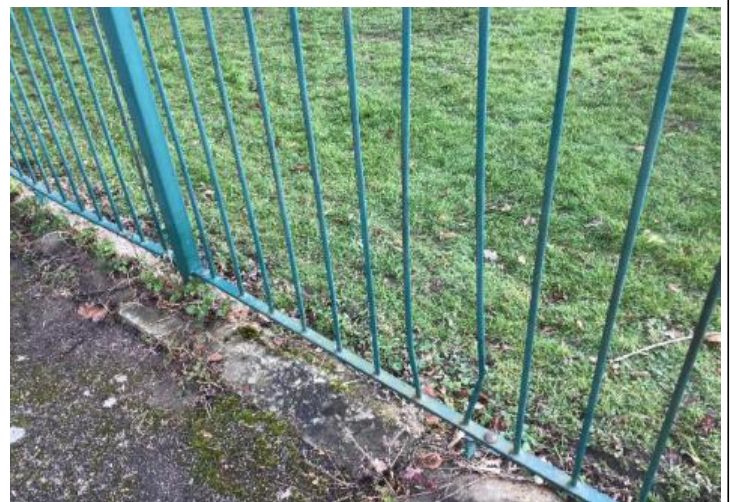
There is some damage to the fence sections - Monitor for any further deterioration and repair as required

**Finding:** There is some damage to the fence sections

**Action:** Monitor for any further deterioration and repair as required

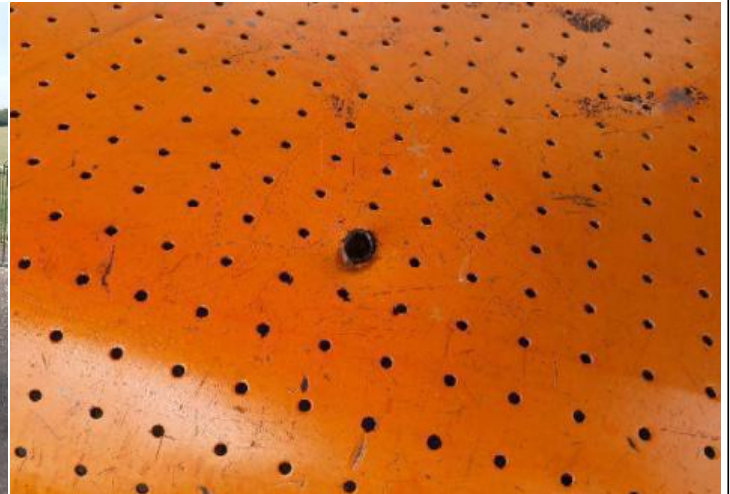
There is some evidence of fire damage to the item - Monitor for any further deterioration and repair as required

**Finding:** There is some evidence of fire damage to the item

**Action:** Monitor for any further deterioration and repair as required

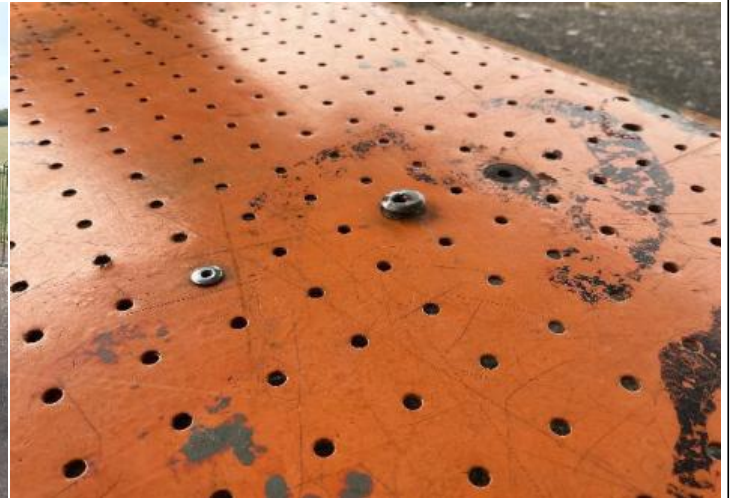
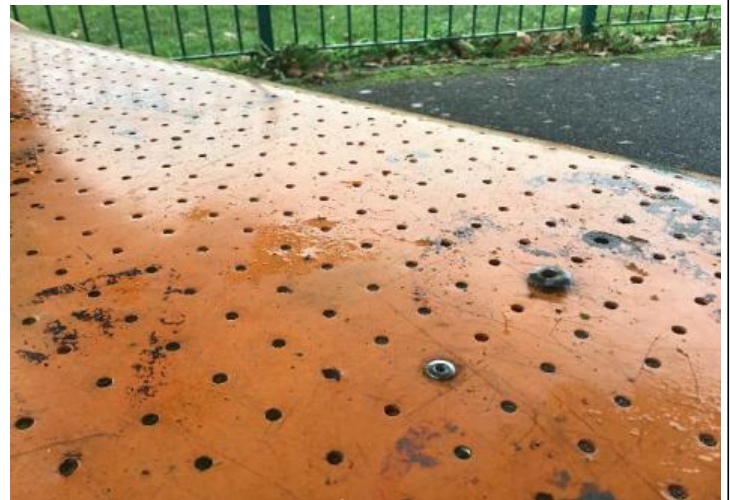
Pop rivet fixings have failed on the seat - Replace the failed pop rivets

**Finding:** Pop rivet fixings have failed on the seat

**Action:** Replace the failed pop rivets

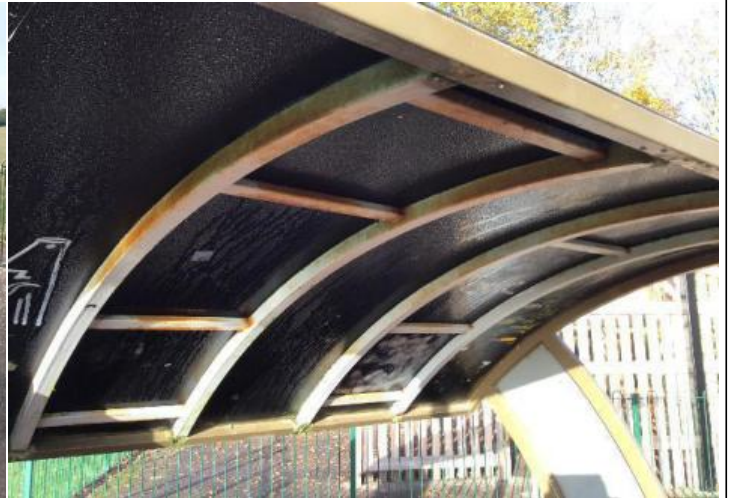
**Finding:** There is surface corrosion / rust present on the item

**Action:** Consider treating the item

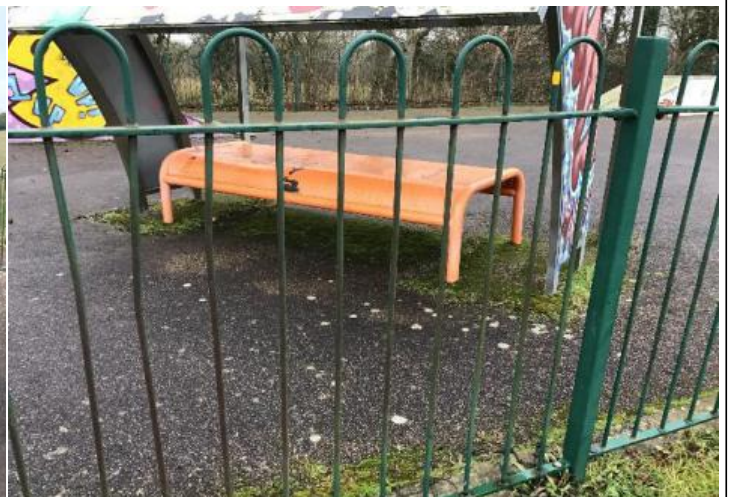
**Finding:** There is algae, silt or moss growth on the surface resulting in slippery conditions

**Action:** Clean and treat appropriately

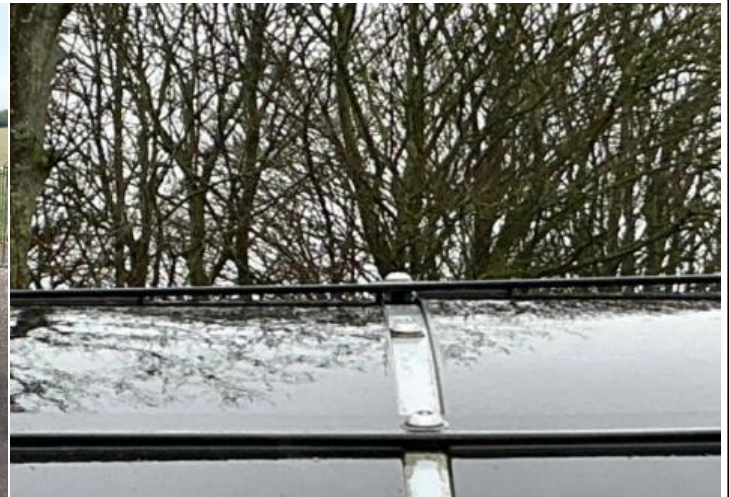
**Finding:** A number of fixing(s) have worked loose

**Action:** Secure all loose fixings

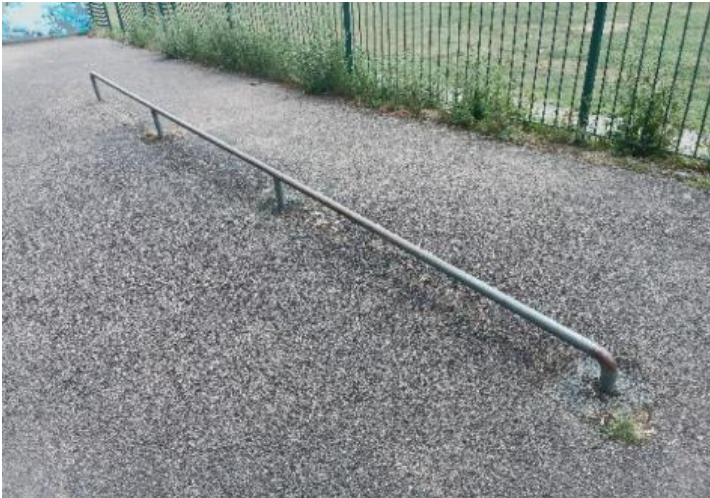
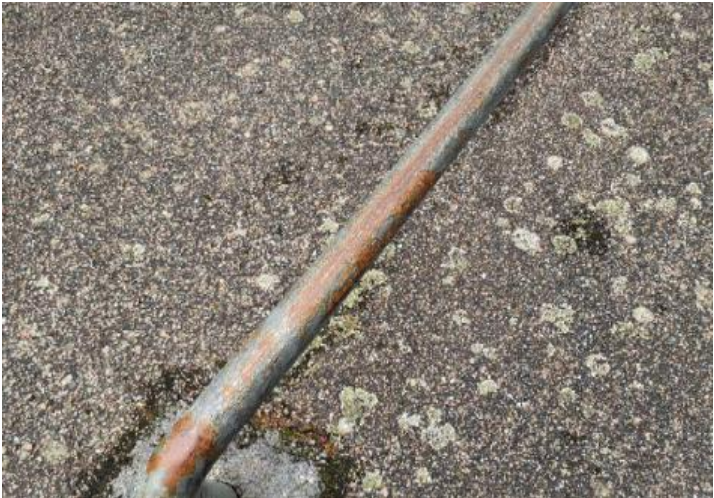
**Finding:** There is surface corrosion / rust present on the item

**Action:** Consider treating the item

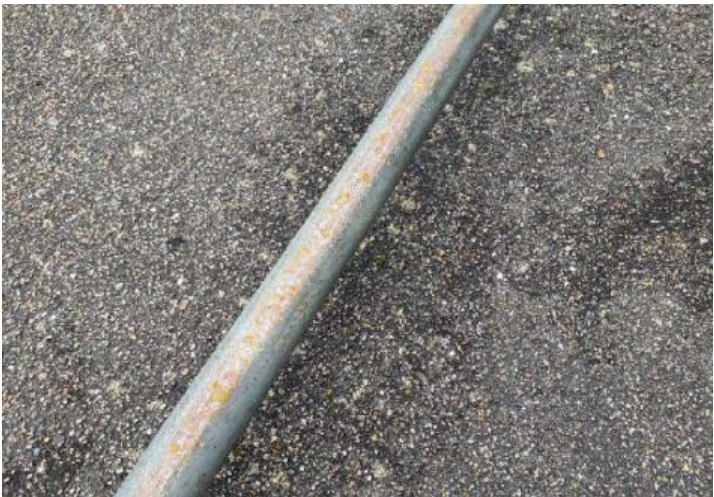
**Finding:** There is surface corrosion / rust present on the item

**Action:** Consider treating the item

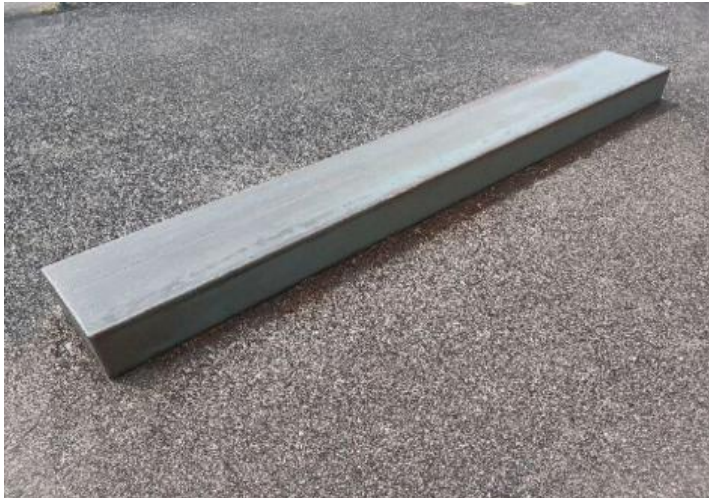
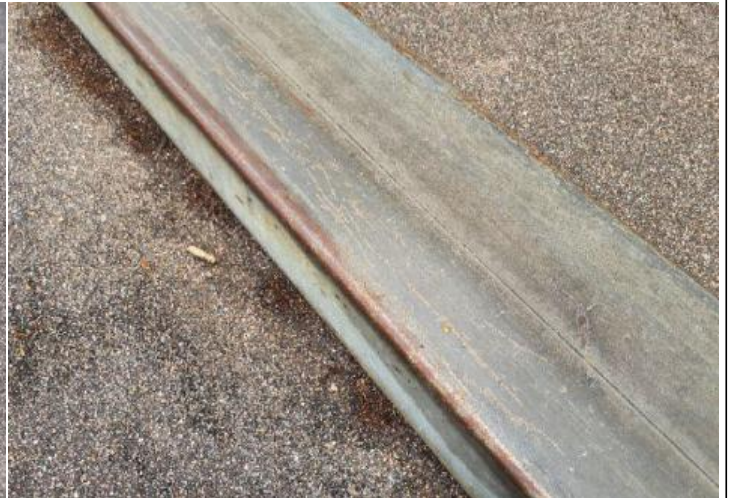
**Finding:** There is surface corrosion / rust present on the item

**Action:** Consider treating the item

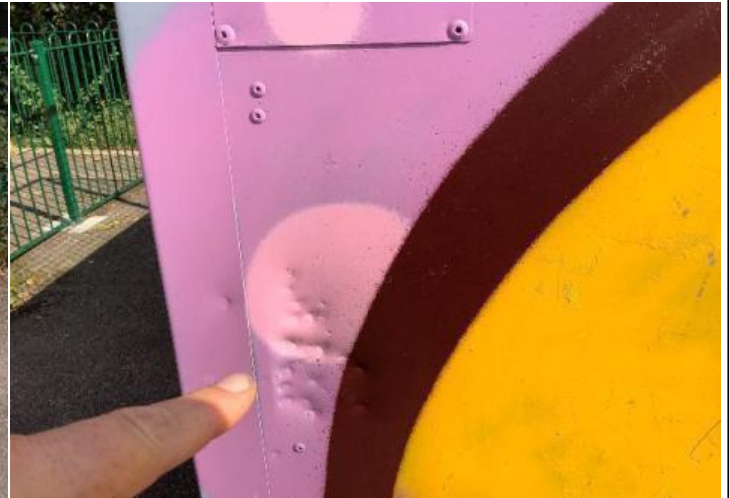
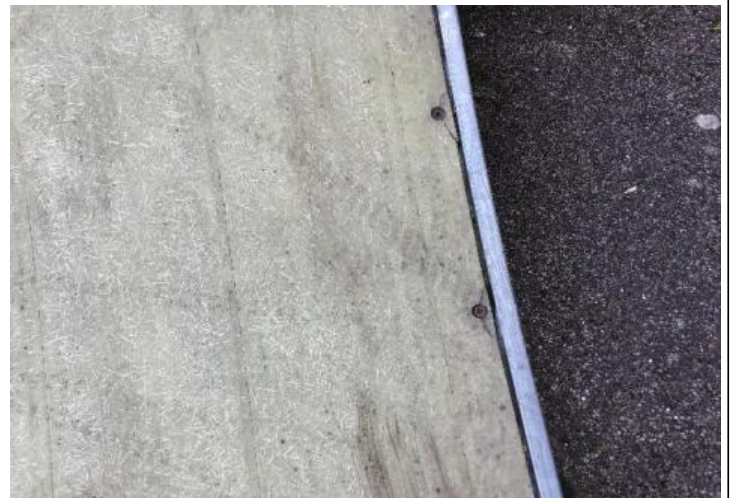
The item has been damaged - Monitor for any further deterioration and replace as required

**Finding:** The item has been damaged

**Action:** Monitor for any further deterioration and replace as required

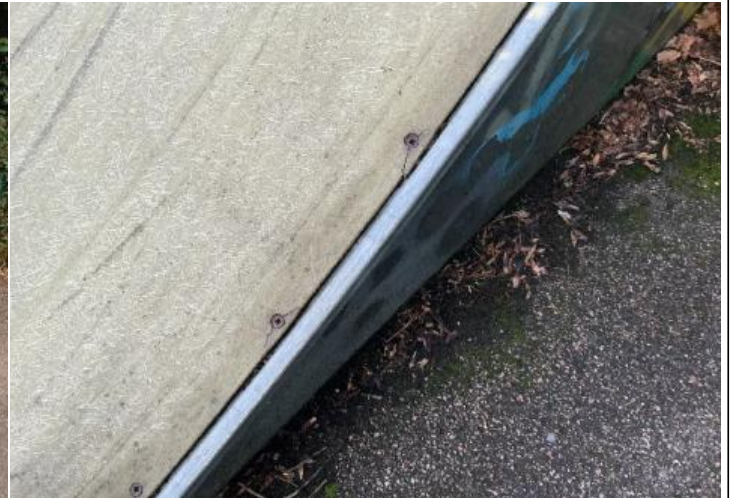
Minor damage to surface - Monitor for deterioration

**Finding:** Minor damage to surface

**Action:** Monitor for deterioration

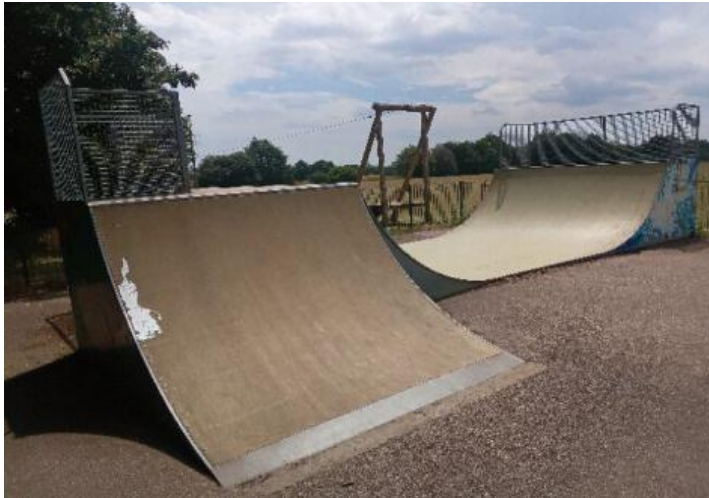
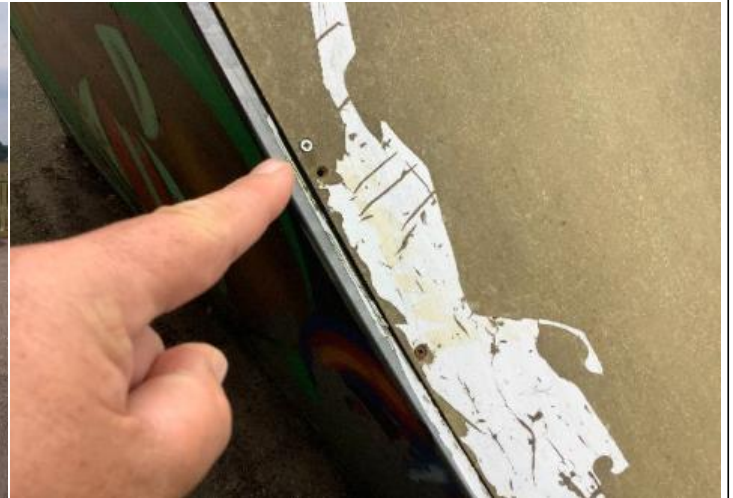
**Finding:** A number of fixing(s) have worked loose

**Action:** Secure all loose fixings

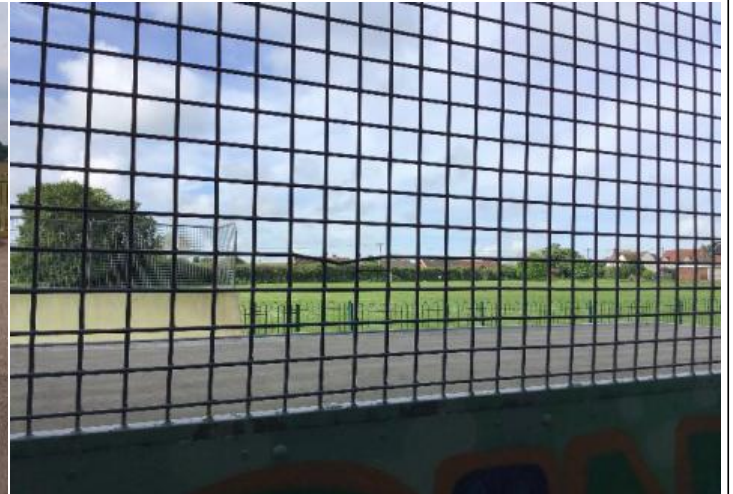
There is some damage to the fence sections - Monitor for any further deterioration and repair as required

**Finding:** There is some damage to the fence sections

**Action:** Monitor for any further deterioration and repair as required

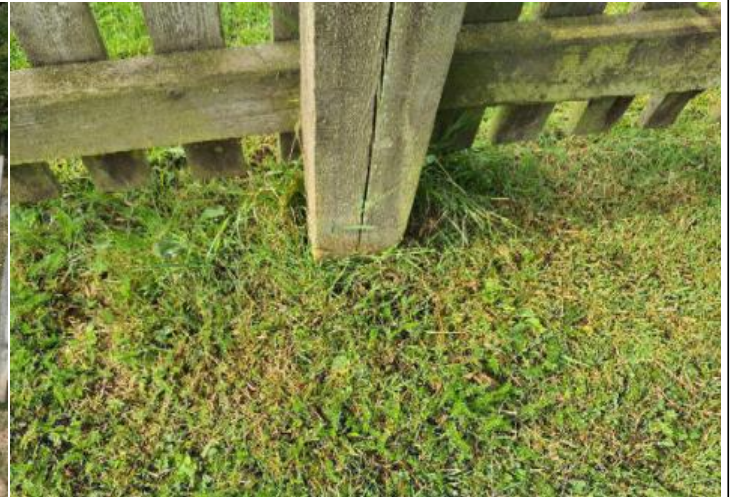
**Finding:** There is some strimmer / machinery damage apparent on the posts, this can penetrate the preservative applied to the timber and accelerate the rotting process

**Action:** Monitor for any deterioration (rot) and replace as required

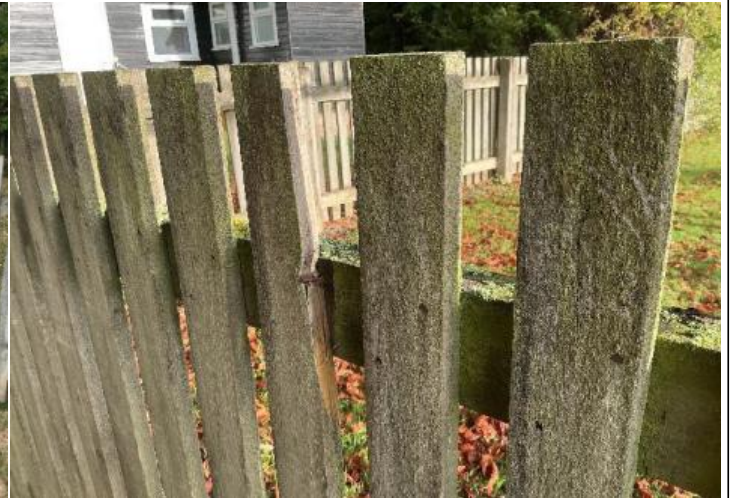
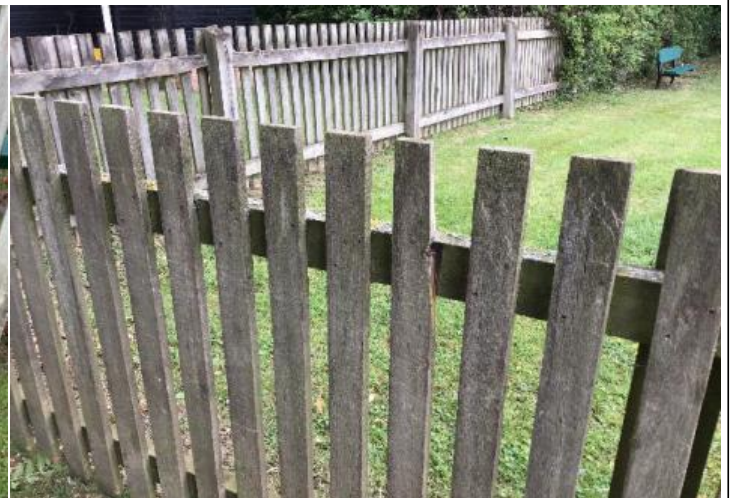
Slats damaged - Replace damaged slat

**Finding:** Slats damaged

**Action:** Replace damaged slat

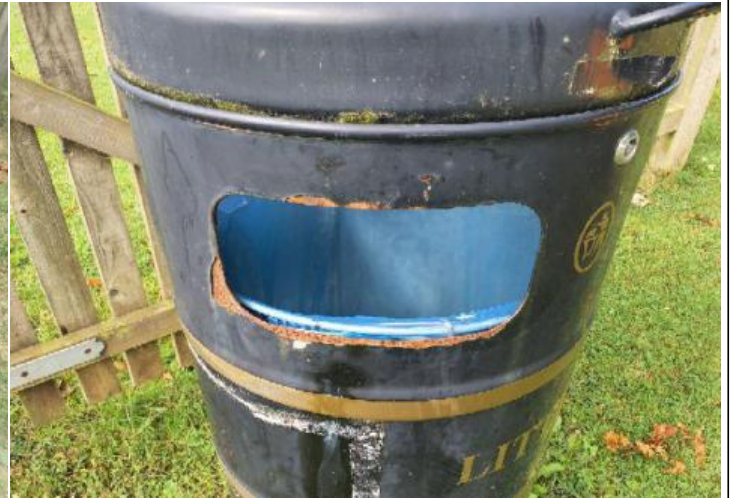
The paintwork on this item has been damaged or worn exposing the metal underneath which is rusting / corroding - Treat affected areas and repaint

**Finding:** The paintwork on this item has been damaged or worn exposing the metal underneath which is rusting / corroding

**Action:** Treat affected areas and repaint

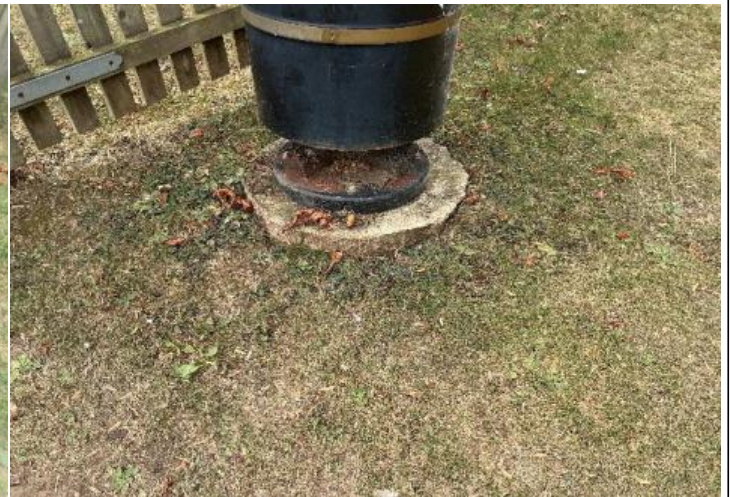
The foundation is loose - Reinststate the foundation

**Finding:** The foundation is loose

**Action:** Reinstate the foundation

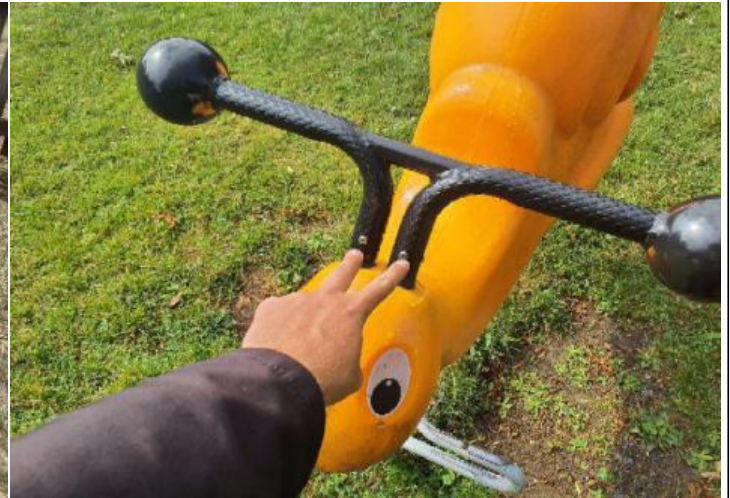
**Finding:** A number of fixing(s) have worked loose

**Action:** Secure all loose fixings

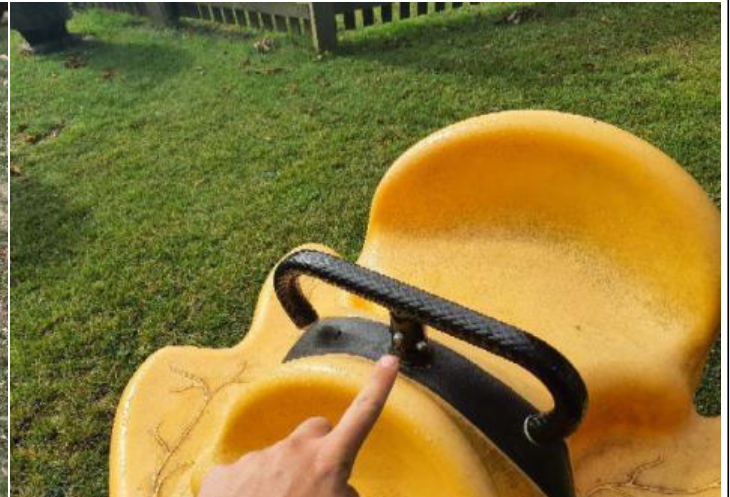
**Finding:** A number of fixing(s) have worked loose

**Action:** Secure all loose fixings

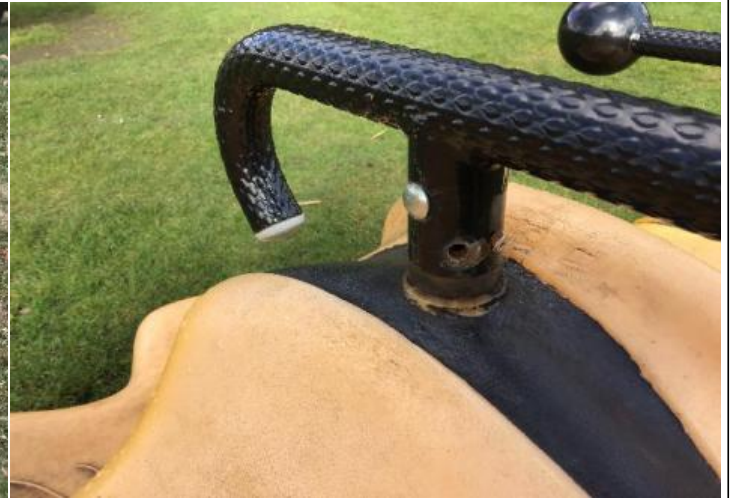
There is or are fixings missing on the item - Replace all missing fixings

**Finding:** There is or are fixings missing on the item

**Action:** Replace all missing fixings

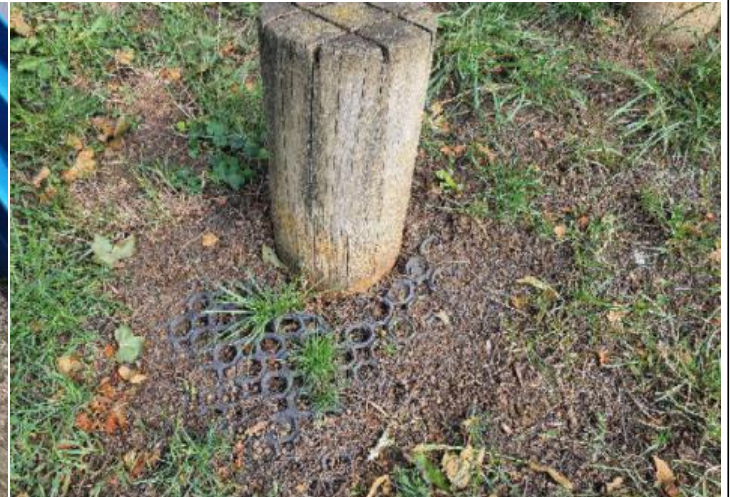
**Finding:** There is some strimmer / machinery damage apparent on the posts, this can penetrate the preservative applied to the timber and accelerate the rotting process

**Action:** Monitor for any deterioration (rot) and replace as required

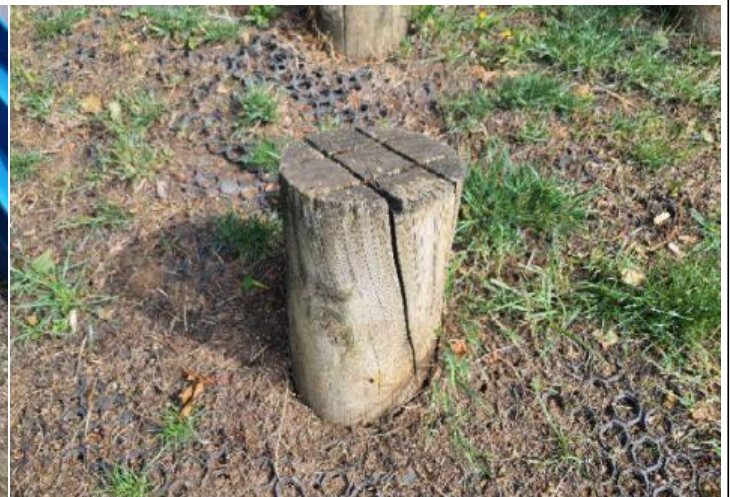
**Finding:** The timber has a number of splits/shakes or air cracks and this may affect the stability or allow water ingress which will accelerate the rotting process

**Action:** Monitor to ensure the splits do not cross through fixing points of the structure and/or cause any instability

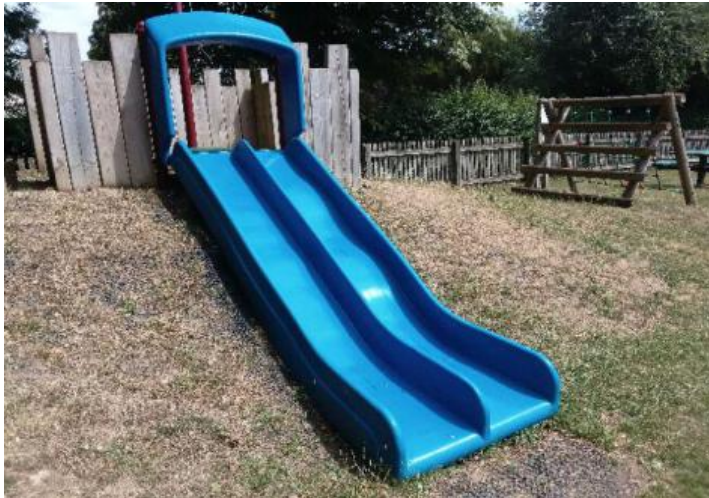
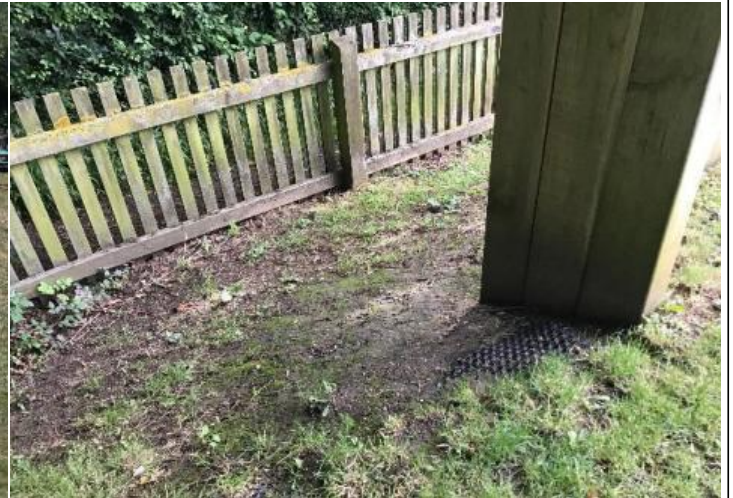
The surface has eroded in some areas and may be slippery in wet conditions - Reinstate the surface

**Finding:** The surface has eroded in some areas and may be slippery in wet conditions  
**Action:** Reinststate the surface

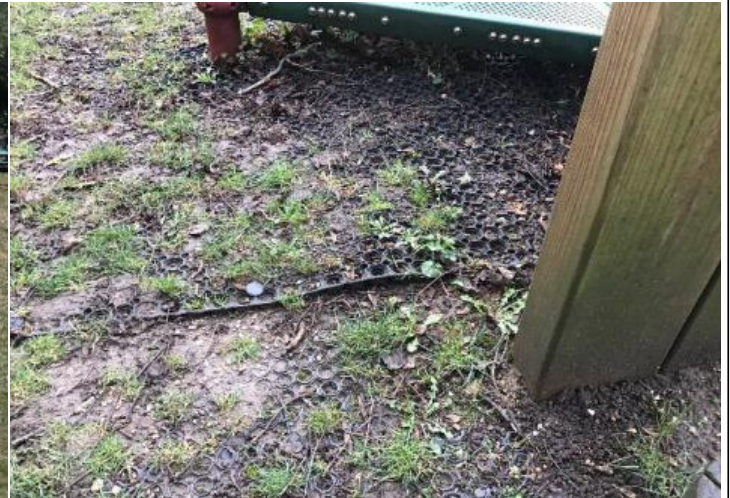
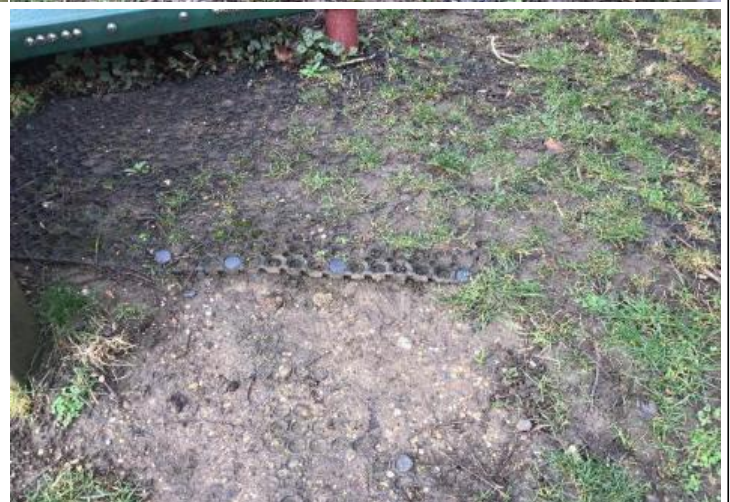
There are trip hazards at the edges of the surface - Reinstate surrounding surface levels to remove the trip points

**Finding:** There are trip hazards at the edges of the surface

**Action:** Reinststate surrounding surface levels to remove the trip points

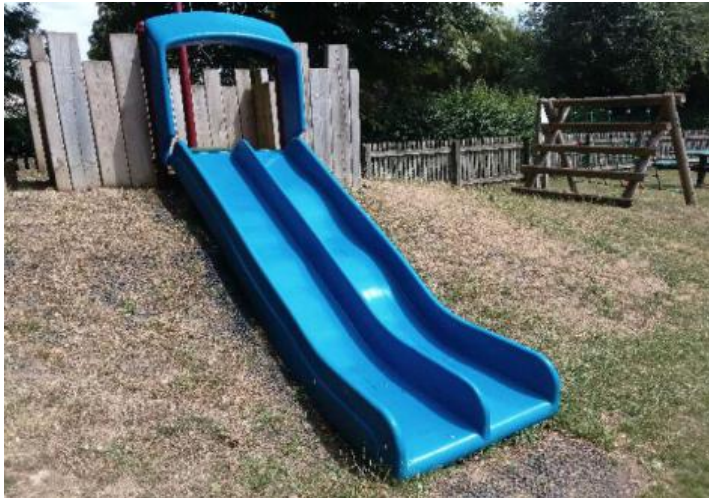
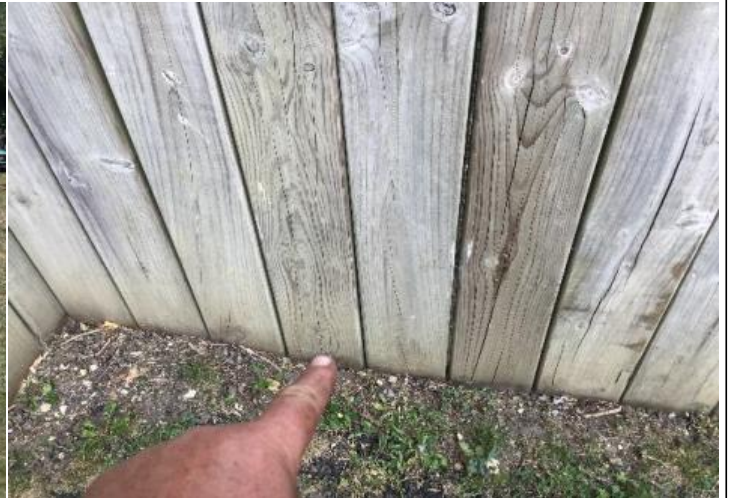
Some timbers are slightly loose in the foundation - Monitor for deterioration

**Finding:** Some timbers are slightly loose in the foundation

**Action:** Monitor for deterioration

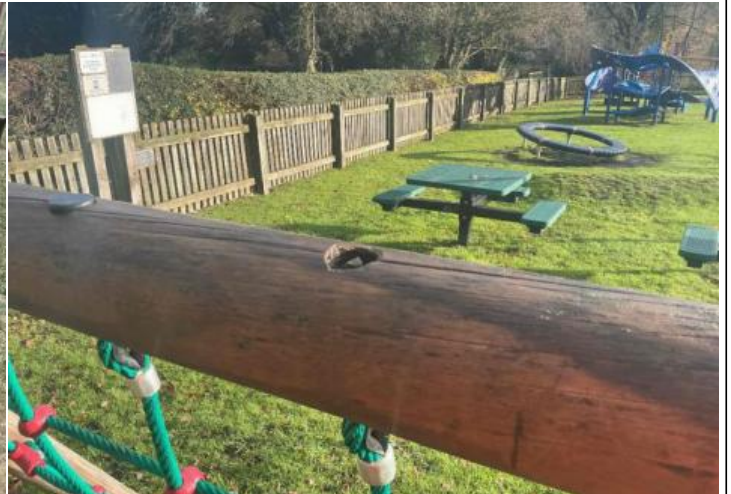
**Finding:** There is/are bolt cap covers missing or damaged on the item

**Action:** Replace missing or damaged bolt cap covers

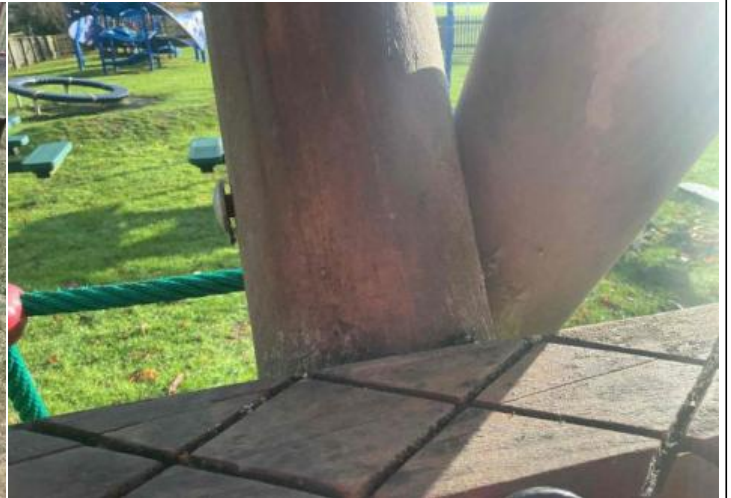
**Finding:** A number of fixing(s) have worked loose

**Action:** Secure all loose fixings

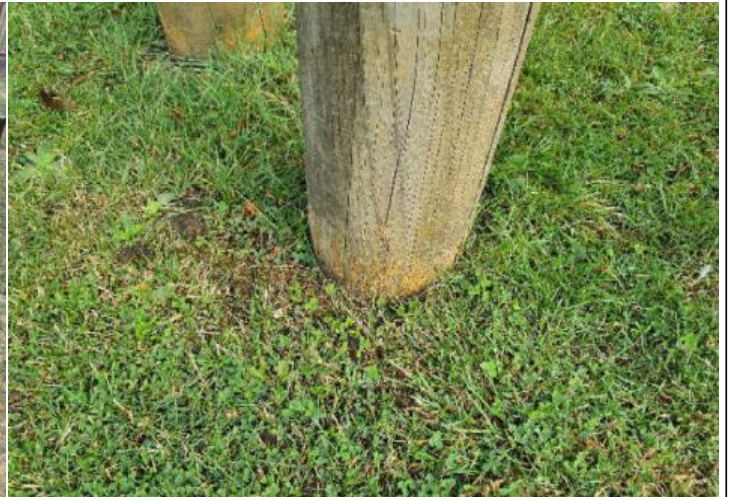
**Finding:** There is some strimmer / machinery damage apparent on the posts, this can penetrate the preservative applied to the timber and accelerate the rotting process

**Action:** Monitor for any deterioration (rot) and replace as required

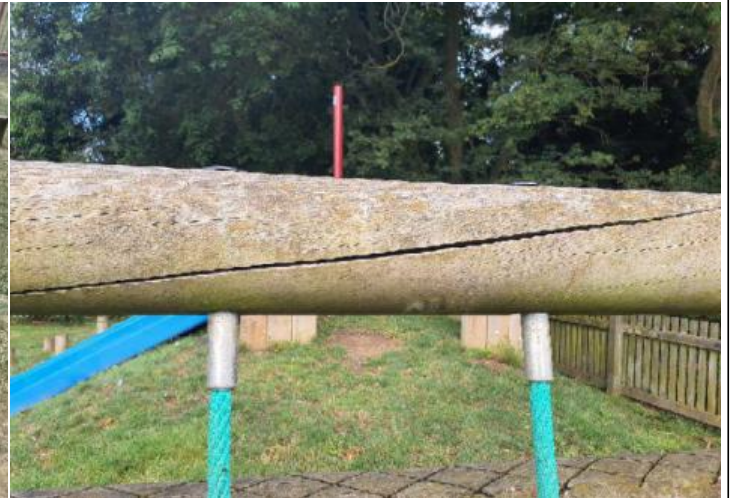
**Finding:** The timber has a number of splits/shakes or air cracks and this may affect the stability or allow water ingress which will accelerate the rotting process  
**Action:** Monitor to ensure the splits do not cross through fixing points of the structure and/or cause any instability

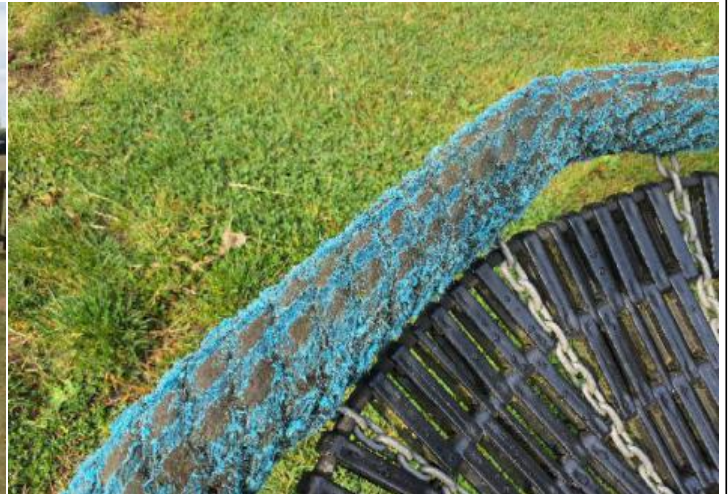
The seat has minor damage or wear - Monitor for any further deterioration and replace as required

**Finding:** The seat has minor damage or wear

**Action:** Monitor for any further deterioration and replace as required

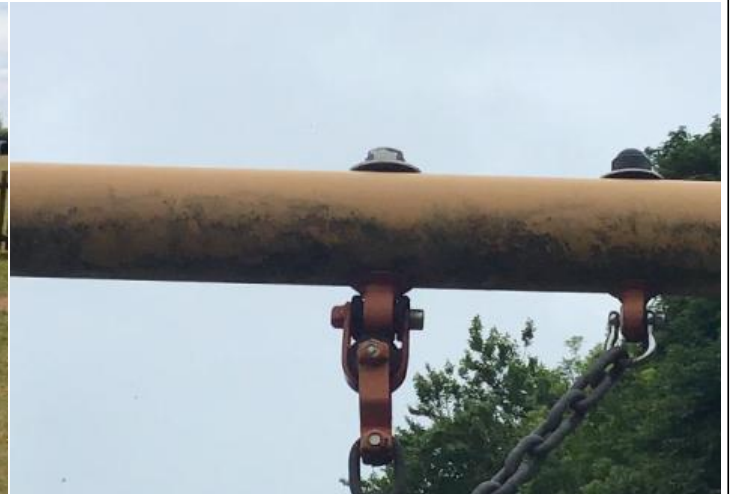
**Finding:** There is/are bolt cap covers missing or damaged on the item

**Action:** Replace missing or damaged bolt cap covers

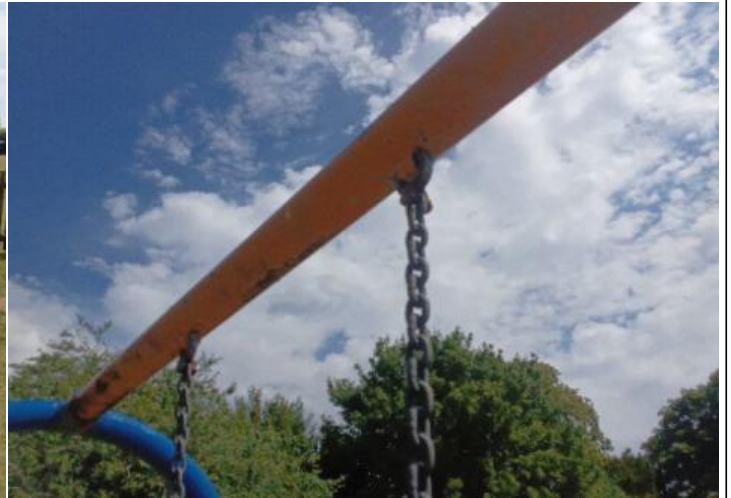
The bushes are showing signs of wear - Monitor for any further deterioration and replace as required

**Finding:** The bushes are showing signs of wear

**Action:** Monitor for any further deterioration and replace as required
