## **Play Area Inspection Reports & Remedial Work**

A copy of the March inspection reports is attached as **Appendix A**, and a summary of work identified is attached as **Appendix B**.

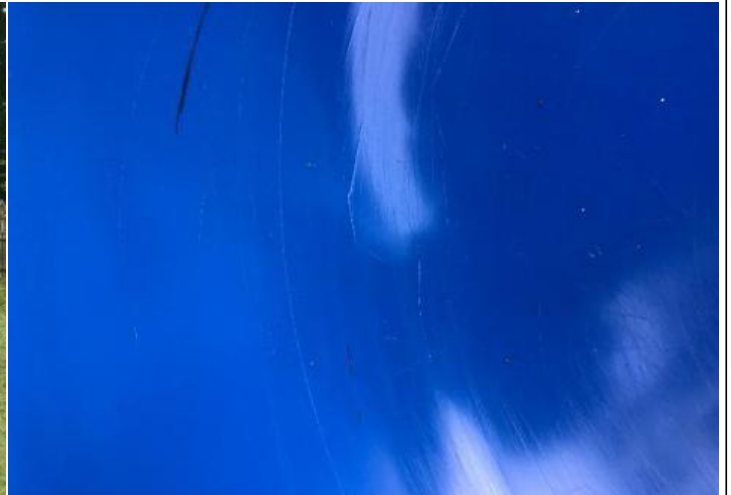
There are a number of dents in the slide surface - Monitor for any further deterioration and repair as required

**Finding:** There are a number of dents in the slide surface

**Action:** Monitor for any further deterioration and repair as required

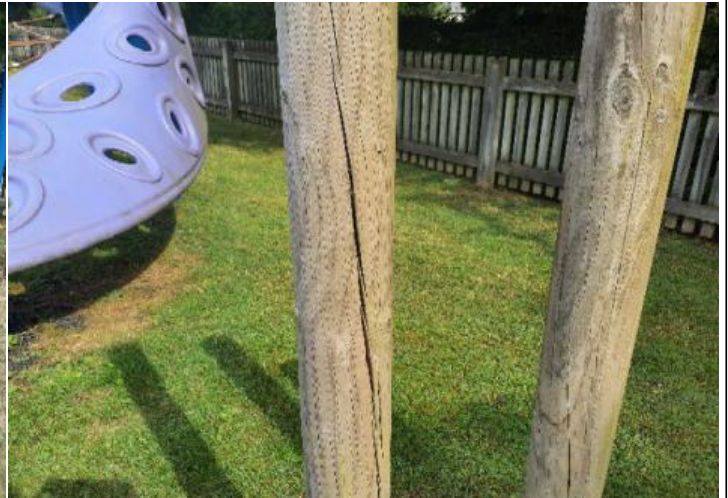
**Finding:** The timber has a number of splits/shakes or air cracks and this may affect the stability or allow water ingress which will accelerate the rotting process

**Action:** Monitor to ensure the splits do not cross through fixing points of the structure and/or cause any instability

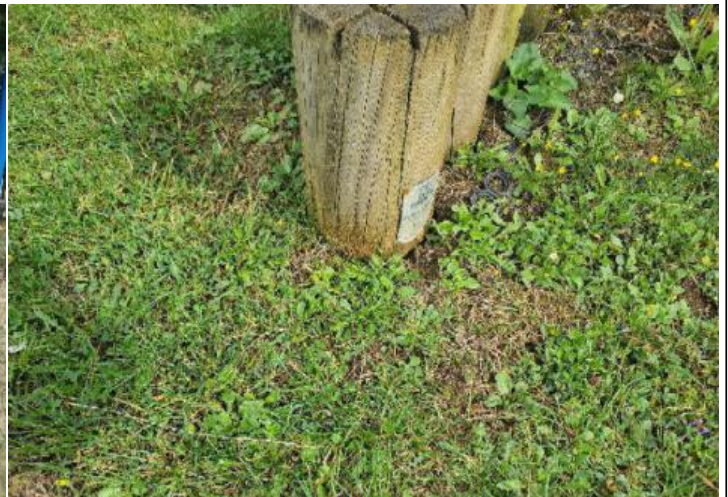
**Finding:** There is some strimmer / machinery damage apparent on the posts, this can penetrate the preservative applied to the timber and accelerate the rotting process

**Action:** Monitor for any deterioration (rot) and replace as required

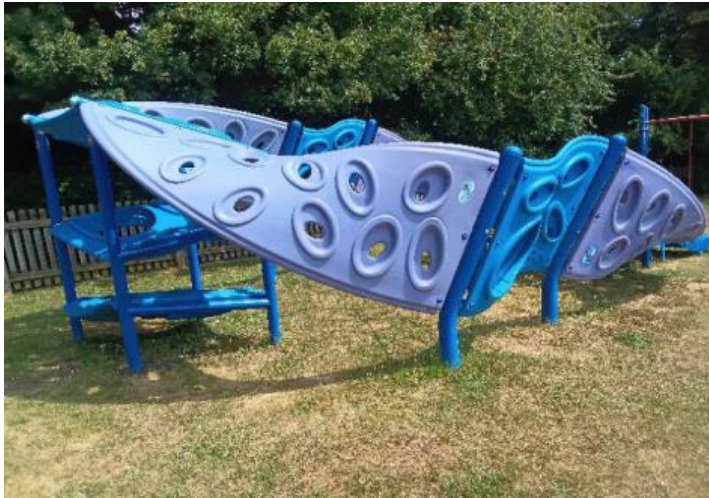
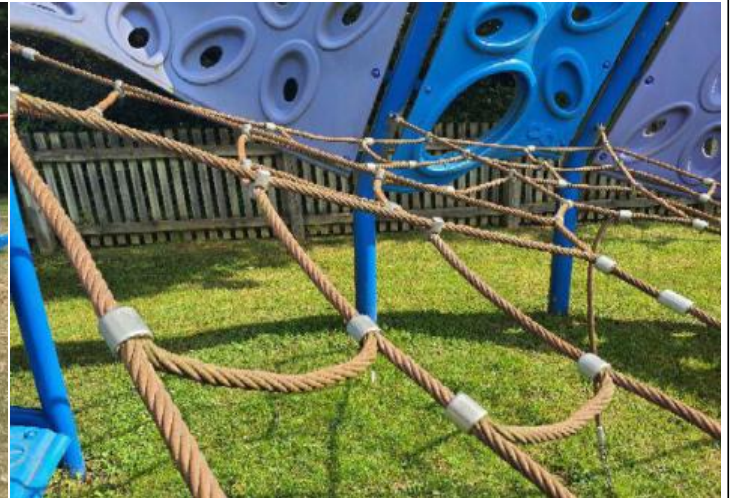
The ropes/nets are worn/damaged in places - Monitor for any further deterioration and repair or replace as required

**Finding:** The ropes/nets are worn/damaged in places

**Action:** Monitor for any further deterioration and repair or replace as required

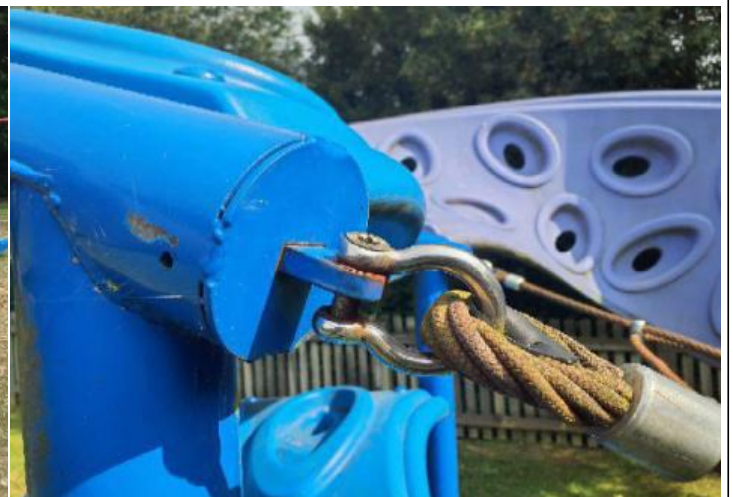
The connecting lugs are showing signs of wear - Monitor for any further deterioration and repair as required

**Finding:** The connecting lugs are showing signs of wear

**Action:** Monitor for any further deterioration and repair as required

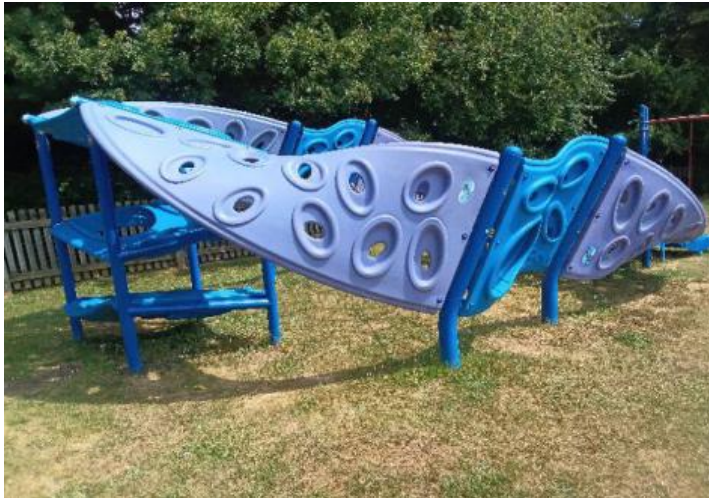
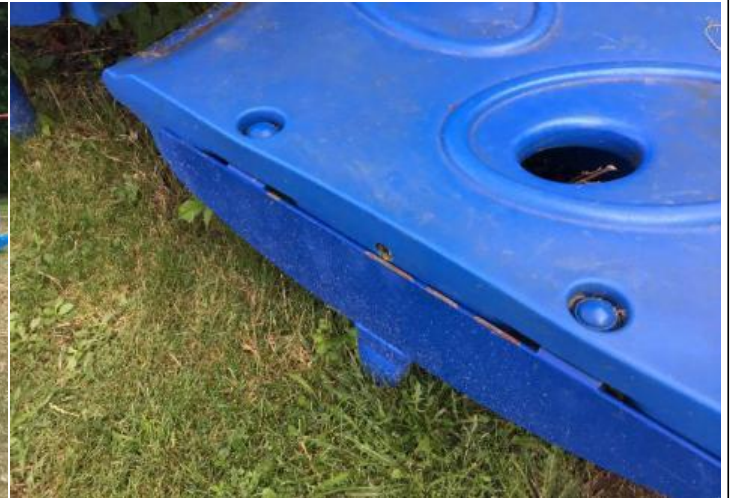
There is surface corrosion / rust present on the item - Consider treating the item

**Finding:** There is surface corrosion / rust present on the item

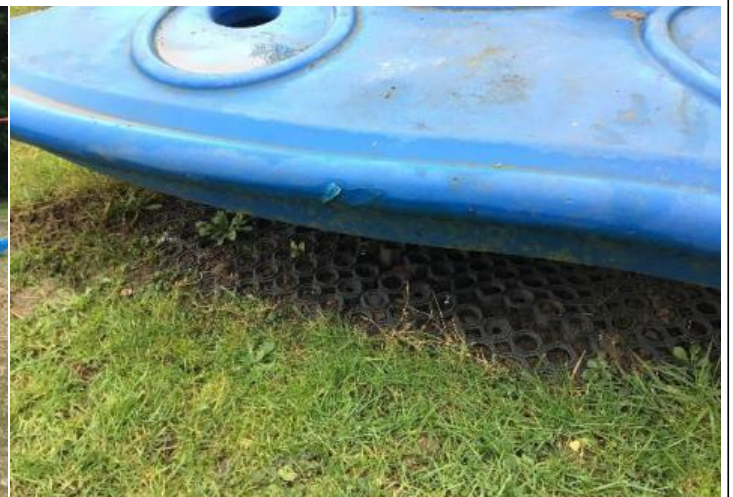
The item has been damaged - Sand down plastic to remove sharp edge

**Finding:** The item has been damaged

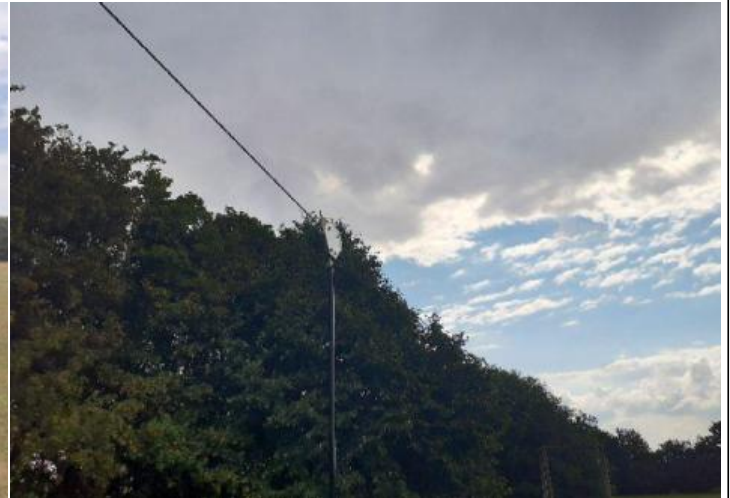
We have completed a visual inspection of the suspension links, cable and fixing points from ground level, however it is not possible to fully inspect these areas without either hiring equipment to gain access or removing the cable and suspension and inspecting at ground level. We recommend that the main cable and fixing security is thoroughly inspected at least in accordance with the manufacturers recommendations to check for wear, damage, security or internal rusting; this will help to ensure the continued safe use of the equipment - Inspect in accordance with the manufacturers recommendations

**Finding:** We have completed a visual inspection of the suspension links, cable and fixing points from ground level, however it is not possible to fully inspect these areas without either hiring equipment to gain access or removing the cable and suspension and inspecting at ground level. We recommend that the main cable and fixing security is thoroughly inspected at least in accordance with the manufacturers recommendations to check for wear, damage, security or internal rusting; this will help to ensure the continued safe use of the equipment

**Action:** Inspect in accordance with the manufacturers recommendations

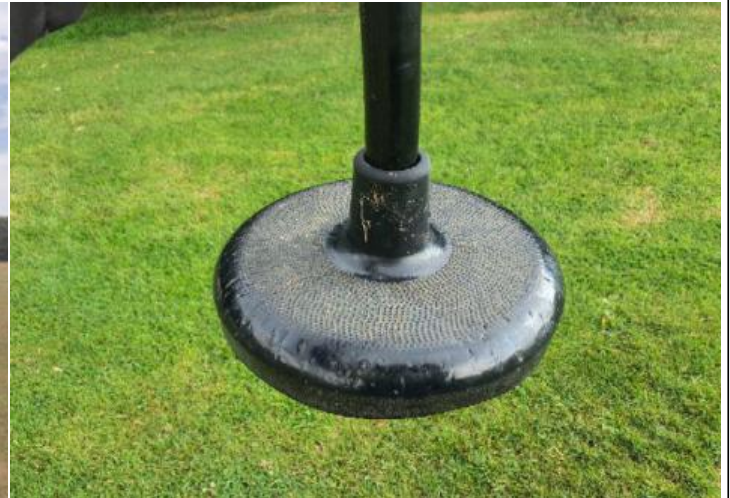
The seat connection cannot be inspected without dismantling the seat - Dismantle the seat to inspect the seat connection for wear

**Finding:** The seat connection cannot be inspected without dismantling the seat

**Action:** Dismantle the seat to inspect the seat connection for wear

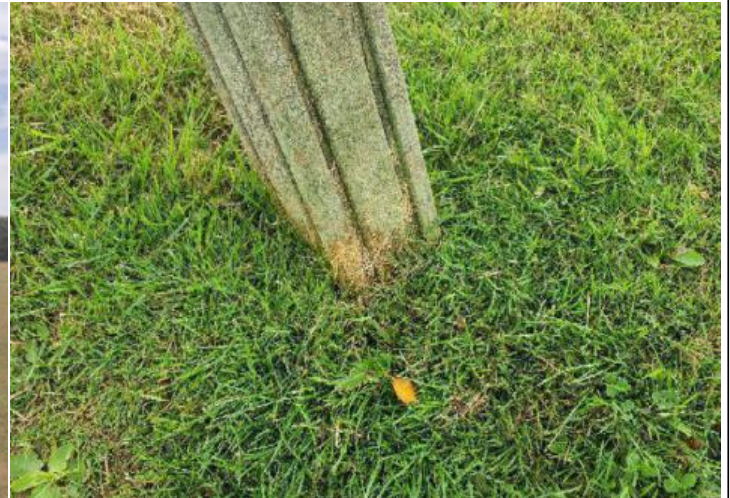
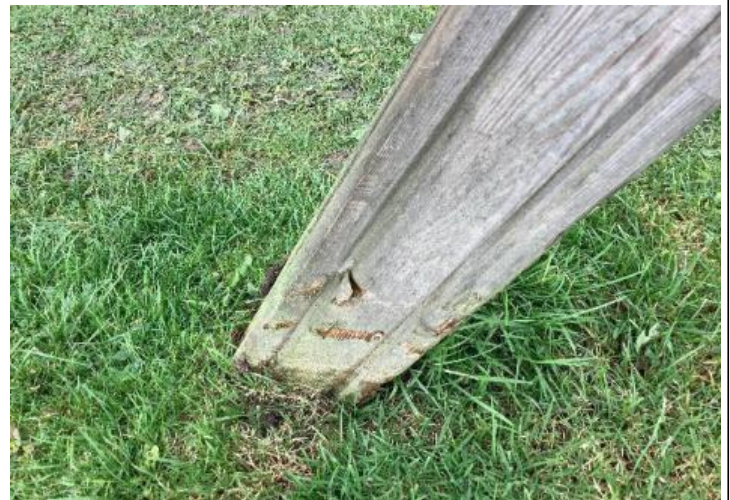
**Finding:** There is some strimmer / machinery damage apparent on the posts, this can penetrate the preservative applied to the timber and accelerate the rotting process

**Action:** Monitor for any deterioration (rot) and replace as required
