WPC.EC.25.11.05 – Play Inspection Reports & Remedial Work

Play Area Inspection Reports & Remedial Work

Wickhambrook. Bury Road

Inspection Ref: 2834689

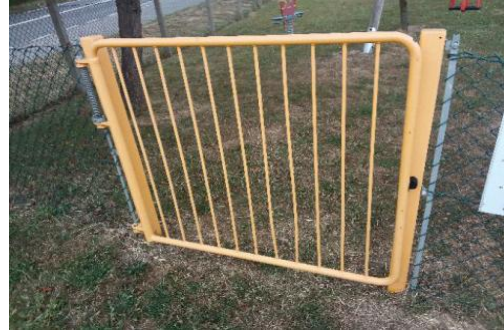
Item: Gate - Self Closing
Manufacturer: Not Identified
Surface Type: Grass
Item Quantity: 1

There is some damage to the item and is slightly out of alignment - Monitor for any further deterioration and repair as required

The gate rebounds when opened quickly and could strike the next user entering the area - Monitor use and adjust/replace as required

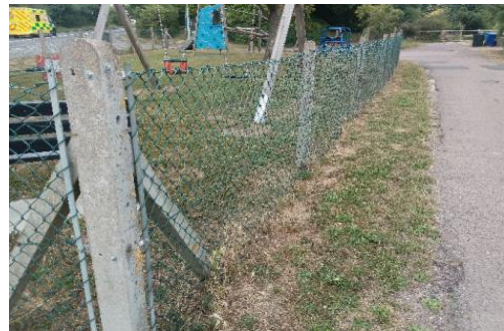
Item: Fence - Chainlink
Manufacturer: Not Identified
Surface Type: Grass
Item Quantity: 1

There is some damage to the fence sections - Monitor for any further deterioration and repair as required

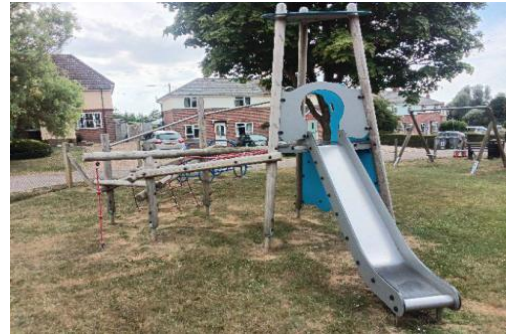
Item: Multi Play (Junior)
Manufacturer: Playforce
Surface Type: Grass Matrix Tiles
Item Part Number: Jungle tops
Item Quantity: 1

The timber has a number of splits/shakes or air cracks and this may affect the stability or allow water ingress which will accelerate the rotting process - Monitor to ensure the splits do not cross through fixing points of the structure and/or cause any instability

There is/are bolt cap covers missing or damaged on the item - Replace missing or damaged bolt cap covers

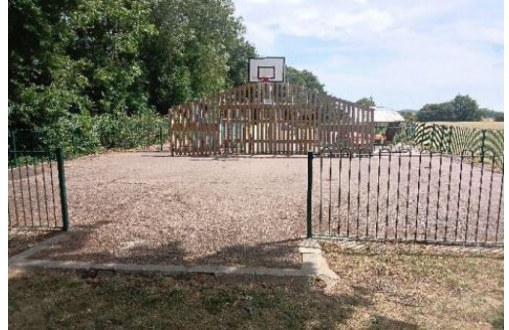
Item: Site General
Manufacturer: Owner/Operator
Surface Type: N/A
Item Quantity: 1

There is moderate damage to the surface - Repair the damaged areas of surfacing

The concrete is breaking up around the edges of the surface - Repair the damaged concrete

The concrete foundation around the goal structure is lifting - Repair

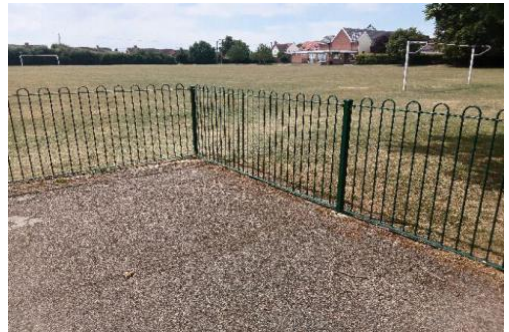
Item: Fence - Bow Top
Manufacturer: Not Identified
Surface Type: Bitmac
Item Quantity: 1

There are a number of fixings missing from the fence - Replace missing fixings

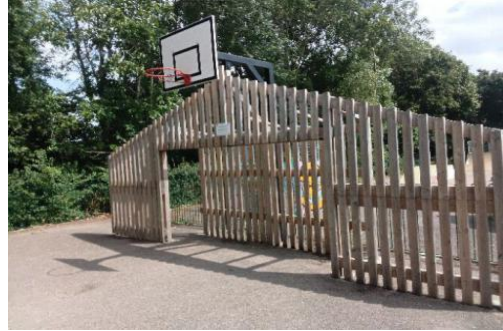
Item: Ball Games Area
Manufacturer: Sovereign Leisure
Surface Type: Tarmac
Item Quantity: 1

There is algae, silt or moss growth on the surface resulting in slippery conditions - Clean and treat appropriately

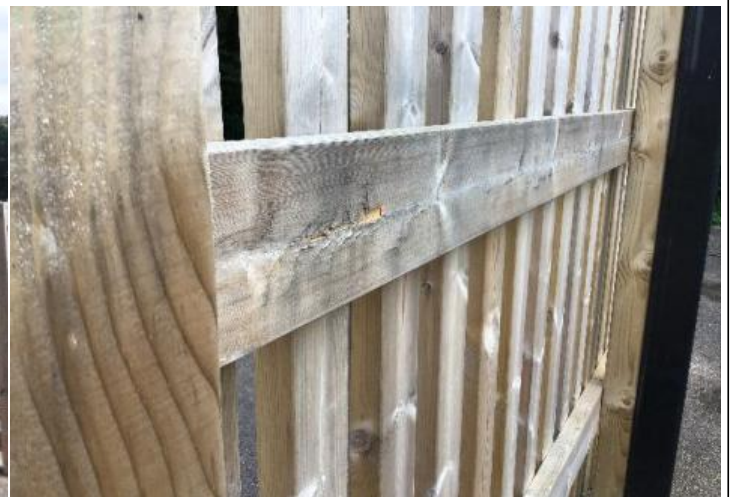
Item: Multi Use Games Area - Ball Games Area
Manufacturer: Sovereign Leisure

Finding: Parts of the timber are rough or splintered

Action: Remove all rough or sharp edges

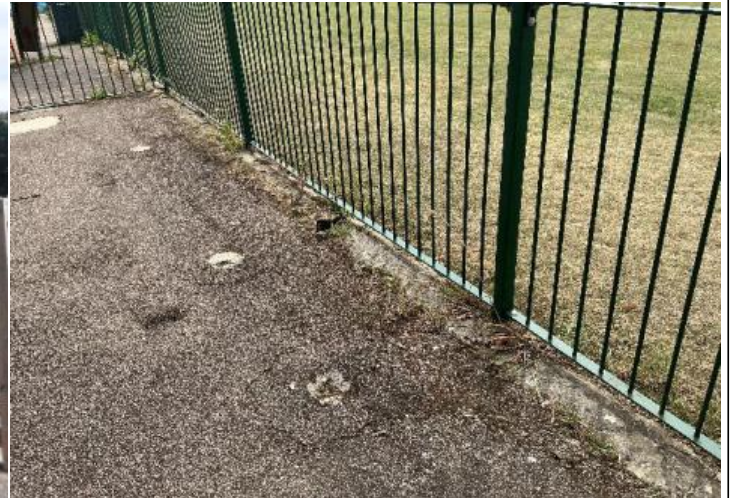
Item: Multi Use Games Area - Ball Games Area
Manufacturer: Sovereign Leisure

Finding: There is weed / vegetation growth on, between, or around the edges of the surfacing

Action: Remove weed / vegetation growth

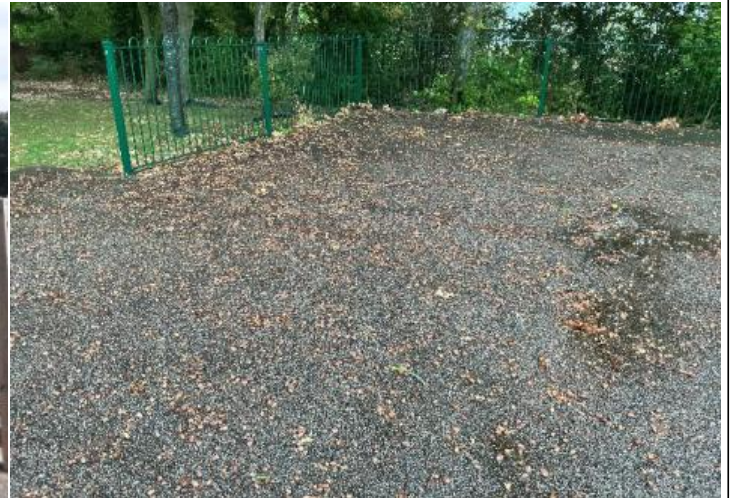
Item: Multi Use Games Area - Ball Games Area
Manufacturer: Sovereign Leisure

Finding: There is some tree debris on the surfacing

Action: Remove and maintain

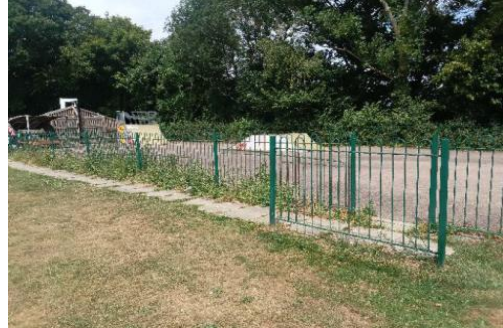
Item: Site General
Manufacturer: Owner/Operator
Surface Type: N/A
Item Quantity: 1

There is root damage to the surfacing creating unforeseen changes in levels - Repair the damaged areas of tarmac to provide a uniform surface

There is some damage apparent to the riding surface - Monitor for any further deterioration and repair as required

There is algae, silt or moss growth on the surface resulting in slippery conditions - Clean and treat appropriately

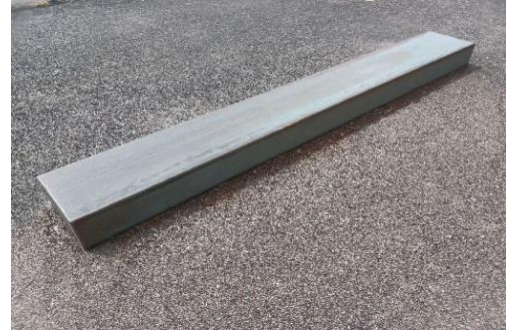
Item: Grind Box
Manufacturer: Eibe Play Ltd
Surface Type: Tarmac
Item Quantity: 1

There is surface corrosion / rust present on the item - Consider treating the item

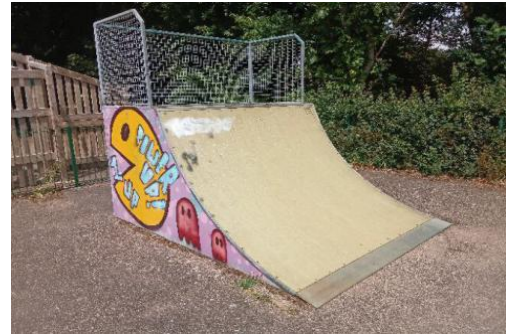
Item: Quarter Pipe
Manufacturer: Eibe Play Ltd
Surface Type: Tarmac
Item Quantity: 1

The item has been damaged - Monitor for any further deterioration and replace as required

Minor damage to surface - Monitor for deterioration

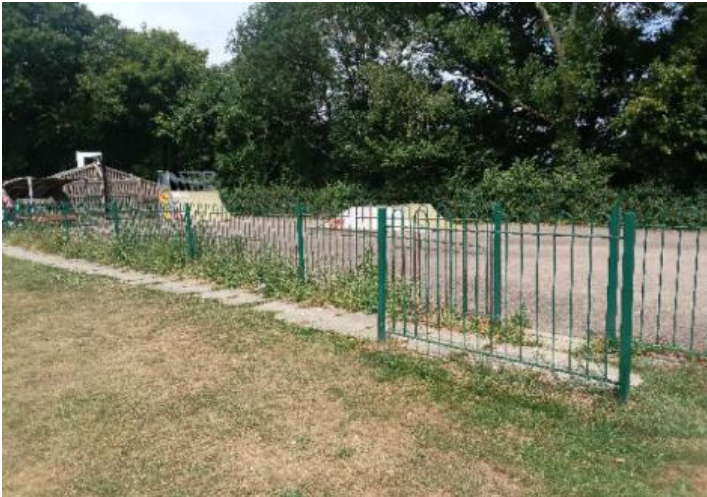
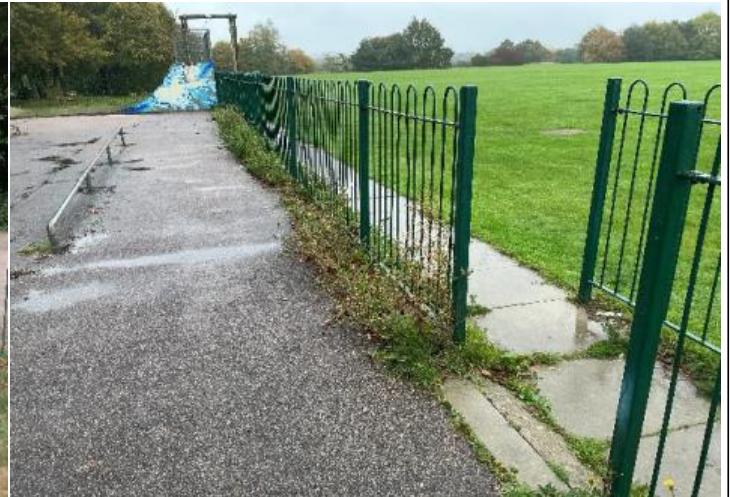
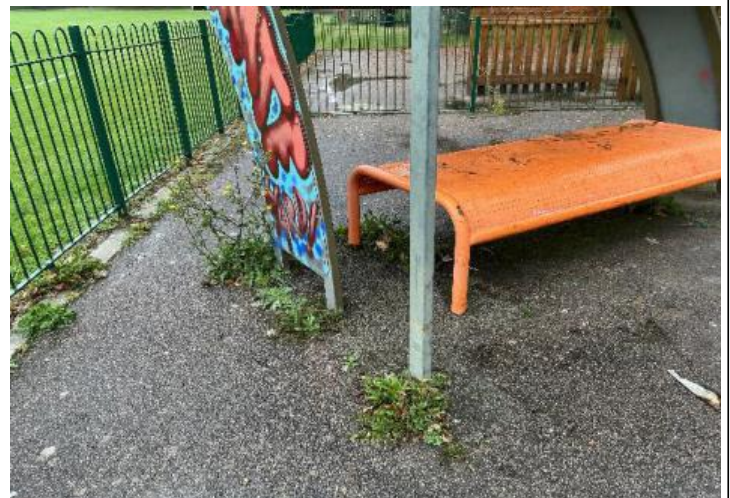
Finding: There is weed / vegetation growth on, between, or around the edges of the surfacing
Action: Remove weed / vegetation growth

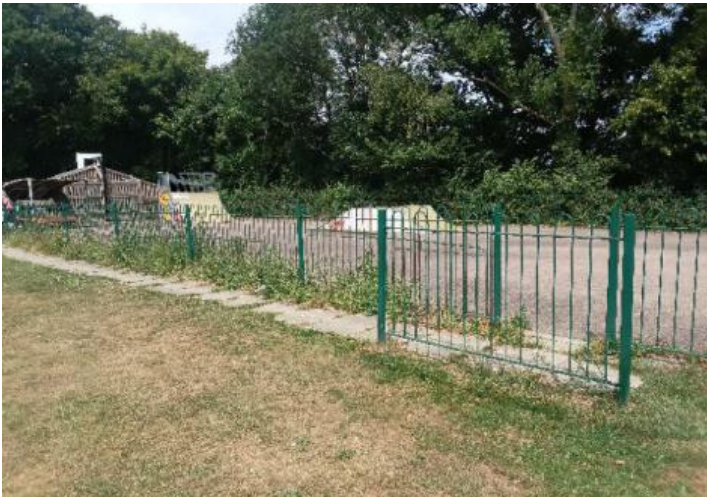
Finding: There is some damage apparent to the riding surface

Action: Monitor for any further deterioration and repair as required

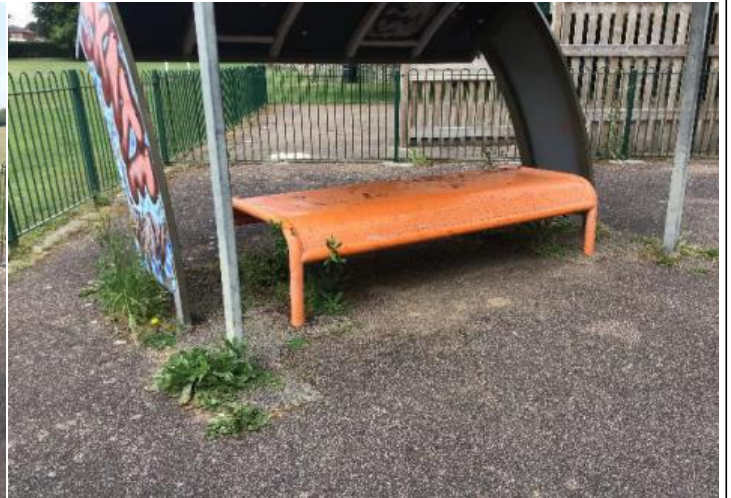
Finding: There is weed / vegetation growth within the surface

Action: Remove weed / vegetation growth

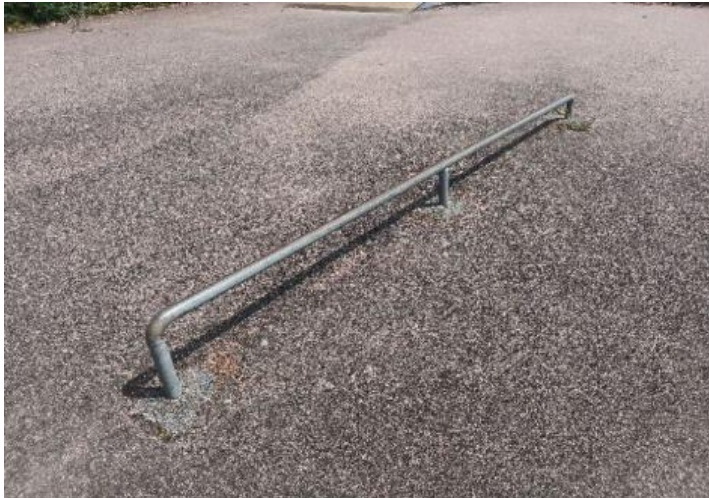
Finding: There is surface corrosion / rust present on the item

Action: Consider treating the item

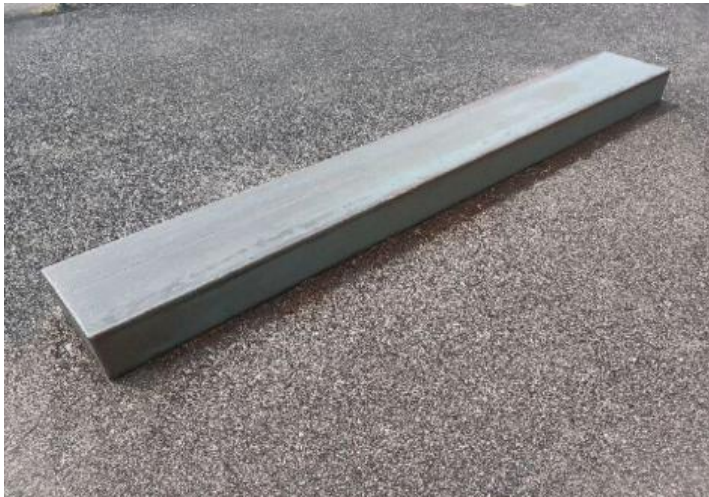
Finding: There is surface corrosion / rust present on the item

Action: Consider treating the item

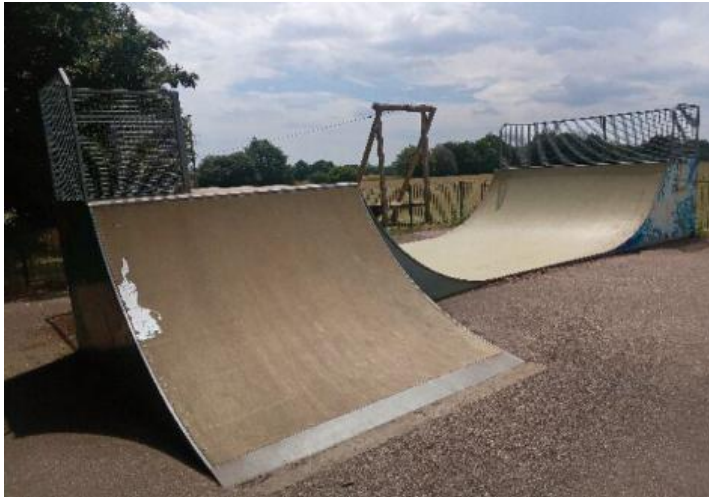
Finding: There is some damage to the fence sections

Action: Monitor for any further deterioration and repair as required

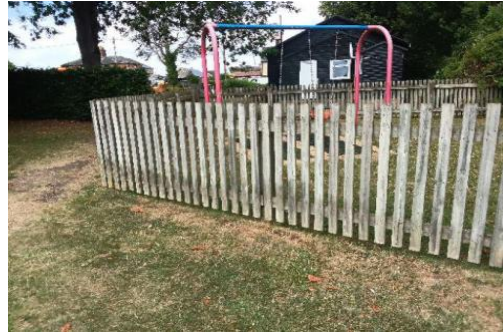
There is some strimmer / machinery damage apparent on the posts, this can penetrate the preservative applied to the timber and accelerate the rotting process - Monitor for any deterioration (rot) and replace as required

Slat damaged - Replace damaged slat

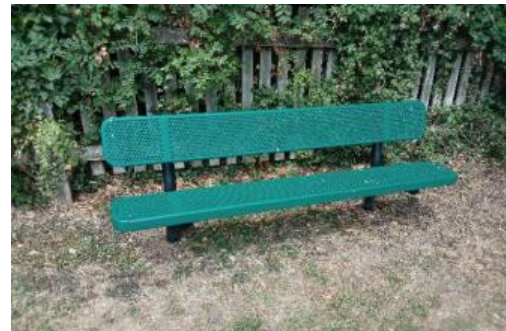
This item is satisfactory - no work required -

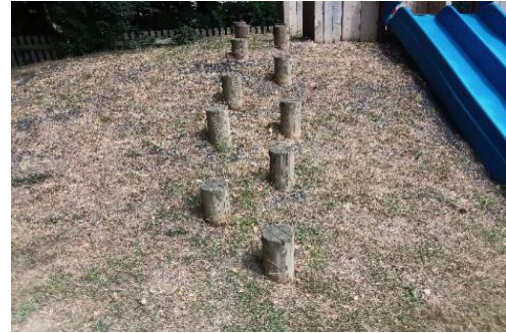
There is some strimmer / machinery damage apparent on the posts, this can penetrate the preservative applied to the timber and accelerate the rotting process - Monitor for any deterioration (rot) and replace as required

The timber has a number of splits/shakes or air cracks and this may affect the stability or allow water ingress which will accelerate the rotting process - Monitor to ensure the splits do not cross through fixing points of the structure and/or cause any instability

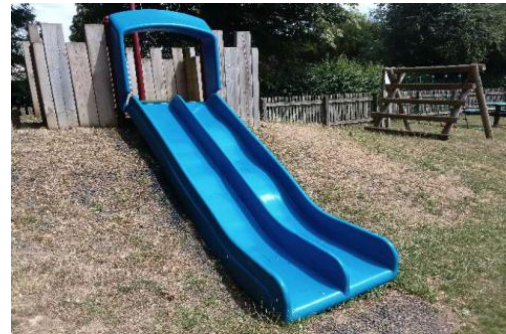
The surface has eroded in some areas and may be slippery in wet conditions - Reinstate the surface

There are trip hazards at the edges of the surface - Reinstate surrounding surface levels to remove the trip points

Some timbers are slightly loose in the foundation - Monitor for deterioration

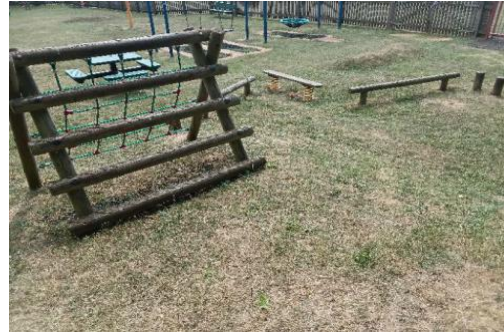
There is some strimmer / machinery damage apparent on the posts, this can penetrate the preservative applied to the timber and accelerate the rotting process - Monitor for any deterioration (rot) and replace as required

The timber has a number of splits/shakes or air cracks and this may affect the stability or allow water ingress which will accelerate the rotting process - Monitor to ensure the splits do not cross through fixing points of the structure and/or cause any instability

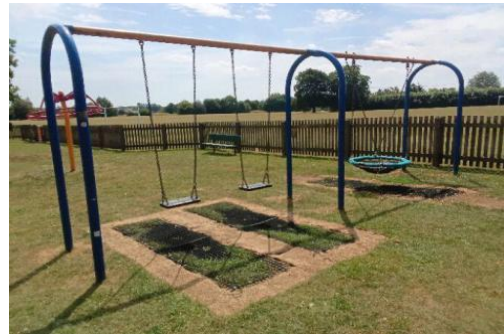
The seat has minor damage or wear - Monitor for any further deterioration and replace as required

There is/are bolt cap covers missing or damaged on the item - Replace missing or damaged bolt cap covers

The bushes are showing signs of wear - Monitor for any further deterioration and replace as required

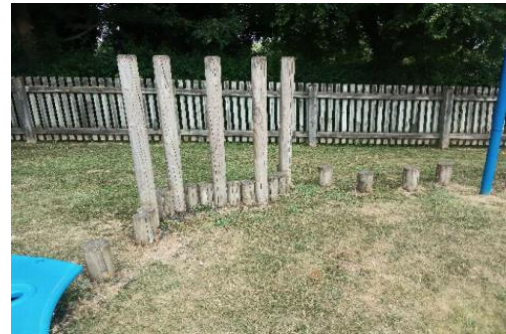
Item: Log Walk
Manufacturer: Miracle Recreation Equipment Company
Surface Type: Grass Matrix Tiles
Item Quantity: 1

The timber has a number of splits/shakes or air cracks and this may affect the stability or allow water ingress which will accelerate the rotting process - Monitor to ensure the splits do not cross through fixing points of the structure and/or cause any instability

There is some strimmer / machinery damage apparent on the posts, this can penetrate the preservative applied to the timber and accelerate the rotting process - Monitor for any deterioration (rot) and replace as required

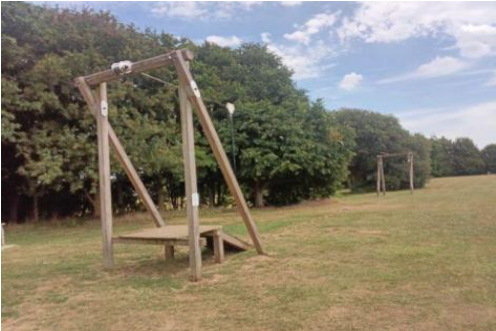
Item: Cable Runway
Manufacturer: Fenland Leisure Products
Surface Type: Grass Matrix Tiles
Item Quantity: 1

We have completed a visual inspection of the suspension links, cable and fixing points from ground level, however it is not possible to fully inspect these areas without either hiring equipment to gain access or removing the cable and suspension and inspecting at ground level. We recommend that the main cable and fixing security is thoroughly inspected at least in accordance with the manufacturers recommendations to check for wear, damage, security or internal rusting; this will help to ensure the continued safe use of the equipment - Inspect in accordance with the manufacturers recommendations

The seat connection cannot be inspected without dismantling the seat - Dismantle the seat to inspect the seat connection for wear

There is some strimmer / machinery damage apparent on the posts, this can penetrate the preservative applied to the timber and accelerate the rotting process - Monitor for any deterioration (rot) and replace as required

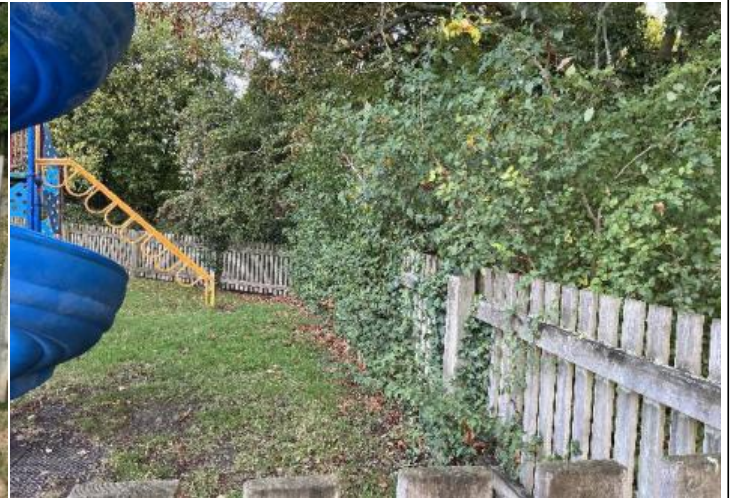
Item: Fences - Fencing - Timber
Manufacturer: Not Identified

Finding: The adjacent foliage is overhanging

Action: Cut back and maintain

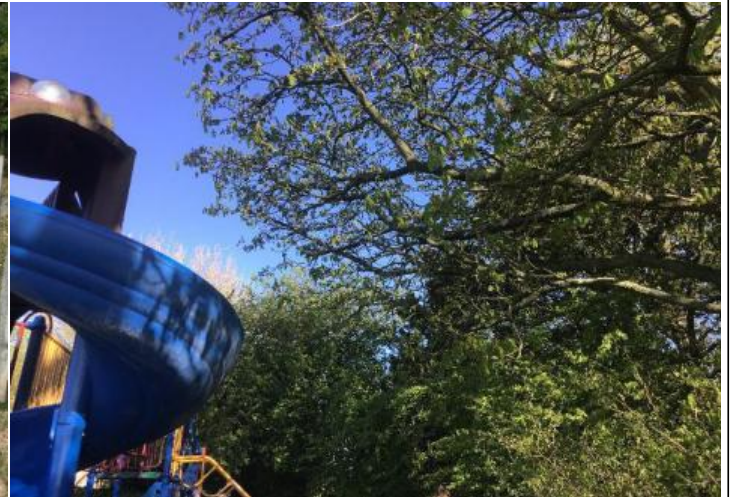
Item: Fences - Fencing - Timber
Manufacturer: Not Identified

Finding: The tree canopy overhangs the equipment and is less than 2.0m away

Action: Lift tree canopy to ensure a minimum clearance of 2.0m from the equipment

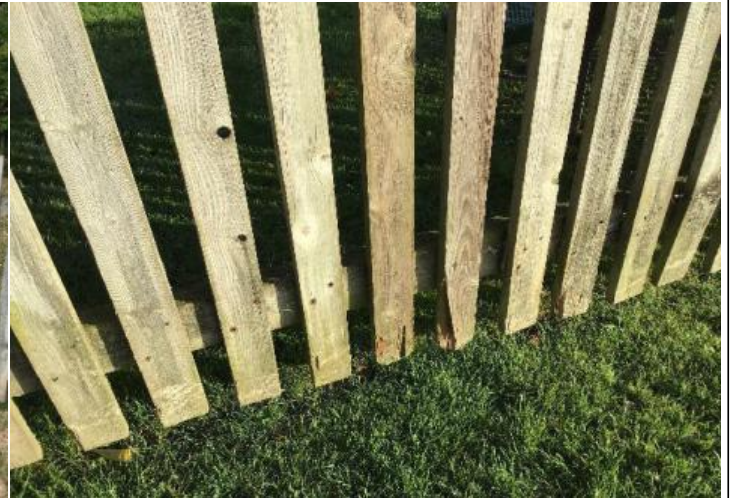
Item: Fences - Fencing - Timber
Manufacturer: Not Identified

Finding: Parts of the timber are rough or splintered

Action: Remove all rough or sharp edges

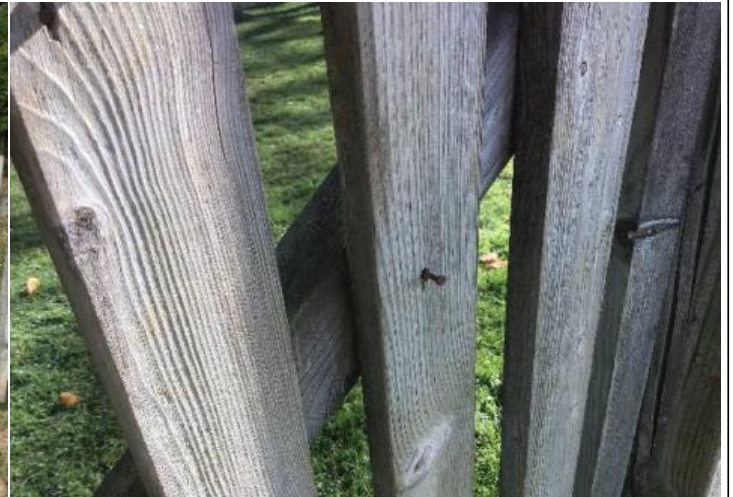
Item: Fences - Fencing - Timber
Manufacturer: Not Identified

Finding: There are projecting nail ends present

Action: Remove and provide more appropriate fixings if required

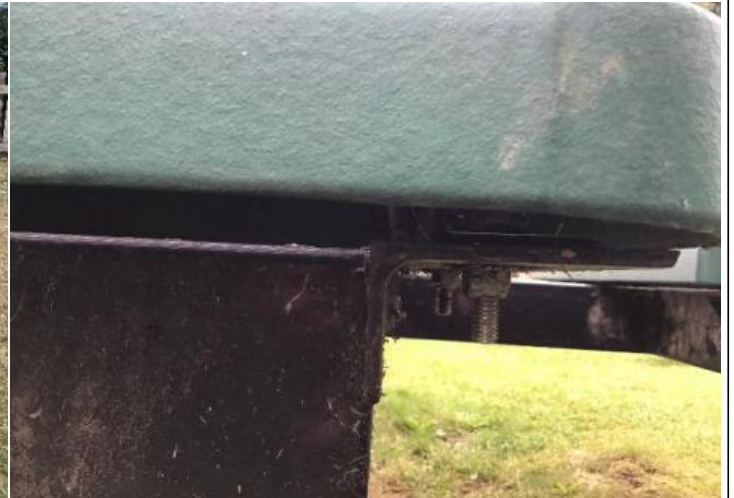
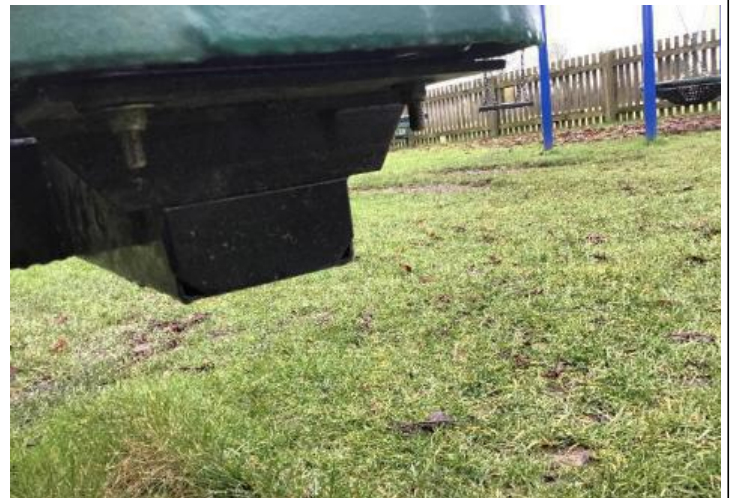
Item: Ancillary Items - Picnic Table
Manufacturer: Not Identified

Finding: There are projecting bolt thread(s) present

Action: Remove excess thread length and deburr or provide cap

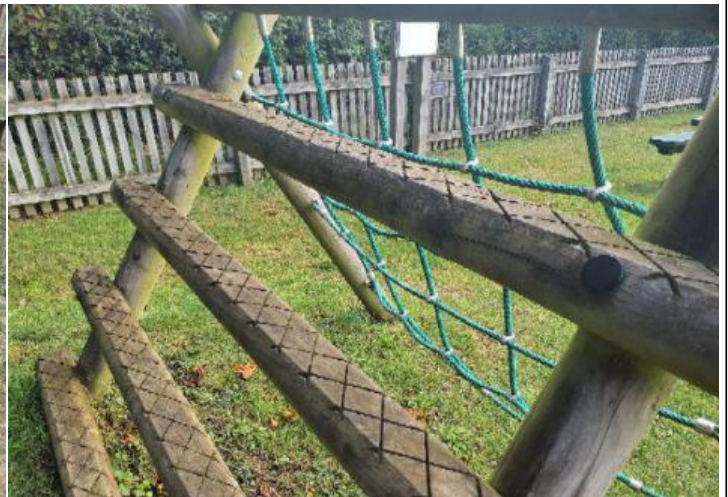
Item: Activity Equipment - Activity Trail
Manufacturer: Miracle Recreation Equipment Company

Finding: There is algae or moss on the surface of the equipment

Action: Clean and treat appropriately

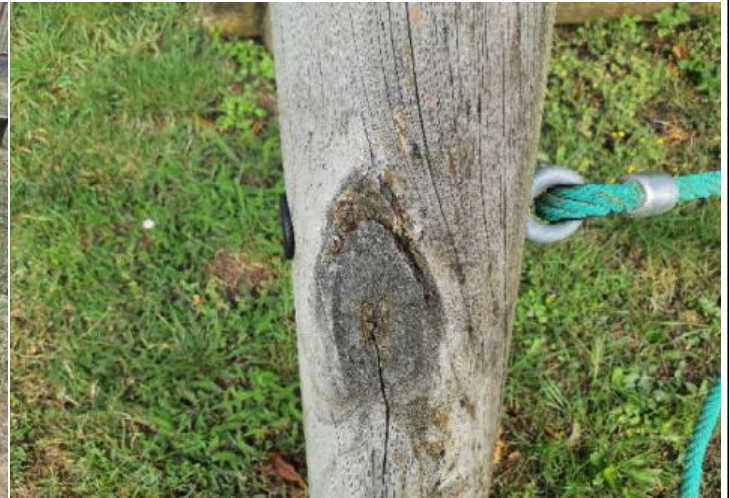
Item: Activity Equipment - Activity Trail
Manufacturer: Miracle Recreation Equipment Company

Finding: Parts of the timber are rough or splintered

Action: Remove all rough or sharp edges

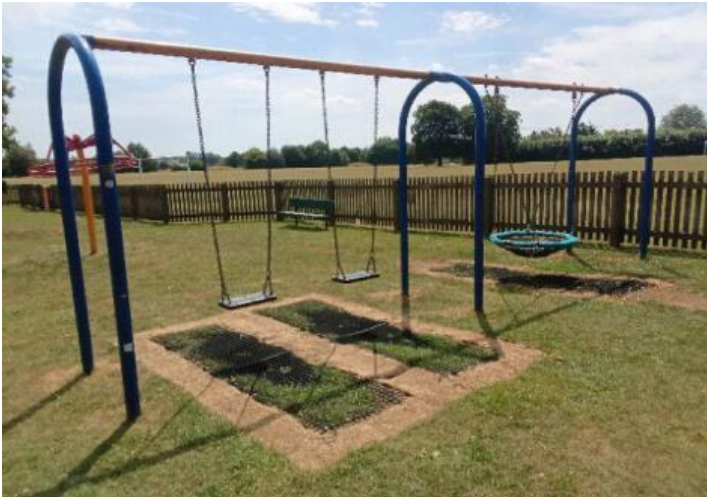
Item: Swings - 2 Bay 2 Flat 1 Basket Seat
Manufacturer: Miracle Recreation Equipment Company

Finding: There is/are bolt cap covers missing or damaged on the item

Action: Replace missing or damaged bolt cap covers

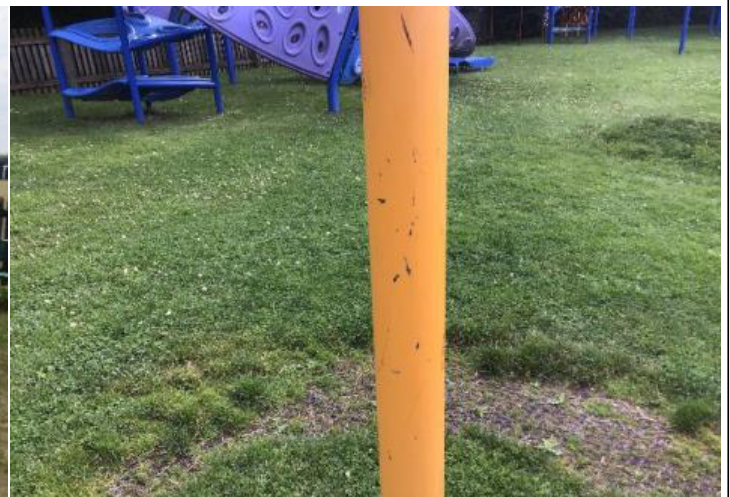
Item: Rotor Play - Overhead Rotator
Manufacturer: Miracle Recreation Equipment Company

Finding: The paint is flaking off the metalwork

Action: Rub down and re-paint

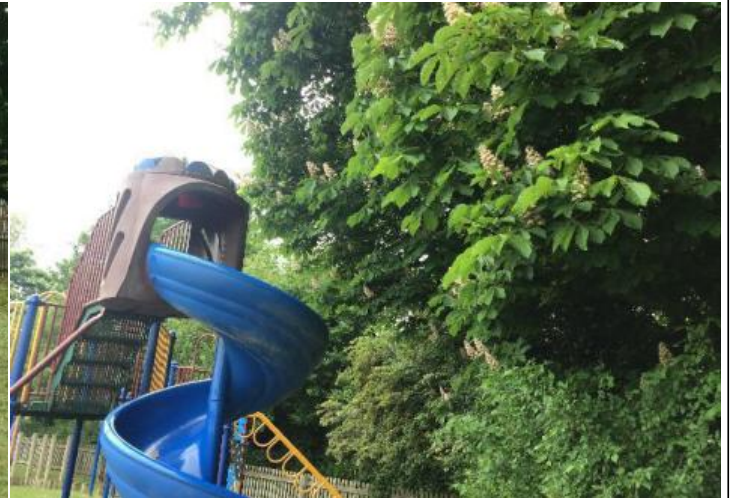
Item: Activity Equipment - Multi Play (Senior)
Manufacturer: Miracle Recreation Equipment Company

Finding: The tree canopy overhangs the equipment and is less than 2.0m away

Action: Lift tree canopy to ensure a minimum clearance of 2.0m from the equipment

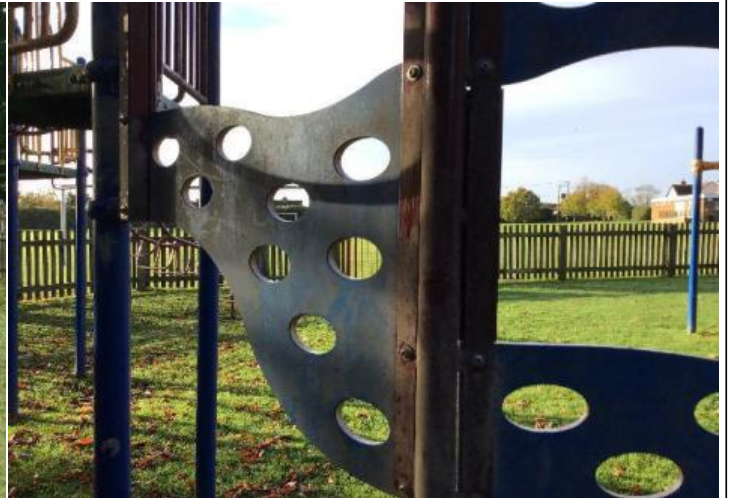
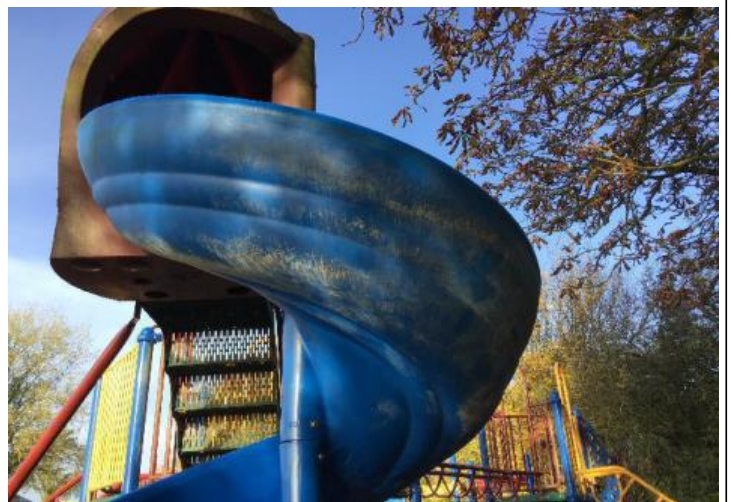
Item: Activity Equipment - Multi Play (Senior)
Manufacturer: Miracle Recreation Equipment Company

Risk Level: L - Low Risk
Surface: Grass Matrix Tiles

Finding: There is algae or moss on the surface of the equipment

Action: Clean and treat appropriately

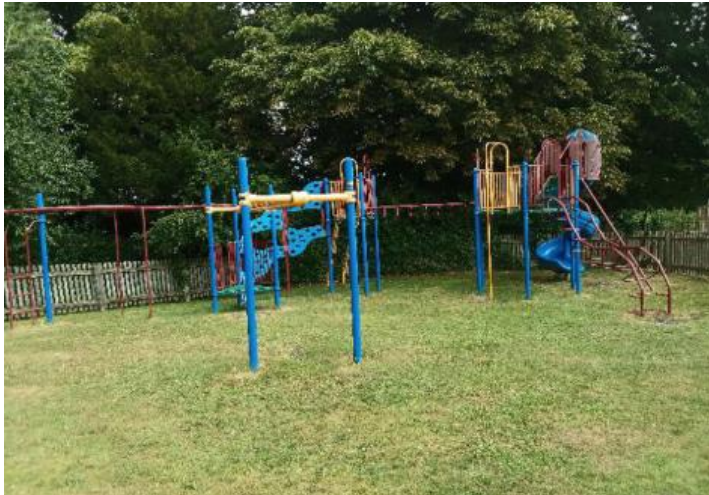
Item: Activity Equipment - Multi Play (Senior)
Manufacturer: Miracle Recreation Equipment Company

Risk Level: V - Very Low Risk
Surface: Grass Matrix Tiles

Finding: There are a number of dents in the slide surface

Action: Monitor for any further deterioration and repair as required

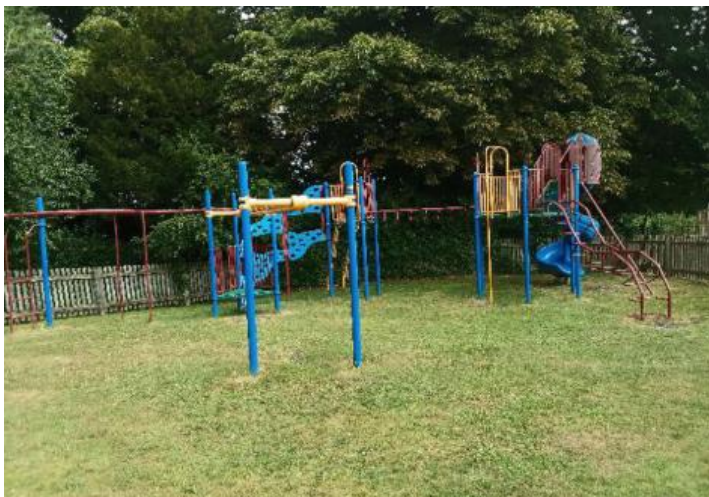
Item: Activity Equipment - Multi Play (Senior)
Manufacturer: Miracle Recreation Equipment Company

Risk Level: L - Low Risk
Surface: Grass Matrix Tiles

Finding: Cable tie around post has been cut leaving sharp edges

Action: Remove cable tie

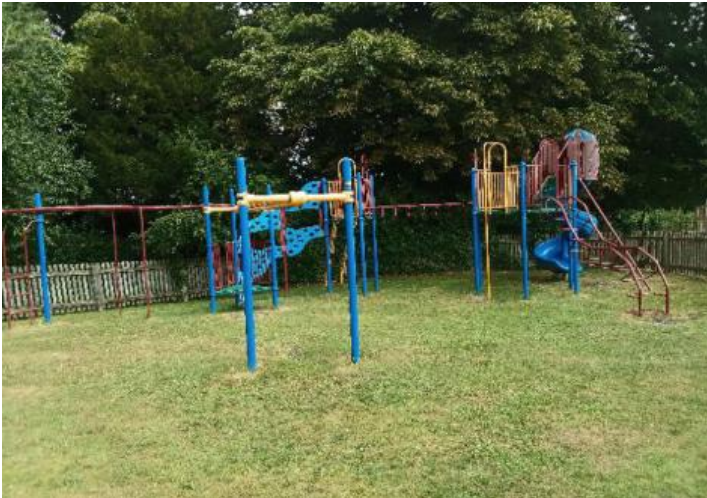
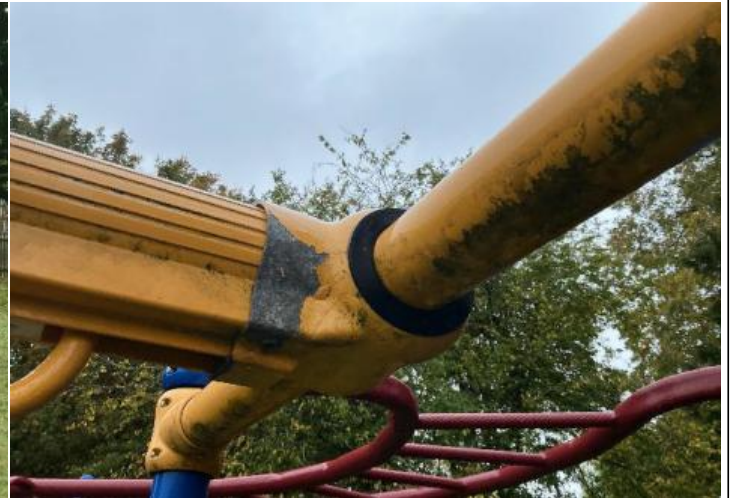
Item: Activity Equipment - Multi Play (Senior)
Manufacturer: Miracle Recreation Equipment Company

Risk Level: L - Low Risk
Surface: Grass Matrix Tiles

Finding: The paint is flaking off the metalwork

Action: Rub down and re-paint

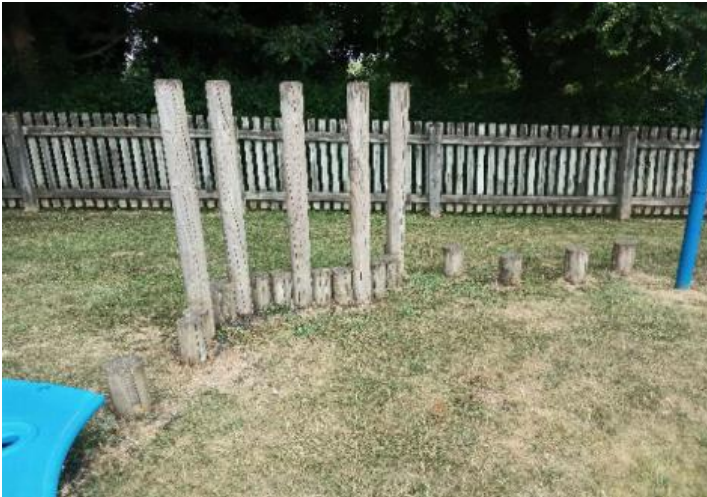
Item: Activity Equipment - Log Walk
Manufacturer: Miracle Recreation Equipment Company

Risk Level: L - Low Risk
Surface: Grass Matrix Tiles

Finding: The timber has a number of splits/shakes or air cracks and this may affect the stability or allow water ingress which will accelerate the rotting process

Action: Monitor to ensure the splits do not cross through fixing points of the structure and/or cause any instability

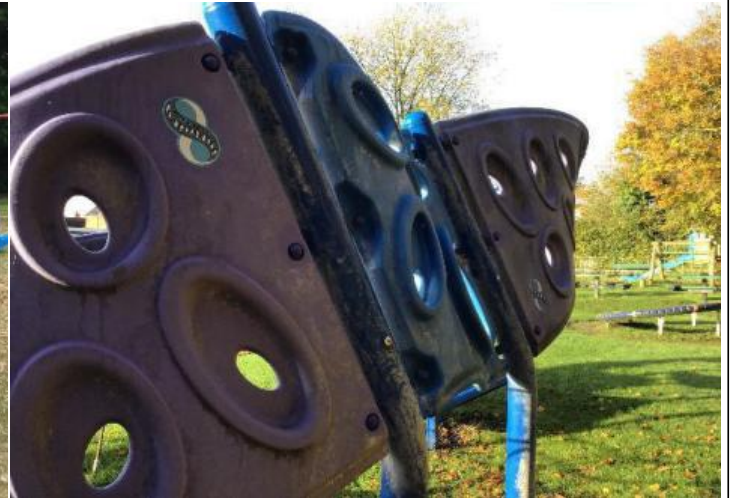
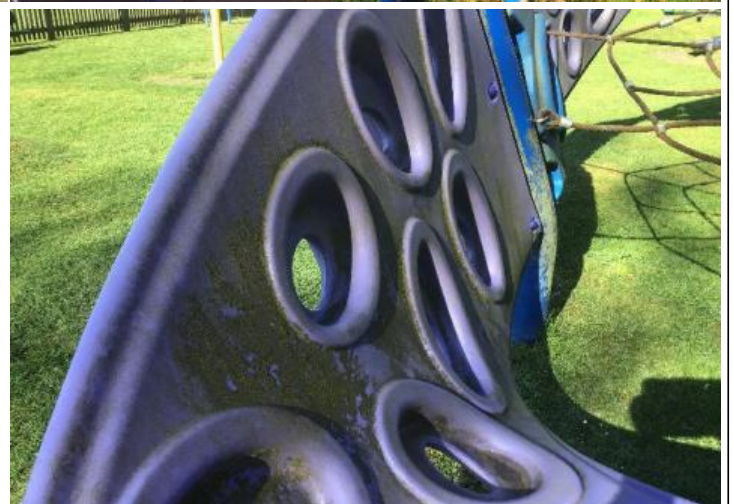
Item: Activity Equipment - Climbing Frame
Manufacturer: Not Identified

Risk Level: L - Low Risk
Surface: Grass Matrix Tiles

Finding: There is algae or moss on the surface of the equipment

Action: Clean and treat appropriately

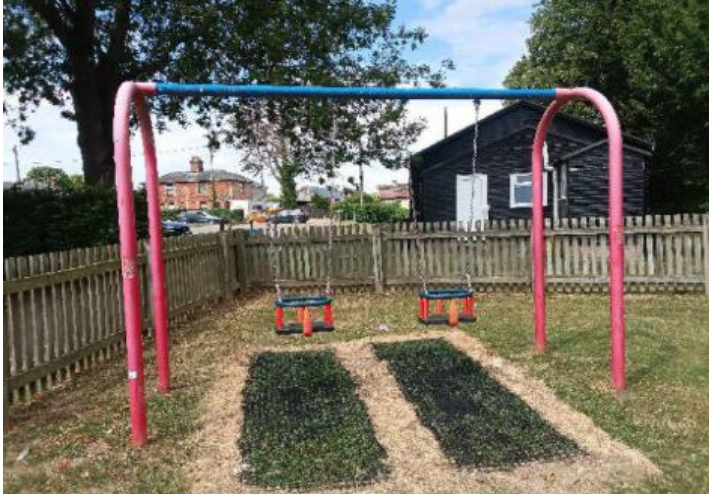
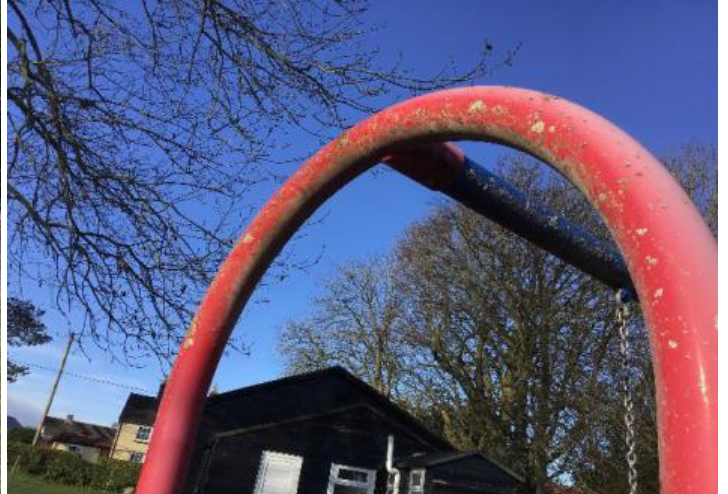
Item: Swings - 1 Bay 2 Seat (Cradle)
Manufacturer: Miracle Recreation Equipment Company

Risk Level: L - Low Risk
Surface: Grass Matrix Tiles

Finding: There is algae or moss on the surface of the equipment

Action: Clean and treat appropriately

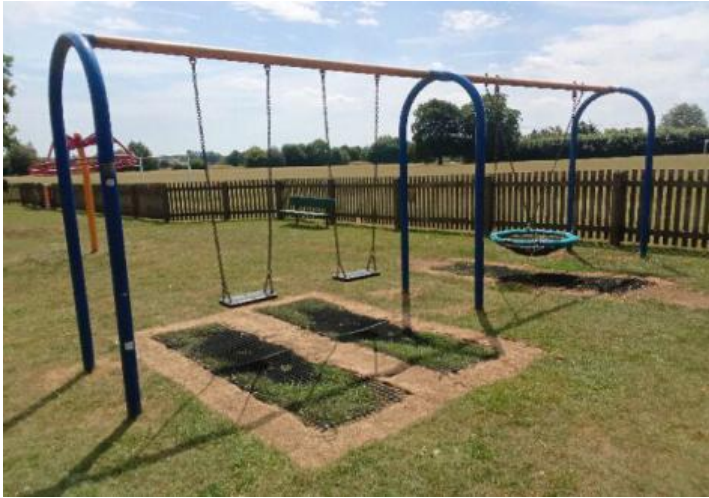
6 - Low Risk (Finding 1) - Marked as complete on 3-October-2025

Item: Swings - 2 Bay 2 Flat 1 Basket Seat
Manufacturer: Miracle Recreation Equipment Company

Risk Level: L - Low Risk
Surface: Grass Matrix Tiles

Finding: There is algae or moss on the surface of the equipment
