Play Area Inspection Reports & Remedial Work

Wickhambrook. Bury Road

Inspection Ref: 2949094

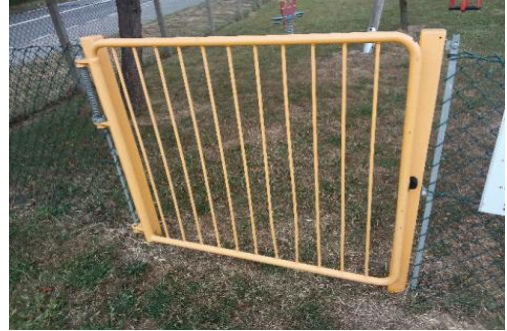
The gate rebounds when opened quickly and could strike the next user entering the area - Monitor use and adjust/replace as required

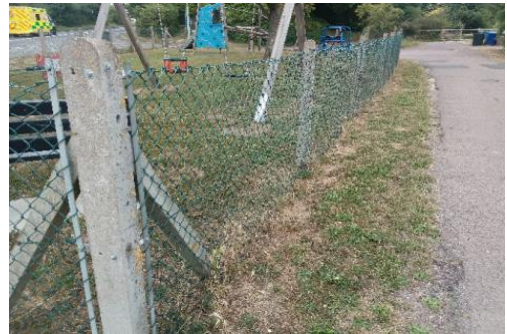
There is some damage to the fence sections - Monitor for any further deterioration and repair as required

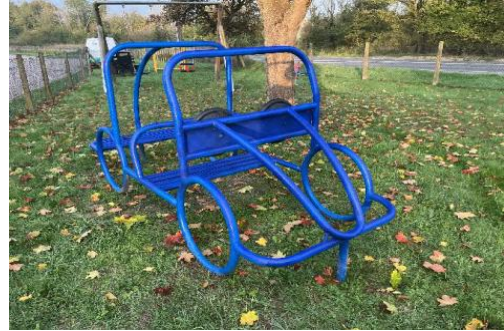
Cap covers missing - Replace

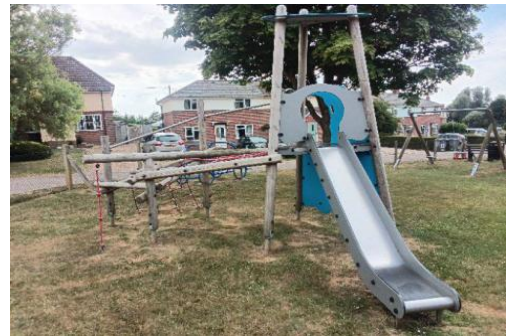
The ropes/nets are worn/damaged in places - Monitor for any further deterioration and repair or replace as required

The timber has a number of splits/shakes or air cracks and this may affect the stability or allow water ingress which will accelerate the rotting process - Monitor to ensure the splits do not cross through fixing points of the structure and/or cause any instability

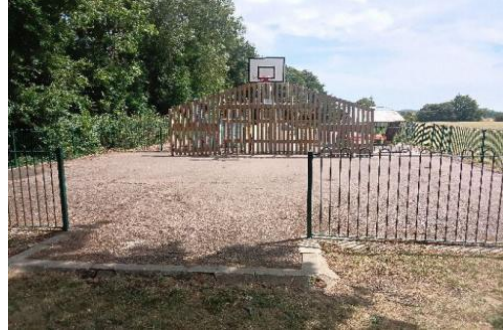
There is moderate damage to the surface - Repair the damaged areas of surfacing

The concrete foundation around the goal structure is lifting - Repair

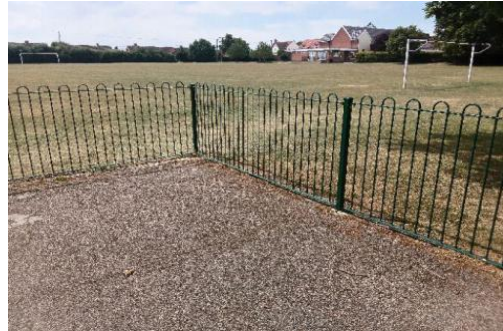
There are a number of fixings missing from the fence - Replace missing fixings

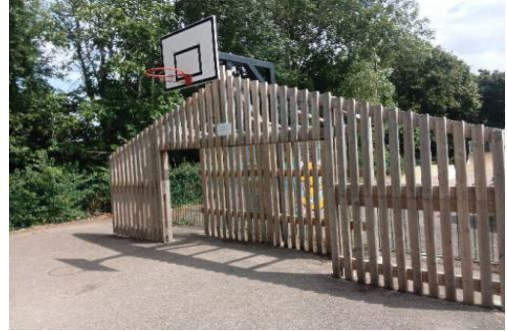
There is some tree debris on the surfacing - Remove and maintain

There is algae, silt or moss growth on the surface resulting in slippery conditions - Clean and treat appropriately

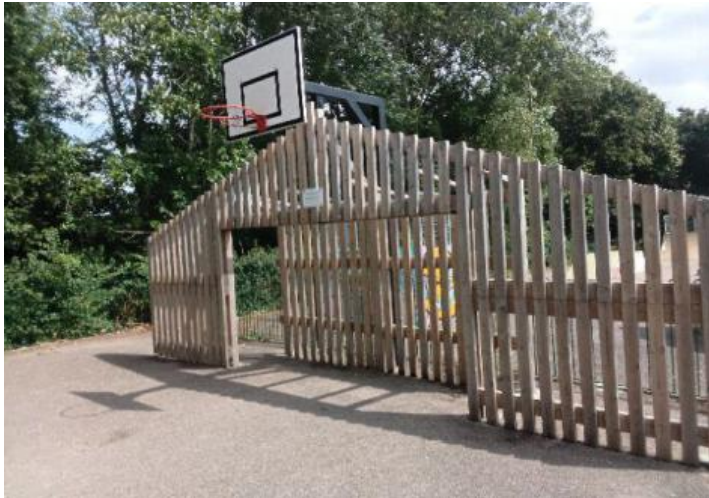
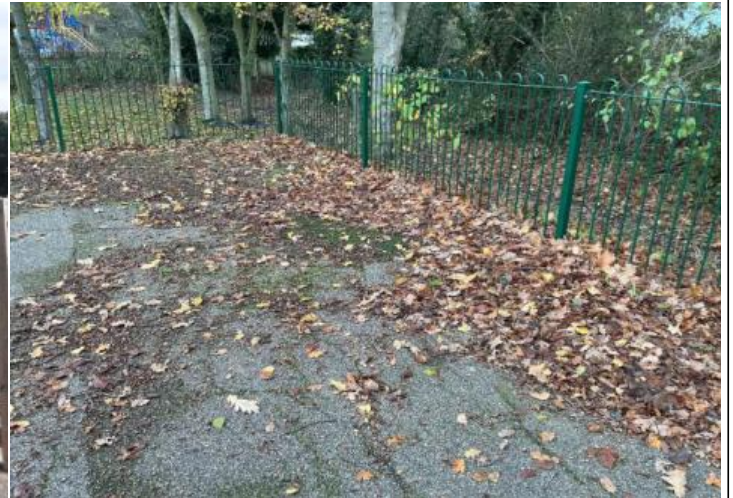
Finding: There is some tree debris on the surfacing

Action: Remove and maintain

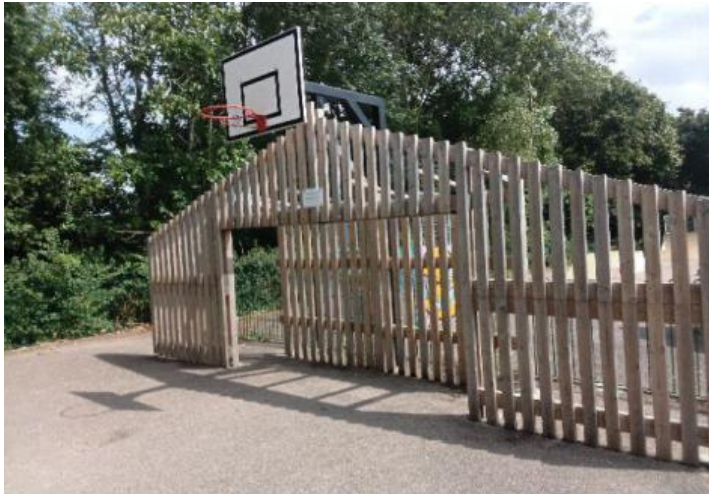
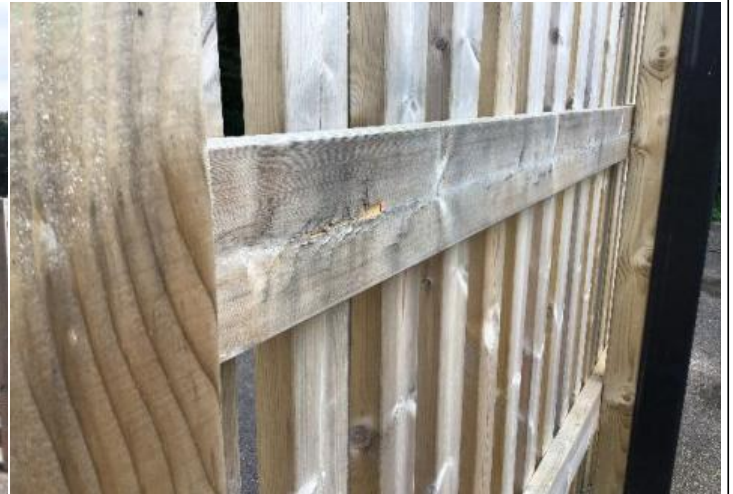
Finding: Parts of the timber are rough or splintered

Action: Remove all rough or sharp edges

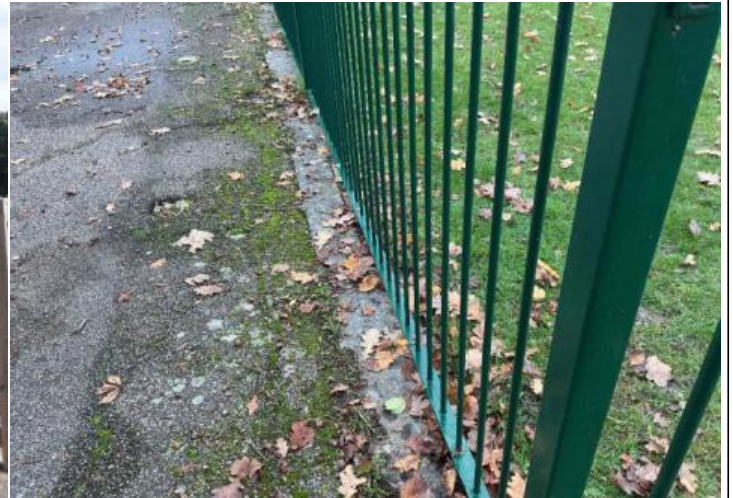
Finding: There is weed / vegetation growth on, between, or around the edges of the surfacing
Action: Remove weed / vegetation growth

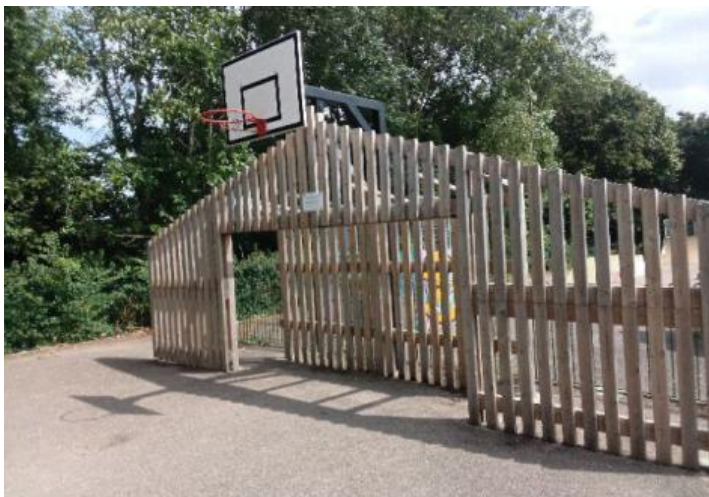
Finding: There is algae, silt or moss growth on the surface resulting in slippery conditions
Action: Clean and treat appropriately

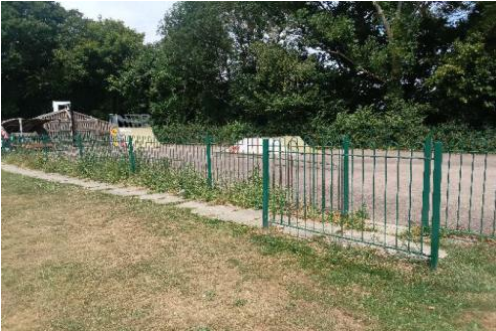
There is root damage to the surfacing creating unforeseen changes in levels - Repair the damaged areas of tarmac to provide a uniform surface

There is some damage apparent to the riding surface - Monitor for any further deterioration and repair as required

There is algae, silt or moss growth on the surface resulting in slippery conditions - Clean and treat appropriately

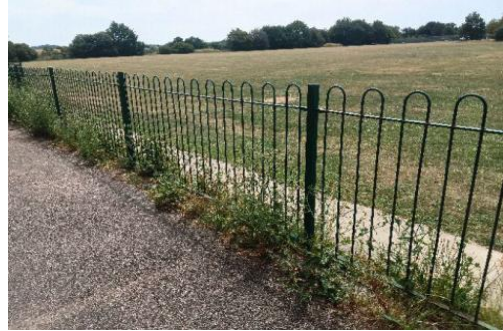
There is some damage to the fence sections - Monitor for any further deterioration and repair as required

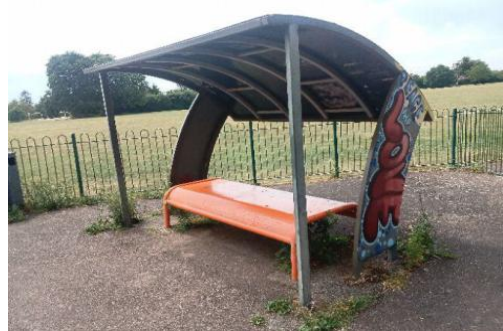
There is some evidence of fire damage to the item - Monitor for any further deterioration and repair as required

Pop rivet fixings have failed on the seat - Replace the failed pop rivets

There is surface corrosion / rust present on the item - Consider treating the item

There is algae, silt or moss growth on the surface resulting in slippery conditions - Clean and treat appropriately

A number of fixing(s) have worked loose - Secure all loose fixings

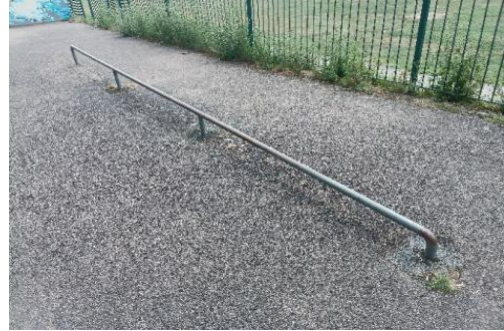
There is surface corrosion / rust present on the item - Consider treating the item

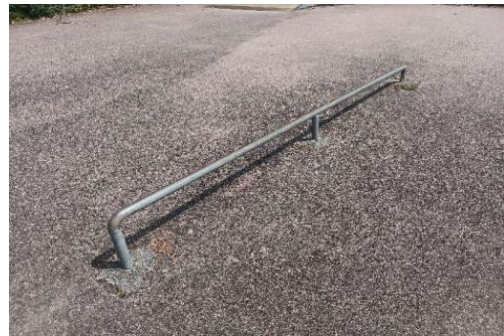
There is surface corrosion / rust present on the item - Consider treating the item

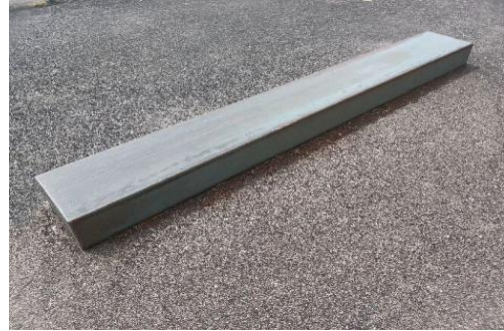
There is surface corrosion / rust present on the item - Consider treating the item

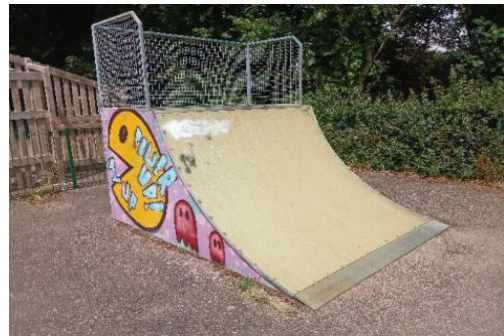
The item has been damaged - Monitor for any further deterioration and replace as required

Minor damage to surface - Monitor for deterioration

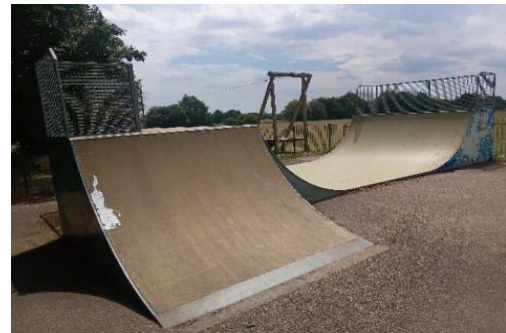
A number of fixing(s) have worked loose - Secure all loose fixings

There is some damage to the fence sections - Monitor for any further deterioration and repair as required

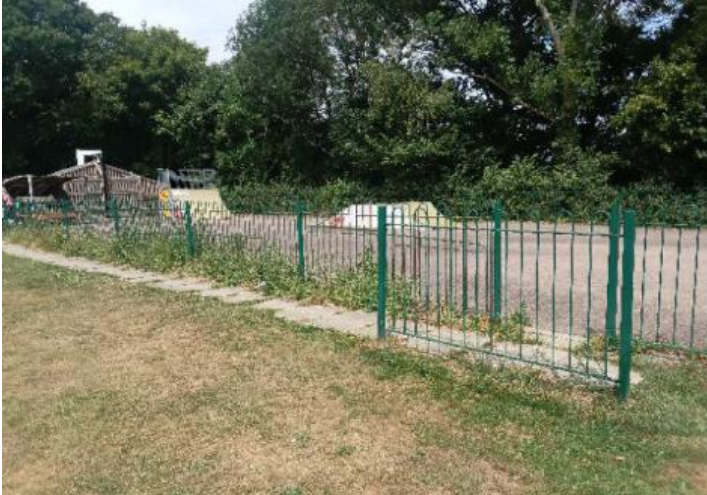
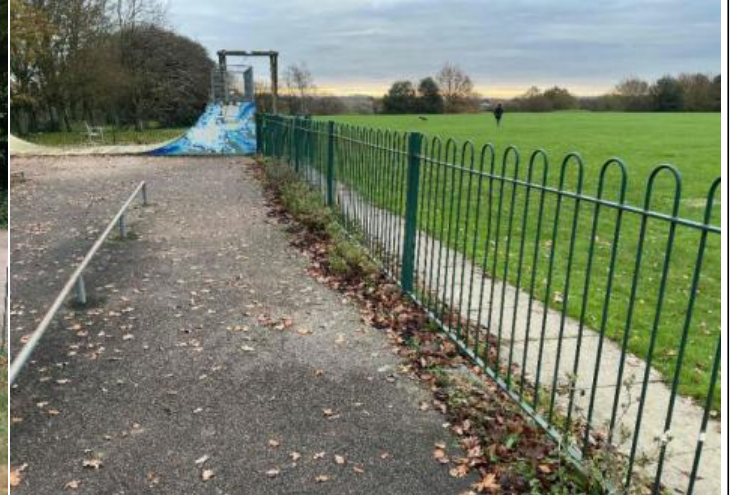
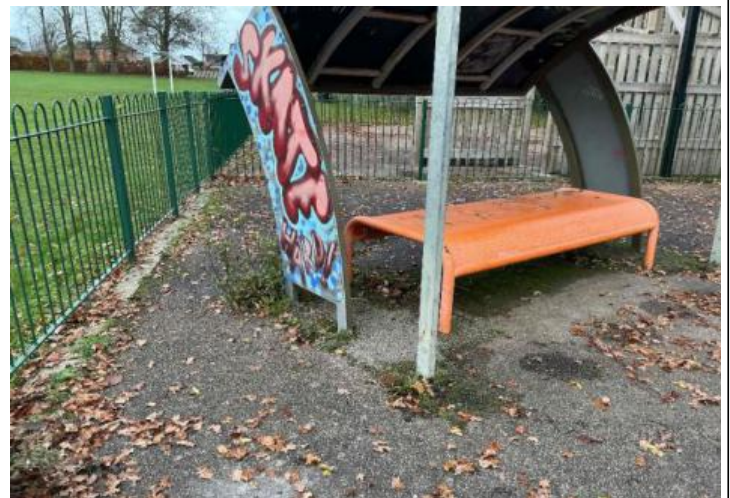
Item: Ancillary Items - Site General
Manufacturer: Owner/Operator

Risk Level: L - Low Risk
Surface: N/A

Finding: There is weed / vegetation growth on, between, or around the edges of the surfacing **Action:** Remove weed / vegetation growth

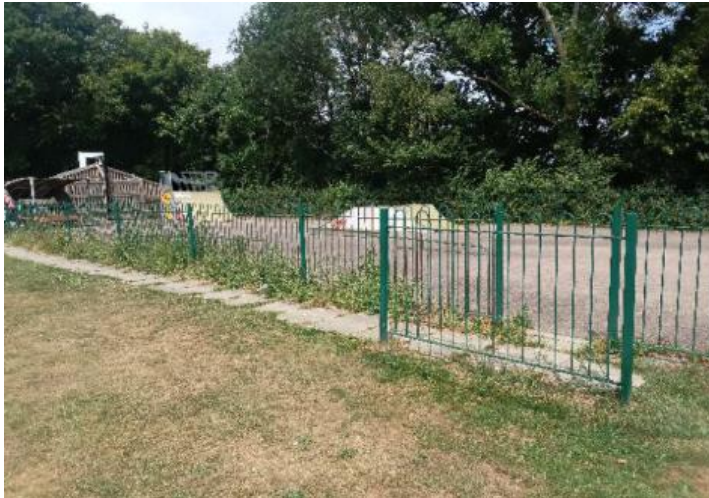
i 8 - Low Risk (Finding 2)

Item: Ancillary Items - Site General
Manufacturer: Owner/Operator

Risk Level: L - Low Risk
Surface: N/A

Finding: There is root damage to the surfacing creating unforeseen changes in levels

Action: Repair the damaged areas of tarmac to provide a uniform surface

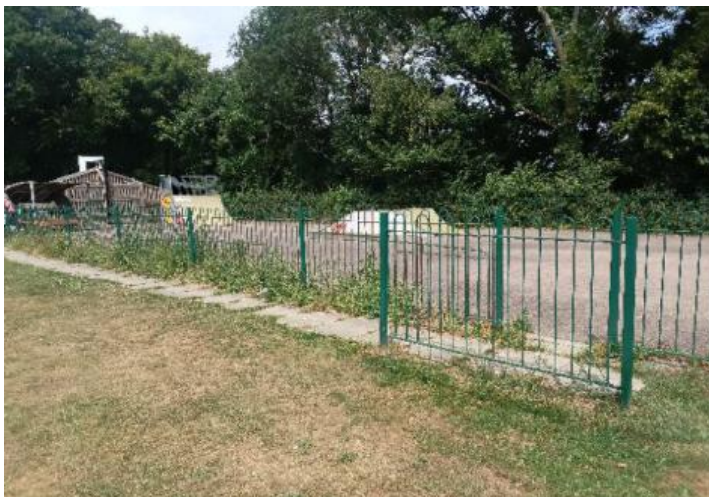
Item: Ancillary Items - Site General
Manufacturer: Owner/Operator

Risk Level: L - Low Risk
Surface: N/A

Finding: There is some damage apparent to the riding surface

Action: Monitor for any further deterioration and repair as required

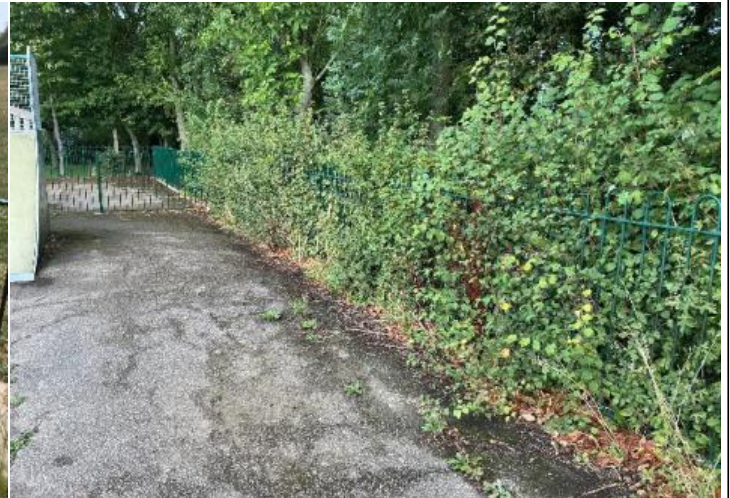
Item: Fences - Fence - Bow Top
Manufacturer: Not Identified

Risk Level: L - Low Risk
Surface: Bitmac

Finding: The adjacent foliage is overhanging

Action: Cut back and maintain

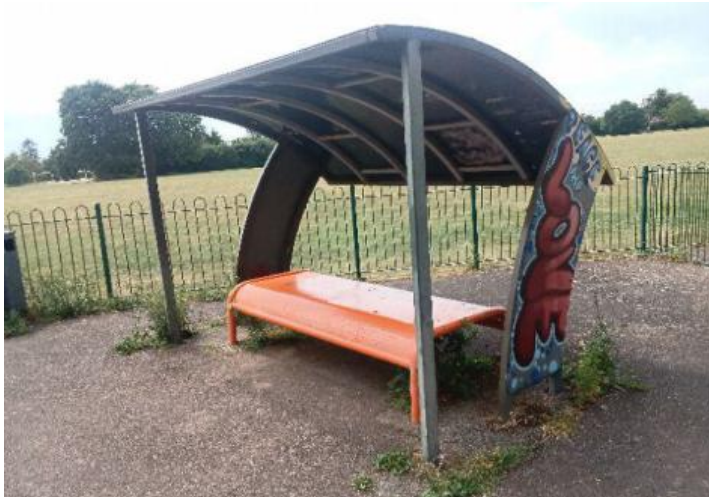
Item: Ancillary Items - Shelter
Manufacturer: Not Identified

Risk Level: L - Low Risk
Surface: Tarmac

Finding: There is some evidence of fire damage to the item

Action: Monitor for any further deterioration and repair as required

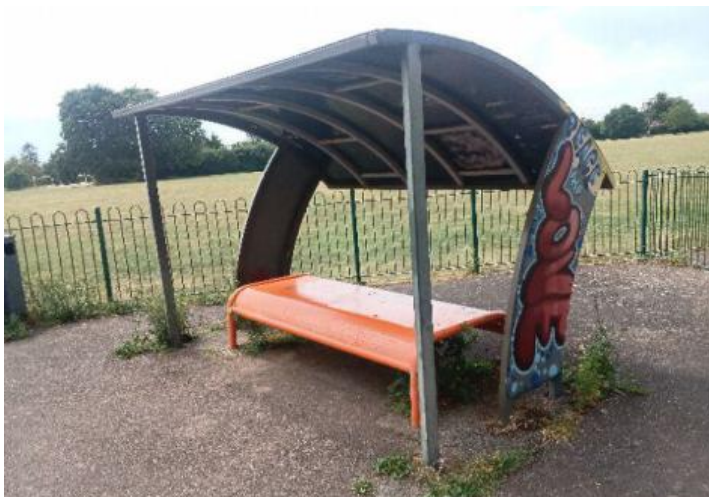
Item: Ancillary Items - Shelter
Manufacturer: Not Identified

Risk Level: L - Low Risk
Surface: Tarmac

Finding: There is algae, silt or moss growth on the surface resulting in slippery conditions

Action: Clean and treat appropriately

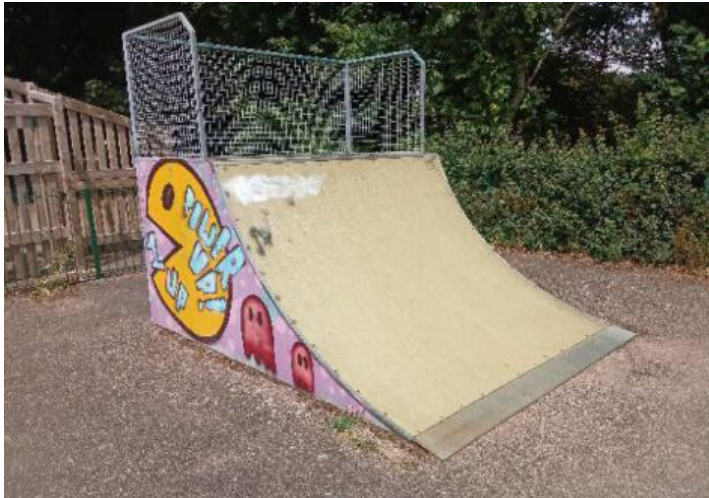
Item: Wheeled Sports - Quarter Pipe
Manufacturer: Eibe Play Ltd

Risk Level: L - Low Risk
Surface: Tarmac

Finding: The item has been damaged

Action: Monitor for any further deterioration and replace as required

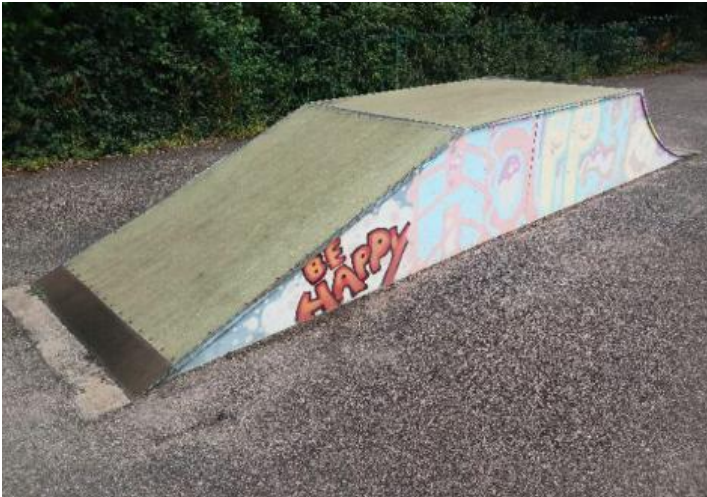
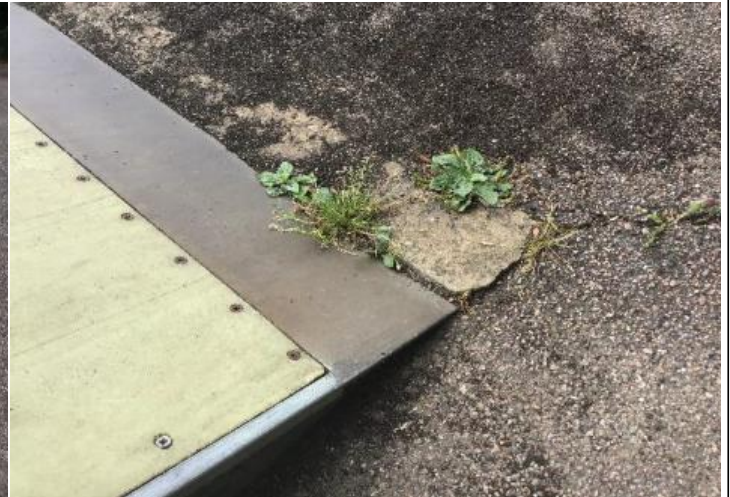
Item: Wheeled Sports - Platform Ramp
Manufacturer: Eibe Play Ltd

Risk Level: L - Low Risk
Surface: Tarmac

Finding: Concrete is lifting at the front of the ramp

Action: Remove and reinstate concrete (level)

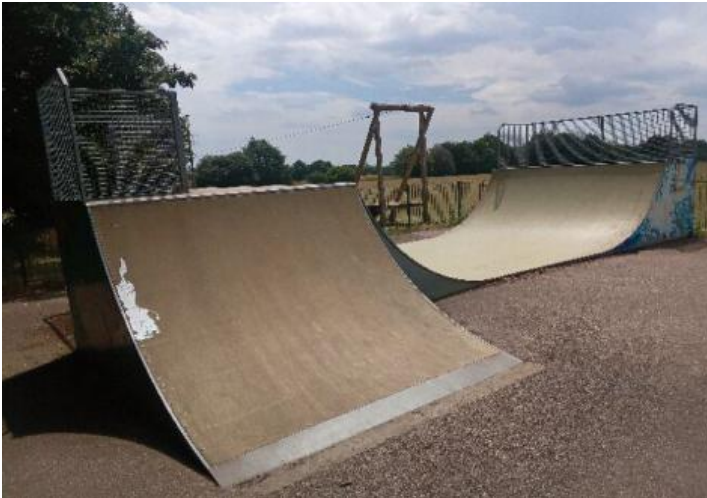
Item: Wheeled Sports - Half Pipe
Manufacturer: Eibe Play Ltd

Risk Level: L - Low Risk
Surface: Tarmac

Finding: A number of fixing(s) have worked loose

Action: Secure all loose fixings

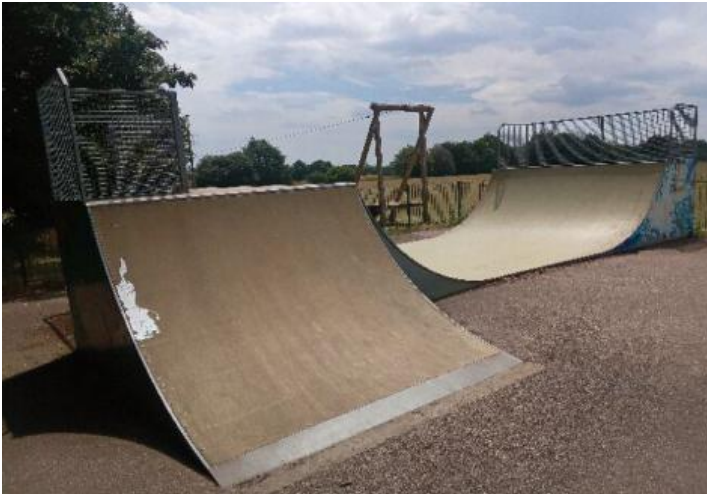
Item: Wheeled Sports - Half Pipe
Manufacturer: Eibe Play Ltd

Risk Level: L - Low Risk
Surface: Tarmac

Finding: There is some damage to the fence sections

Action: Monitor for any further deterioration and repair as required

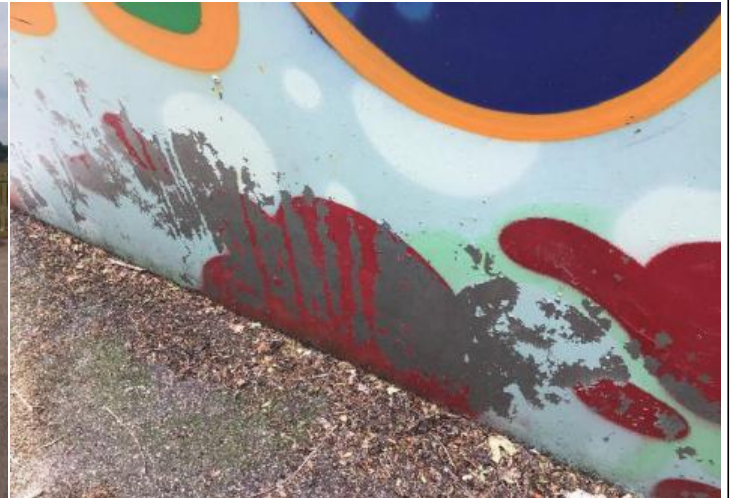
Item: Wheeled Sports - Half Pipe
Manufacturer: Eibe Play Ltd

Risk Level: L - Low Risk
Surface: Tarmac

Finding: The paint is flaking off the metalwork

Action: Rub down and re-paint

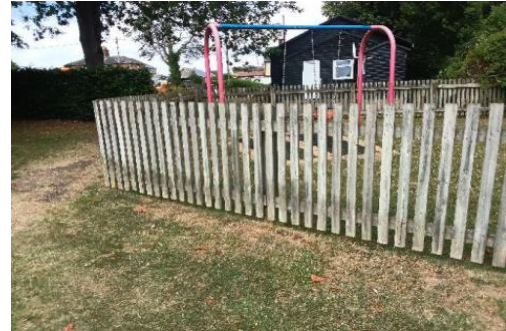
i 8 - Low Risk

Item: Fencing - Timber
Manufacturer: Not Identified
Surface Type: Grass
Item Quantity: 1

There is some strimmer / machinery damage apparent on the posts, this can penetrate the preservative applied to the timber and accelerate the rotting process - Monitor for any deterioration (rot) and replace as required

Slats damaged - Replace damaged slat

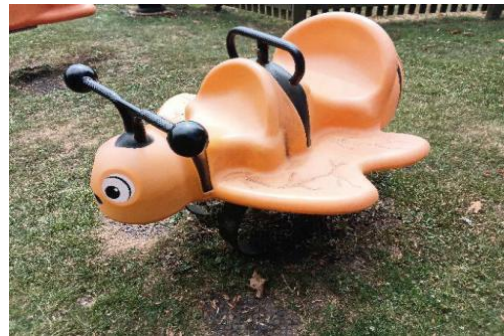
i 8 - Low Risk

Item: Spring Bee
Manufacturer: Miracle Recreation Equipment Company
Surface Type: Grass Matrix Tiles
Item Quantity: 1

A number of fixing(s) have worked loose - Secure all loose fixings

There is or are fixings missing on the item - Replace all missing fixings

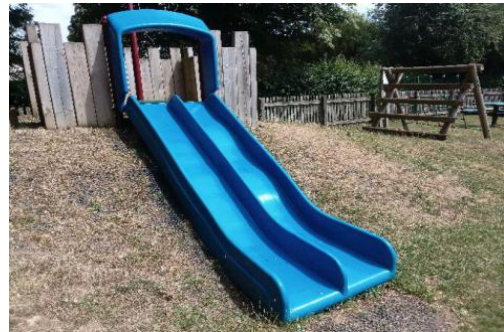
i 8 - Low Risk

Item: Embankment Slide
Manufacturer: Miracle Recreation Equipment Company
Surface Type: Grass Matrix Tiles
Item Quantity: 1

The surface has eroded in some areas and may be slippery in wet conditions - Reinstate the surface

There are trip hazards at the edges of the surface - Reinstate surrounding surface levels to remove the trip points

Some timbers are slightly loose in the foundation - Monitor for deterioration

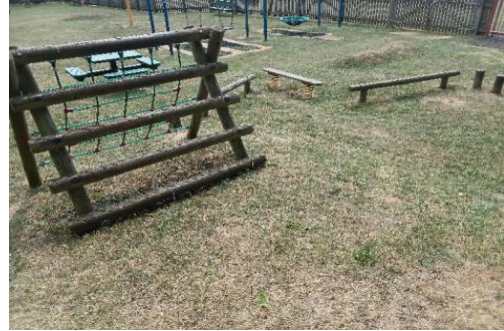
i 8 - Low Risk

Item: Activity Trail
Manufacturer: Miracle Recreation Equipment Company
Surface Type: Grass Matrix Tiles
Item Quantity: 1

There is/are bolt cap covers missing or damaged on the item - Replace missing or damaged bolt cap covers

A number of fixing(s) have worked loose - Secure all loose fixings

There is some strimmer / machinery damage apparent on the posts, this can penetrate the preservative applied to the timber and accelerate the rotting process - Monitor for any deterioration (rot) and replace as required

The timber has a number of splits/shakes or air cracks and this may affect the stability or allow water ingress which will accelerate the rotting process - Monitor to ensure the splits do not cross through fixing points of the structure and/or cause any instability

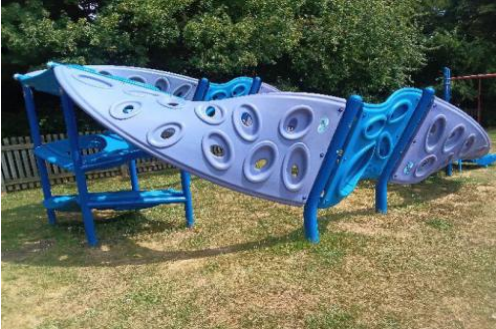
Item: Climbing Frame
Manufacturer: Not Identified
Surface Type: Grass Matrix Tiles
Item Quantity: 1

The connecting lugs are showing signs of wear - Monitor for any further deterioration and repair as required

The item has been damaged - Sand down plastic to remove sharp edge

The ropes/nets are worn/damaged in places - Monitor for any further deterioration and repair or replace as required

There is surface corrosion / rust present on the item - Consider treating the item

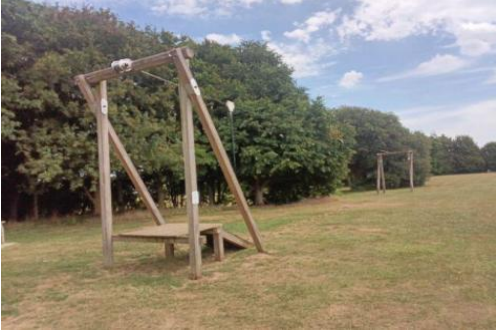
Item: Cable Runway
Manufacturer: Fenland Leisure Products
Surface Type: Grass Matrix Tiles
Item Quantity: 1

We have completed a visual inspection of the suspension links, cable and fixing points from ground level, however it is not possible to fully inspect these areas without either hiring equipment to gain access or removing the cable and suspension and inspecting at ground level. We recommend that the main cable and fixing security is thoroughly inspected at least in accordance with the manufacturers recommendations to check for wear, damage, security or internal rusting; this will help to ensure the continued safe use of the equipment - Inspect in accordance with the manufacturers recommendations

The seat connection cannot be inspected without dismantling the seat - Dismantle the seat to inspect the seat connection for wear

There is some strimmer / machinery damage apparent on the posts, this can penetrate the preservative applied to the timber and accelerate the rotting process - Monitor for any deterioration (rot) and replace as required

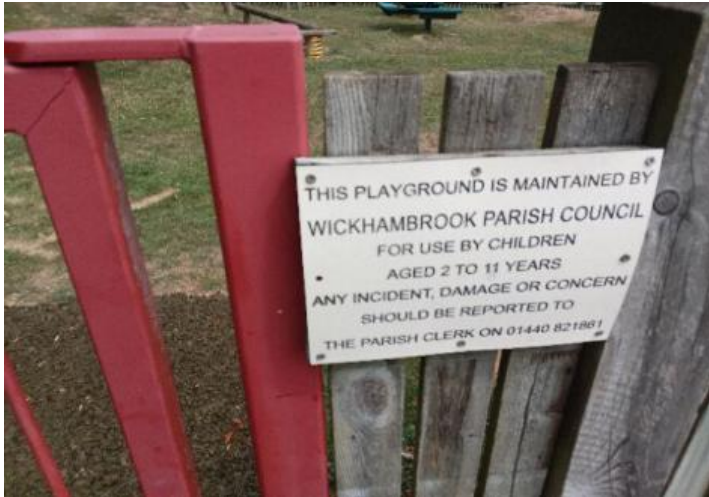
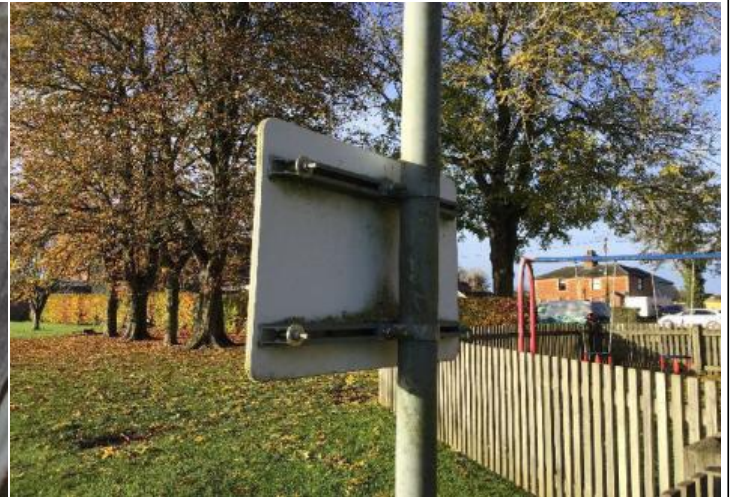
Item: Ancillary Items - Sign
Manufacturer: Not Identified

Risk Level: L - Low Risk
Surface: N/A

Finding: There are projecting bolt thread(s) present

Action: Remove excess thread length and deburr or provide cap

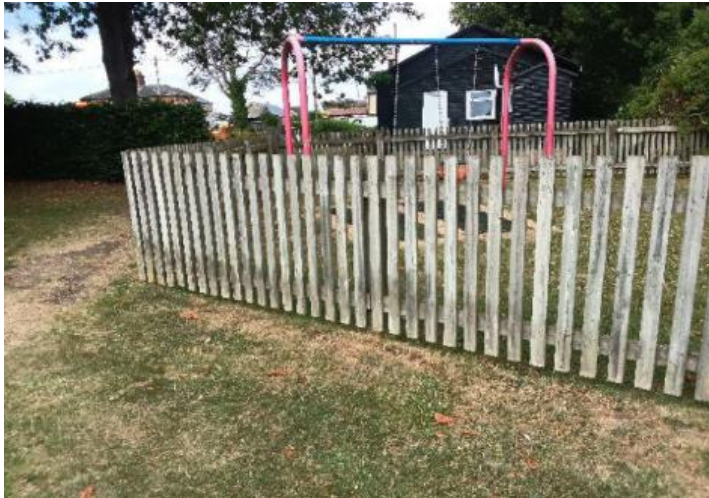
Item: Fences - Fencing - Timber
Manufacturer: Not Identified

Risk Level: L - Low Risk
Surface: Grass

Finding: Parts of the timber are rough or splintered

Action: Remove all rough or sharp edges

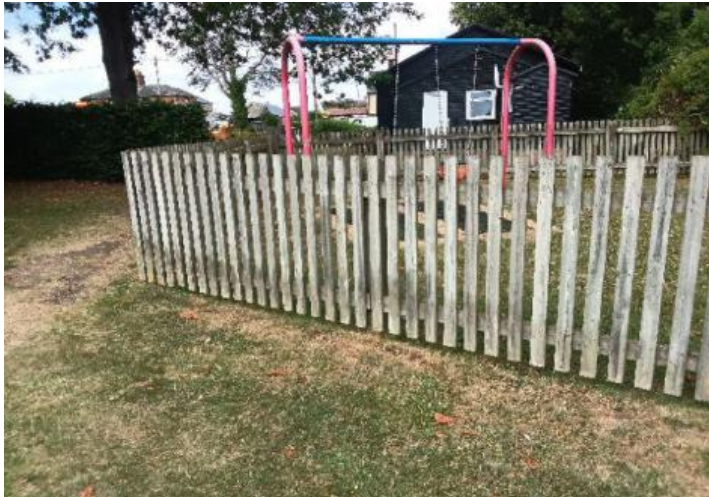
Item: Fences - Fencing - Timber
Manufacturer: Not Identified

Risk Level: L - Low Risk
Surface: Grass

Finding: There are projecting nail ends present

Action: Remove and provide more appropriate fixings if required

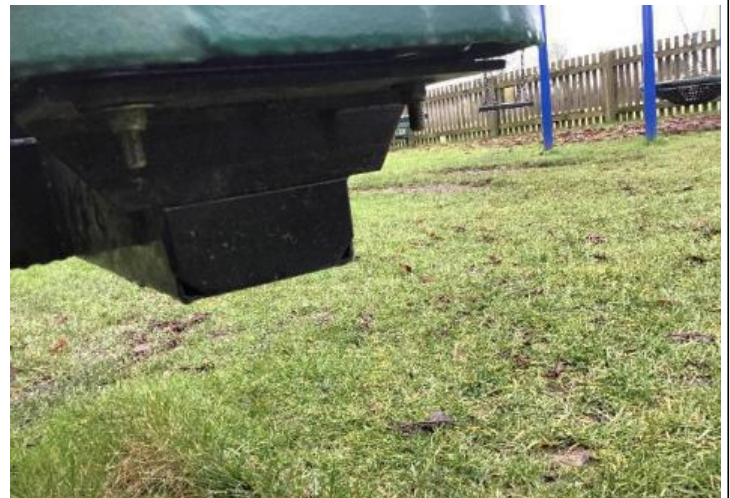
Item: Ancillary Items - Picnic Table
Manufacturer: Not Identified

Risk Level: L - Low Risk
Surface: Grass

Finding: There are projecting bolt thread(s) present

Action: Remove excess thread length and deburr or provide cap

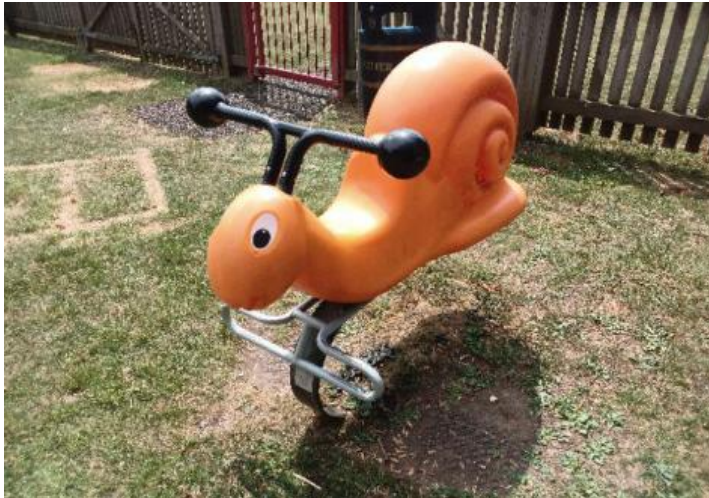
Item: Rocking Equipment - Spring Snail
Manufacturer: Miracle Recreation Equipment Company

Risk Level: V - Very Low Risk
Surface: Grass Matrix Tiles

Finding: A number of fixing(s) have worked loose

Action: Secure all loose fixings

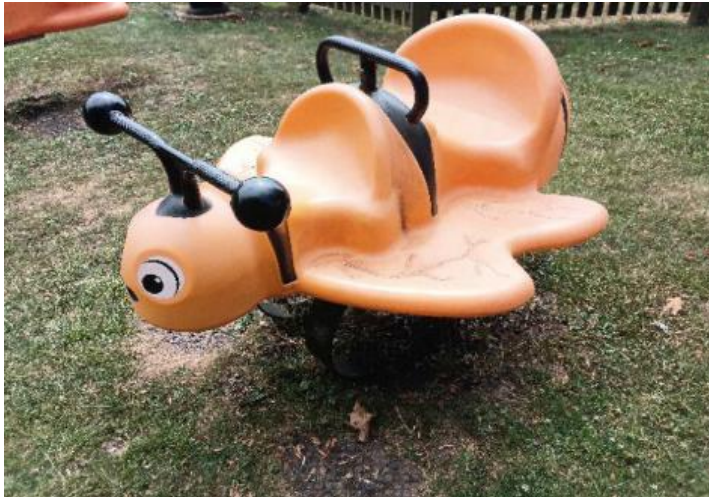
Item: Rocking Equipment - Spring Bee
Manufacturer: Miracle Recreation Equipment Company

Risk Level: V - Very Low Risk
Surface: Grass Matrix Tiles

Finding: A number of fixing(s) have worked loose

Action: Secure all loose fixings

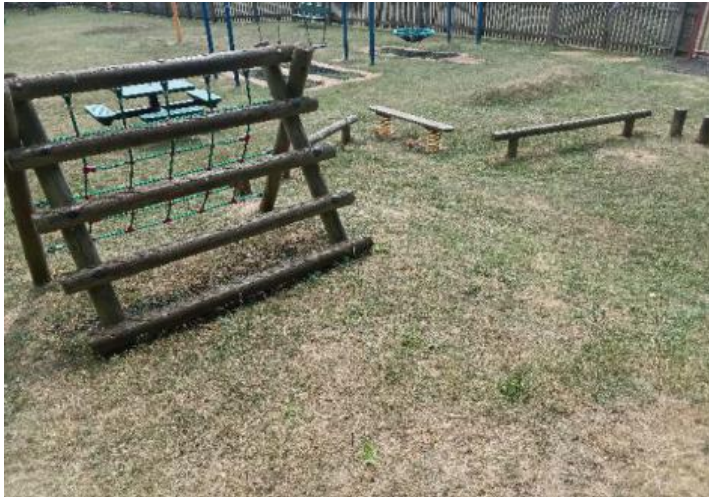
Item: Activity Equipment - Activity Trail
Manufacturer: Miracle Recreation Equipment Company

Risk Level: V - Very Low Risk
Surface: Grass Matrix Tiles

Finding: There is/are bolt cap covers missing or damaged on the item

Action: Replace missing or damaged bolt cap covers

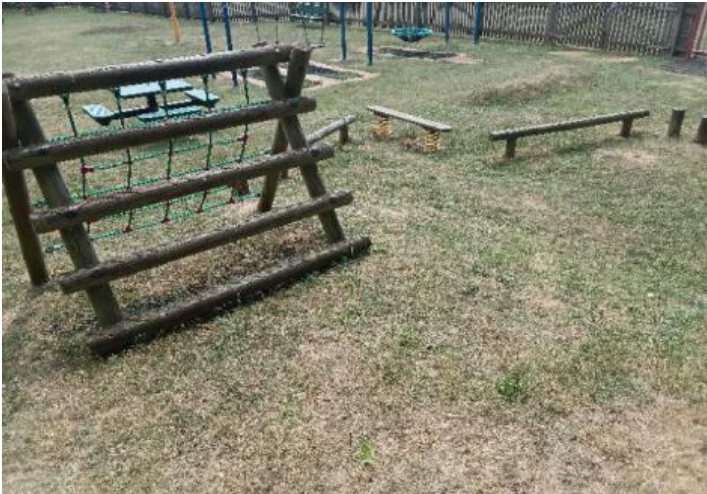
Item: Activity Equipment - Activity Trail
Manufacturer: Miracle Recreation Equipment Company

Risk Level: L - Low Risk
Surface: Grass Matrix Tiles

Finding: There is some strimmer / machinery damage apparent on the posts, this can penetrate the preservative applied to the timber and accelerate the rotting process

Action: Monitor for any deterioration (rot) and replace as required

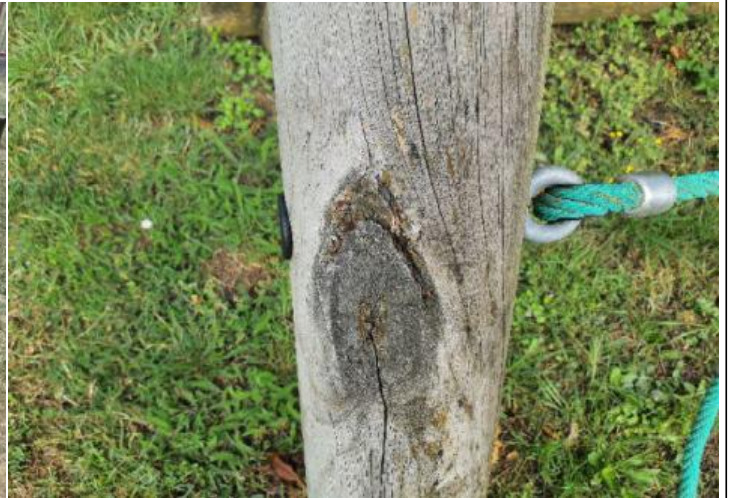
i 6 - Low Risk (Finding 6)

Item: Activity Equipment - Activity Trail
Manufacturer: Miracle Recreation Equipment Company

Risk Level: L - Low Risk
Surface: Grass Matrix Tiles

Finding: Parts of the timber are rough or splintered

Action: Remove all rough or sharp edges

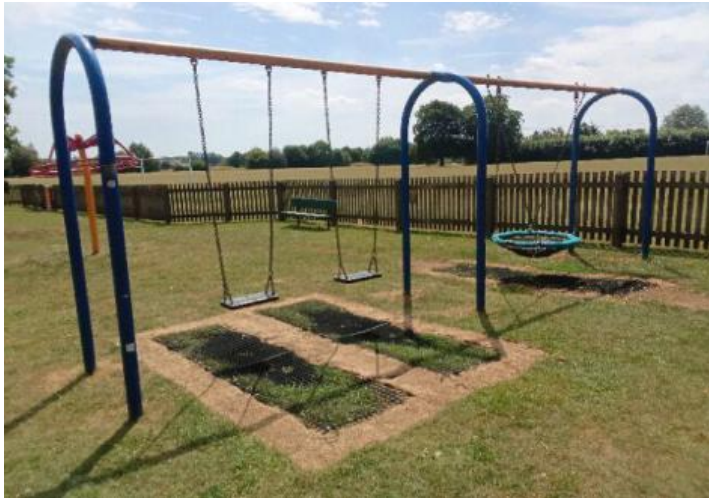
Item: Swings - 2 Bay 2 Flat 1 Basket Seat
Manufacturer: Miracle Recreation Equipment Company

Risk Level: L - Low Risk
Surface: Grass Matrix Tiles

Finding: The paint is flaking off the metalwork

Action: Rub down and re-paint

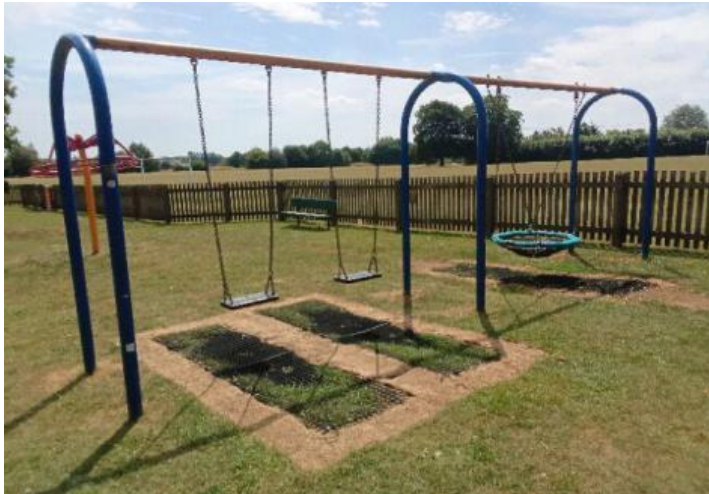
Item: Swings - 2 Bay 2 Flat 1 Basket Seat
Manufacturer: Miracle Recreation Equipment Company

Risk Level: V - Very Low Risk
Surface: Grass Matrix Tiles

Finding: There is/are bolt cap covers missing or damaged on the item

Action: Replace missing or damaged bolt cap covers

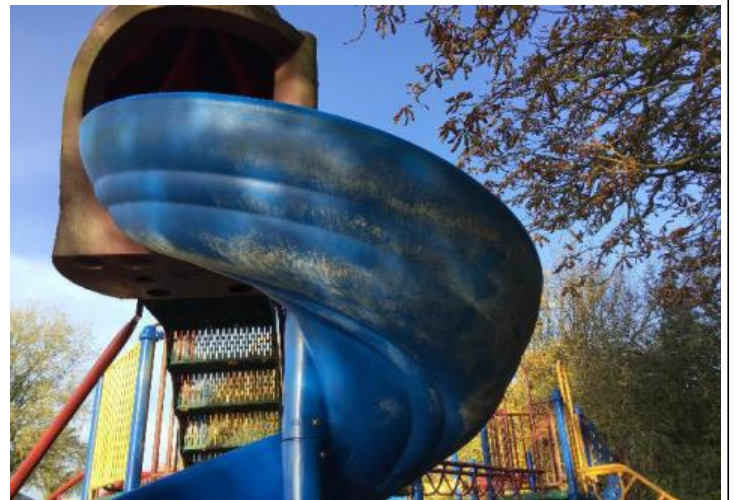
Item: Activity Equipment - Multi Play (Senior)
Manufacturer: Miracle Recreation Equipment Company

Risk Level: L - Low Risk
Surface: Grass Matrix Tiles

Finding: There is algae or moss on the surface of the equipment

Action: Clean and treat appropriately

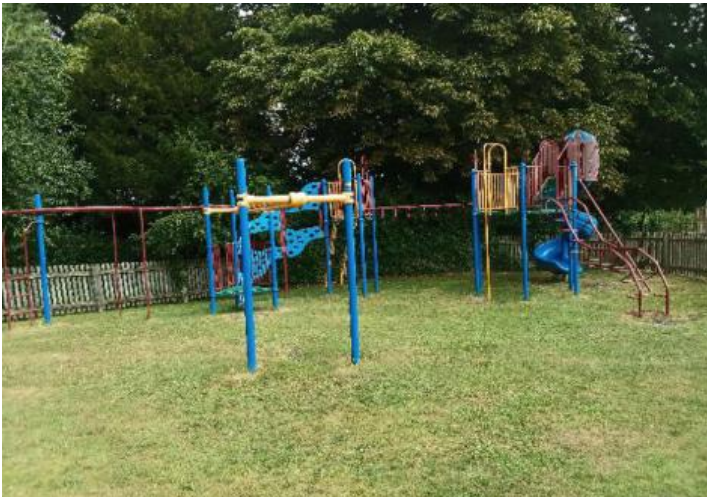
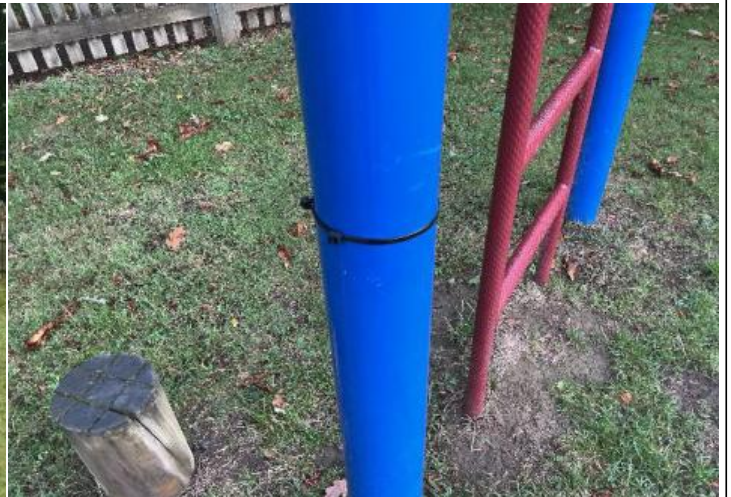
Item: Activity Equipment - Multi Play (Senior)
Manufacturer: Miracle Recreation Equipment Company

Risk Level: L - Low Risk
Surface: Grass Matrix Tiles

Finding: Cable tie around post has been cut leaving sharp edges

Action: Remove cable tie

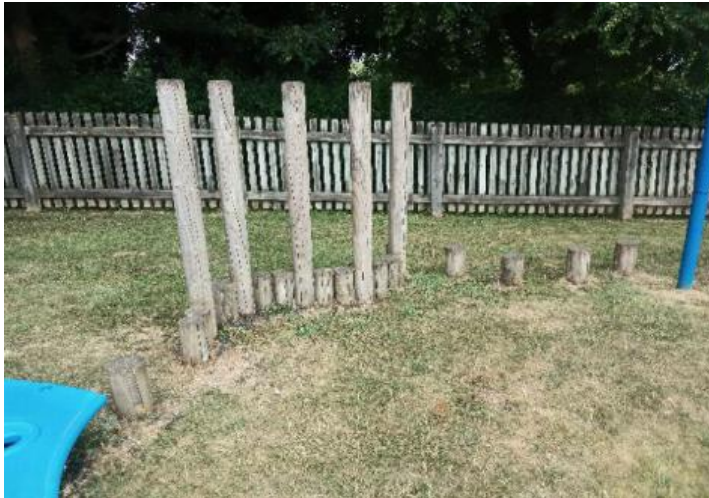
Item: Activity Equipment - Log Walk
Manufacturer: Miracle Recreation Equipment Company

Risk Level: L - Low Risk
Surface: Grass Matrix Tiles

Finding: The timber has a number of splits/shakes or air cracks and this may affect the stability or allow water ingress which will accelerate the rotting process
Action: Monitor to ensure the splits do not cross through fixing points of the structure and/or cause any instability

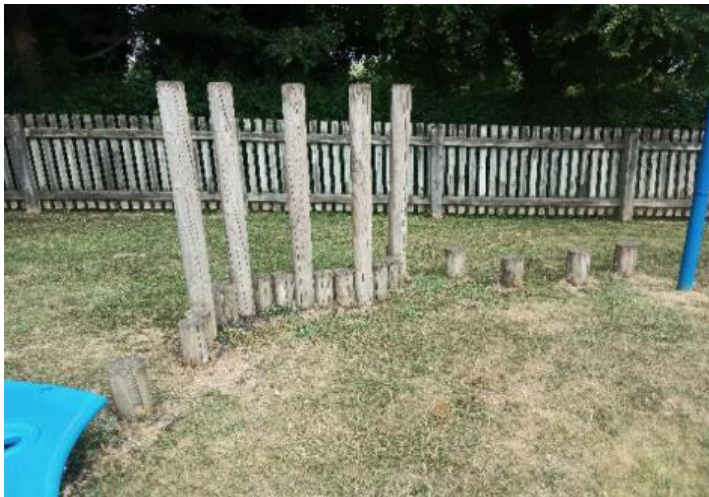
Item: Activity Equipment - Log Walk
Manufacturer: Miracle Recreation Equipment Company

Risk Level: L - Low Risk
Surface: Grass Matrix Tiles

Finding: There is some strimmer / machinery damage apparent on the posts, this can penetrate the preservative applied to the timber and accelerate the rotting process
Action: Monitor for any deterioration (rot) and replace as required

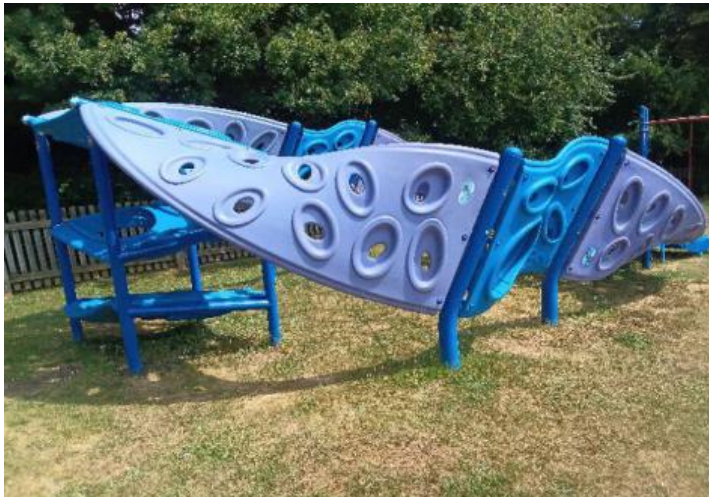
Item: Activity Equipment - Climbing Frame
Manufacturer: Not Identified

Risk Level: L - Low Risk
Surface: Grass Matrix Tiles

Finding: The connecting lugs are showing signs of wear

Action: Monitor for any further deterioration and repair as required
