## Play Area Inspection Reports & Remedial Work

## Wickhambrook. Bury Road

Inspection Ref: 2999726

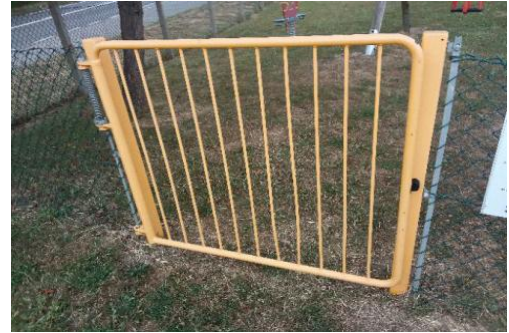
**Item:** Gate - Self Closing  
**Manufacturer:** Not Identified  
**Surface Type:** Grass  
**Item Quantity:** 1

The gate rebounds when opened quickly and could strike the next user entering the area - Monitor use and adjust/replace as required

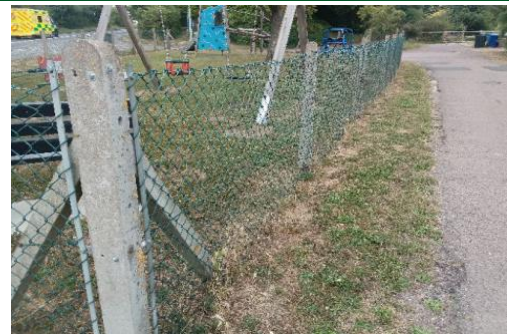
**Item:** Fence - Chainlink  
**Manufacturer:** Not Identified  
**Surface Type:** Grass  
**Item Quantity:** 1

There is some damage to the fence sections - Monitor for any further deterioration and repair as required

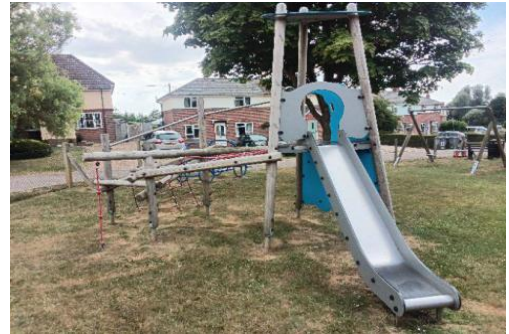
**Item:** Multi Play (Junior)  
**Manufacturer:** Playforce  
**Surface Type:** Grass Matrix Tiles  
**Item Part Number:** Jungle tops  
**Item Quantity:** 1

The ropes/nets are worn/damaged in places - Monitor for any further deterioration and repair or replace as required

The timber has a number of splits/shakes or air cracks and this may affect the stability or allow water ingress which will accelerate the rotting process - Monitor to ensure the splits do not cross through fixing points of the structure and/or cause any instability

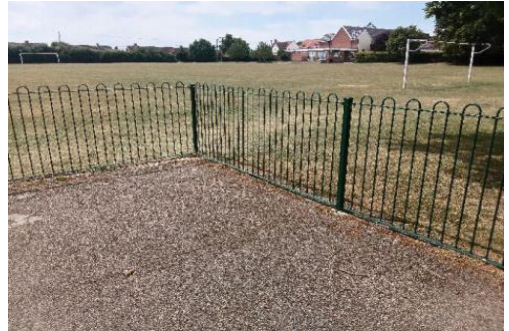
**Item:** Fence - Bow Top  
**Manufacturer:** Not Identified  
**Surface Type:** Bitmac  
**Item Quantity:** 1

There are a number of fixings missing from the fence - Replace missing fixings

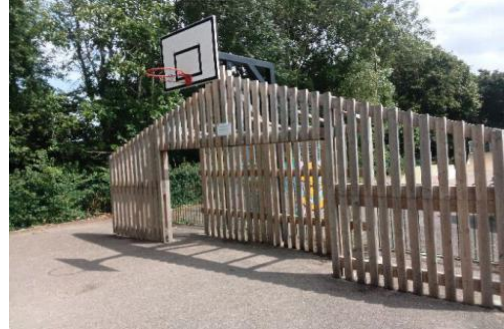
**Item:** Ball Games Area  
**Manufacturer:** Sovereign Leisure  
**Surface Type:** Tarmac  
**Item Quantity:** 1

There is some tree debris on the surfacing - Remove and maintain

There is algae, silt or moss growth on the surface resulting in slippery conditions - Clean and treat appropriately

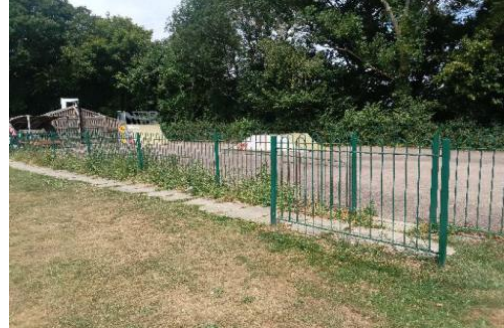
**Item:** Site General  
**Manufacturer:** Owner/Operator  
**Surface Type:** N/A  
**Item Quantity:** 1

There is root damage to the surfacing creating unforeseen changes in levels - Repair the damaged areas of tarmac to provide a uniform surface

There is some damage apparent to the riding surface - Monitor for any further deterioration and repair as required

There is algae, silt or moss growth on the surface resulting in slippery conditions - Clean and treat appropriately

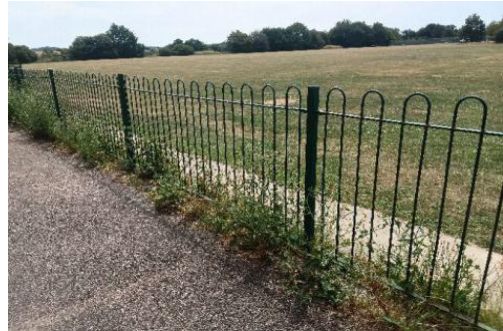
**Item:** Fence - Bow Top  
**Manufacturer:** Not Identified  
**Surface Type:** Bitmac  
**Item Quantity:** 1

There is some damage to the fence sections - Monitor for any further deterioration and repair as required

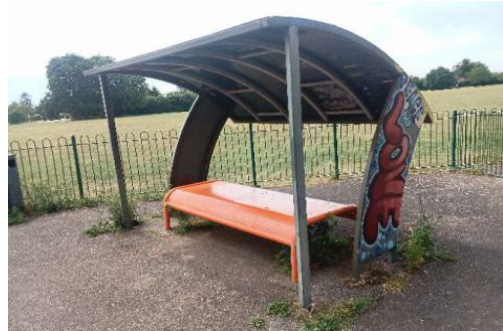
**Item:** Shelter  
**Manufacturer:** Not Identified  
**Surface Type:** Tarmac  
**Item Quantity:** 1

There is some evidence of fire damage to the item - Monitor for any further deterioration and repair as required

Pop rivet fixings have failed on the seat - Replace the failed pop rivets

There is surface corrosion / rust present on the item - Consider treating the item

There is algae, silt or moss growth on the surface resulting in slippery conditions - Clean and treat appropriately

A number of fixing(s) have worked loose - Secure all loose fixings

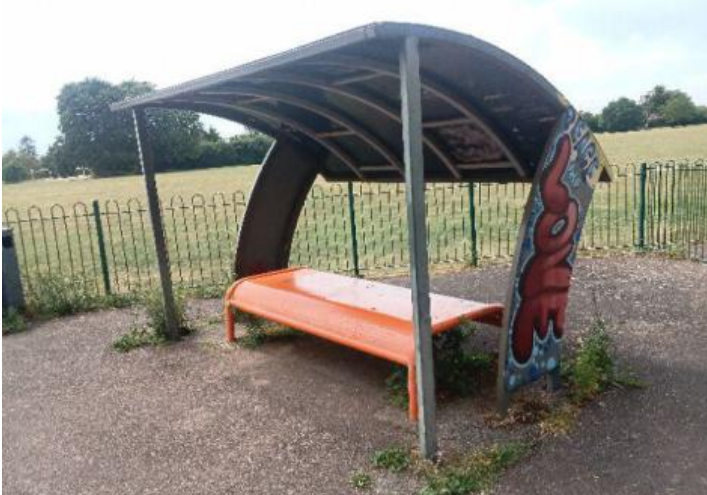
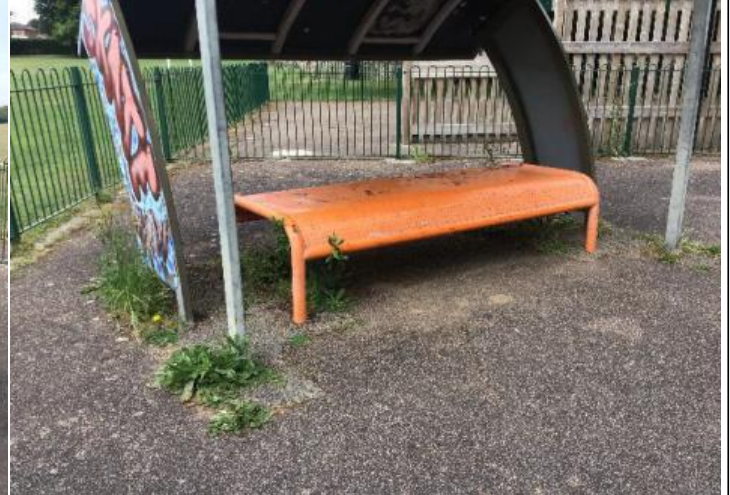
**Item:** Ancillary Items - Shelter  
**Manufacturer:** Not Identified

**Risk Level:** L - Low Risk  
**Surface:** Tarmac

**Finding:** There is weed / vegetation growth within the surface

**Action:** Remove weed / vegetation growth

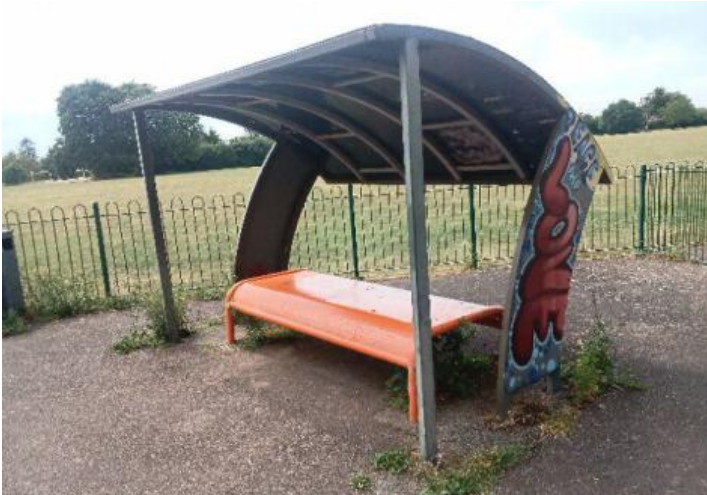
**Item:** Ancillary Items - Shelter  
**Manufacturer:** Not Identified

**Risk Level:** L - Low Risk  
**Surface:** Tarmac

**Finding:** A number of fixing(s) have worked loose

**Action:** Secure all loose fixings

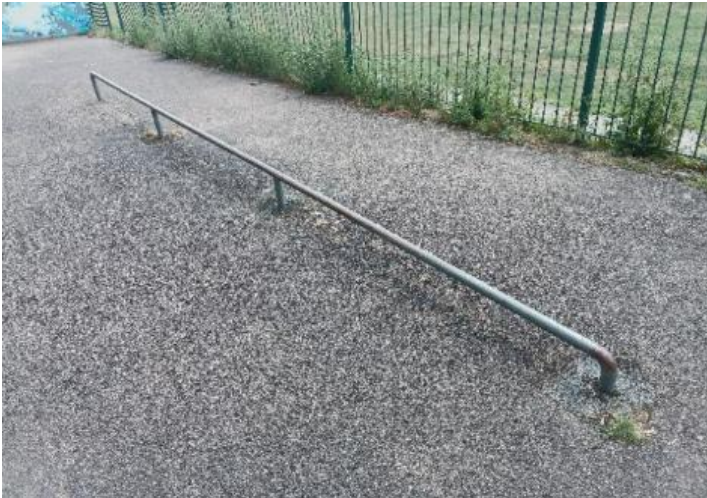
**Item:** Wheeled Sports - Grind Rail  
**Manufacturer:** Eibe Play Ltd

**Risk Level:** L - Low Risk  
**Surface:** Tarmac

**Finding:** There is surface corrosion / rust present on the item

**Action:** Consider treating the item

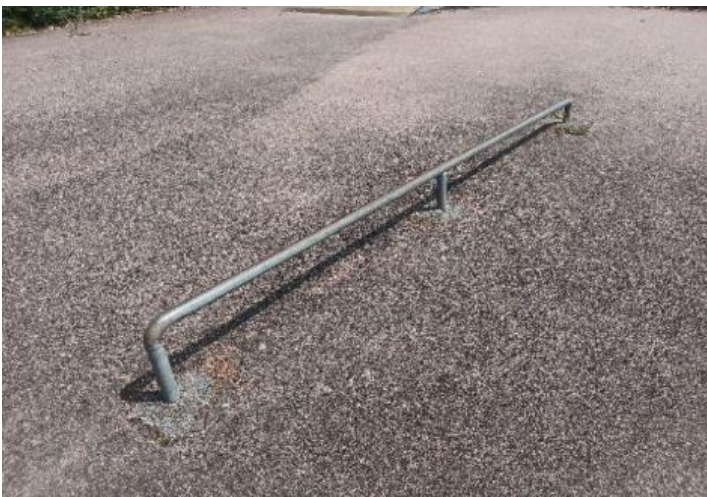
**Item:** Wheeled Sports - Grind Rail  
**Manufacturer:** Eibe Play Ltd

**Risk Level:** L - Low Risk  
**Surface:** Tarmac

**Finding:** There is surface corrosion / rust present on the item

**Action:** Consider treating the item

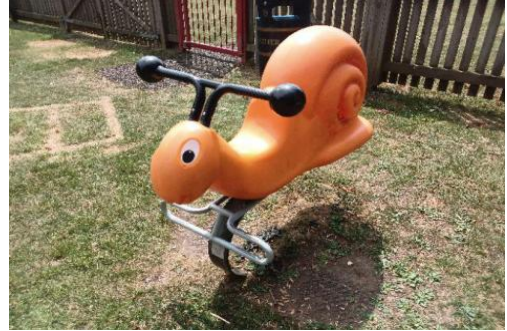
**Item:** Spring Snail  
**Manufacturer:** Miracle Recreation Equipment Company  
**Surface Type:** Grass Matrix Tiles  
**Item Quantity:** 1

A number of fixing(s) have worked loose - Secure all loose fixings

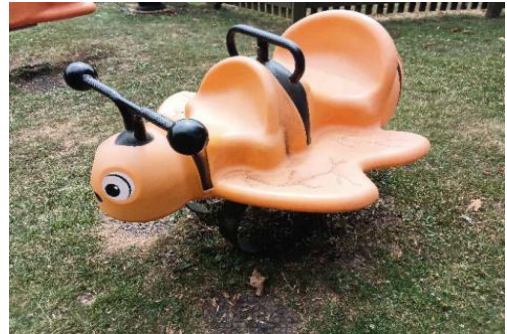
**Item:** Spring Bee  
**Manufacturer:** Miracle Recreation Equipment Company  
**Surface Type:** Grass Matrix Tiles  
**Item Quantity:** 1

A number of fixing(s) have worked loose - Secure all loose fixings

There is or are fixings missing on the item - Replace all missing fixings

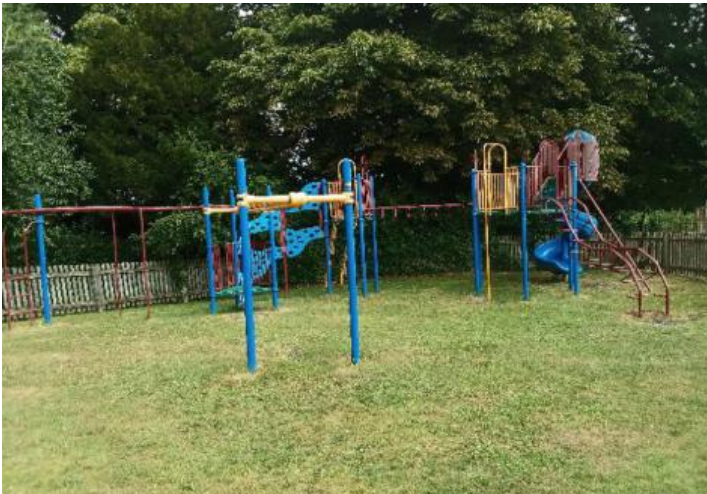
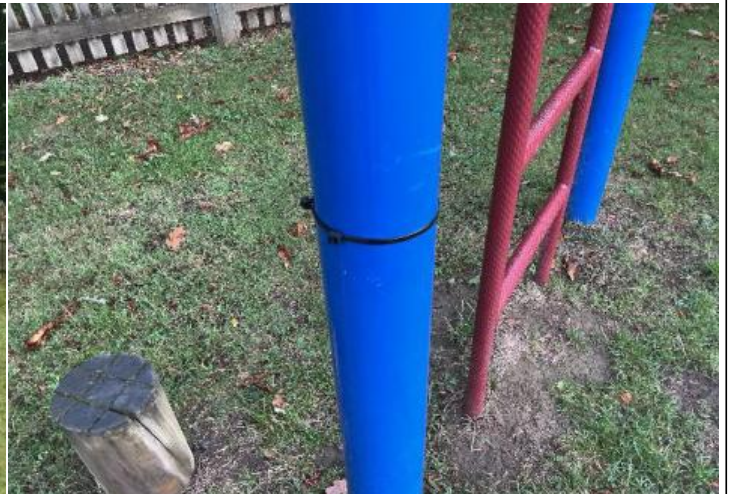
**Item:** Activity Equipment - Multi Play (Senior)  
**Manufacturer:** Miracle Recreation Equipment Company

**Risk Level:** L - Low Risk  
**Surface:** Grass Matrix Tiles

**Finding:** Cable tie around post has been cut leaving sharp edges

**Action:** Remove cable tie

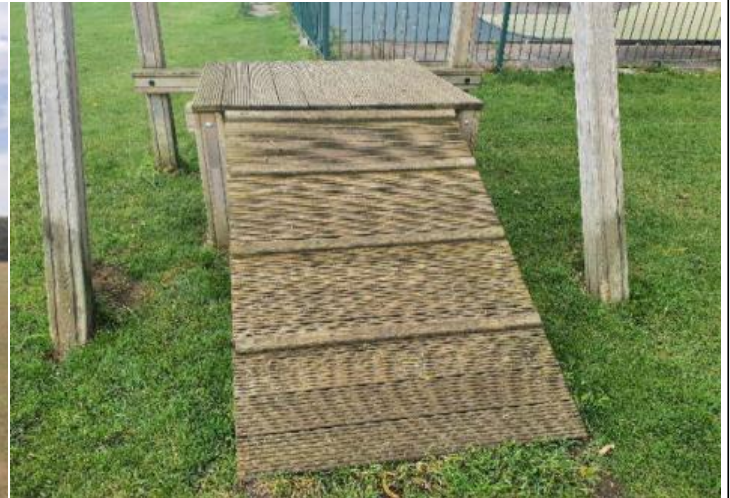
**Item:** Other - Cable Runway  
**Manufacturer:** Fenland Leisure Products

**Risk Level:** L - Low Risk  
**Surface:** Grass Matrix Tiles

**Finding:** There is algae or moss on the surface of the equipment

**Action:** Clean and treat appropriately
