## **Play Area Inspection Reports & Remedial Work**

### Playground Maintenance Estimate for Three Site Remedials

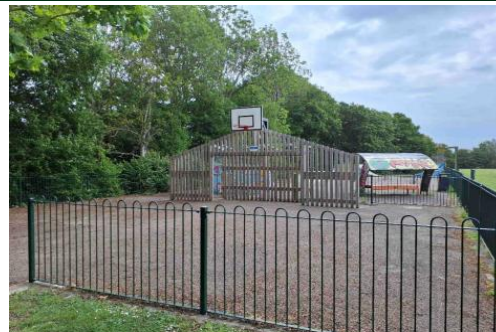
There is moderate damage to the surface - Repair the damaged areas of surfacing

The concrete at site entrance is damaged creating a trip hazard - Repair

The concrete foundation around the goal structure is lifting - Repair

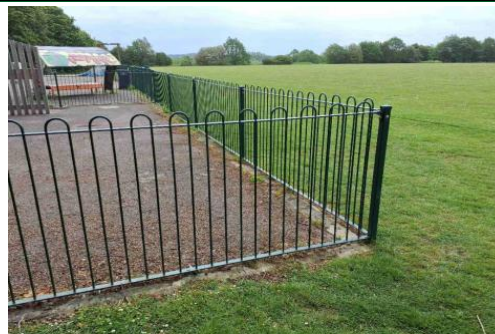
There are a number of fixings missing from the fence - Replace missing fixings

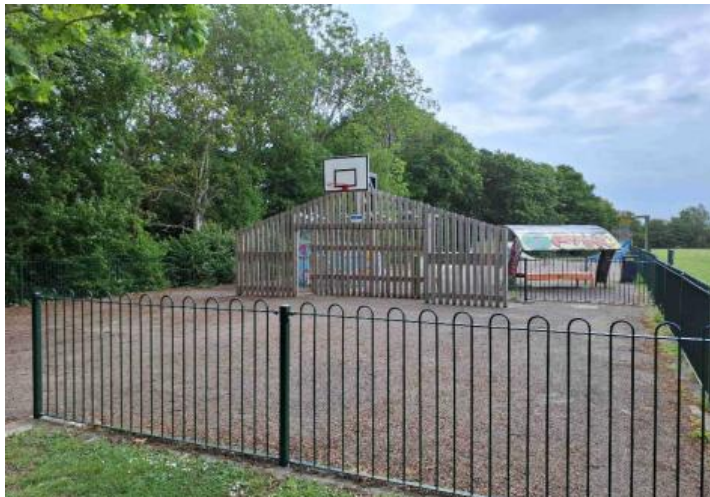
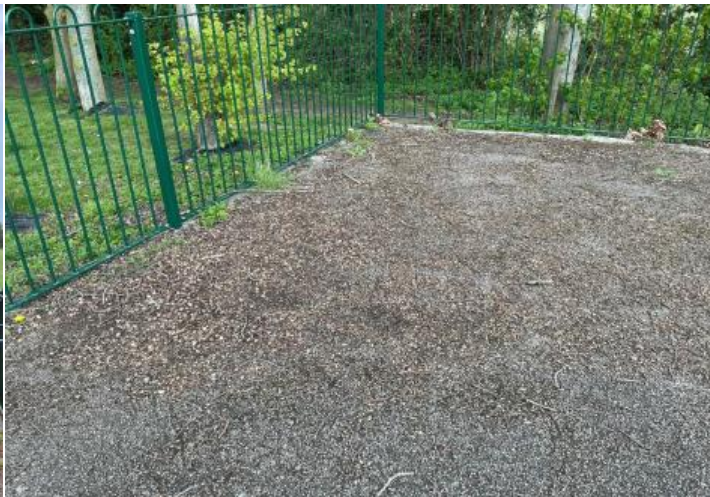
**Finding:** There is some tree debris on the surfacing

**Finding:** The concrete at site entrance is damaged creating a trip hazard

**Action:** Remove and maintain

**Action:** Repair

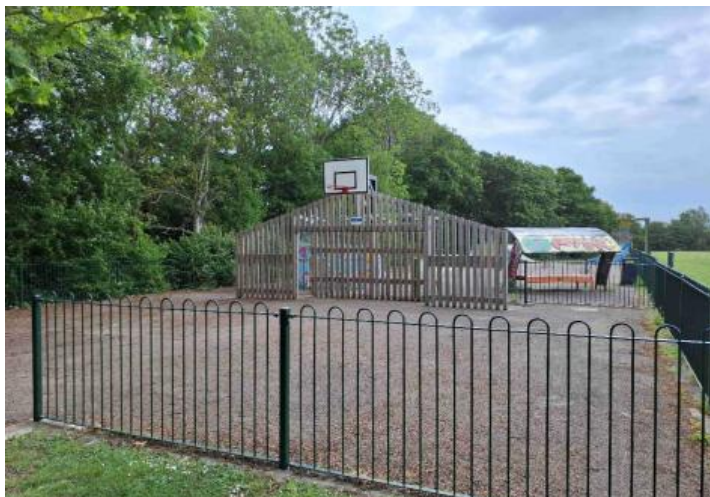
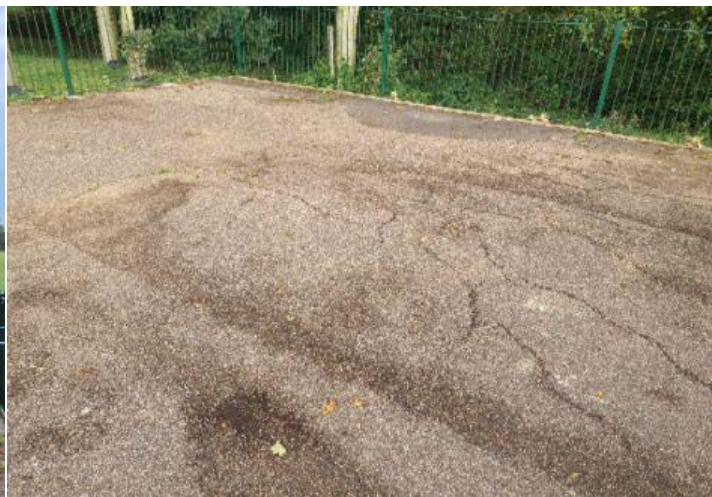
**Finding:** There is moderate damage to the surface

**Finding:** The concrete foundation around the goal structure is lifting

**Action:** Repair the damaged areas of surfacing

**Action:** Repair

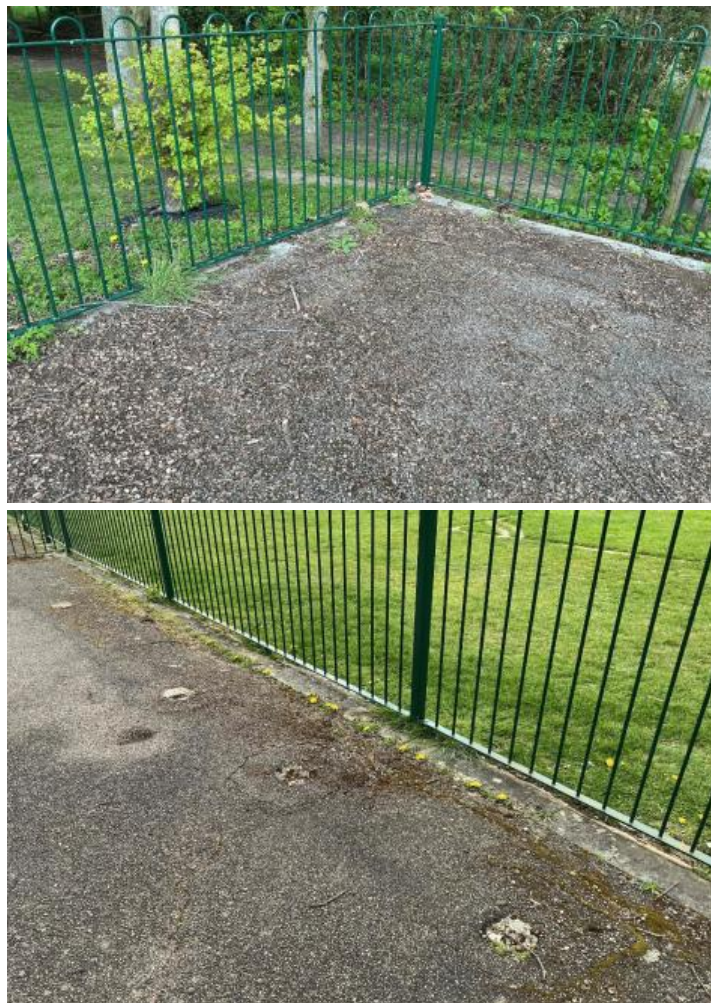
**Finding:** There is weed / vegetation growth on, between, or around the edges of the surfacing  
**Action:** Remove weed / vegetation growth

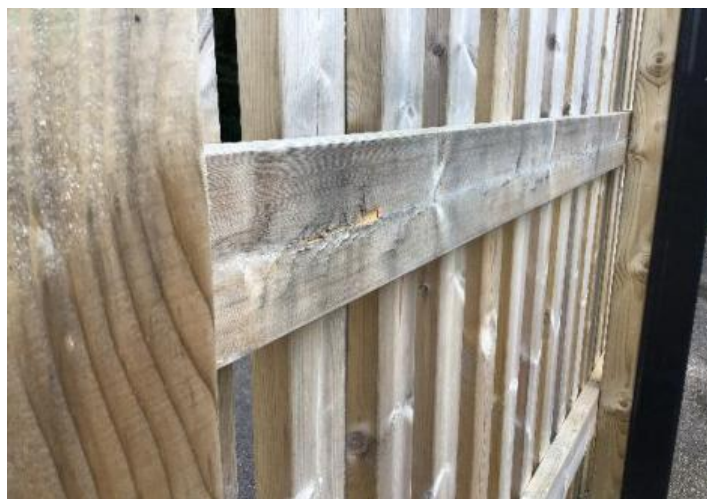
**i** 6 - Low Risk (Finding 2)

**Finding:** Parts of the timber are rough or splintered

**Action:** Remove all rough or sharp edges

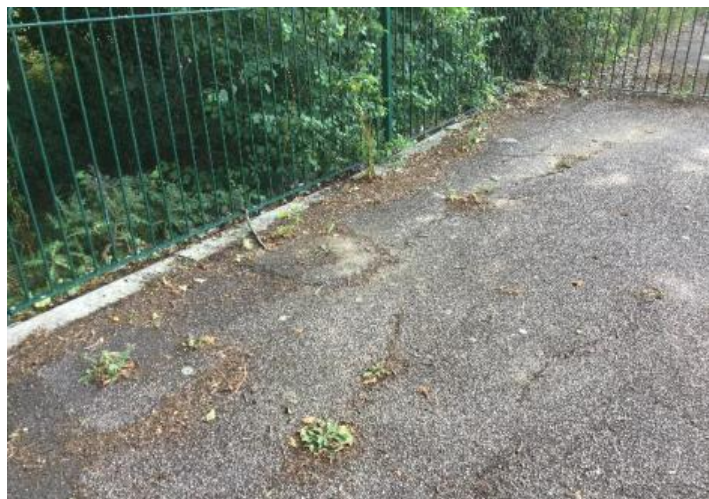
**i** 8 - Low Risk (Finding 3)

**Finding:** There is algae, silt or moss growth on the surface resulting in slippery conditions

**Action:** Clean and treat appropriately

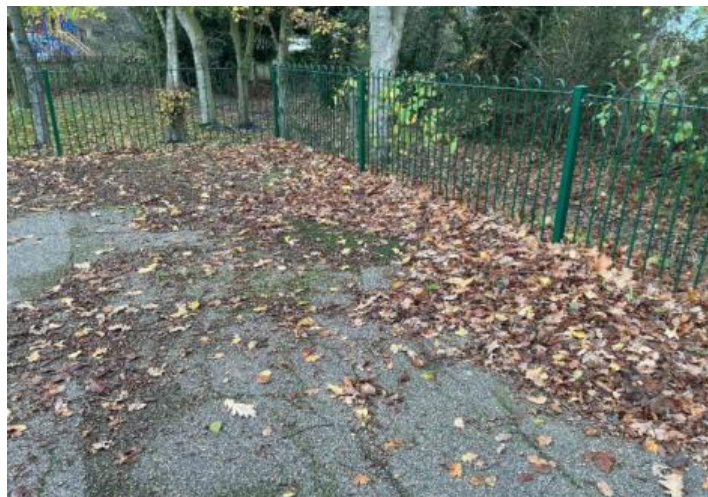
**i** 6 - Low Risk (Finding 4)

**Finding:** There is some tree debris on the surfacing

**Action:** Remove and maintain

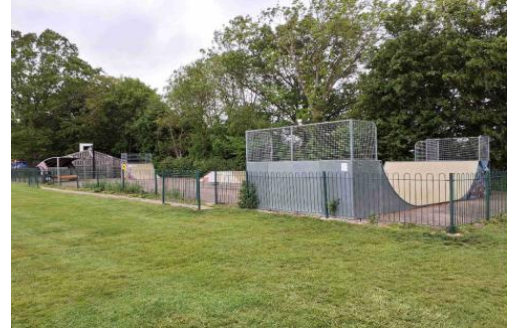
There is root damage to the surfacing creating unforeseen changes in levels - Repair the damaged areas of tarmac to provide a uniform surface

There is some damage apparent to the riding surface - Monitor for any further deterioration and repair as required

There is algae, silt or moss growth on the surface resulting in slippery conditions - Clean and treat appropriately

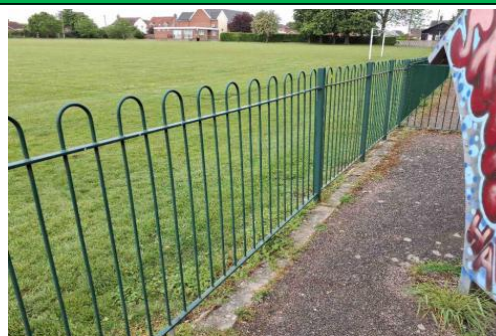
There is some damage to the fence sections - Monitor for any further deterioration and repair as required

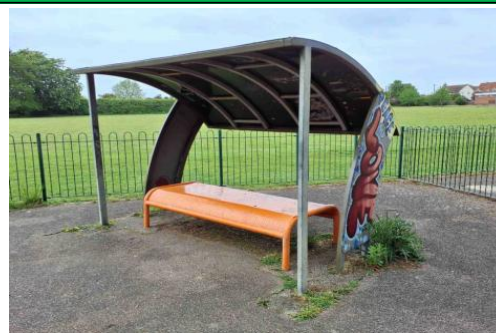
The item has been damaged leaving sharp edges - Repair item

A number of fixing(s) have worked loose - Secure all loose fixings

There is algae, silt or moss growth on the surface resulting in slippery conditions - Clean and treat appropriately

There is surface corrosion / rust present on the item - Consider treating the item

Pop rivet fixings have failed on the seat - Replace the failed pop rivets

There is some evidence of fire damage to the item - Monitor for any further deterioration and repair as required

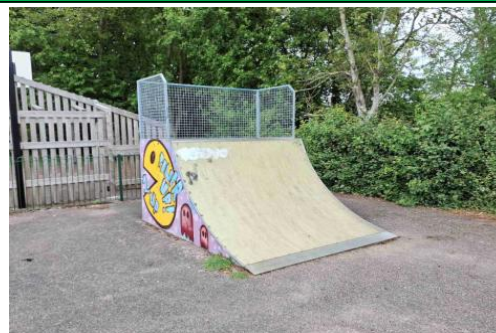
Minor damage to surface - Monitor for deterioration

The item has been damaged - Monitor for any further deterioration and replace as required

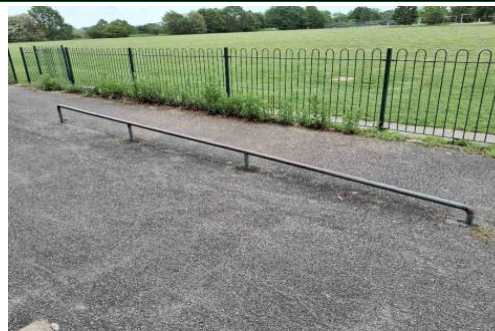
There is surface corrosion / rust present on the item - Consider treating the item

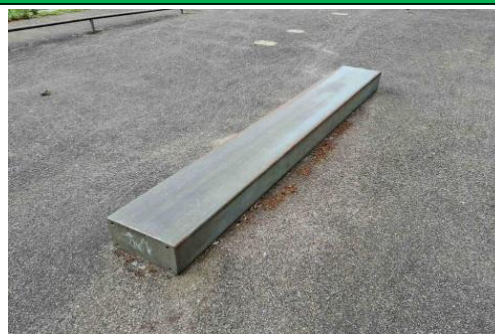
There is surface corrosion / rust present on the item - Consider treating the item

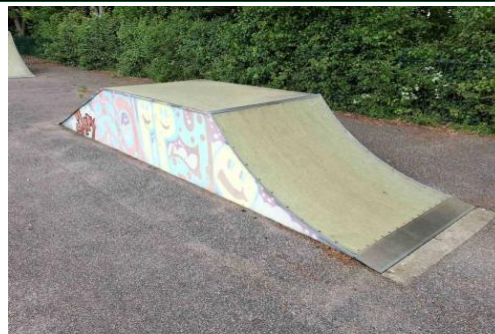
The riding surface has minor damage apparent - Monitor for any further deterioration and repair as required

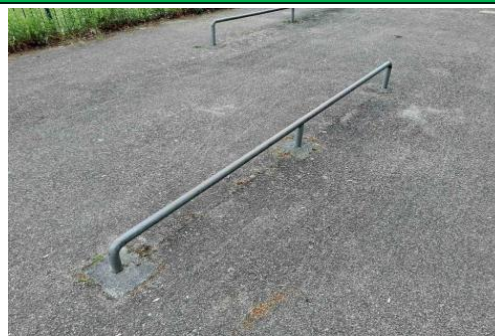
There is surface corrosion / rust present on the item - Consider treating the item

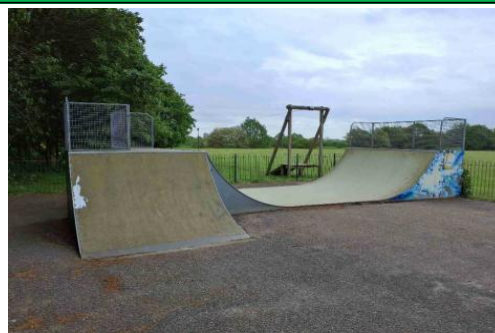
There is offensive graffiti present - Remove as soon as practicable

There is some damage to the fence sections - Monitor for any further deterioration and repair as required

A number of fixing(s) have worked loose - Secure all loose fixings

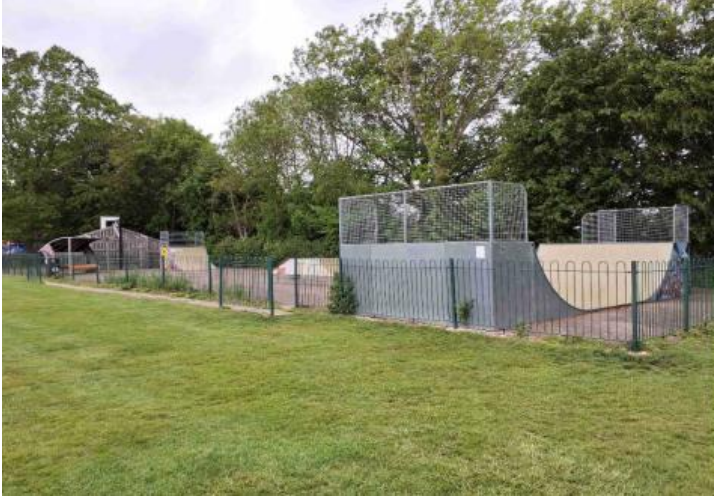
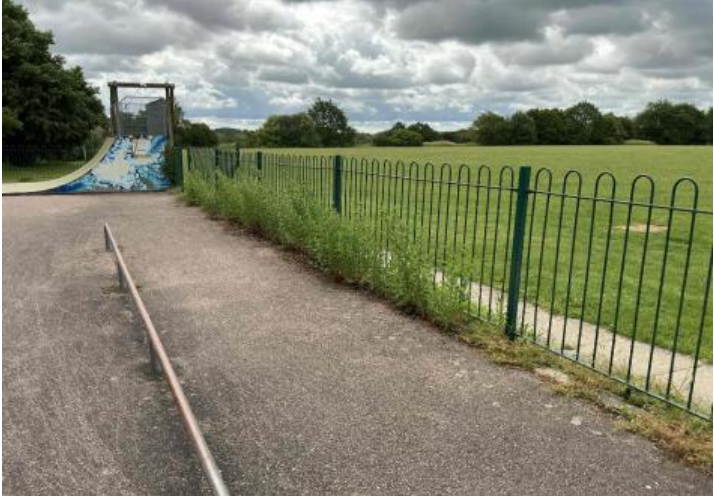
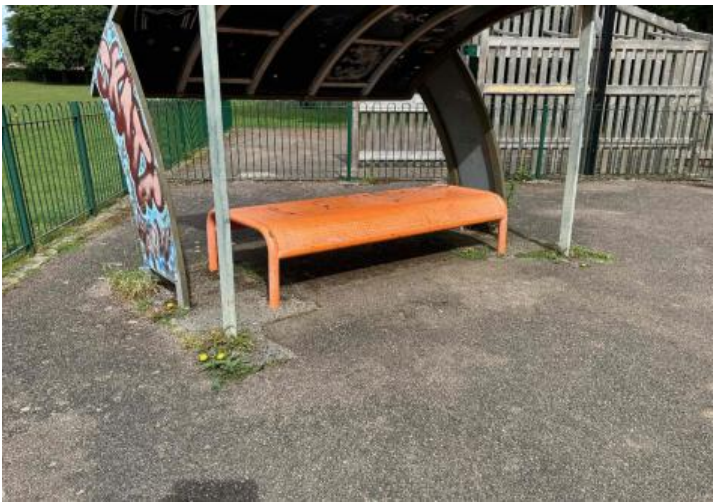
| <div> <div> <div></div> <div>6 - Low Risk (Finding 2)</div> </div> </div> | | | |
|---|---|---|---|
| <div> <b>Finding:</b> There is weed / vegetation growth on, between, or around the edges of the surfacing </div> | | <div> <b>Action:</b> Remove weed / vegetation growth </div> | |

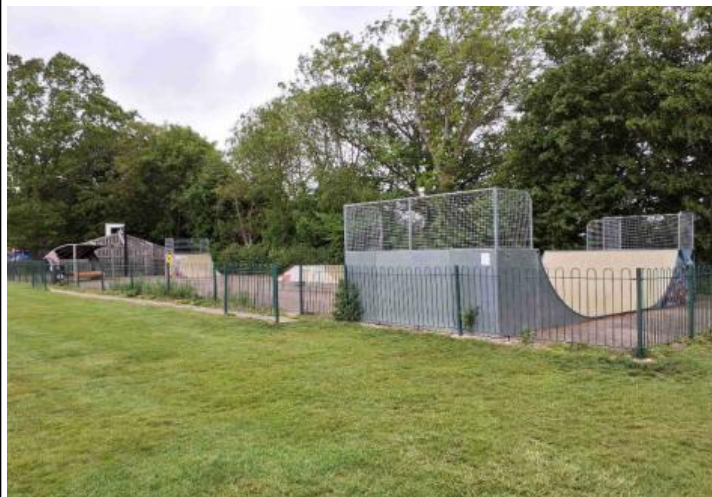
**Finding:** There is algae, silt or moss growth on the surface resulting in slippery conditions

**Action:** Clean and treat appropriately

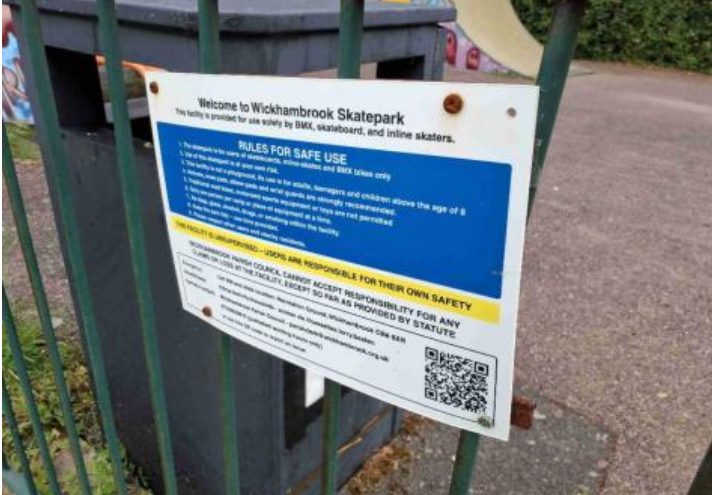
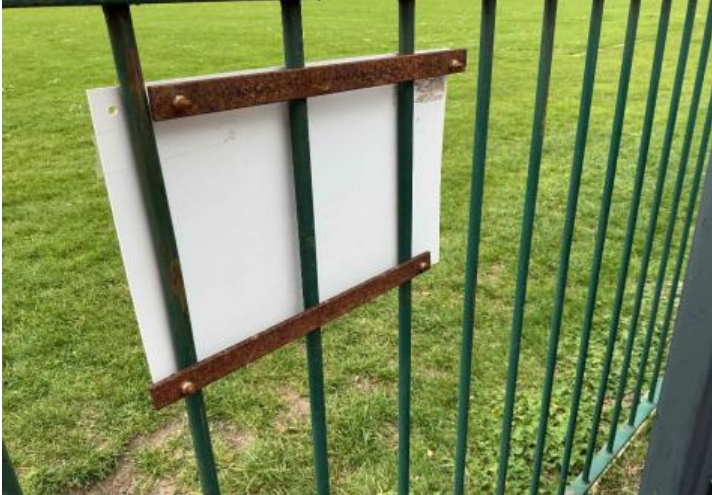
| <b>Finding:</b> There are projecting bolt thread(s) present | | <b>Action:</b> Remove excess thread length and deburr or provide cap | |

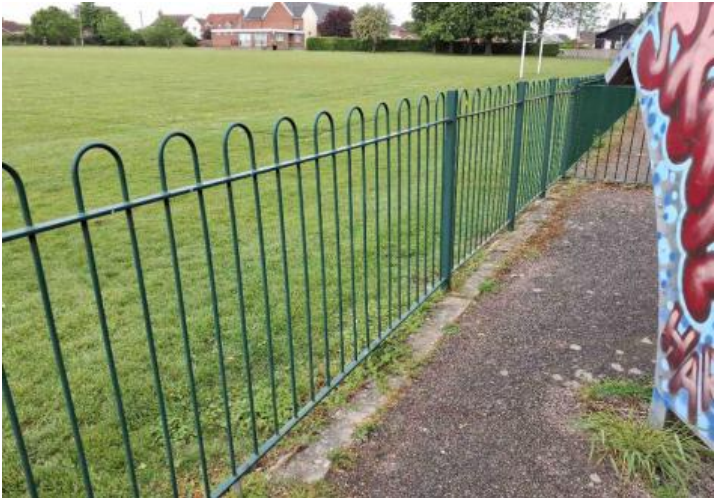
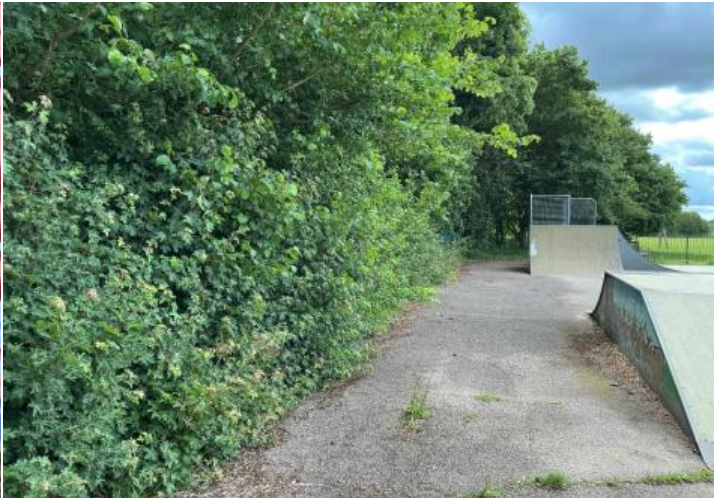
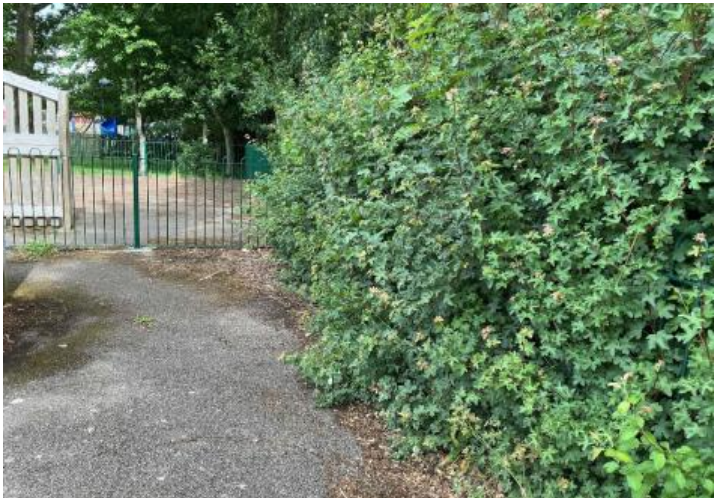
| <div> <div></div> <div>6 - Low Risk (Finding 2)</div> </div> | | | |
|---|--|---|--|
| <div>Finding: The adjacent foliage is overhanging</div> | | <div>Action: Cut back and maintain</div> | |

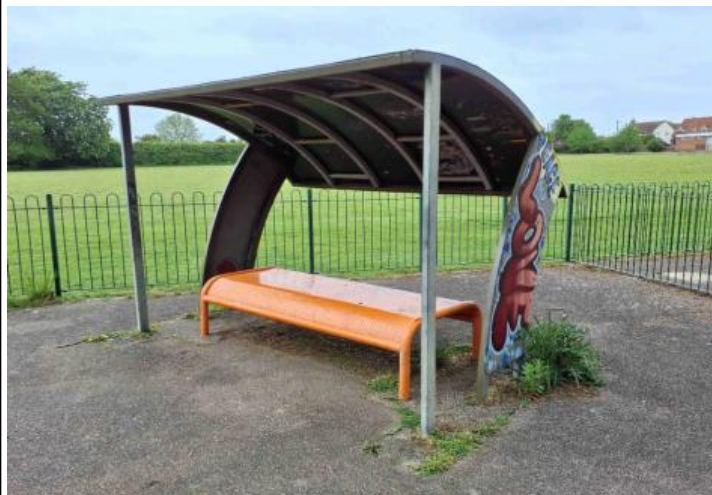
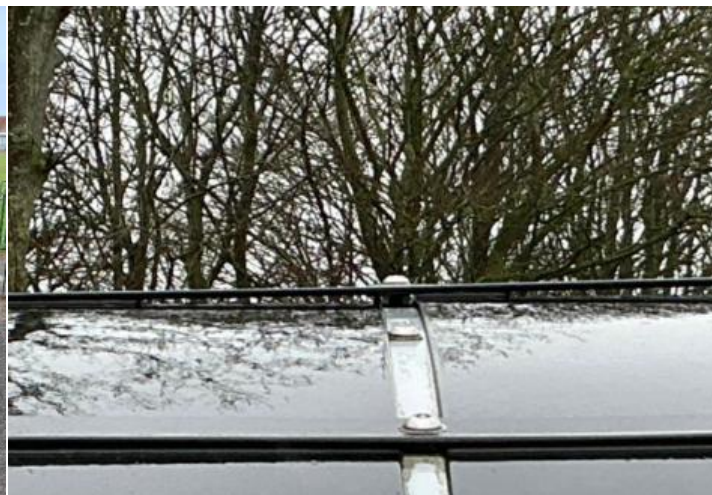
**Finding:** A number of fixing(s) have worked loose

**Action:** Secure all loose fixings

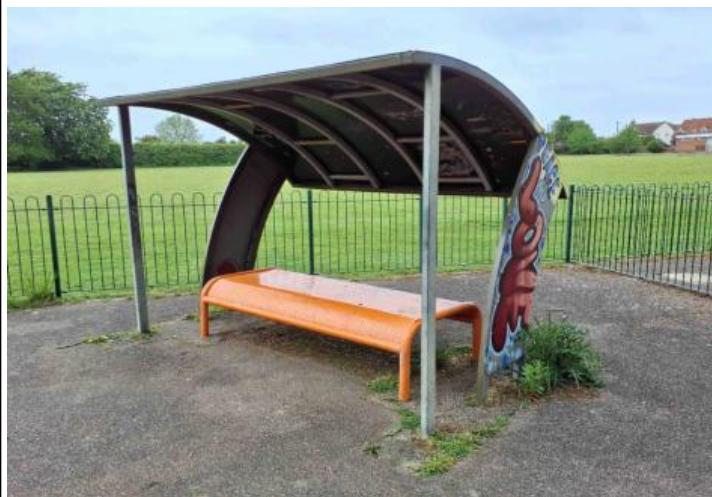
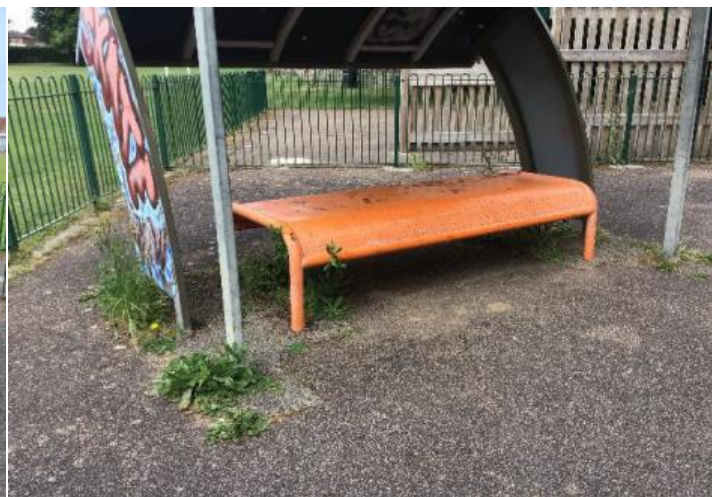
**Finding:** There is weed / vegetation growth within the surface

**Action:** Remove weed / vegetation growth

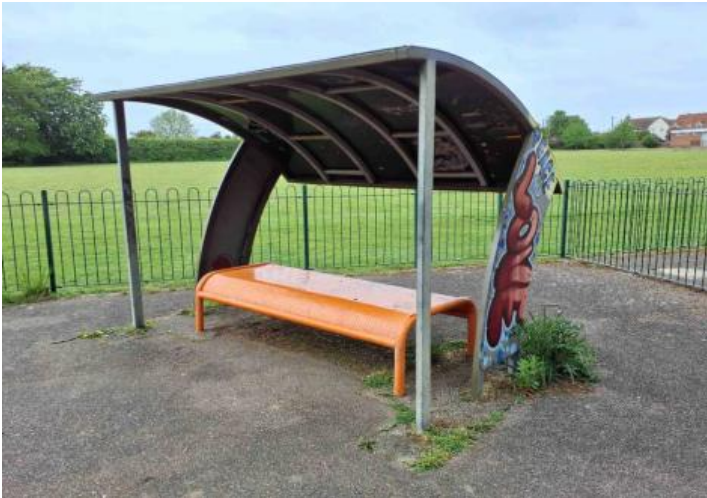
**Finding:** There is algae, silt or moss growth on the surface resulting in slippery conditions

**Action:** Clean and treat appropriately

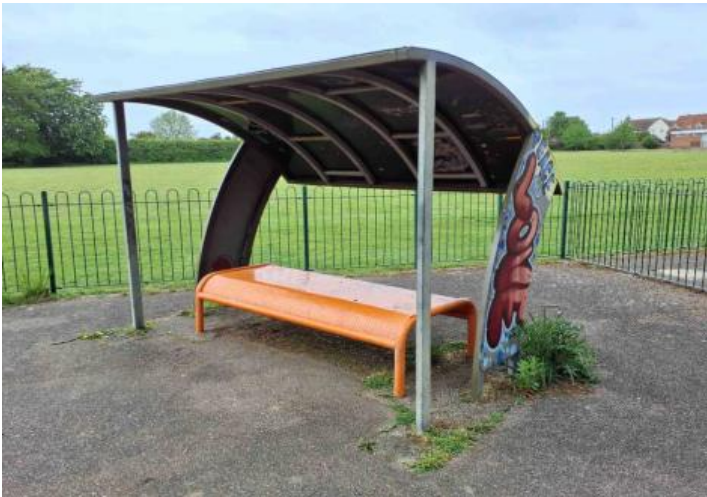
**Finding:** There is some evidence of fire damage to the item

**Action:** Monitor for any further deterioration and repair as required

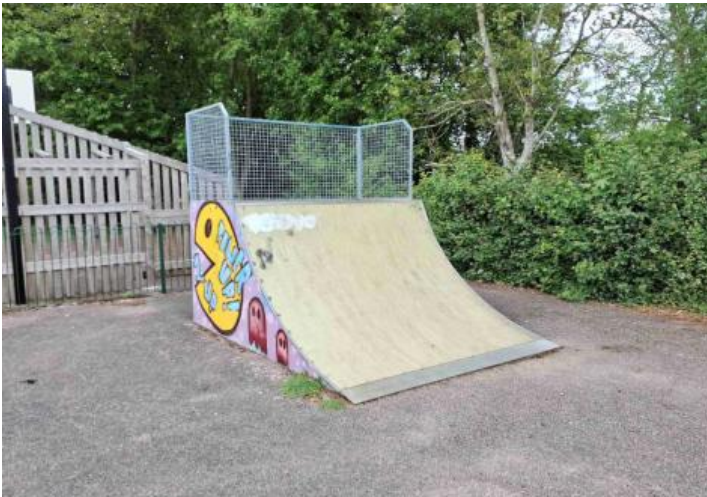
**Finding:** Minor damage to surface

**Action:** Monitor for deterioration

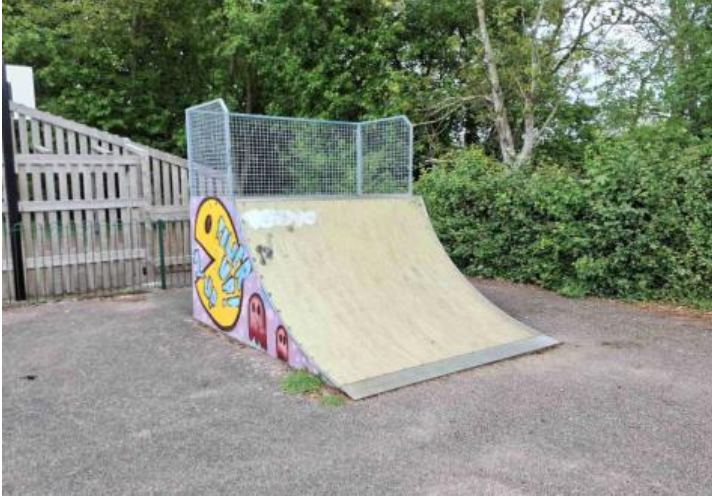
| <div> 6 - Low Risk (Finding 2) </div> | | | |
|---|--|---|--|
| | | <b>Finding:</b> The item has been damaged | |

| <div> 6 - Low Risk (Finding 2) </div> | | | |
|---|--|---|--|
| | | <b>Action:</b> Monitor for any further deterioration and replace as required | |

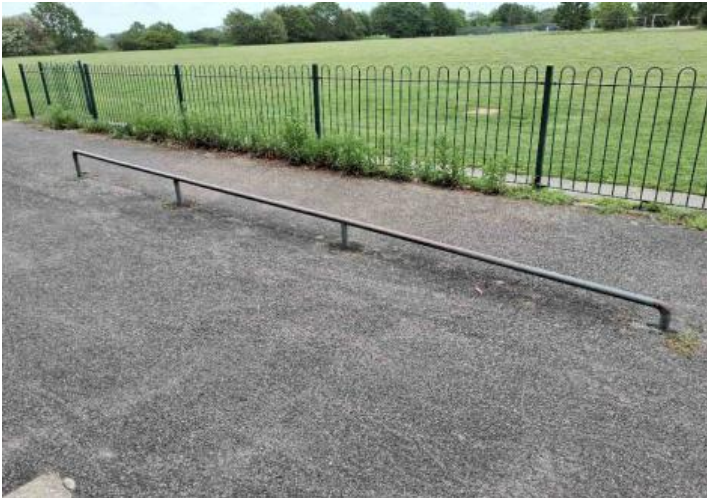
**Finding:** There is surface corrosion / rust present on the item

**Action:** Consider treating the item

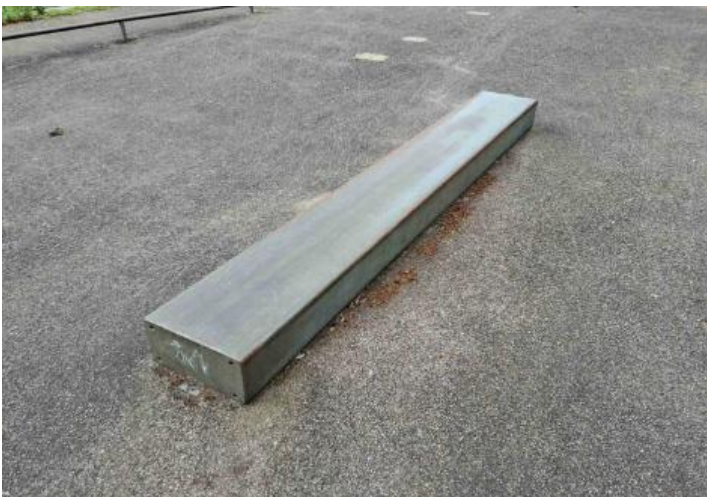
**Finding:** There is surface corrosion / rust present on the item

**Action:** Consider treating the item

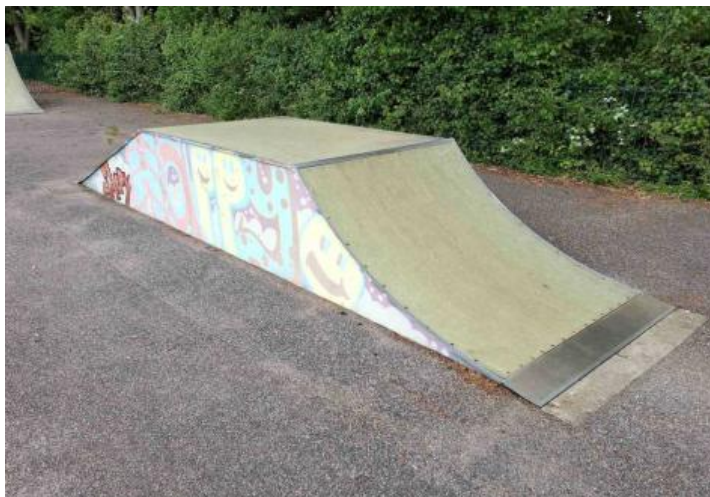
**Finding:** The riding surface has minor damage apparent

**Action:** Monitor for any further deterioration and repair as required

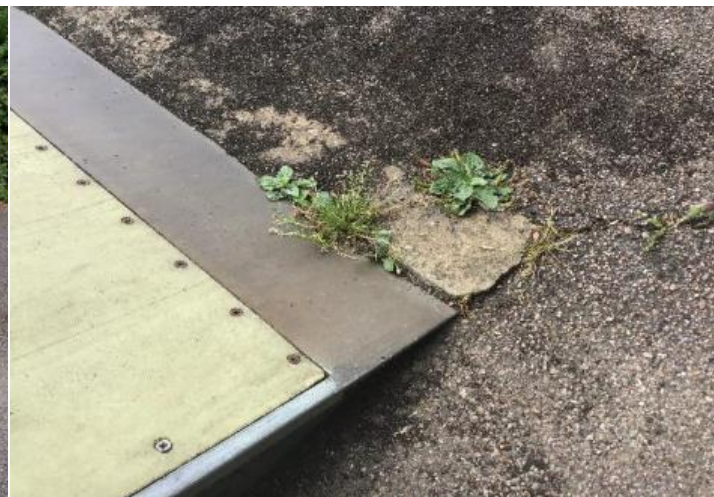
**Finding:** Concrete is lifting at the front of the ramp

**Action:** Remove and reinstate concrete (level)

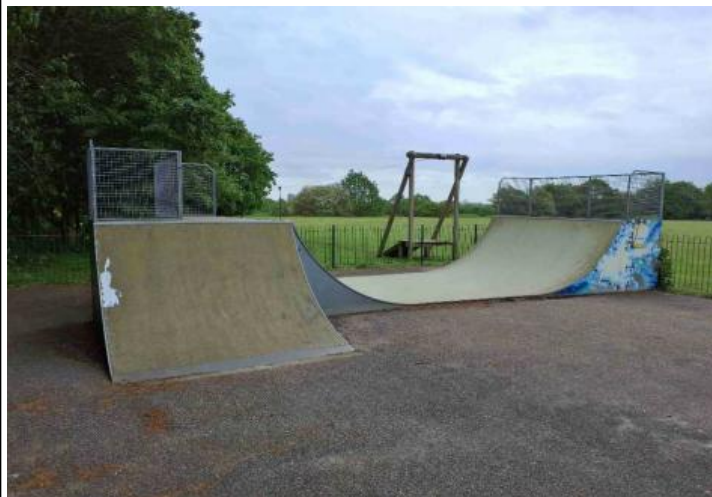
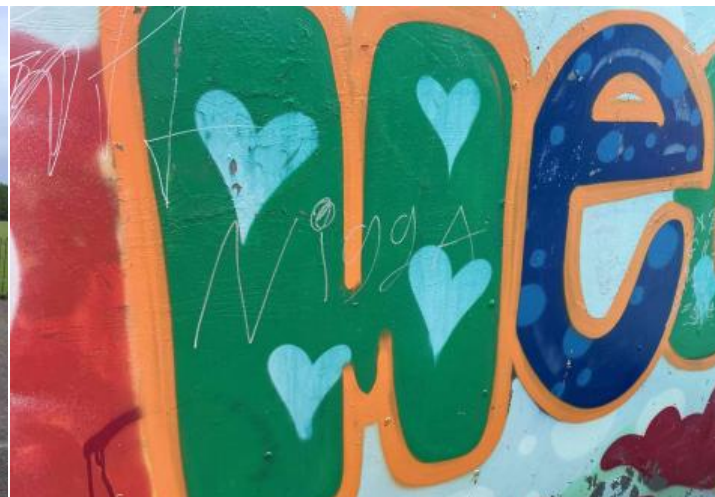
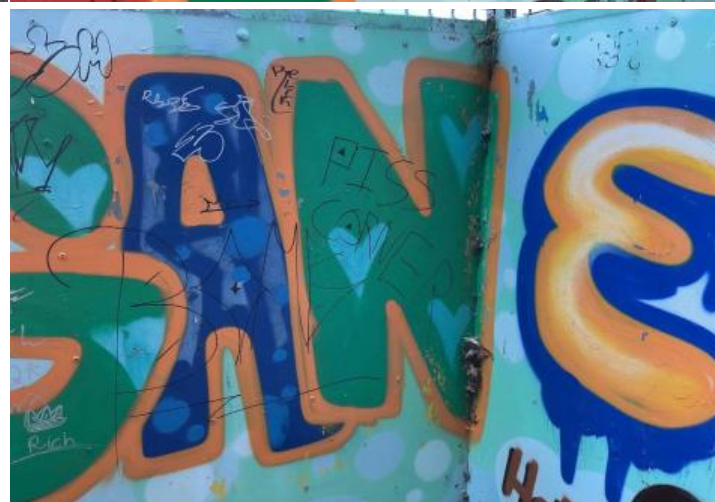
**Finding:** There is offensive graffiti present

**Action:** Remove as soon as practicable

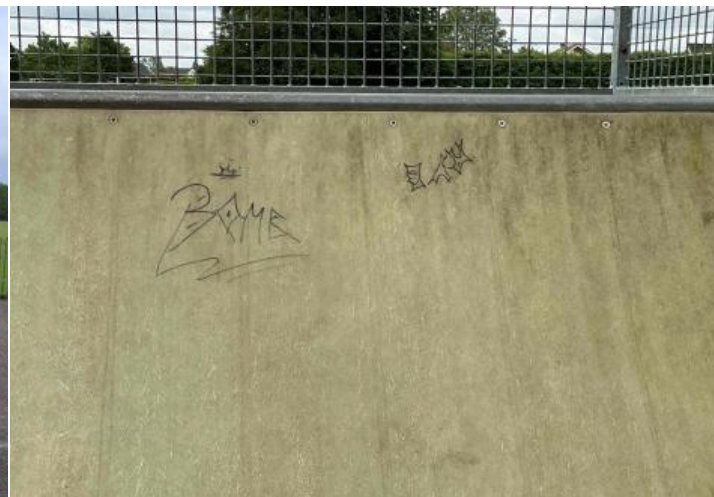
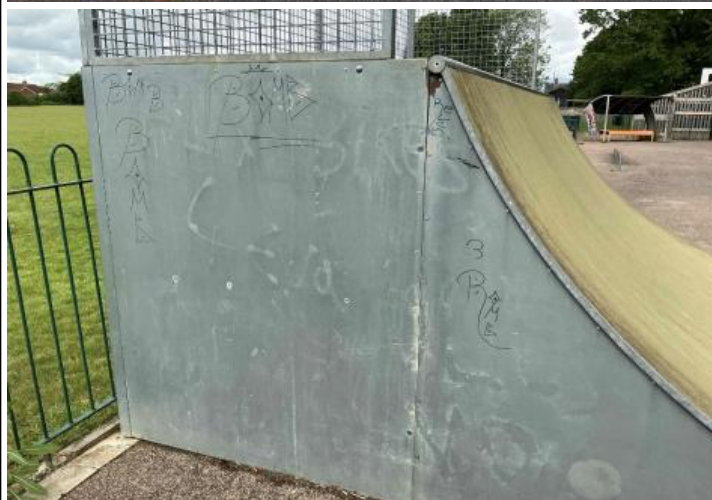
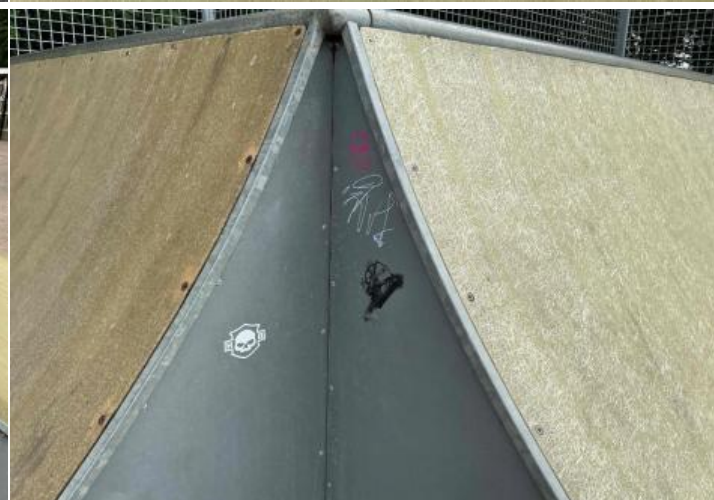
**Finding:** There is some graffiti present

**Action:** Remove the graffiti

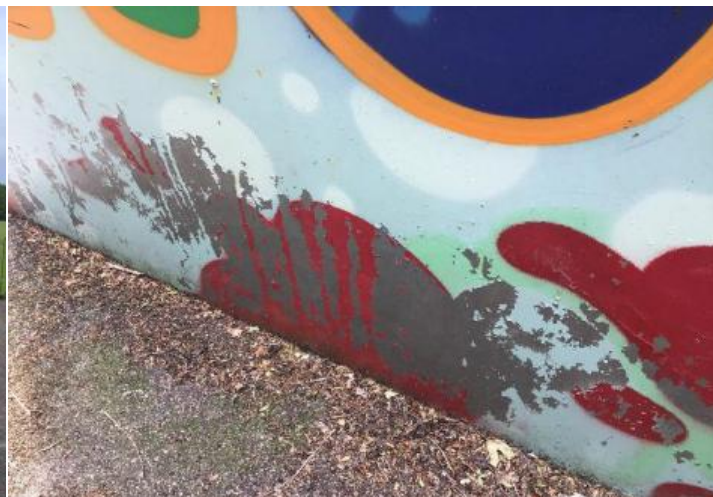
**Finding:** The paint is flaking off the metalwork

**Action:** Rub down and re-paint

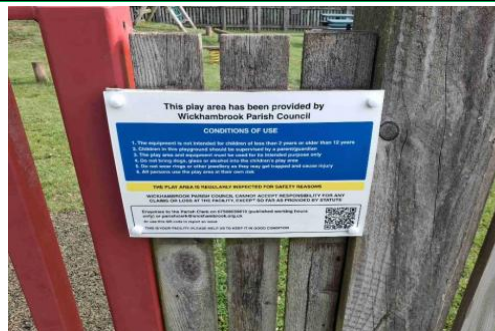
There are projecting bolt thread(s) present - Remove excess thread length and deburr or provide cap

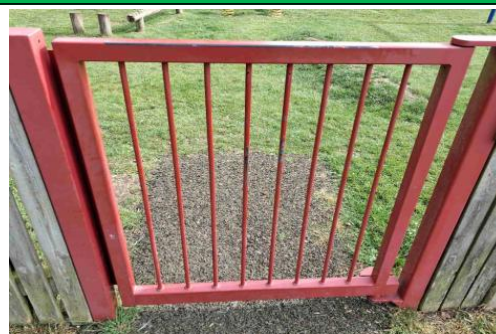
The paint is flaking off the metalwork - Rub down and re-paint

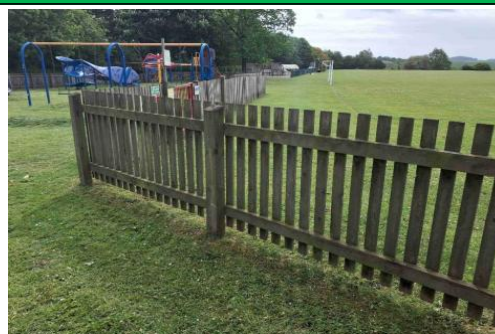
Parts of the timber are rough or splintered - Remove all rough or sharp edges

There are a number of fixings missing from the fence - Replace missing fixings

There is some strimmer / machinery damage apparent on the posts, this can penetrate the preservative applied to the timber and accelerate the rotting process - Monitor for any deterioration (rot) and replace as required

Slats damaged - Replace damaged slat

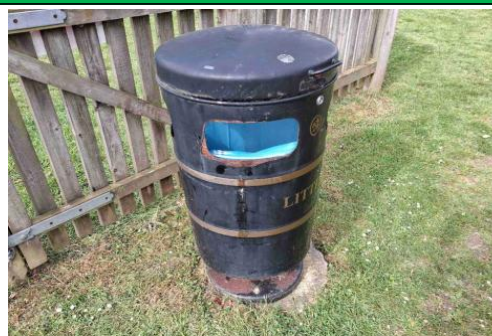
The paintwork on this item has been damaged or worn exposing the metal underneath which is rusting / corroding -  
Treat affected areas and repaint

The foundation is loose - Reinstate the foundation

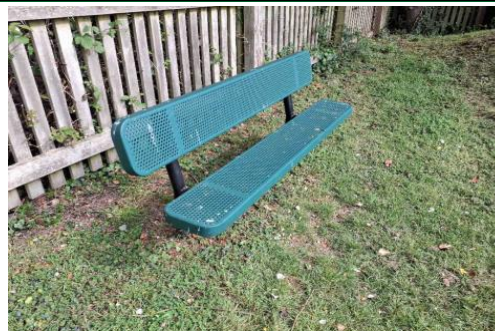
A number of fixing(s) have worked loose - Secure all loose fixings

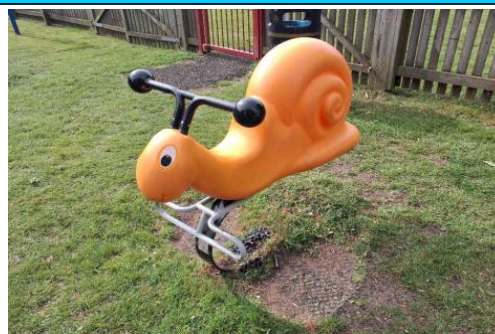
A number of fixing(s) have worked loose - Secure all loose fixings

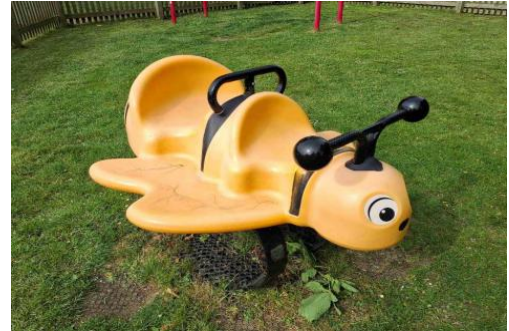
There is or are fixings missing on the item - Replace all missing fixings

A number of fixing(s) have worked loose - Secure all loose fixings

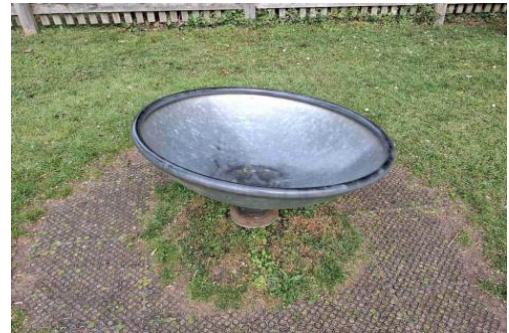
**Item:** Dish Roundabout  
**Manufacturer:** Sutcliffe Play Limited  
**Surface Type:** Grass Matrix Tiles  
**Item Quantity:** 1

The grass mats are silted up, the soil is compacted and the area will become very slippery when the soil is wet. - Reinstate as required

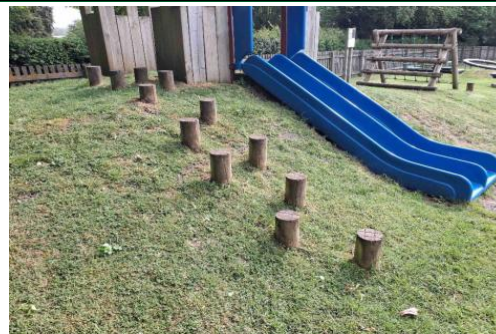
**Item:** Stepping Posts Timber  
**Manufacturer:** Playworld Systems (Europe) Ltd  
**Surface Type:** Grass Matrix Tiles  
**Item Quantity:** 1

There is some strimmer / machinery damage apparent on the posts, this can penetrate the preservative applied to the timber and accelerate the rotting process - Monitor for any deterioration (rot) and replace as required

The timber has a number of splits/shakes or air cracks and this may affect the stability or allow water ingress which will accelerate the rotting process - Monitor to ensure the splits do not cross through fixing points of the structure and/or cause any instability

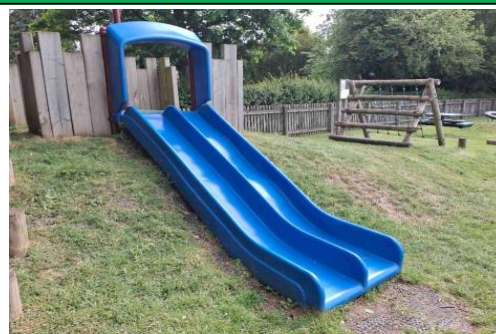
**Item:** Embankment Slide  
**Manufacturer:** Miracle Recreation Equipment Company  
**Surface Type:** Grass Matrix Tiles  
**Item Quantity:** 1

There are trip hazards at the edges of the surface - Reinstate surrounding surface levels to remove the trip points

The surface has eroded in some areas and may be slippery in wet conditions - Reinstate the surface

Some timbers are slightly loose in the foundation - Monitor for deterioration

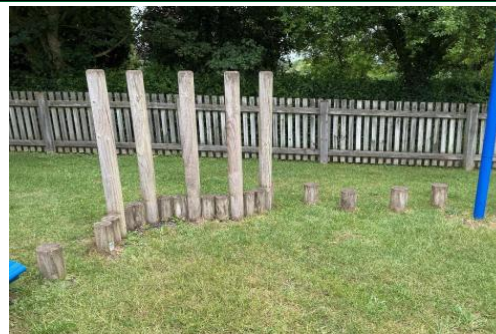
**Item:** Log Walk  
**Manufacturer:** Miracle Recreation Equipment Company  
**Surface Type:** Grass Matrix Tiles  
**Item Quantity:** 1

There is some strimmer / machinery damage apparent on the posts, this can penetrate the preservative applied to the timber and accelerate the rotting process - Monitor for any deterioration (rot) and replace as required

There is some evidence of rot in the timber - Monitor for any further deterioration and replace as required

The timber has a number of splits/shakes or air cracks and this may affect the stability or allow water ingress which will accelerate the rotting process - Monitor to ensure the splits do not cross through fixing points of the structure and/or cause any instability

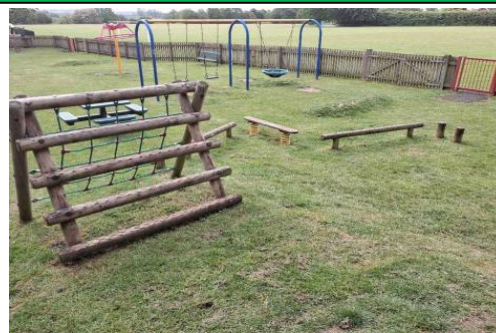
**Item:** Activity Trail  
**Manufacturer:** Miracle Recreation Equipment Company  
**Surface Type:** Grass Matrix Tiles  
**Item Quantity:** 1

A number of fixing(s) have worked loose - Secure all loose fixings

The timber has a number of splits/shakes or air cracks and this may affect the stability or allow water ingress which will accelerate the rotting process - Monitor to ensure the splits do not cross through fixing points of the structure and/or cause any instability

There is some strimmer / machinery damage apparent on the posts, this can penetrate the preservative applied to the timber and accelerate the rotting process - Monitor for any deterioration (rot) and replace as required

There is/are bolt cap covers missing or damaged on the item - Replace missing or damaged bolt cap covers

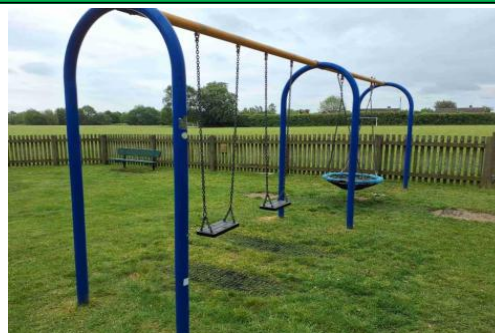
**Item:** 2 Bay 2 Flat 1 Basket Seat  
**Manufacturer:** Miracle Recreation Equipment Company  
**Surface Type:** Grass Matrix Tiles  
**Item Quantity:** 1

The bushes are showing signs of wear - Monitor for any further deterioration and replace as required

The seat has minor damage or wear - Monitor for any further deterioration and replace as required

There is some wear to the shackles - Monitor for any further deterioration and replace when 40% worn

There is/are bolt cap covers missing or damaged on the item - Replace missing or damaged bolt cap covers

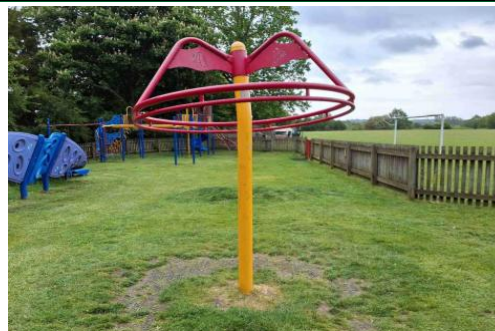
**Item:** Overhead Rotator  
**Manufacturer:** Miracle Recreation Equipment Company  
**Surface Type:** Grass Matrix Tiles  
**Item Quantity:** 1

The paint is flaking off the metalwork - Rub down and re-paint

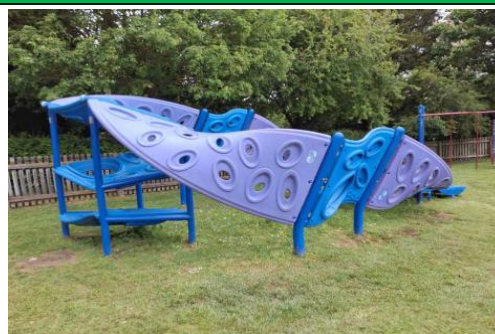
**Item:** Climbing Frame  
**Manufacturer:** Not Identified  
**Surface Type:** Grass Matrix Tiles  
**Item Quantity:** 1

The connecting lugs are showing signs of wear - Monitor for any further deterioration and repair as required

The item has been damaged - Sand down plastic to remove sharp edge

There is surface corrosion / rust present on the item - Consider treating the item

The ropes/nets are worn/damaged in places - Monitor for any further deterioration and repair or replace as required

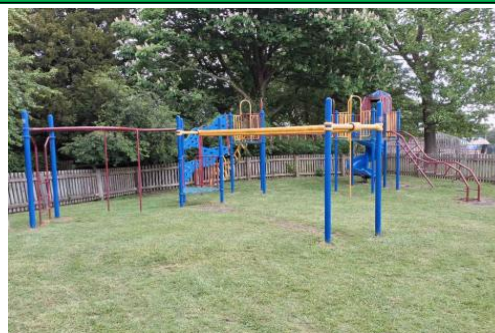
**Item:** Multi Play (Senior)  
**Manufacturer:** Miracle Recreation Equipment Company  
**Surface Type:** Grass Matrix Tiles  
**Item Quantity:** 1

There is some graffiti present - Remove the graffiti

There are a number of dents in the slide surface - Monitor for any further deterioration and repair as required

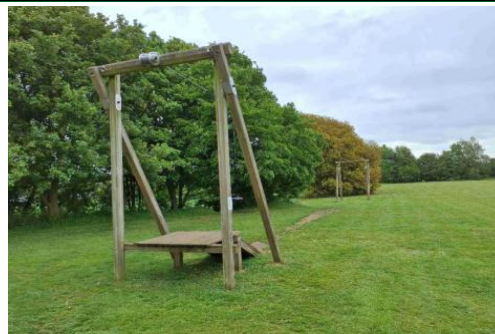
**Item:** Cable Runway  
**Manufacturer:** Fenland Leisure Products  
**Surface Type:** Grass Matrix Tiles  
**Item Quantity:** 1

The adjacent foliage is overhanging - Cut back and maintain

The seat connection cannot be inspected without dismantling the seat - Dismantle the seat to inspect the seat connection for wear

The seat and chain have been removed - Replace

We have completed a visual inspection of the suspension links, cable and fixing points from ground level, however it is not possible to fully inspect these areas without either hiring equipment to gain access or removing the cable and suspension and inspecting at ground level. We recommend that the main cable and fixing security is thoroughly inspected at least in accordance with the manufacturers recommendations to check for wear, damage, security or internal rusting; this will help to ensure the continued safe use of the equipment - Inspect in accordance with the manufacturers recommendations

There is some strimmer / machinery damage apparent on the posts, this can penetrate the preservative applied to the timber and accelerate the rotting process - Monitor for any deterioration (rot) and replace as required

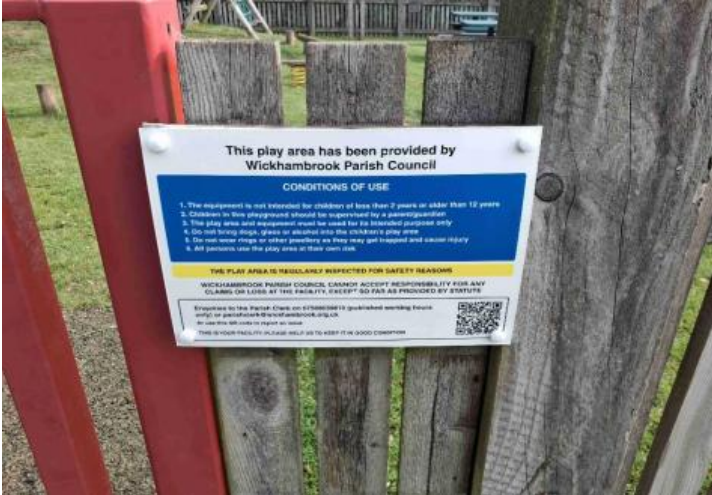
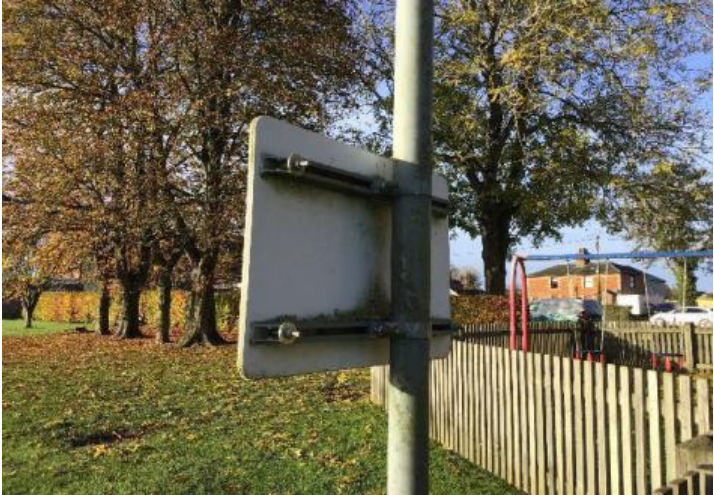
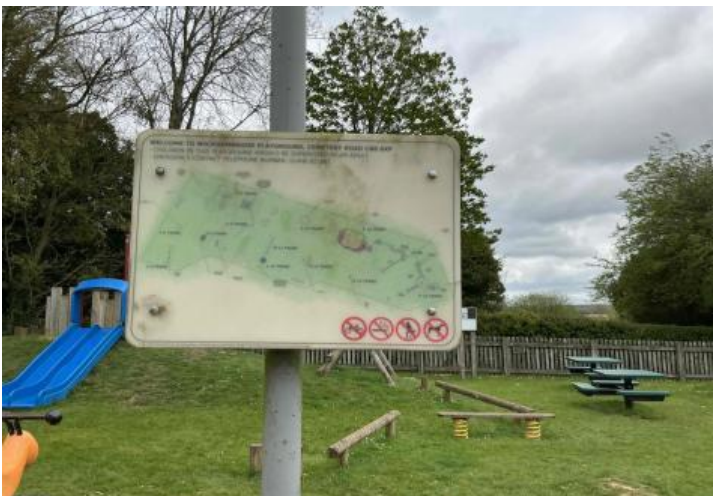
| 8 - Low Risk (Finding 1) | | | |
|---|---|---|---|
| Item: | Ancillary Items - Sign | Risk Level: | L - Low Risk |

| 8 - Low Risk (Finding 1) | | | |
|---|---|---|---|
| <b>Finding:</b> There are projecting bolt thread(s) present | | <b>Action:</b> Remove excess thread length and deburr or provide cap | |

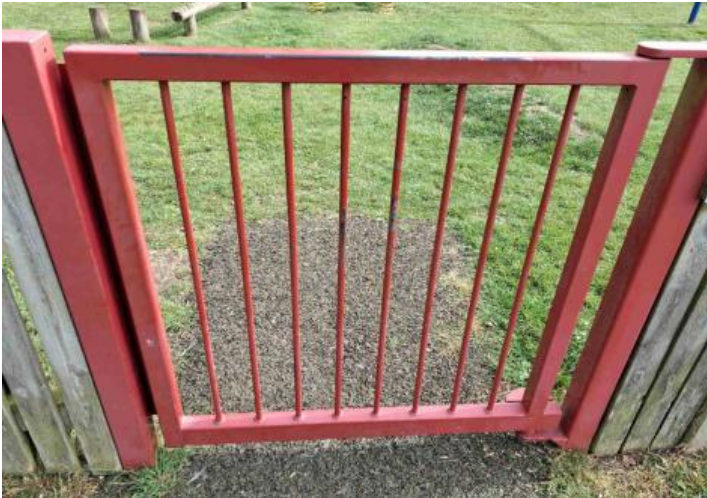
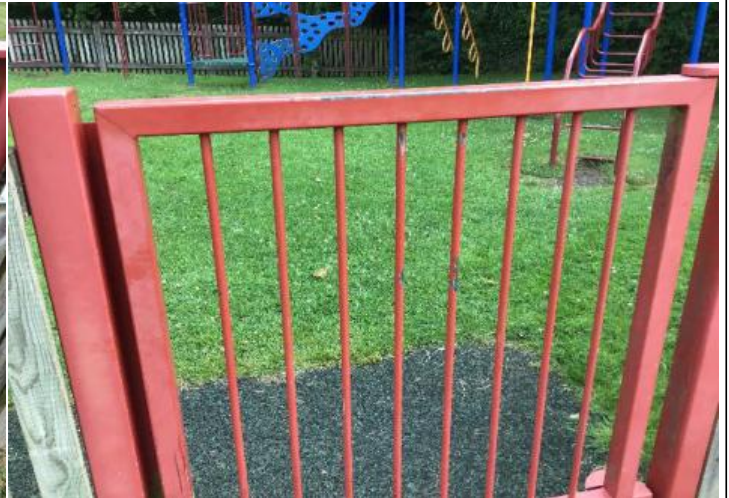
**Item:** Gates - Gate - Self Closing  
**Manufacturer:** Easy Gate Ltd

**Finding:** The paint is flaking off the metalwork

**Action:** Rub down and re-paint
