## **Play Area Inspection Reports & Remedial Work**

### Playground Maintenance Estimate for Three Site Remedials

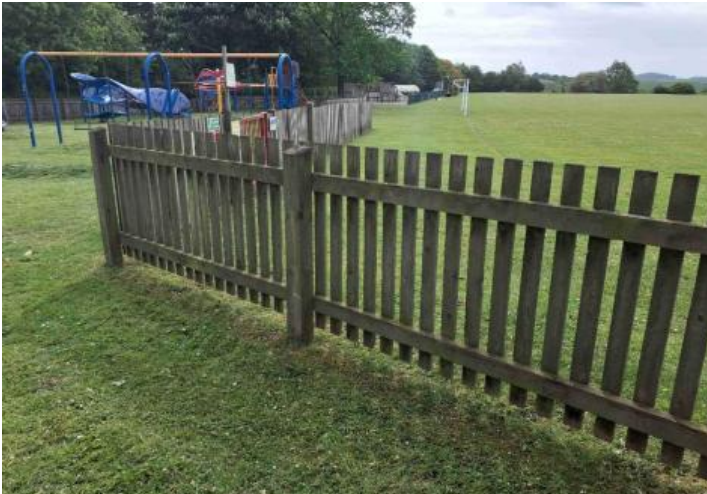
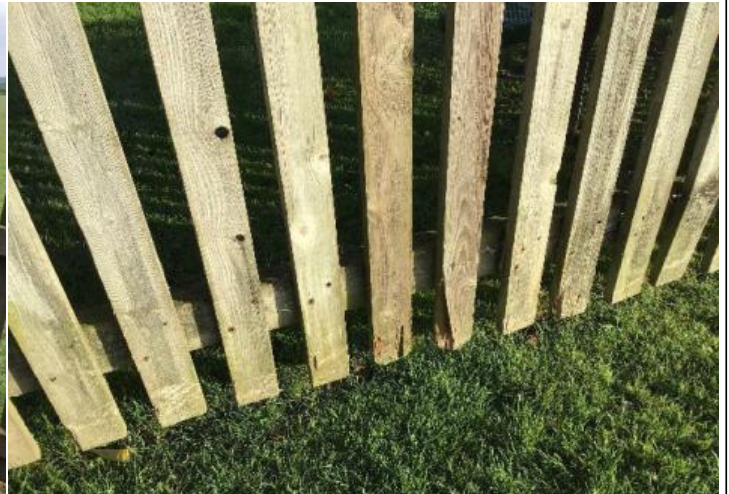
**Item:** Fences - Fencing - Timber  
**Manufacturer:** Not Identified

**Finding:** Parts of the timber are rough or splintered

**Action:** Remove all rough or sharp edges

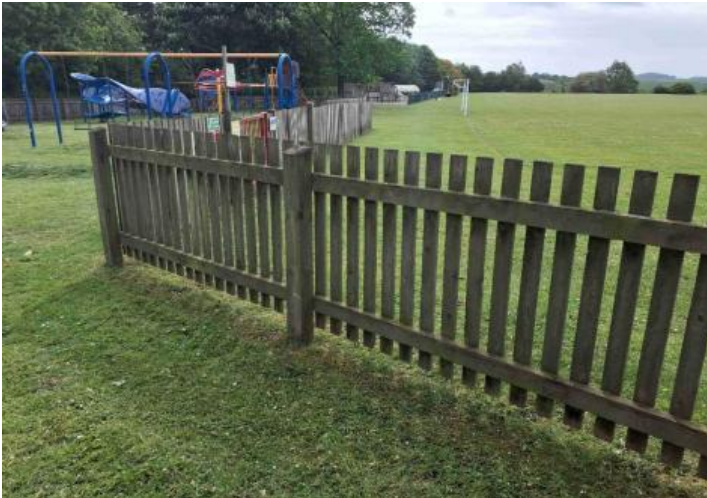
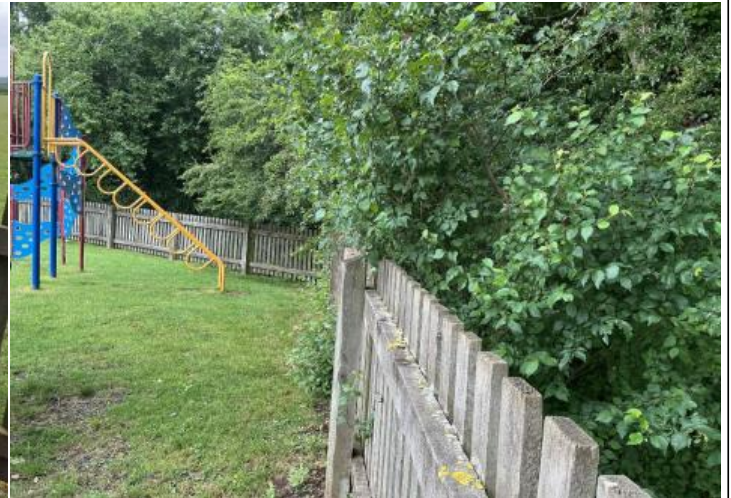
**Item:** Fences - Fencing - Timber  
**Manufacturer:** Not Identified

**Finding:** The adjacent foliage is overhanging

**Action:** Cut back and maintain

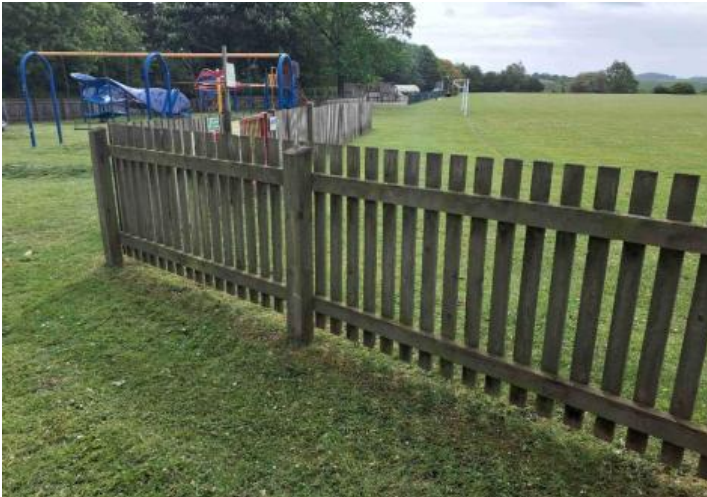
**Item:** Fences - Fencing - Timber  
**Manufacturer:** Not Identified

**Finding:** There are a number of fixings missing from the fence

**Action:** Replace missing fixings

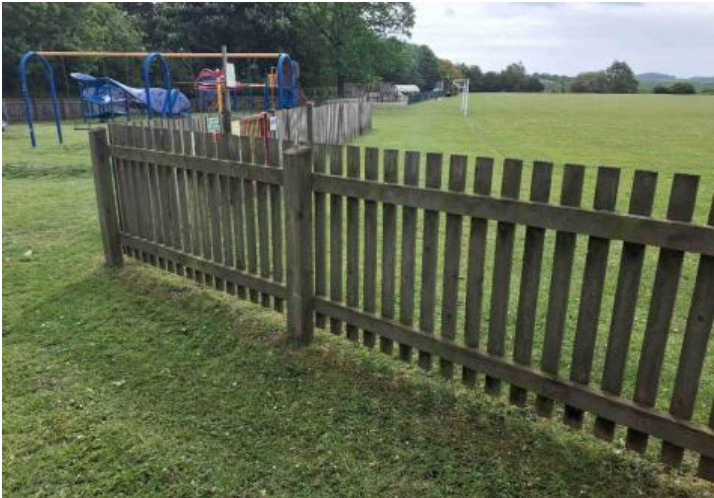
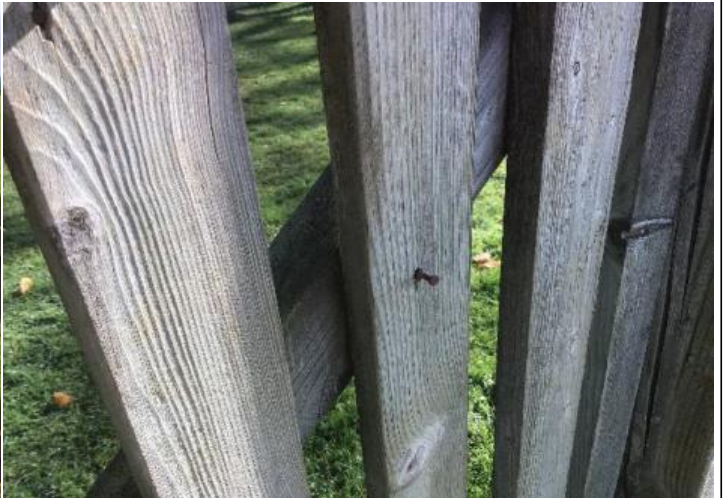
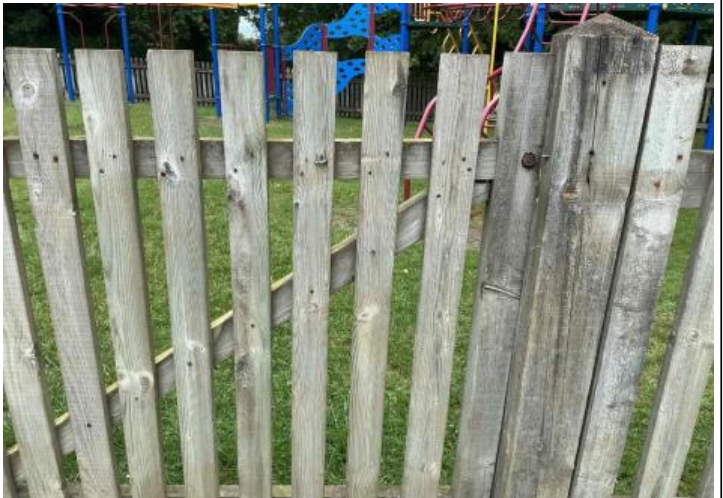
**Item:** Fences - Fencing - Timber  
**Manufacturer:** Not Identified

**Finding:** There are projecting nail ends present

**Action:** Remove and provide more appropriate fixings if required

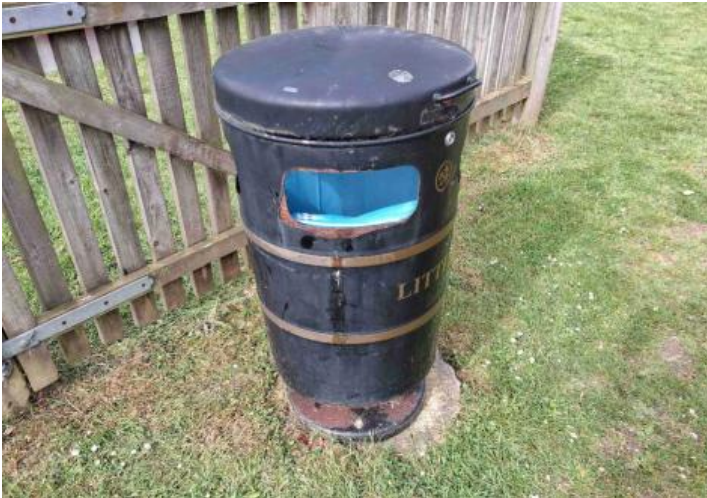
**Item:** Ancillary Items - Litter Bin  
**Manufacturer:** Not Identified

**Finding:** The paintwork on this item has been damaged or worn exposing the metal underneath which is rusting / corroding

**Action:** Treat affected areas and repaint

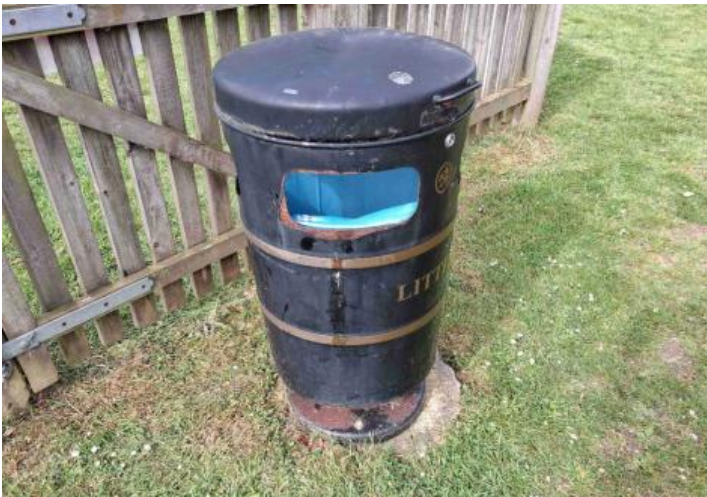
**Item:** Ancillary Items - Litter Bin  
**Manufacturer:** Not Identified

**Finding:** The foundation is loose

**Action:** Reinstate the foundation

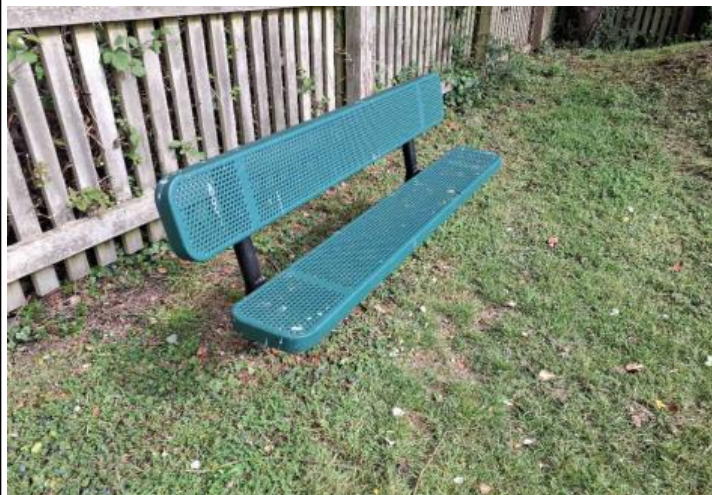
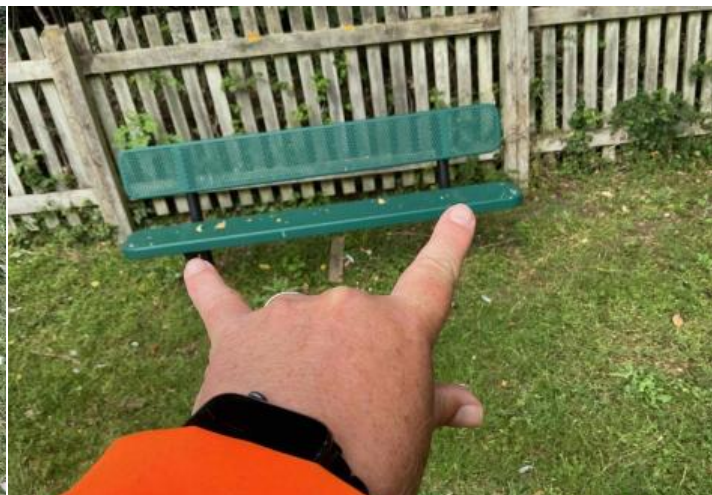
**Item:** Ancillary Items - Bench  
**Manufacturer:** Not Identified

**Finding:** A number of fixing(s) have worked loose

**Action:** Secure all loose fixings

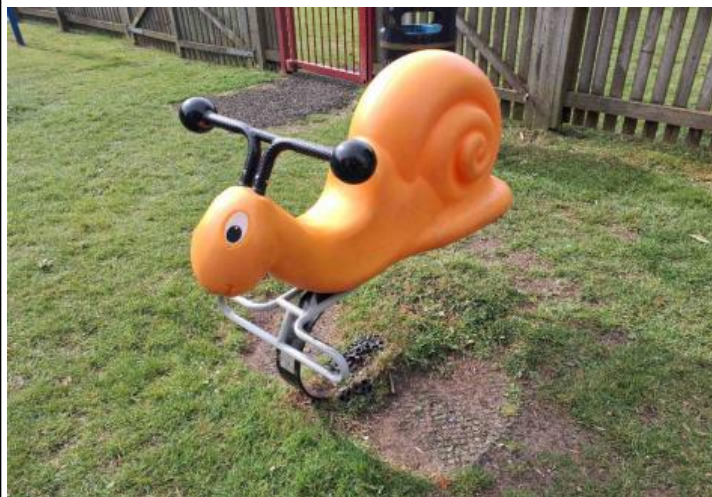
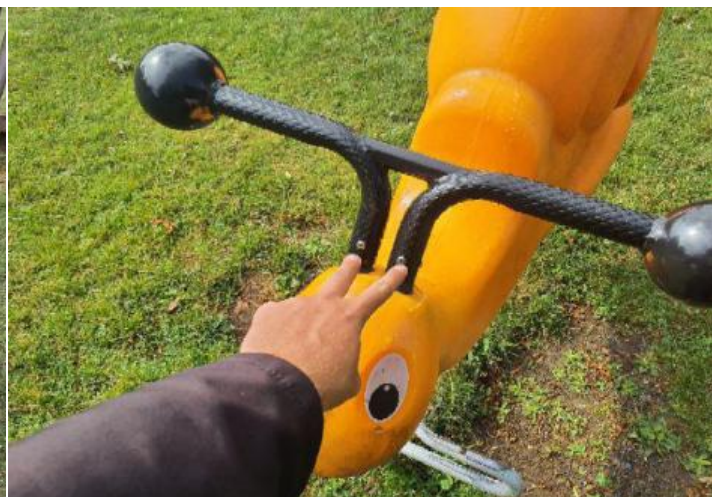
**Item:** Rocking Equipment - Spring Snail  
**Manufacturer:** Miracle Recreation Equipment Company

**Finding:** A number of fixing(s) have worked loose

**Action:** Secure all loose fixings

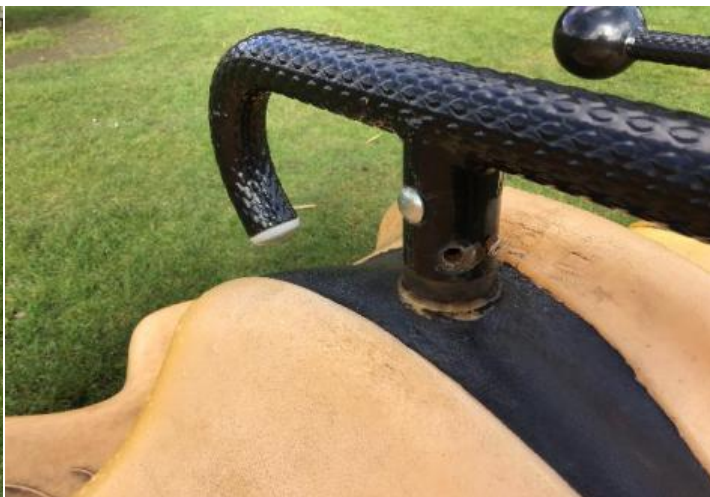
**Item:** Rocking Equipment - Spring Bee  
**Manufacturer:** Miracle Recreation Equipment Company

**Finding:** There is or are fixings missing on the item

**Action:** Replace all missing fixings

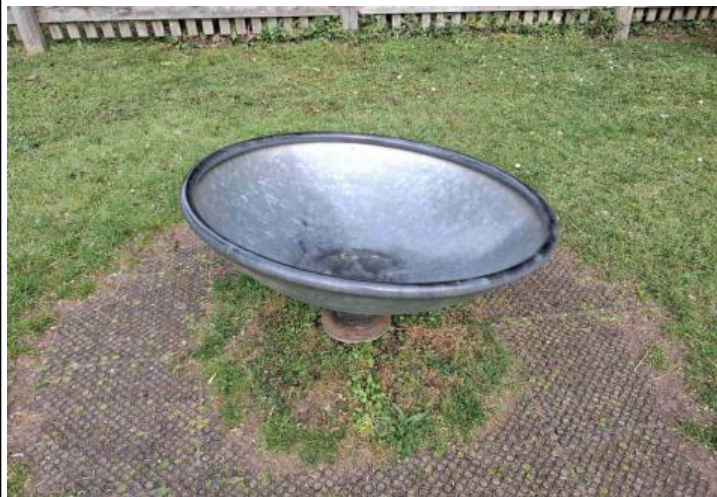
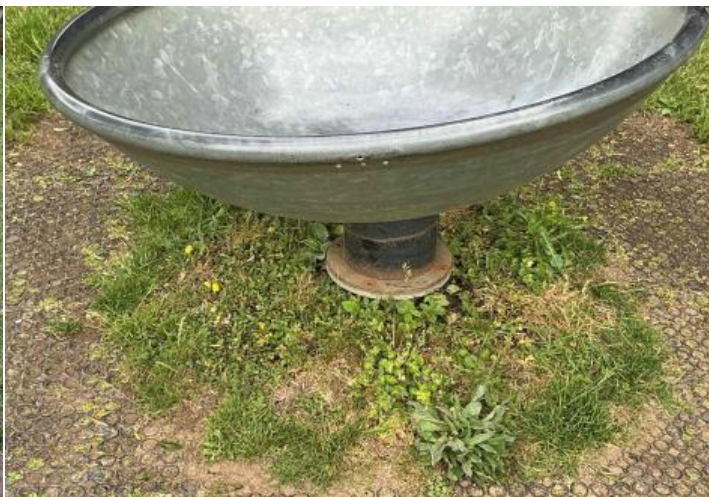
**Item:** Rotor Play - Dish Roundabout  
**Manufacturer:** Sutcliffe Play Limited

**Finding:** The grass mats are silted up, the soil is compacted and the area will become very slippery when the soil is wet.  
**Action:** Reinststate as required

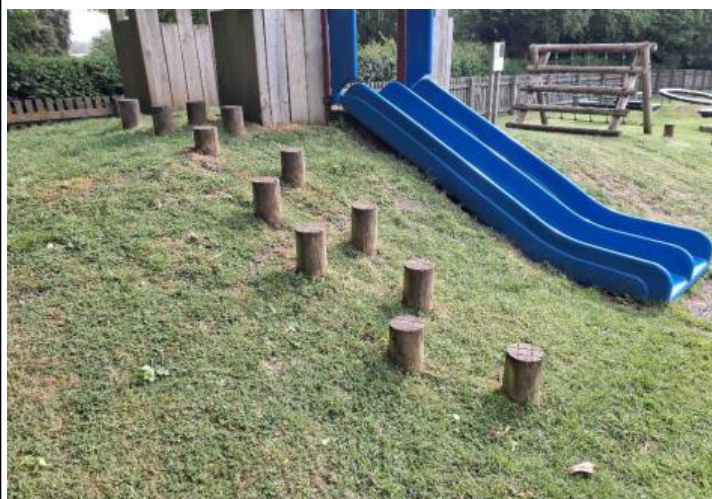
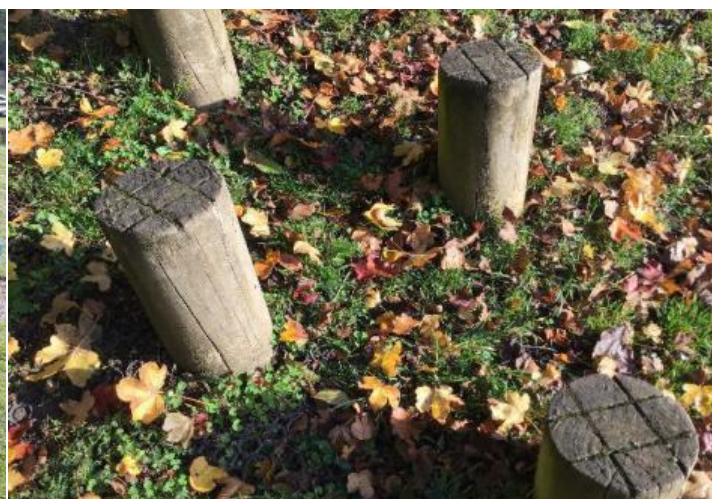
**Item:** Activity Equipment - Stepping Posts  
Timber  
**Manufacturer:** Playworld Systems (Europe) Ltd

**Finding:** There is algae or moss on the surface of the equipment  
**Action:** Clean and treat appropriately

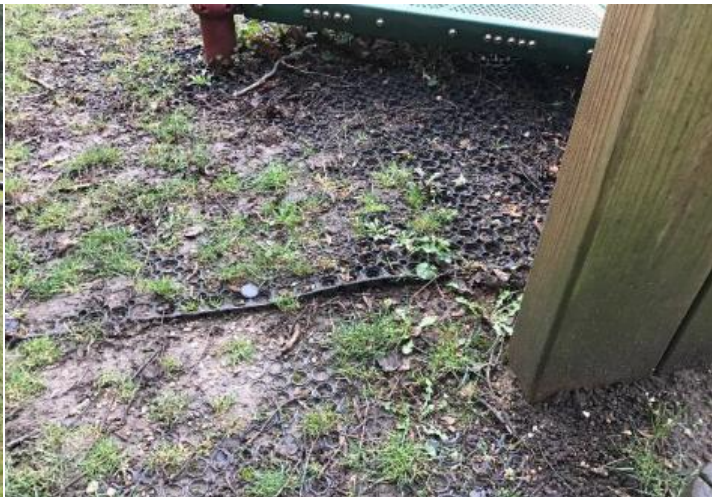
**Item:** Other - Embankment Slide  
**Manufacturer:** Miracle Recreation Equipment Company

**Finding:** There are trip hazards at the edges of the surface

**Action:** Reinstall surrounding surface levels to remove the trip points

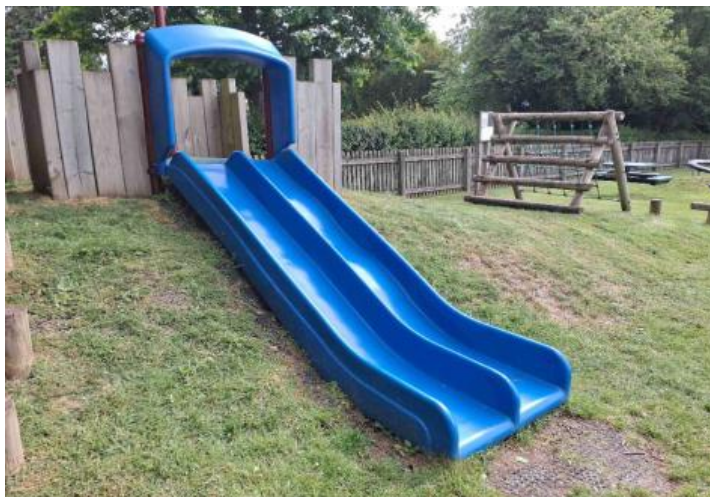
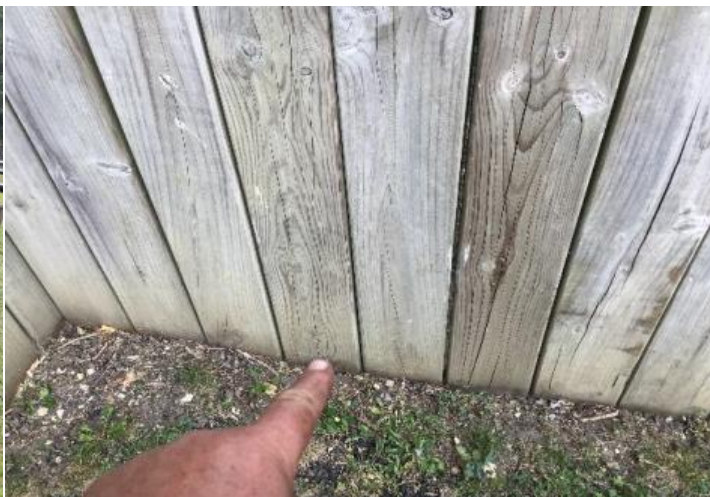
**Item:** Other - Embankment Slide  
**Manufacturer:** Miracle Recreation Equipment Company

**Finding:** Some timbers are slightly loose in the foundation

**Action:** Monitor for deterioration

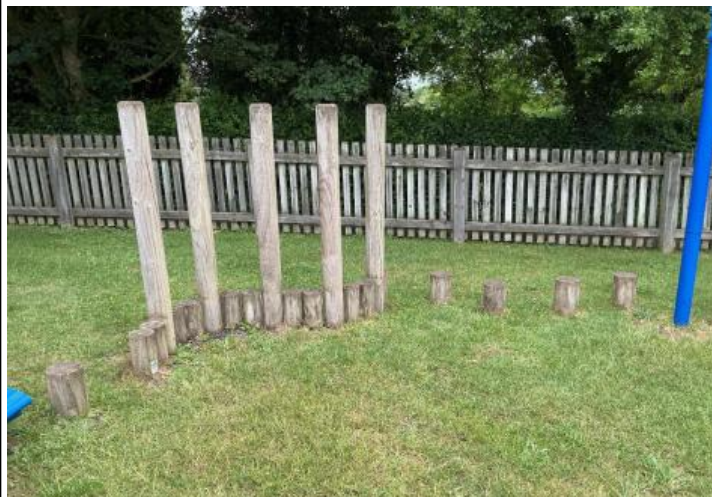
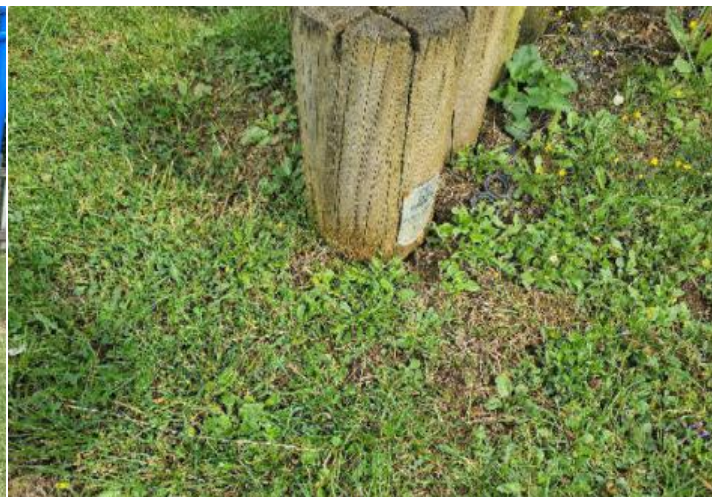
**Item:** Activity Equipment - Log Walk  
**Manufacturer:** Miracle Recreation Equipment Company

**Finding:** There is some strimmer / machinery damage apparent on the posts, this can penetrate the preservative applied to the timber and accelerate the rotting process

**Action:** Monitor for any deterioration (rot) and replace as required

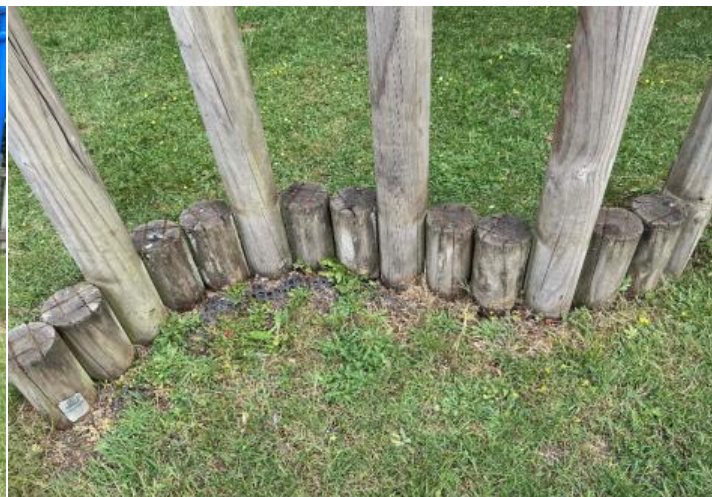
**Item:** Activity Equipment - Log Walk  
**Manufacturer:** Miracle Recreation Equipment Company

**Finding:** There is some evidence of rot in the timber

**Action:** Monitor for any further deterioration and replace as required

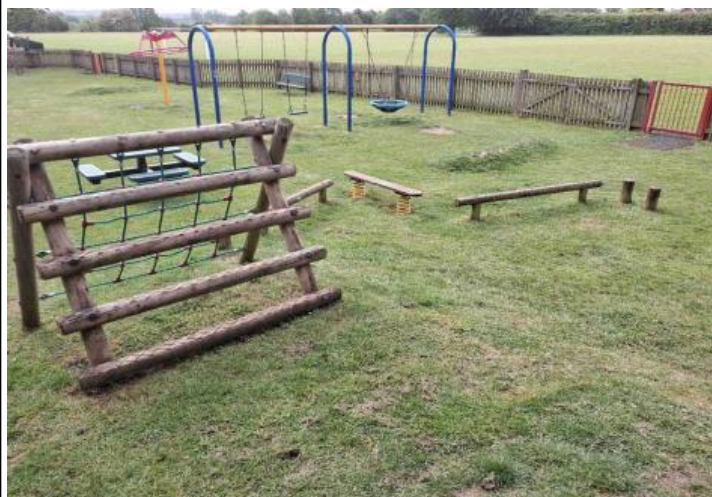
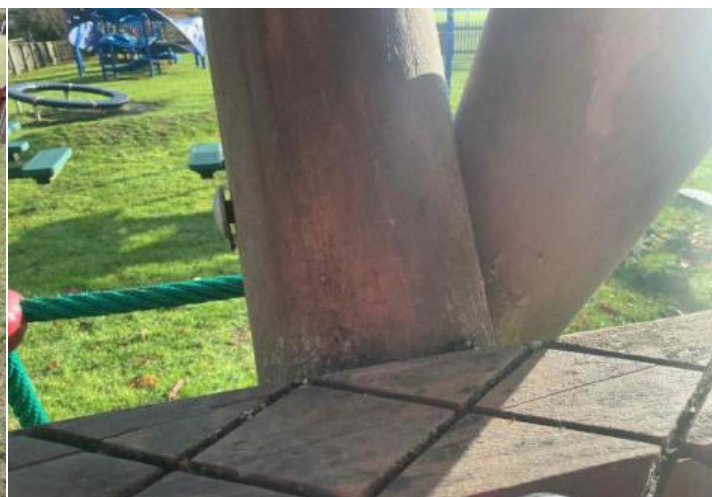
**Item:** Activity Equipment - Activity Trail  
**Manufacturer:** Miracle Recreation Equipment Company

**Finding:** A number of fixing(s) have worked loose

**Action:** Secure all loose fixings

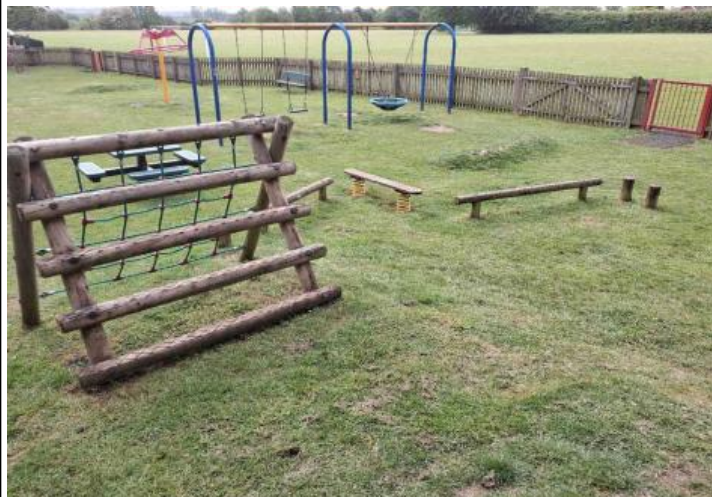
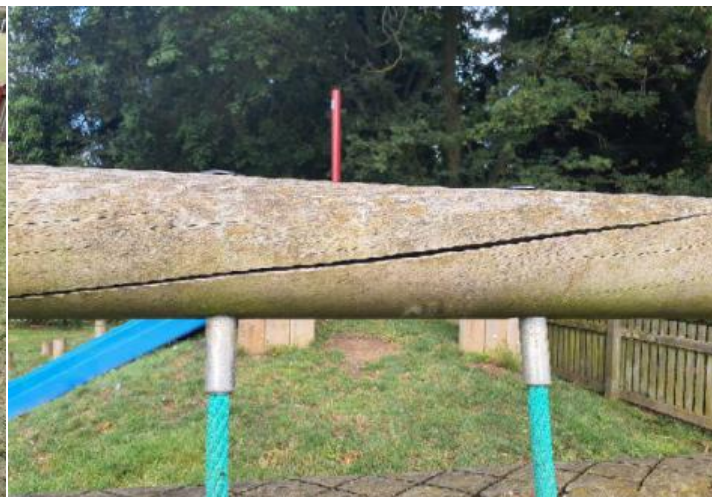
**Item:** Activity Equipment - Activity Trail  
**Manufacturer:** Miracle Recreation Equipment Company

**Finding:** The timber has a number of splits/shakes or air cracks and this may affect the stability or allow water ingress which will accelerate the rotting process

**Action:** Monitor to ensure the splits do not cross through fixing points of the structure and/or cause any instability

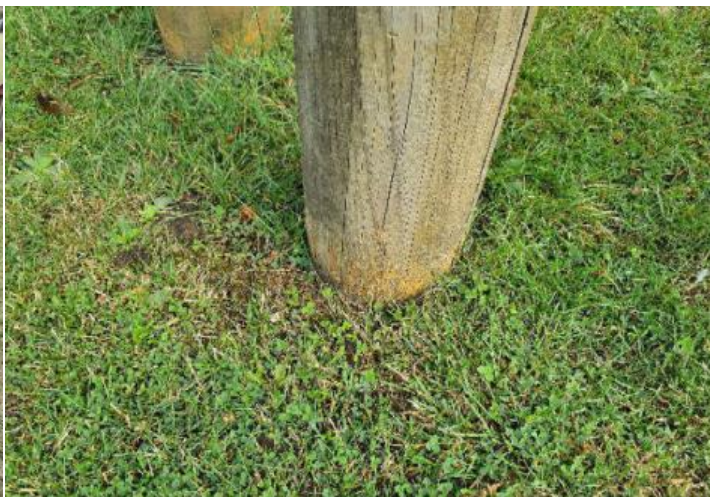
**Item:** Activity Equipment - Activity Trail  
**Manufacturer:** Miracle Recreation Equipment Company

**Finding:** There is some strimmer / machinery damage apparent on the posts, this can penetrate the preservative applied to the timber and accelerate the rotting process

**Action:** Monitor for any deterioration (rot) and replace as required

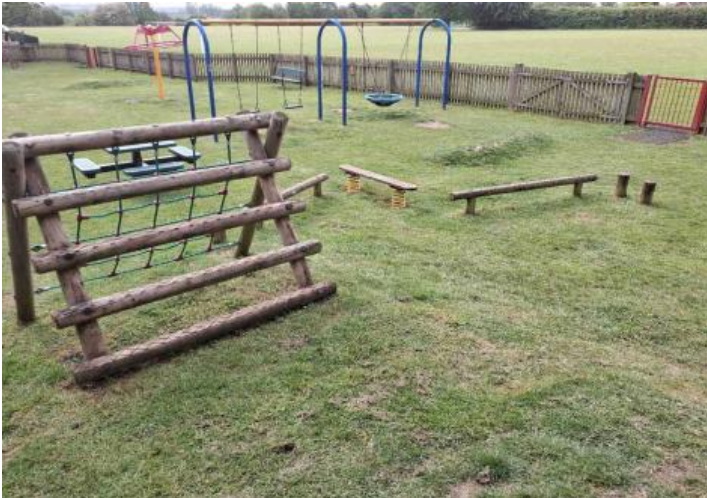
**Item:** Activity Equipment - Activity Trail  
**Manufacturer:** Miracle Recreation Equipment Company

**Finding:** There is/are bolt cap covers missing or damaged on the item

**Action:** Replace missing or damaged bolt cap covers

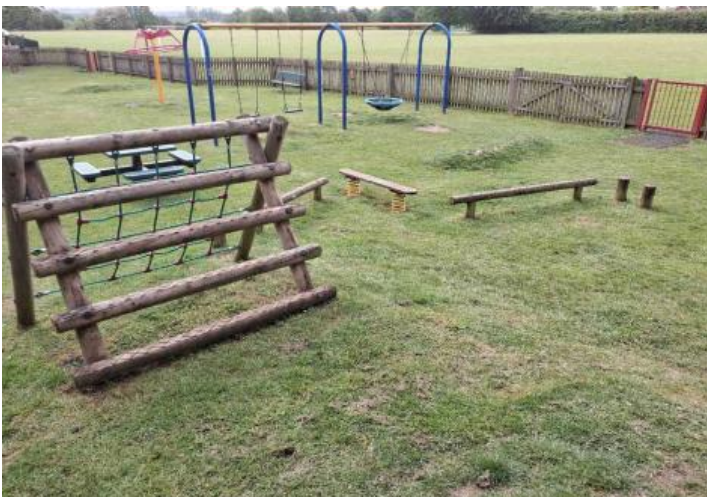
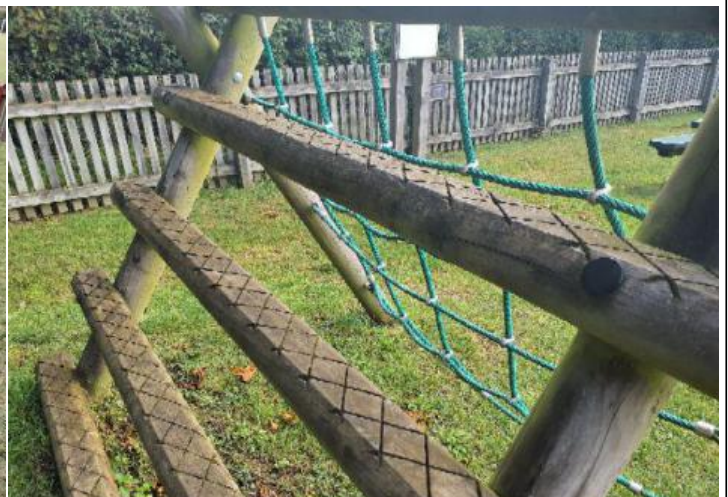
**Item:** Activity Equipment - Activity Trail  
**Manufacturer:** Miracle Recreation Equipment Company

**Finding:** There is algae or moss on the surface of the equipment

**Action:** Clean and treat appropriately

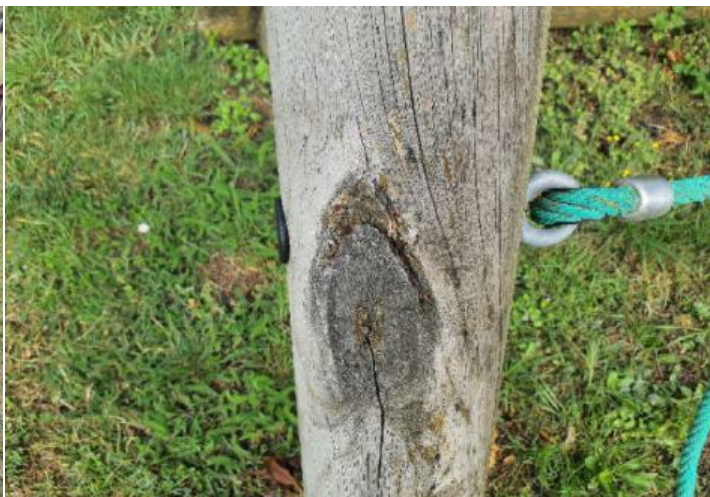
**Item:** Activity Equipment - Activity Trail  
**Manufacturer:** Miracle Recreation Equipment Company

**Finding:** Parts of the timber are rough or splintered

**Action:** Remove all rough or sharp edges

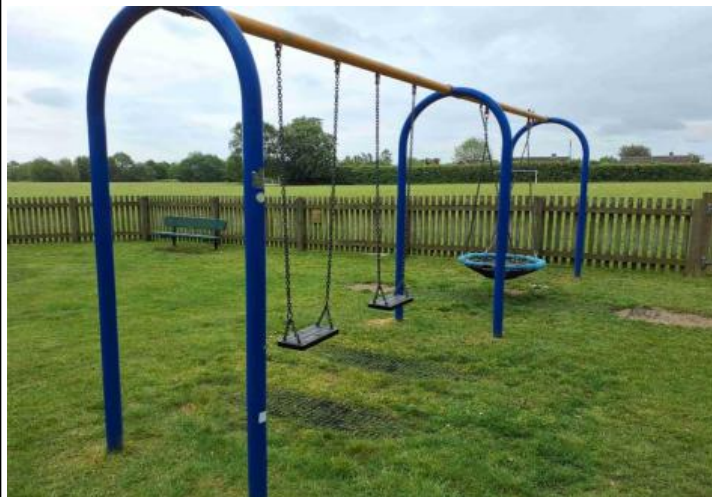
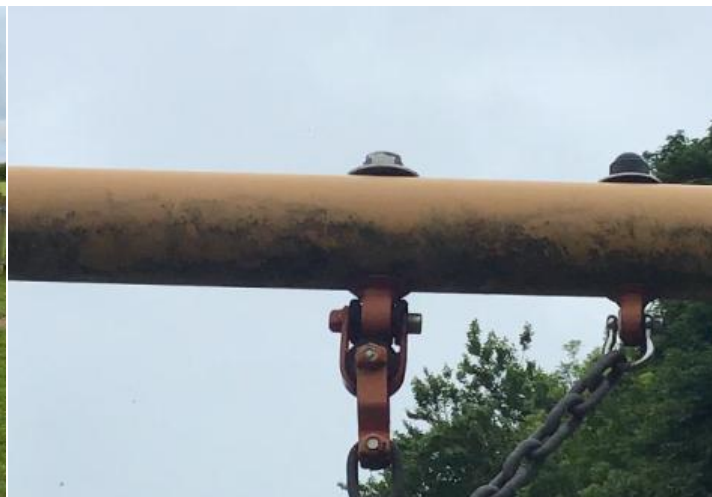
**Item:** Swings - 2 Bay 2 Flat 1 Basket Seat  
**Manufacturer:** Miracle Recreation Equipment Company

**Finding:** There is/are bolt cap covers missing or damaged on the item

**Action:** Replace missing or damaged bolt cap covers

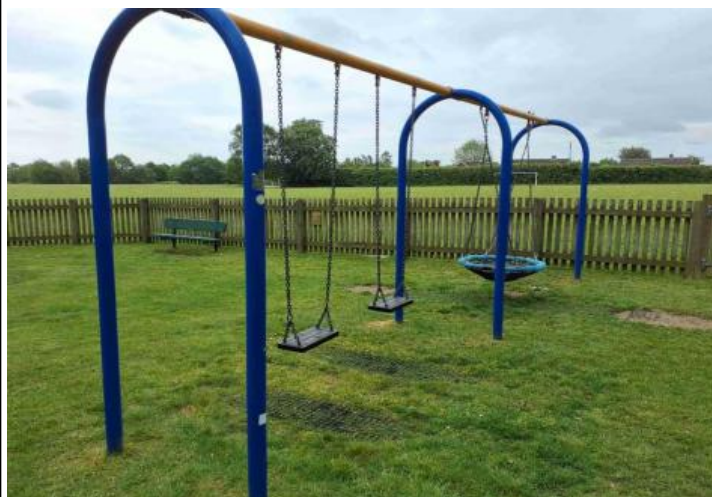
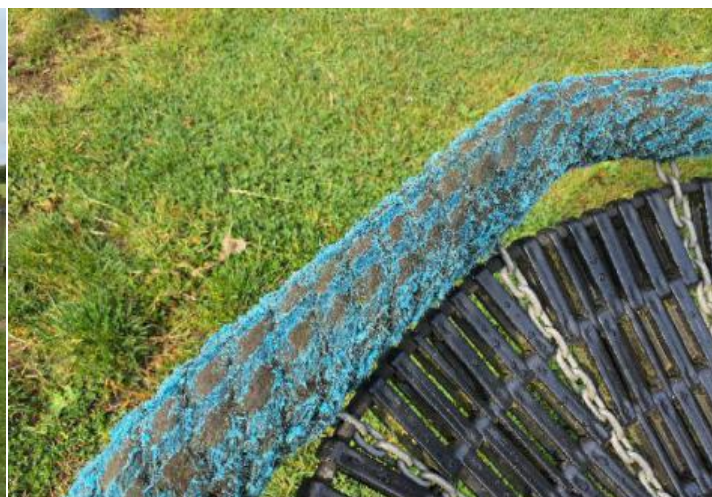
**Item:** Swings - 2 Bay 2 Flat 1 Basket Seat  
**Manufacturer:** Miracle Recreation Equipment Company

**Finding:** The seat has minor damage or wear

**Action:** Monitor for any further deterioration and replace as required

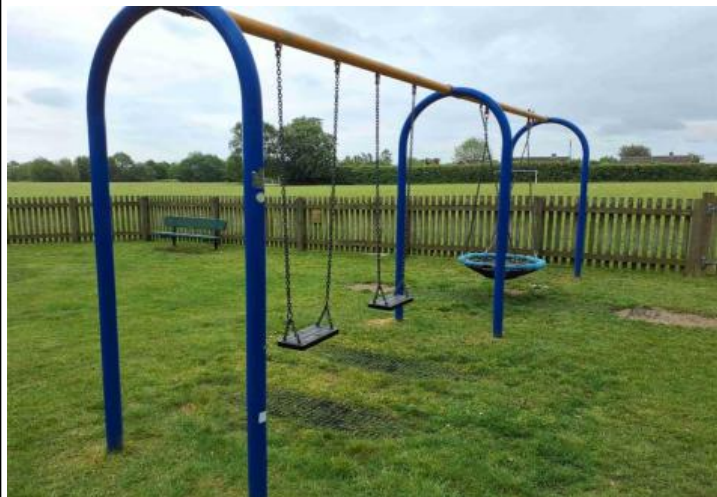
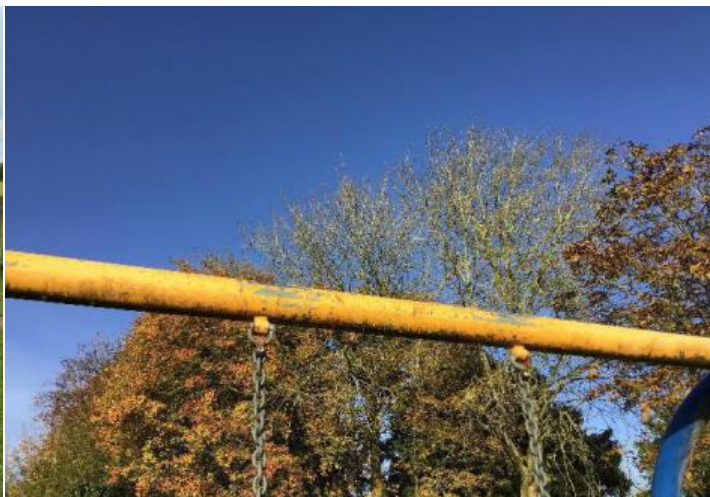
**Item:** Swings - 2 Bay 2 Flat 1 Basket Seat  
**Manufacturer:** Miracle Recreation Equipment Company

**Finding:** The paint is flaking off the metalwork

**Action:** Rub down and re-paint

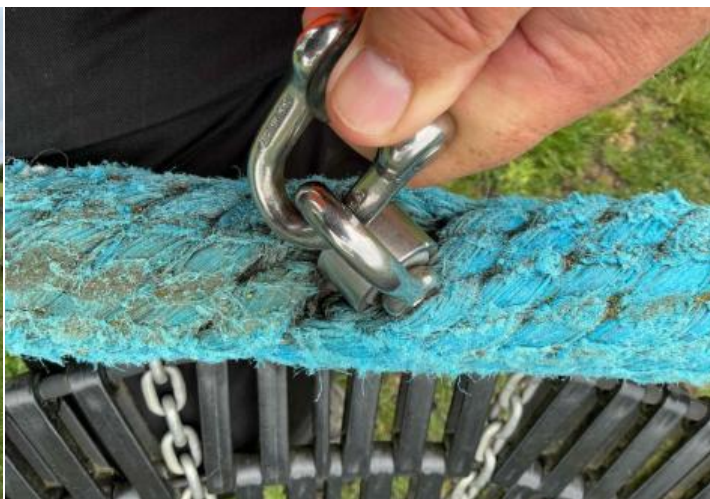
**Item:** Swings - 2 Bay 2 Flat 1 Basket Seat  
**Manufacturer:** Miracle Recreation Equipment Company

**Finding:** There is some wear to the shackles

**Action:** Monitor for any further deterioration and replace when 40% worn

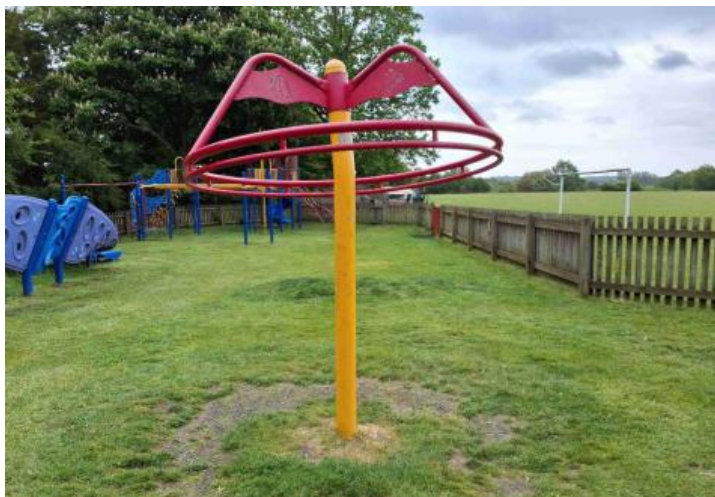
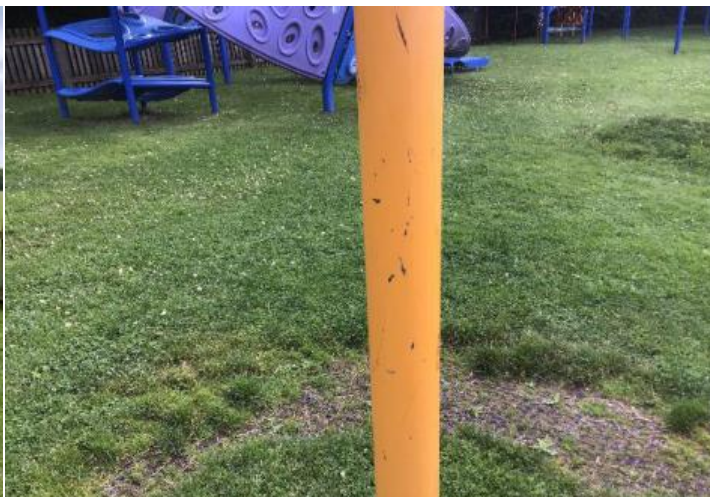
**Item:** Rotor Play - Overhead Rotator  
**Manufacturer:** Miracle Recreation Equipment Company

**Finding:** The paint is flaking off the metalwork

**Action:** Rub down and re-paint

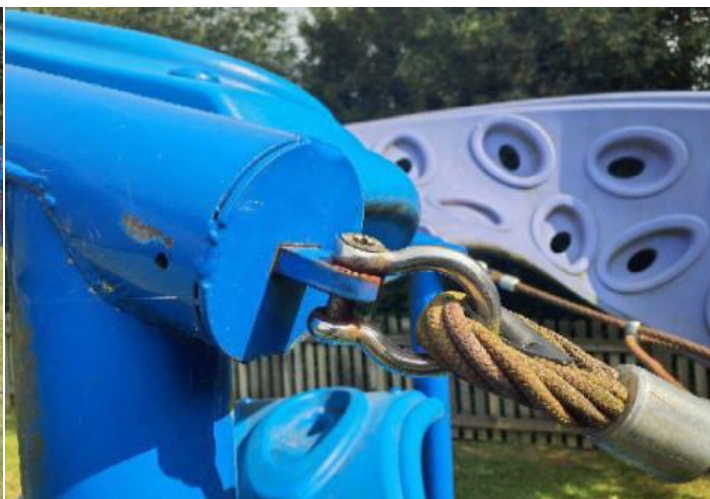
**Item:** Activity Equipment - Climbing Frame  
**Manufacturer:** Not Identified

**Finding:** The connecting lugs are showing signs of wear

**Action:** Monitor for any further deterioration and repair as required

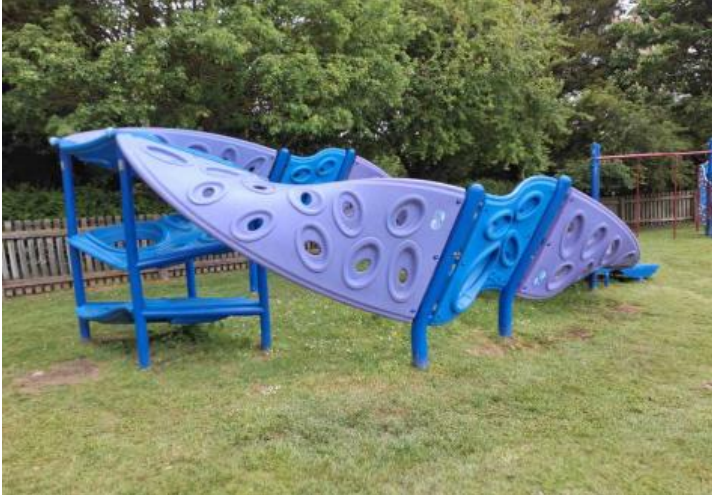
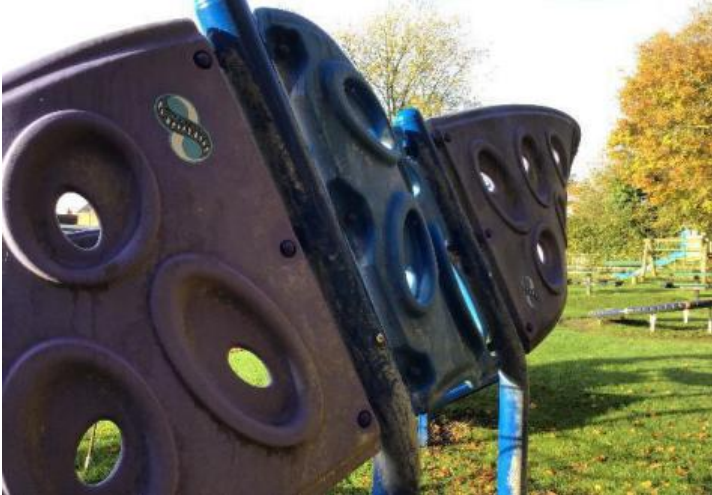
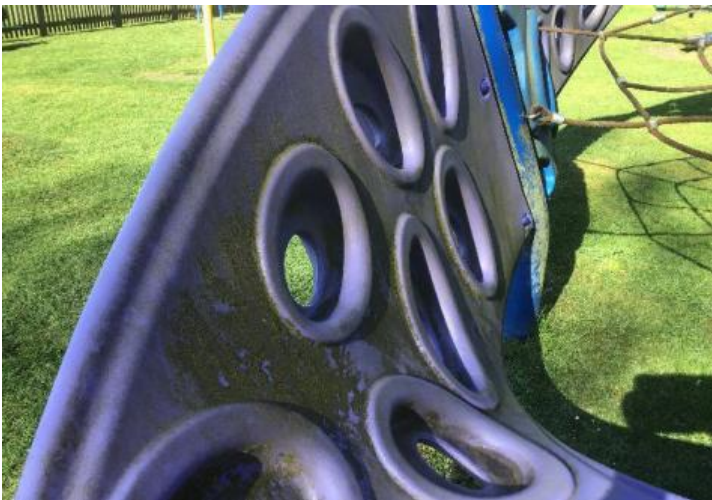
| <div> 8 - Low Risk (Finding 2) </div> | | | |
|---|---|---|---|
| Item: | Activity Equipment - Climbing Frame | Risk Level: | L - Low Risk |
| <b>Finding:</b> There is algae or moss on the surface of the equipment | | <b>Action:</b> Clean and treat appropriately | |

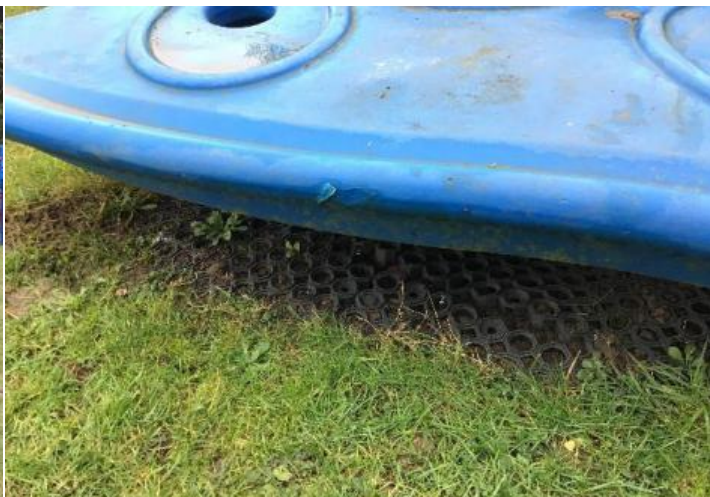
**Item:** Activity Equipment - Climbing Frame  
**Manufacturer:** Not Identified

**Finding:** The item has been damaged

**Action:** Sand down plastic to remove sharp edge

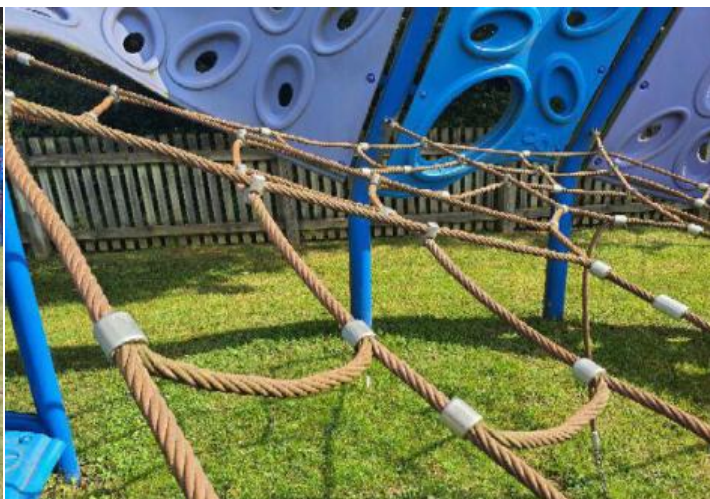
**Item:** Activity Equipment - Climbing Frame  
**Manufacturer:** Not Identified

**Finding:** The ropes/nets are worn/damaged in places

**Action:** Monitor for any further deterioration and repair or replace as required

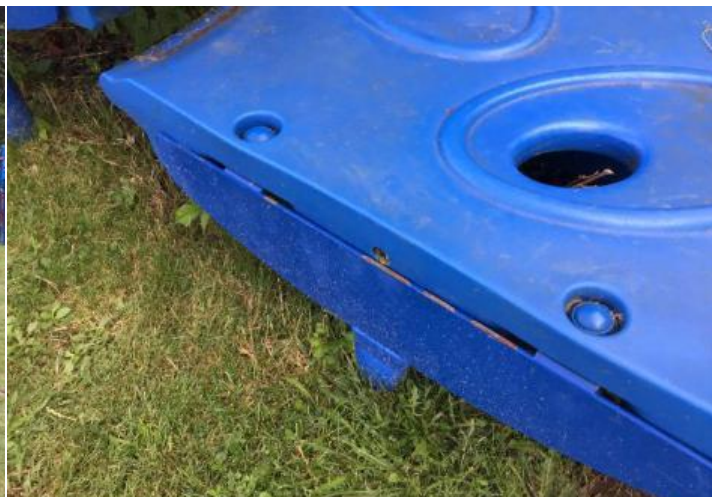
**Item:** Activity Equipment - Climbing Frame  
**Manufacturer:** Not Identified

**Finding:** There is surface corrosion / rust present on the item

**Action:** Consider treating the item

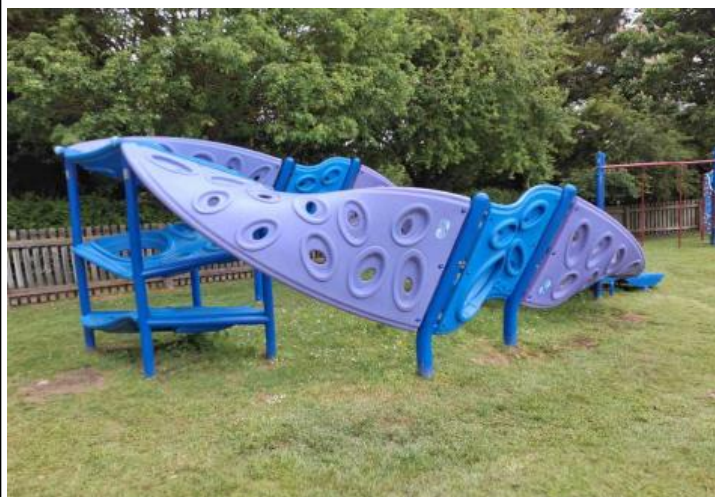
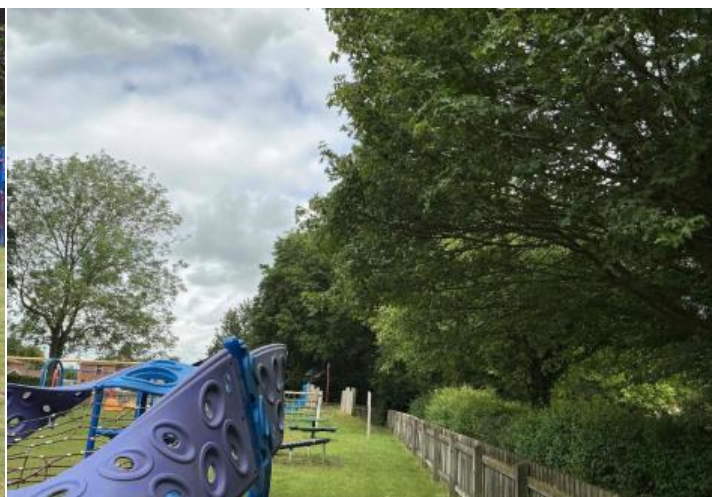
**Item:** Activity Equipment - Climbing Frame  
**Manufacturer:** Not Identified

**Finding:** The tree canopy overhangs the equipment and is less than 2.0m away

**Action:** Lift tree canopy to ensure a minimum clearance of 2.0m from the equipment

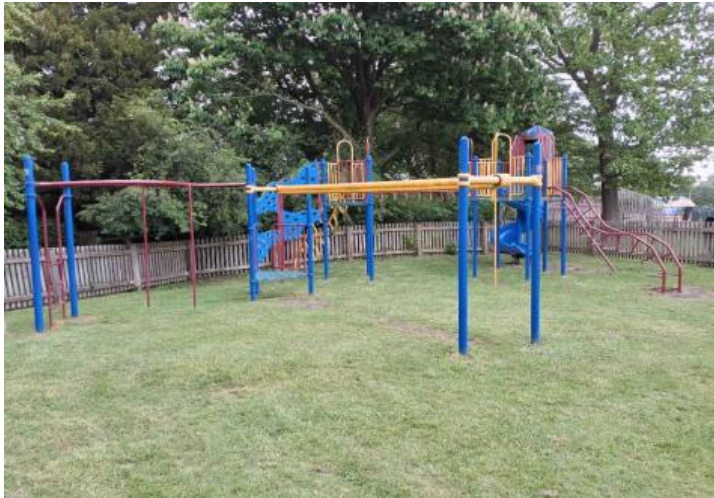
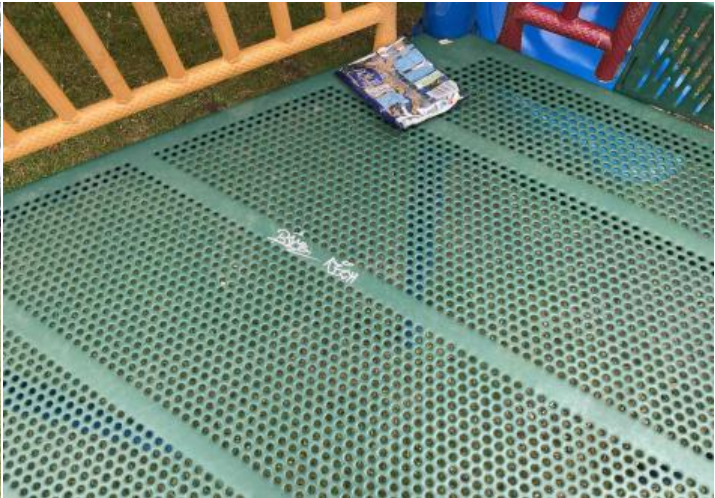
| <div> 0 - Risk Assessment not Undertaken (Finding 1) </div> | | | |
|---|--|---|--|
| <b>Item:</b> Activity Equipment - Multi Play (Senior)<br><b>Manufacturer:</b> Miracle Recreation Equipment Company | | <b>Risk Level:</b> N - Risk Assessment not Undertaken<br><b>Surface:</b> Grass Matrix Tiles | |
| <b>Finding:</b> There is some graffiti present | | <b>Action:</b> Remove the graffiti | |

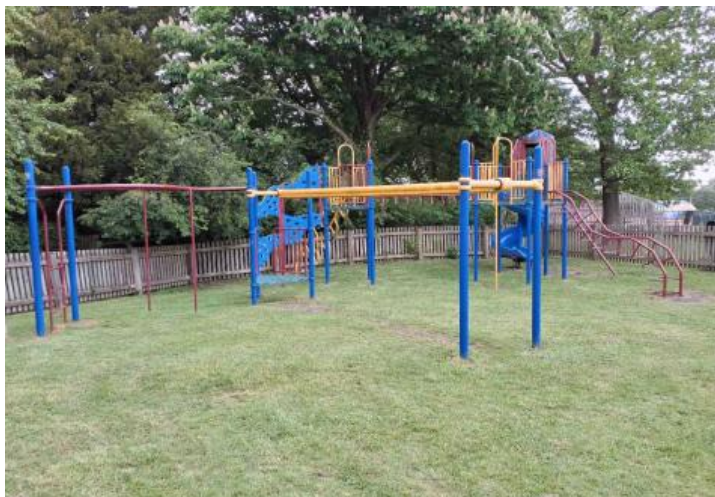
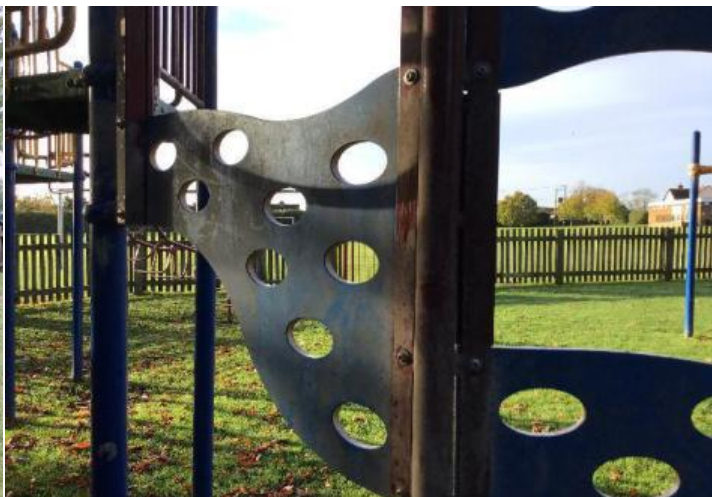
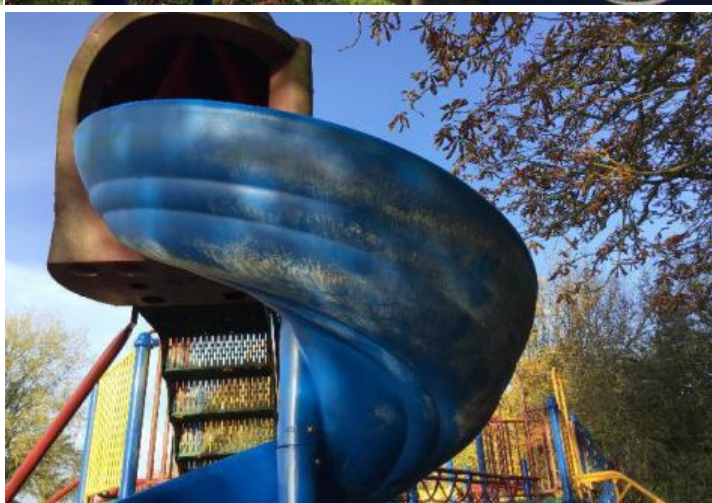
**Item:** Activity Equipment - Multi Play (Senior)  
**Manufacturer:** Miracle Recreation Equipment Company

**Finding:** There is algae or moss on the surface of the equipment

**Action:** Clean and treat appropriately

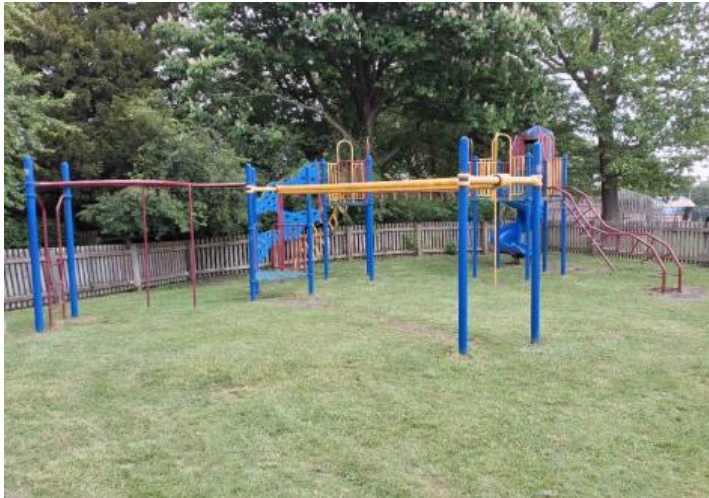
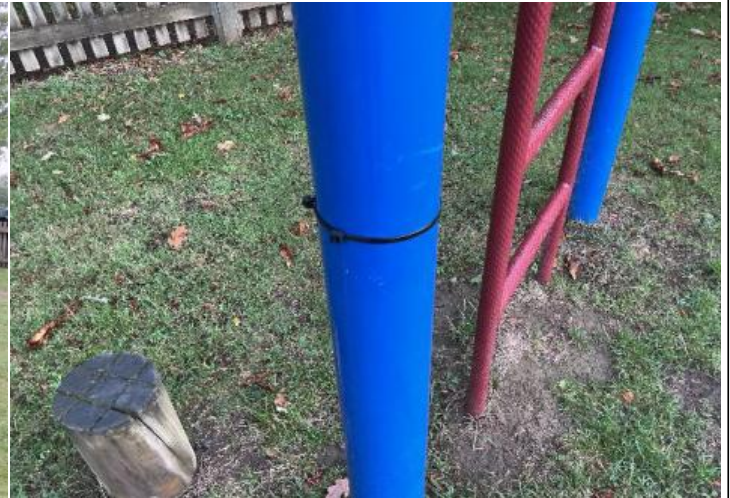
**Item:** Activity Equipment - Multi Play (Senior)  
**Manufacturer:** Miracle Recreation Equipment Company

**Finding:** Cable tie around post has been cut leaving sharp edges

**Action:** Remove cable tie
