## **Play Area Inspection Reports & Remedial Work**

### Playground Maintenance Estimate for Three Site Remedials

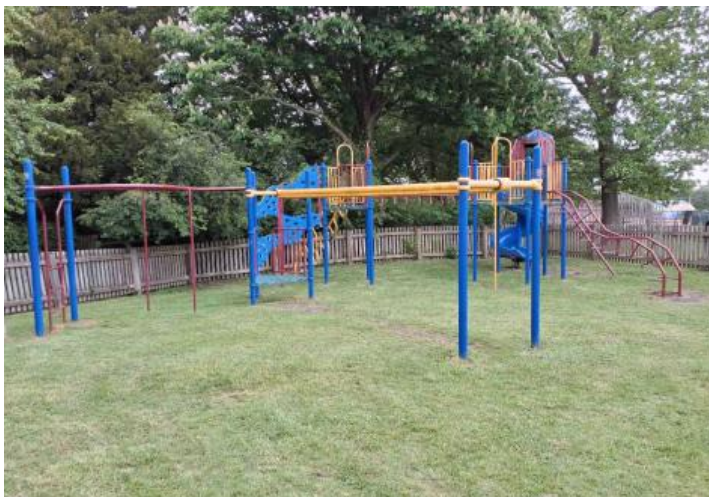
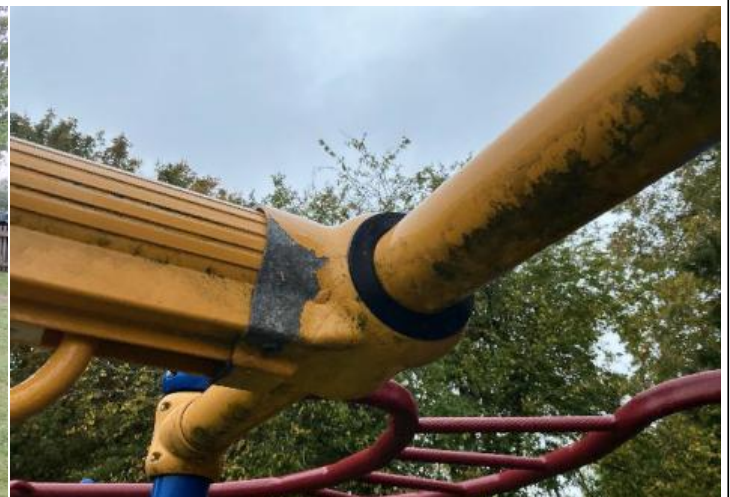
**Item:** Activity Equipment - Multi Play (Senior)  
**Manufacturer:** Miracle Recreation Equipment Company

**Finding:** The paint is flaking off the metalwork

**Action:** Rub down and re-paint

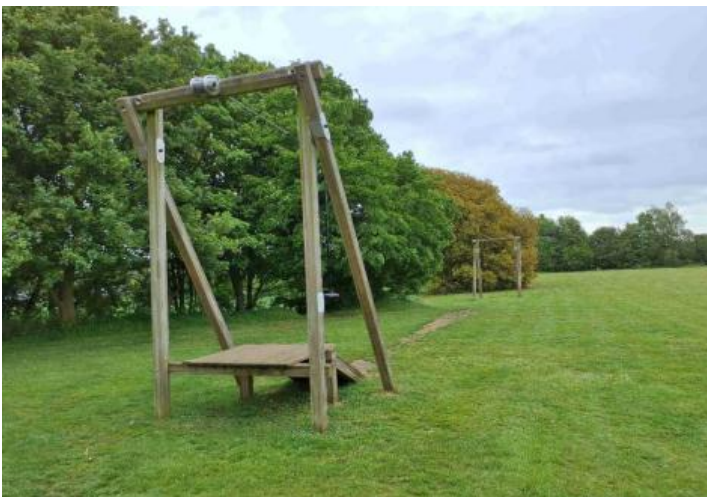
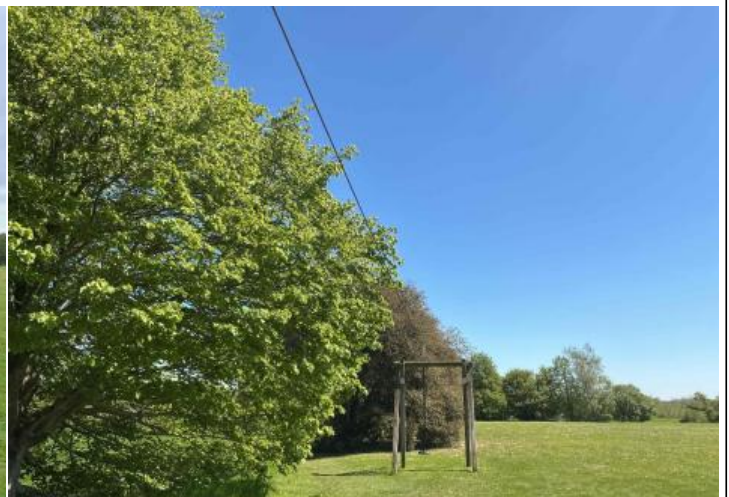
**Item:** Other - Cable Runway  
**Manufacturer:** Fenland Leisure Products

**Finding:** The adjacent foliage is overhanging

**Action:** Cut back and maintain

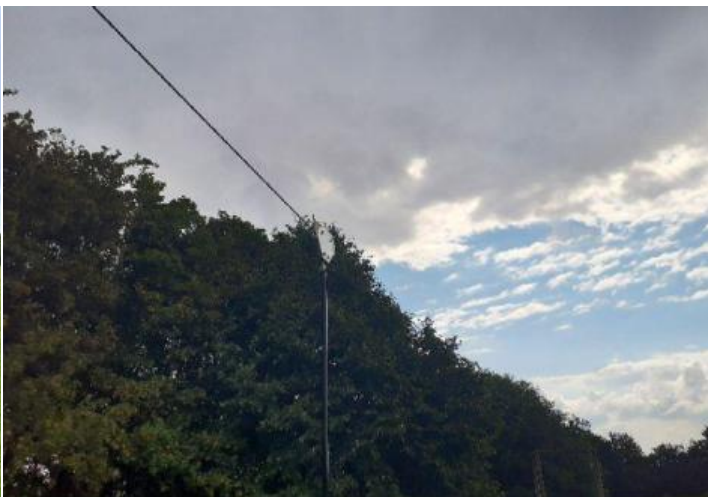
**Item:** Other - Cable Runway  
**Manufacturer:** Fenland Leisure Products

**Finding:** We have completed a visual inspection of the suspension links, cable and fixing points from ground level, however it is not possible to fully inspect these areas without either hiring equipment to gain access or removing the cable and suspension and inspecting at ground level. We recommend that the main cable and fixing security is thoroughly inspected at least in accordance with the manufacturers recommendations to check for wear, damage, security or internal rusting; this will help to ensure the continued safe use of the equipment

**Action:** Inspect in accordance with the manufacturers recommendations

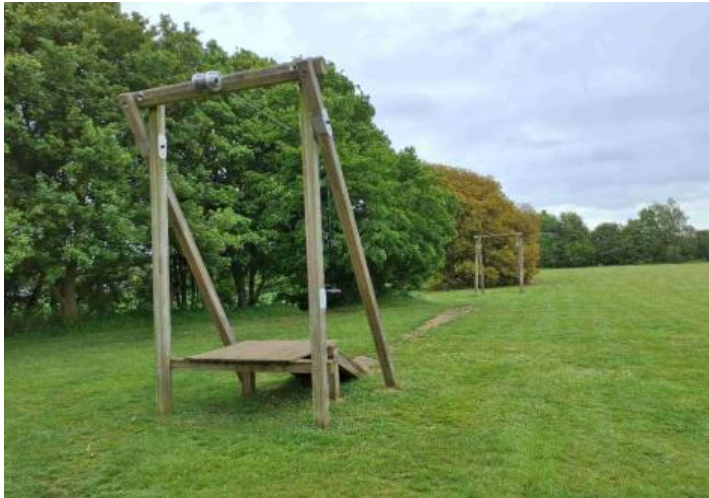
**Item:** Other - Cable Runway  
**Manufacturer:** Fenland Leisure Products

**Finding:** There is some strimmer / machinery damage apparent on the posts, this can penetrate the preservative applied to the timber and accelerate the rotting process

**Action:** Monitor for any deterioration (rot) and replace as required

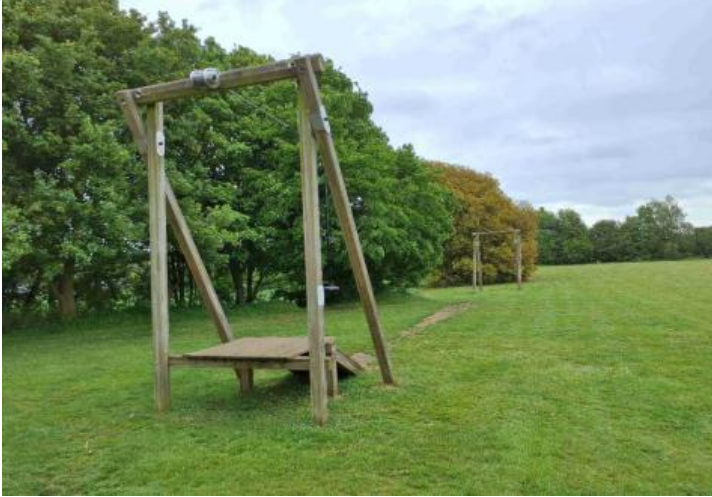
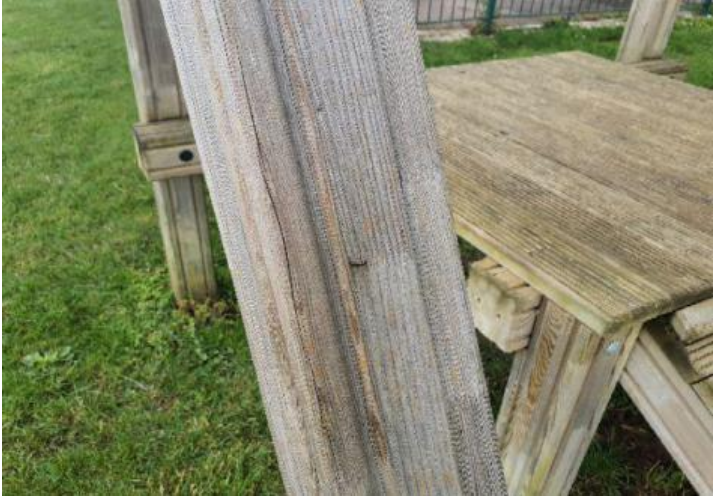
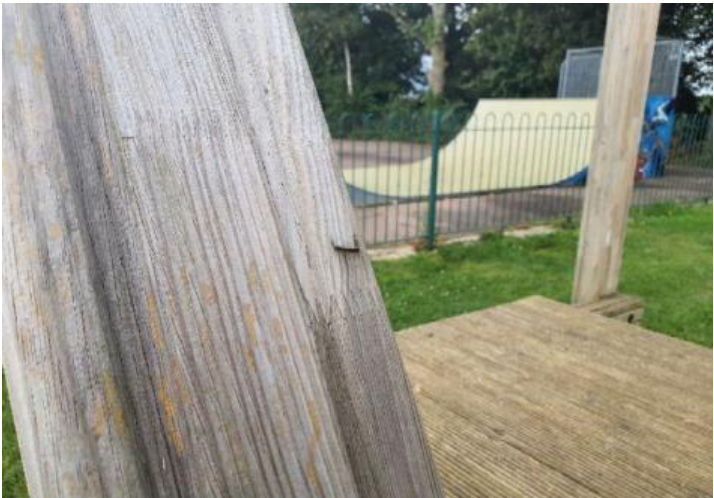
| Item: | Other - Cable Runway | Risk Level: | L - Low Risk |

| <b>Finding:</b> There are a number of redundant staples attached to the equipment | | <b>Action:</b> Remove redundant staples | |

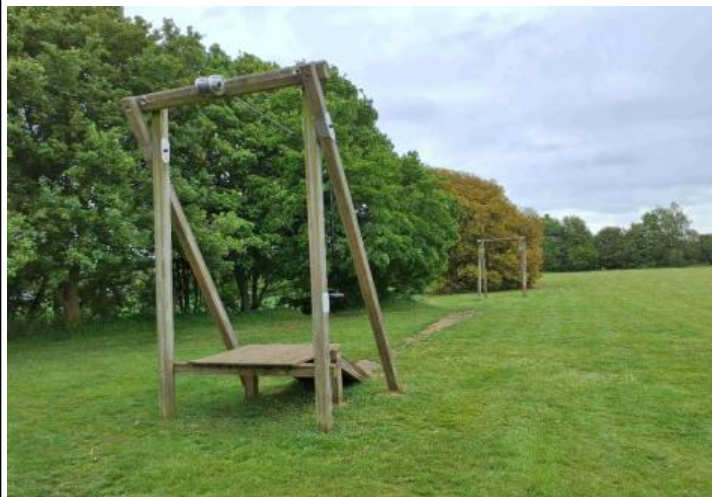
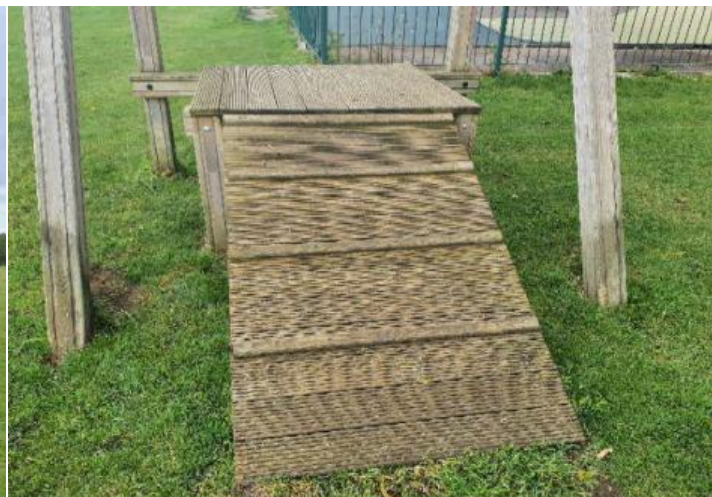
**Item:** Other - Cable Runway  
**Manufacturer:** Fenland Leisure Products

**Finding:** There is algae or moss on the surface of the equipment

**Action:** Clean and treat appropriately

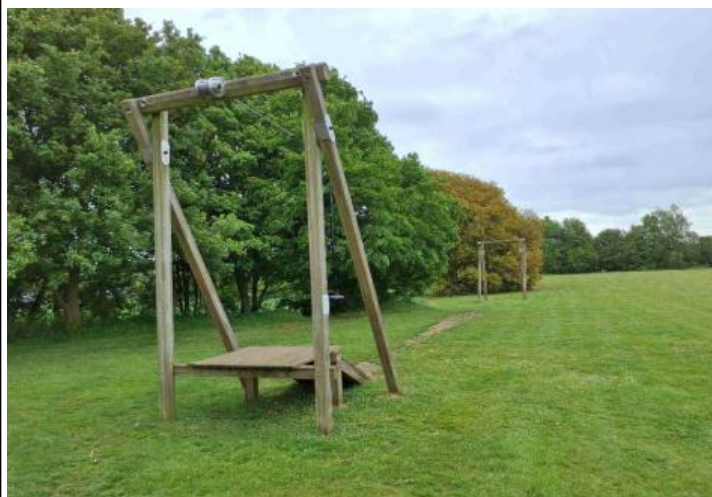
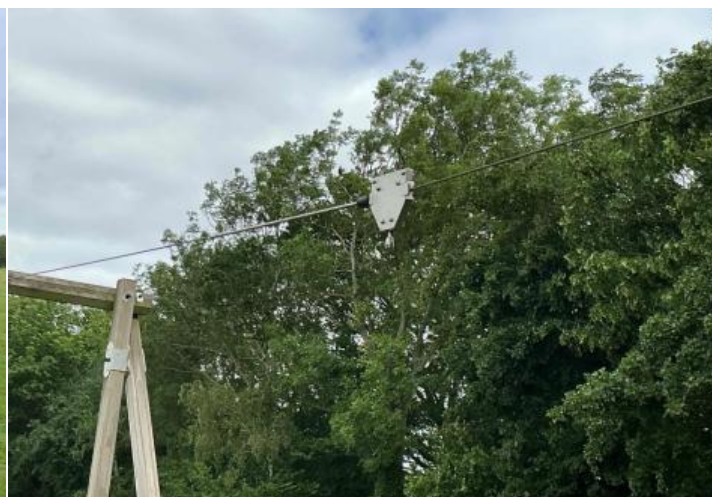
**Item:** Other - Cable Runway  
**Manufacturer:** Fenland Leisure Products

**Finding:** The seat and chain have been removed

**Action:** Replace

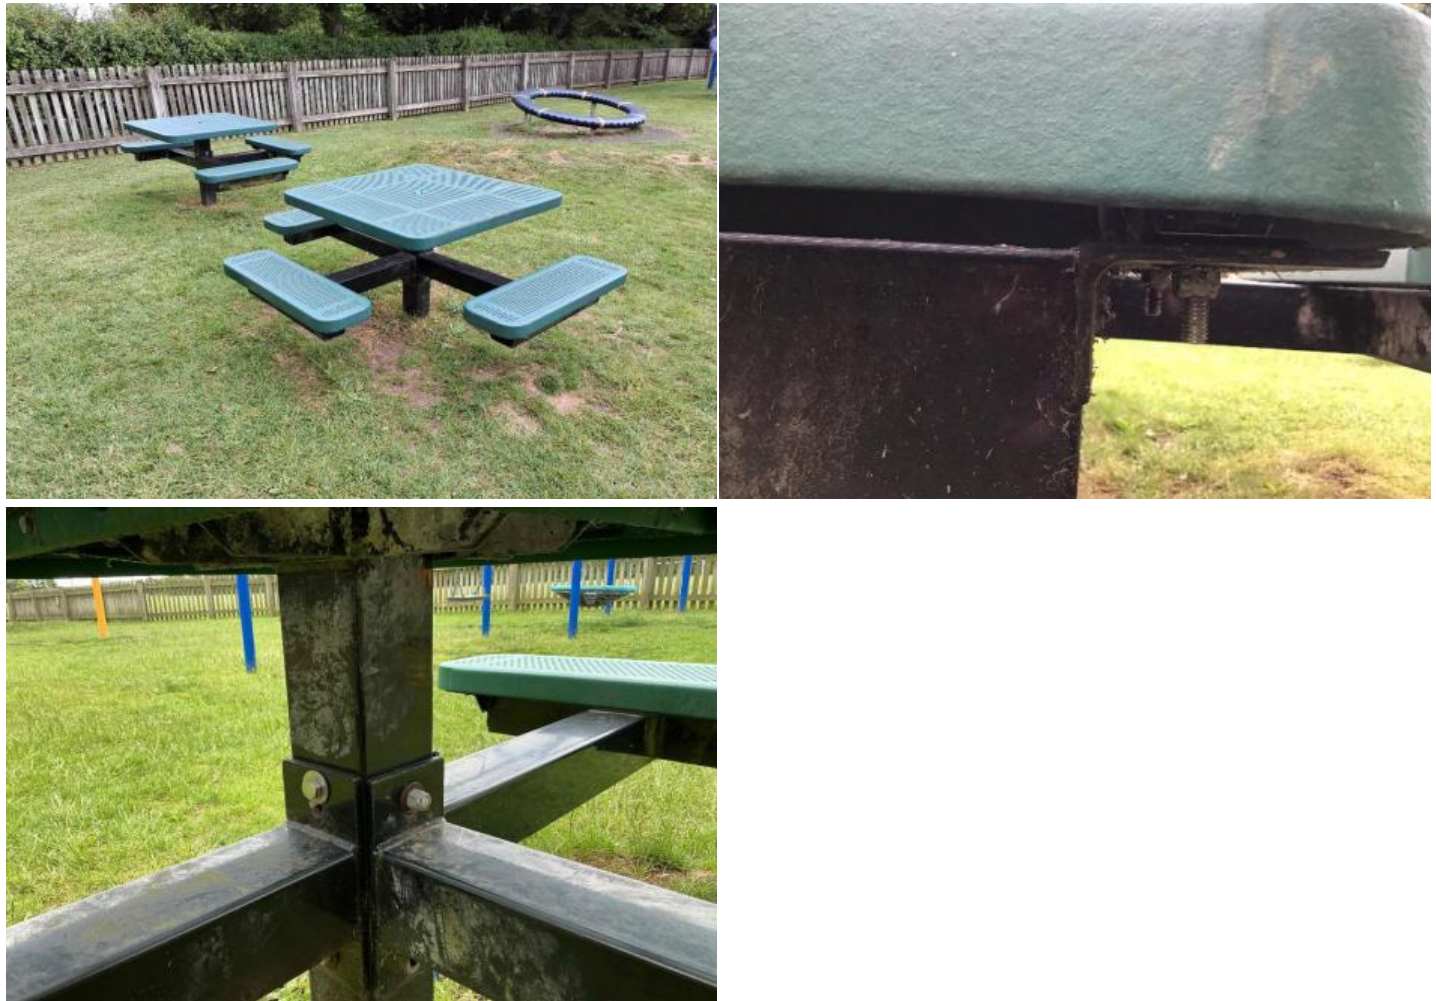
**Item:** Ancillary Items - Picnic Table  
**Manufacturer:** Not Identified

**Finding:** There are projecting bolt thread(s) present

**Action:** Remove excess thread length and deburr or provide cap
