## **Play Area Inspection Reports & Remedial Work**

## Wickhambrook. Bury Road

Inspection Ref: 3230454

Operational Inspection - 8-October-2026 - 08:11 Inspector Philip Smith

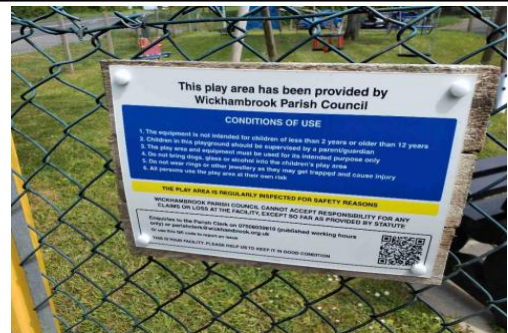
Cable tie has become detached from sign due to damage to sign leaving a sharp edge on the cable tie - Repair

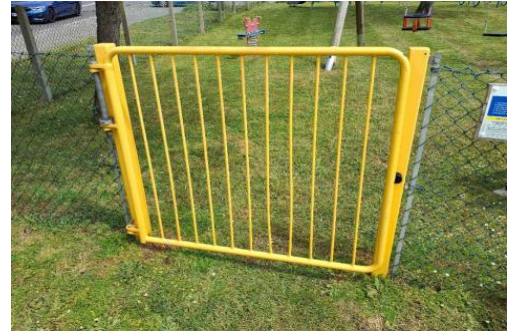
The gate rebounds when opened quickly and could strike the next user entering the area - Monitor use and adjust/replace as required

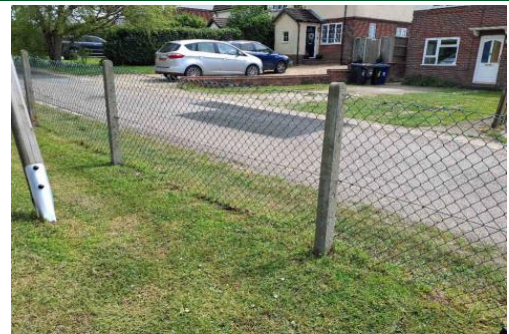
There is some damage to the fence sections - Monitor for any further deterioration and repair as required

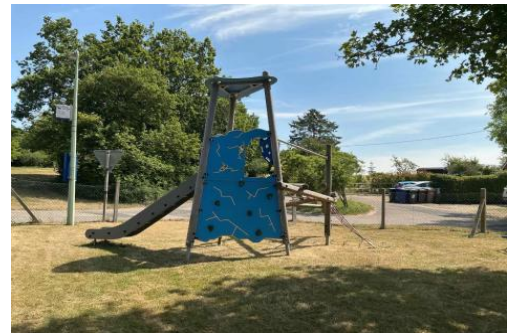
The timber has a number of splits/shakes or air cracks and this may affect the stability or allow water ingress which will accelerate the rotting process - Monitor to ensure the splits do not cross through fixing points of the structure and/or cause any instability

The ropes/nets are worn/damaged in places - Monitor for any further deterioration and repair or replace as required

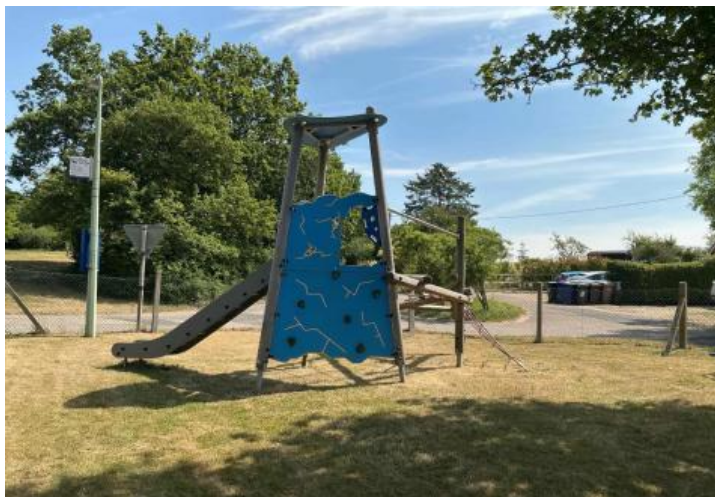
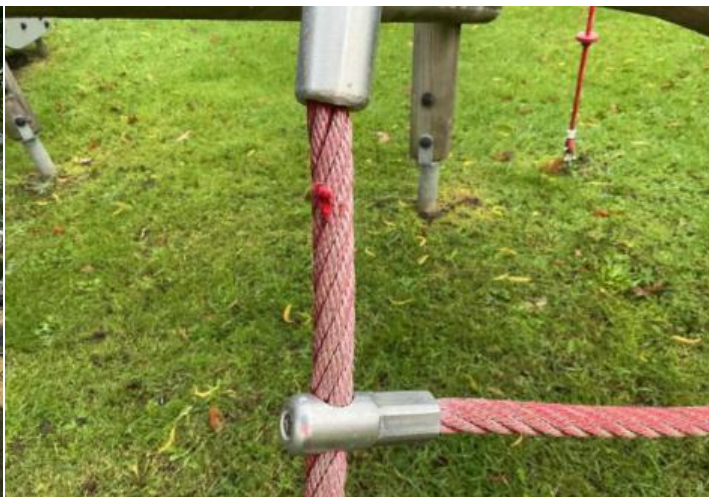
**Finding:** The ropes/nets are worn/damaged in places

**Action:** Monitor for any further deterioration and repair or replace as required

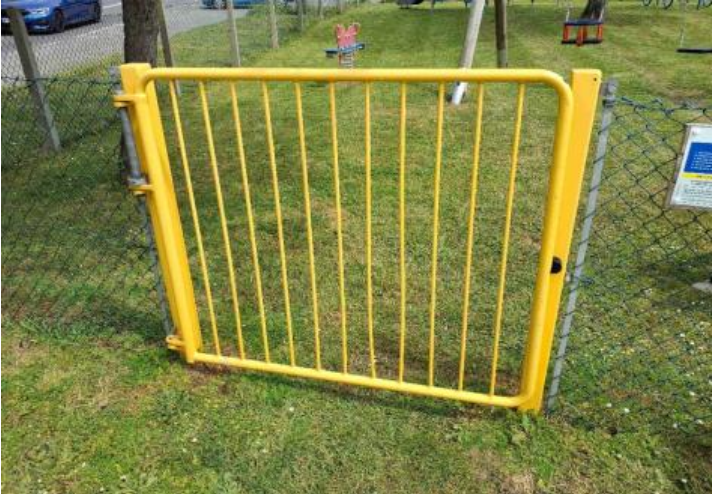
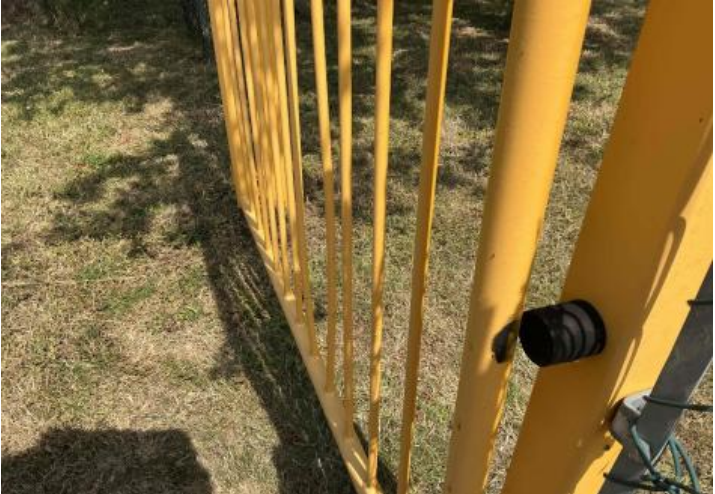
| Finding: The item has been damaged | | Action: Monitor for any further deterioration and replace as required | |

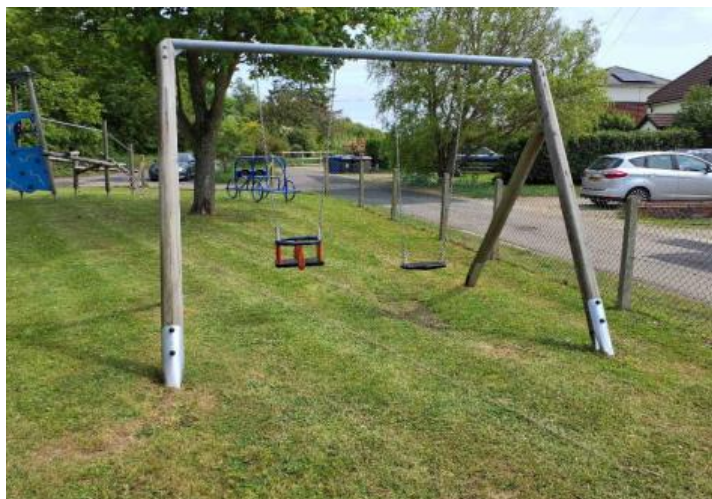
**Finding:** The bushes are showing signs of wear

**Action:** Monitor for any further deterioration and replace as required

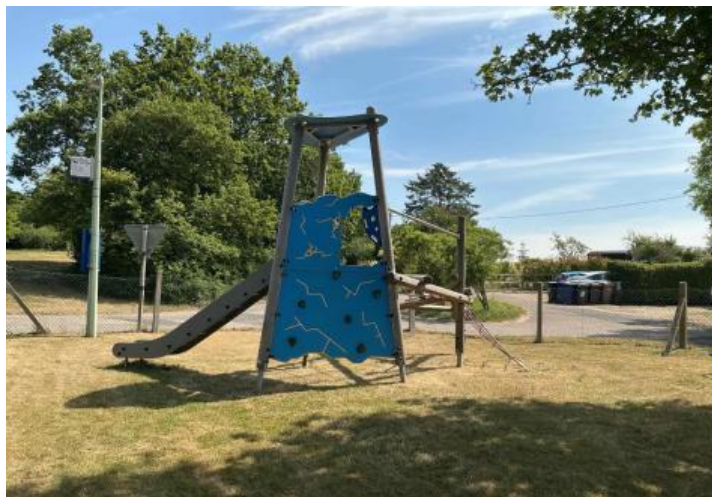
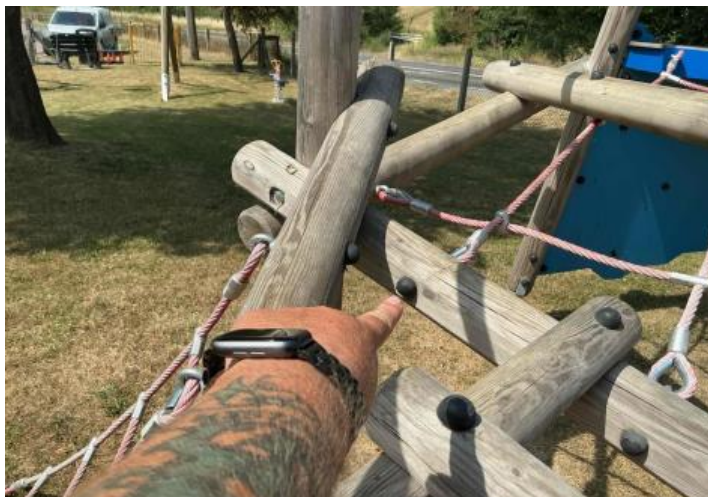
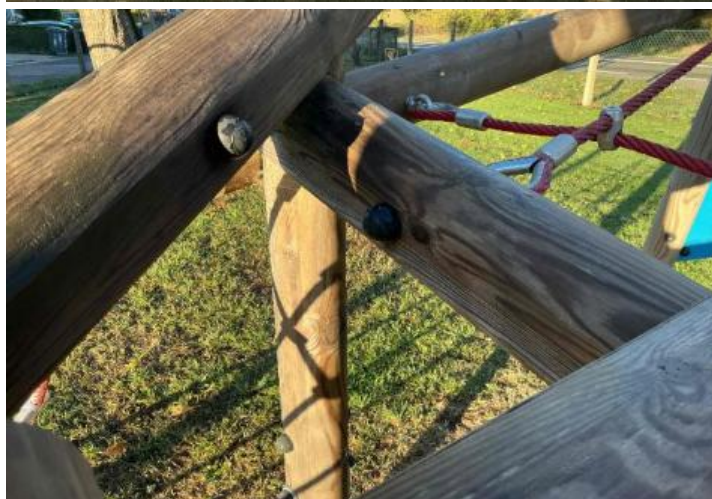
**Finding:** A number of fixing(s) have worked loose

**Action:** Secure all loose fixings

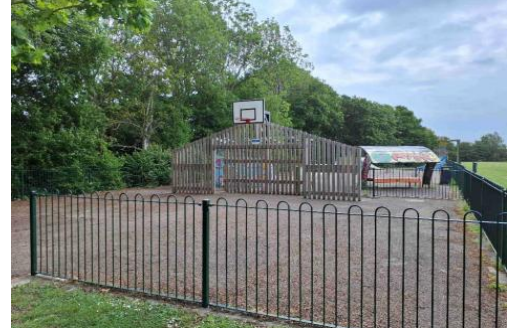
The concrete at site entrance is damaged creating a trip hazard - Repair

There is moderate damage to the surface - Repair the damaged areas of surfacing

The concrete foundation around the goal structure is lifting - Repair

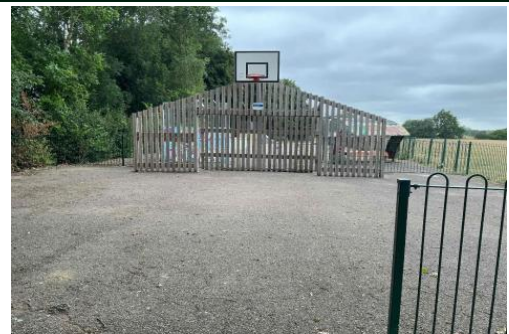
Parts of the timber are rough or splintered - Remove all rough or sharp edges

There is algae, silt or moss growth on the surface resulting in slippery conditions - Clean and treat appropriately

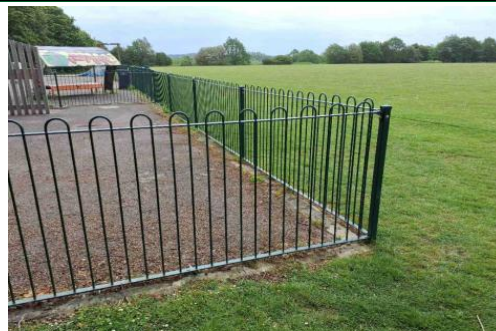
There are a number of fixings missing from the fence - Replace missing fixings

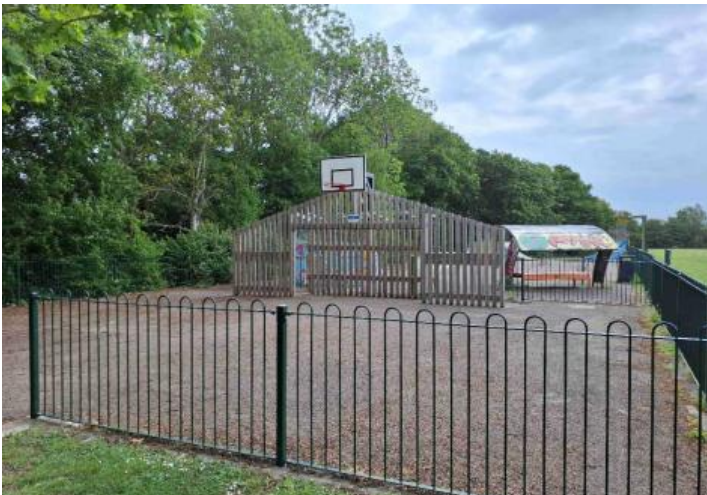
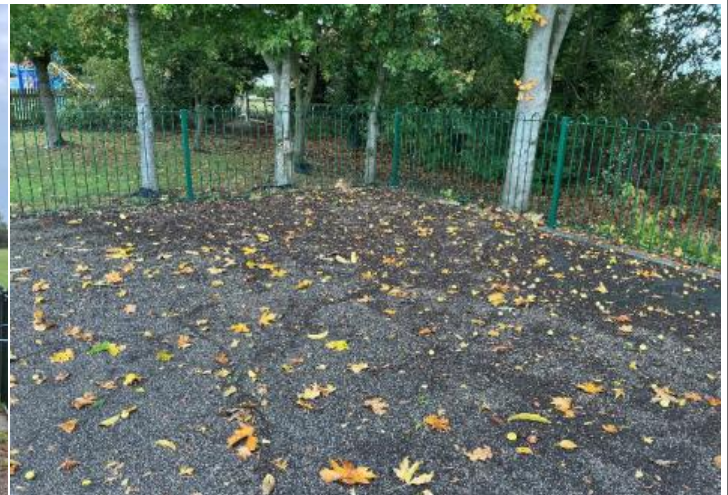
**Finding:** There is some tree debris on the surfacing  
**Action:** Remove and maintain

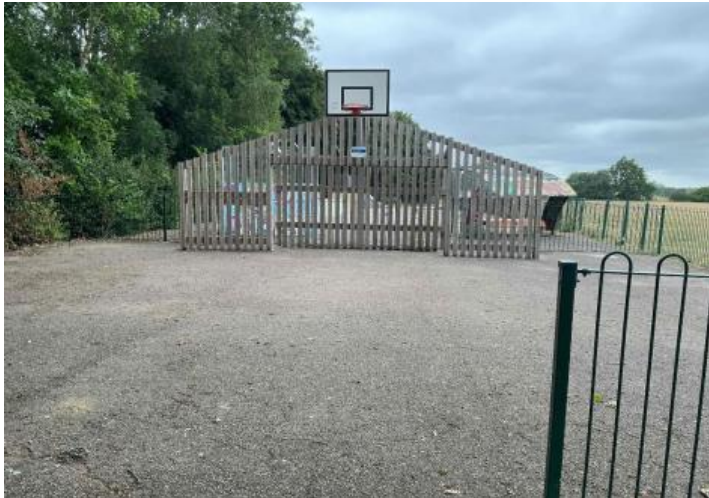
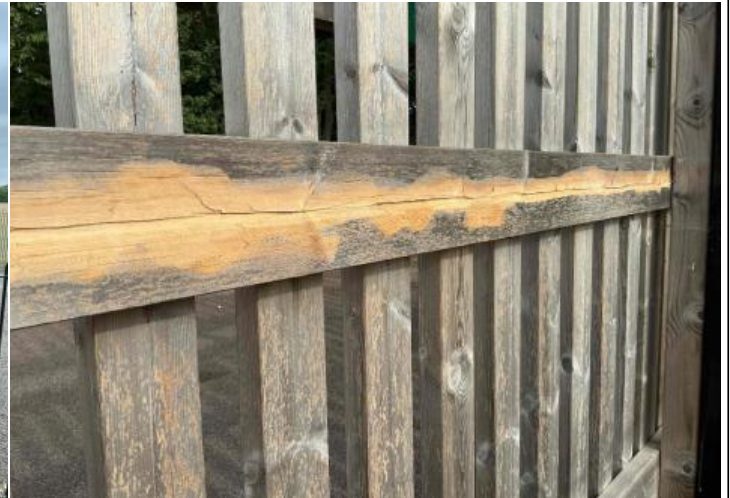
**Finding:** Parts of the timber are rough or splintered

**Action:** Remove all rough or sharp edges

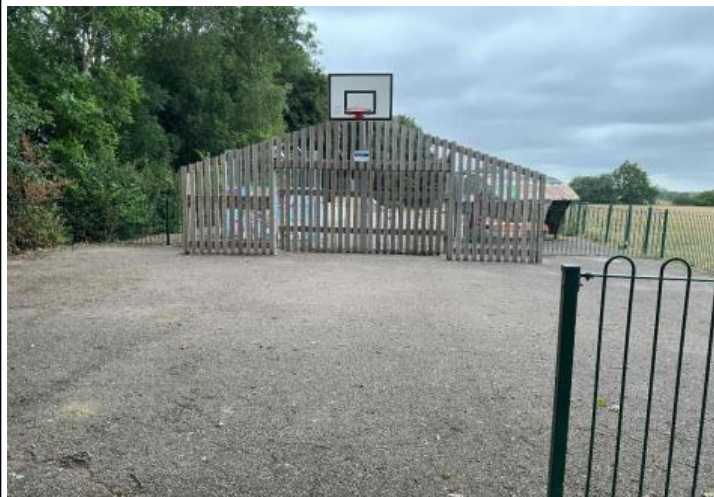
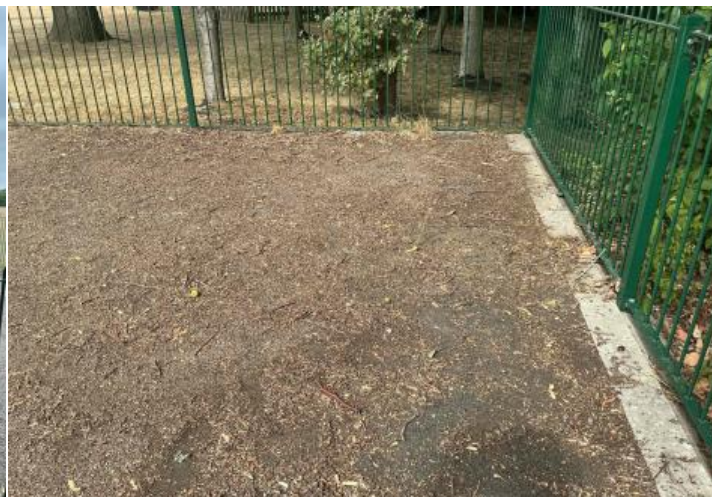
**Finding:** There is some tree debris on the surfacing

**Action:** Remove and maintain

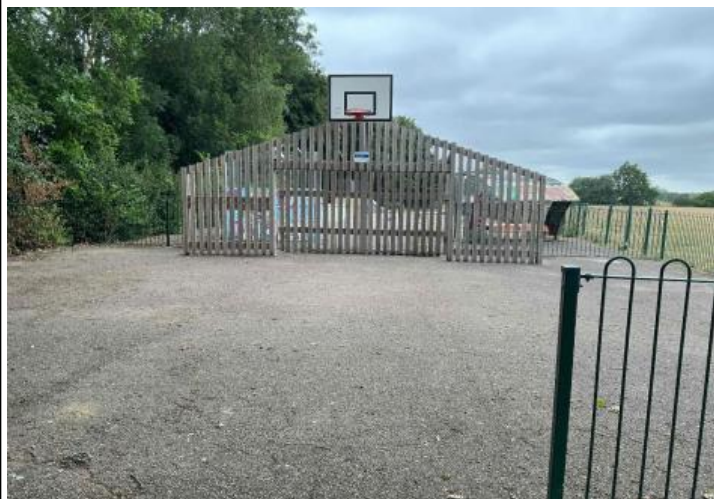
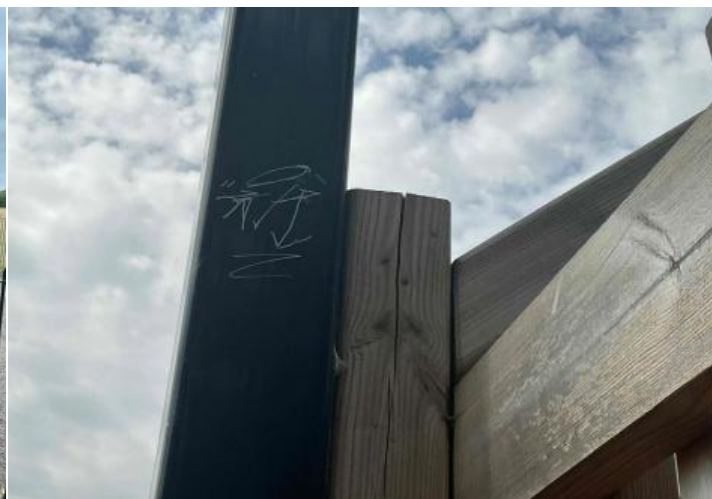
**Finding:** There is some graffiti present

**Action:** Remove the graffiti

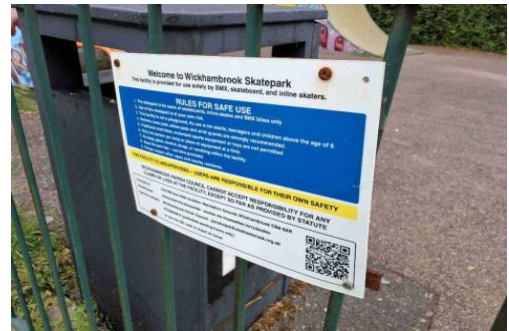
There are projecting bolt thread(s) present - Remove excess thread length and deburr or provide cap

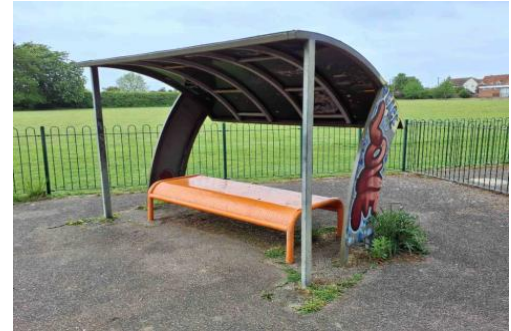
There is some evidence of fire damage to the item - Monitor for any further deterioration and repair as required

There is surface corrosion / rust present on the item - Consider treating the item

The item has been damaged leaving sharp edges - Repair item

Pop rivet fixings have failed on the seat - Replace the failed pop rivets

There is algae, silt or moss growth on the surface resulting in slippery conditions - Clean and treat appropriately

A number of fixing(s) have worked loose - Secure all loose fixings

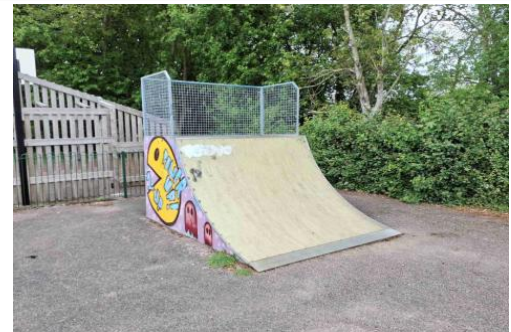
The item has been damaged - Monitor for any further deterioration and replace as required

Minor damage to surface - Monitor for deterioration

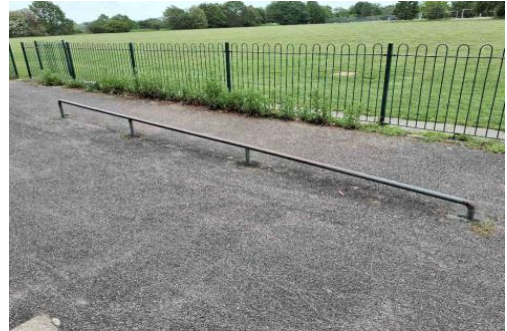
There is surface corrosion / rust present on the item - Consider treating the item

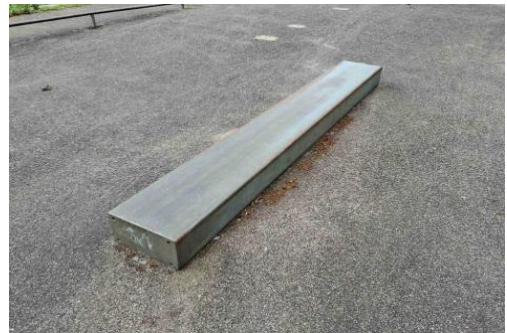
There is surface corrosion / rust present on the item - Consider treating the item

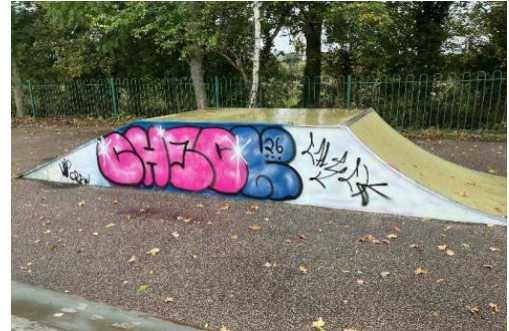
The riding surface has minor damage apparent - Monitor for any further deterioration and repair as required

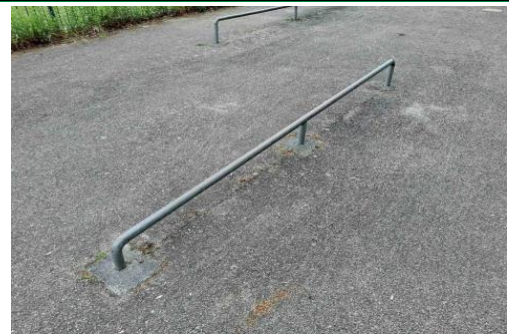
There is surface corrosion / rust present on the item - Consider treating the item

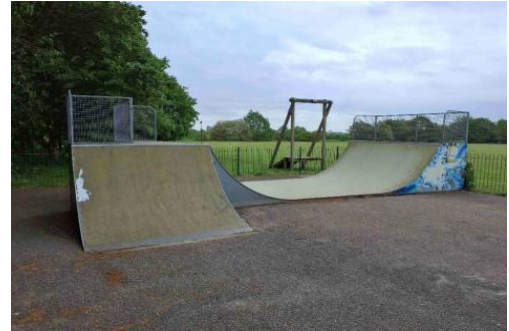
A number of fixing(s) have worked loose - Secure all loose fixings

There is some damage to the fence sections - Monitor for any further deterioration and repair as required

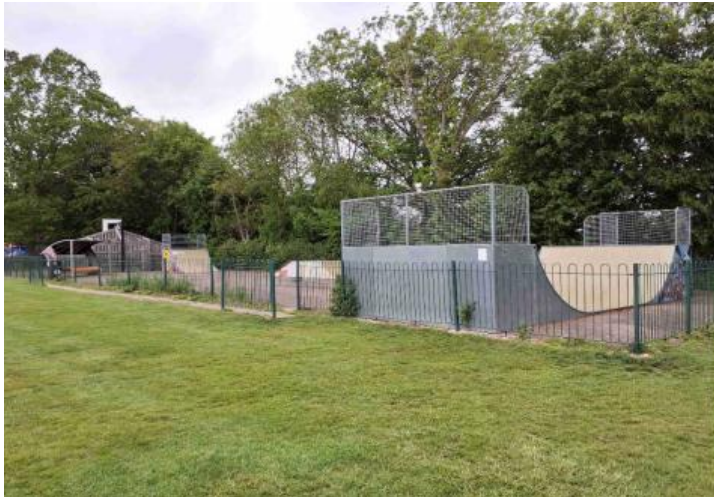
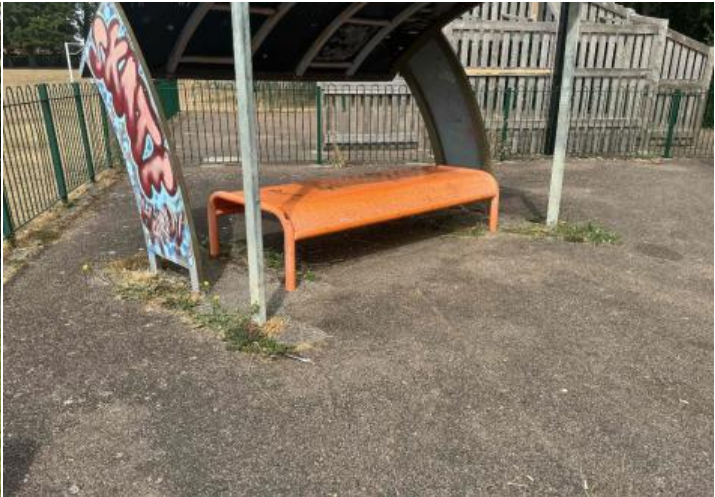
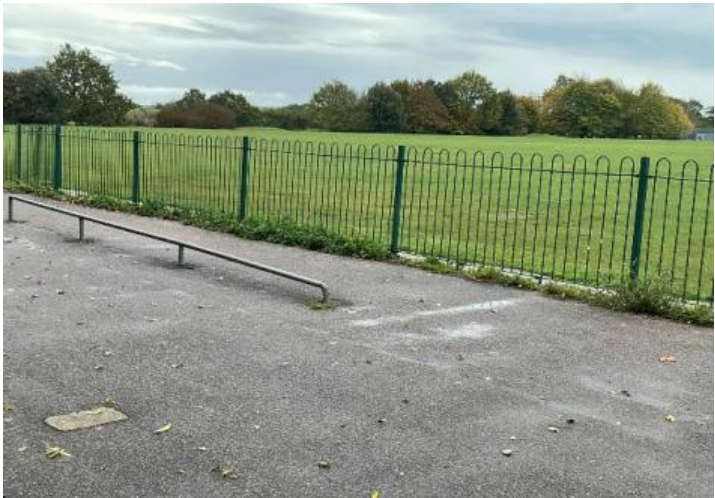
| <b>Finding:</b> There is weed / vegetation growth on, between, or around the edges of the surfacing | | <b>Action:</b> Remove weed / vegetation growth | |

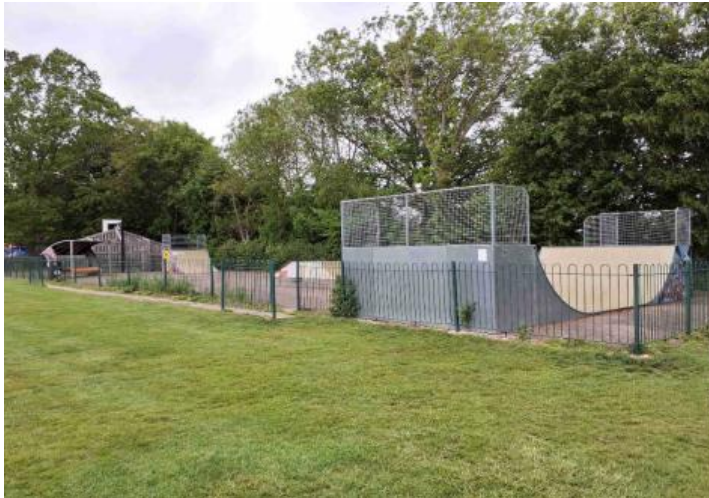
**Finding:** There is root damage to the surfacing creating unforeseen changes in levels

**Action:** Repair the damaged areas of tarmac to provide a uniform surface

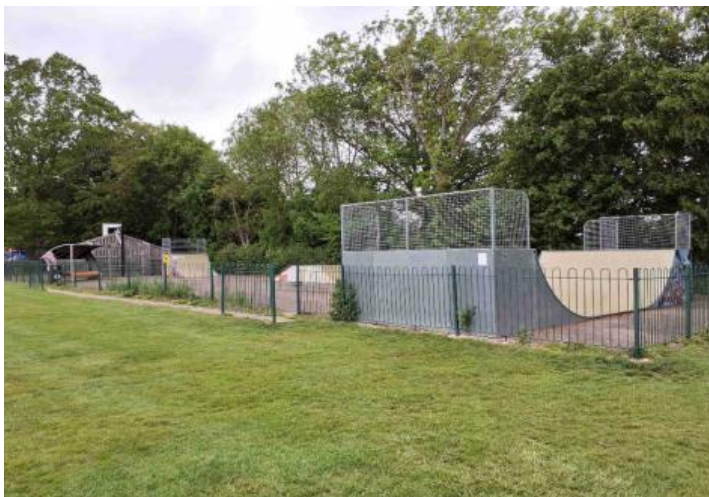
**Finding:** There is some damage apparent to the riding surface

**Action:** Monitor for any further deterioration and repair as required

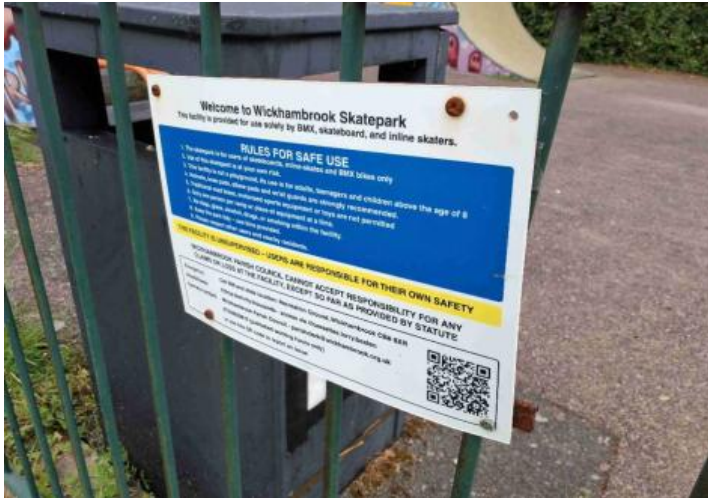
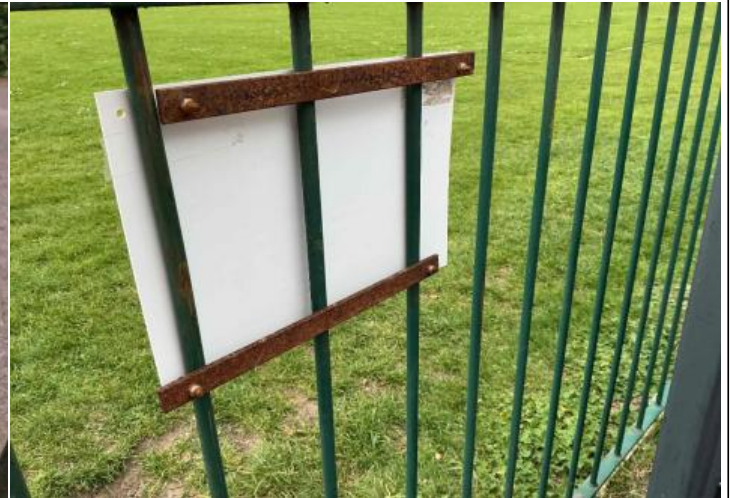
**Finding:** There are projecting bolt thread(s) present

**Action:** Remove excess thread length and deburr or provide cap

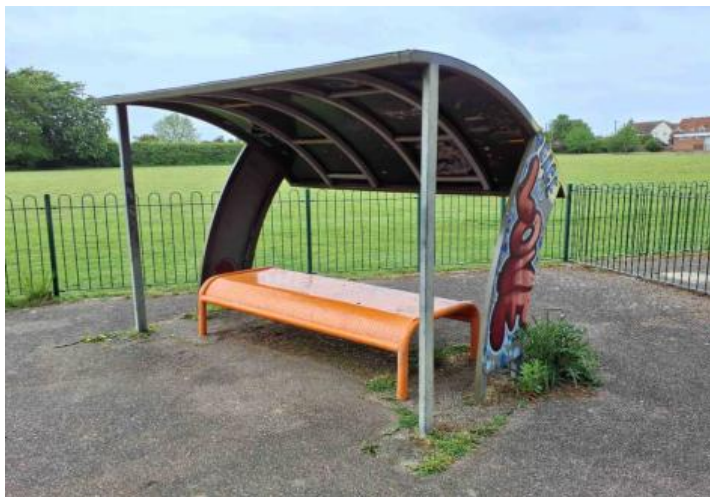
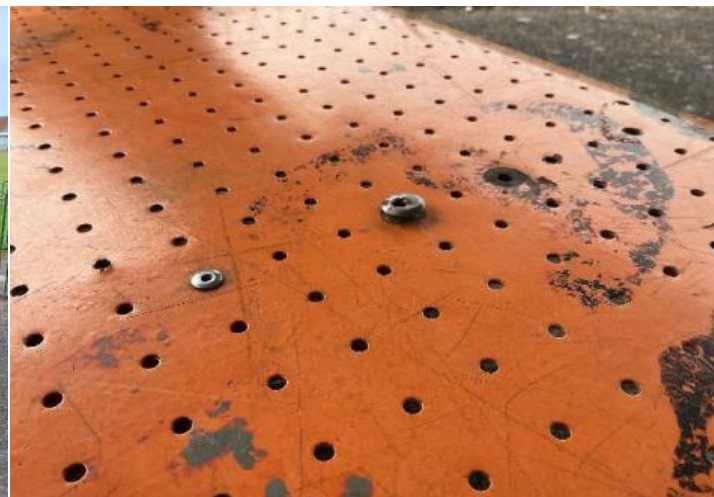
**Finding:** Pop rivet fixings have failed on the seat

**Action:** Replace the failed pop rivets

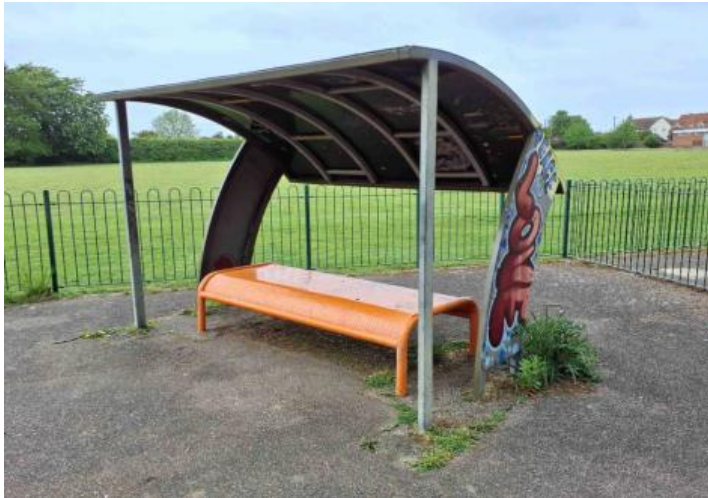
**Finding:** There is surface corrosion / rust present on the item

**Action:** Consider treating the item

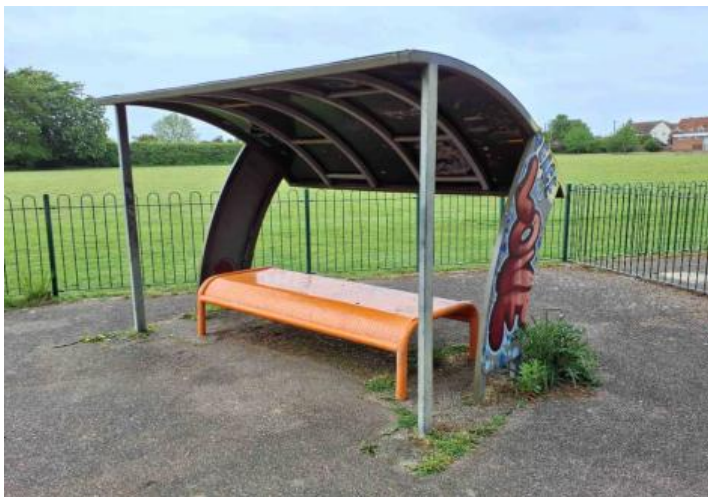
**Finding:** There is algae, silt or moss growth on the surface resulting in slippery conditions

**Action:** Clean and treat appropriately

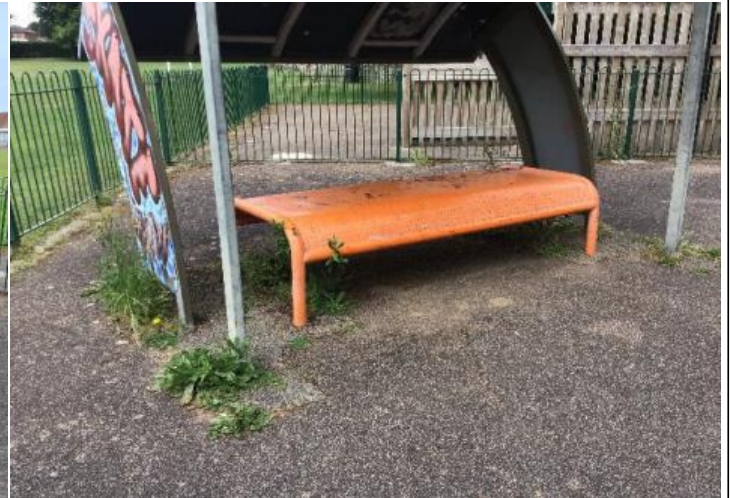
**Finding:** There is weed / vegetation growth within the surface

**Action:** Remove weed / vegetation growth

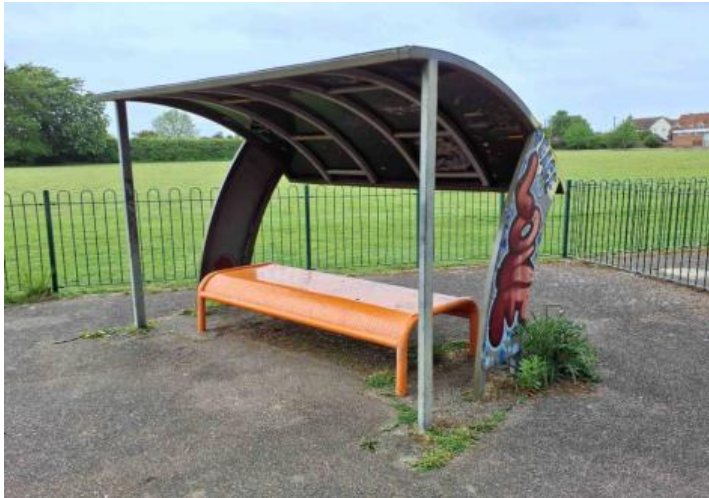
**Finding:** The item has been damaged leaving sharp edges **Action:** Repair item

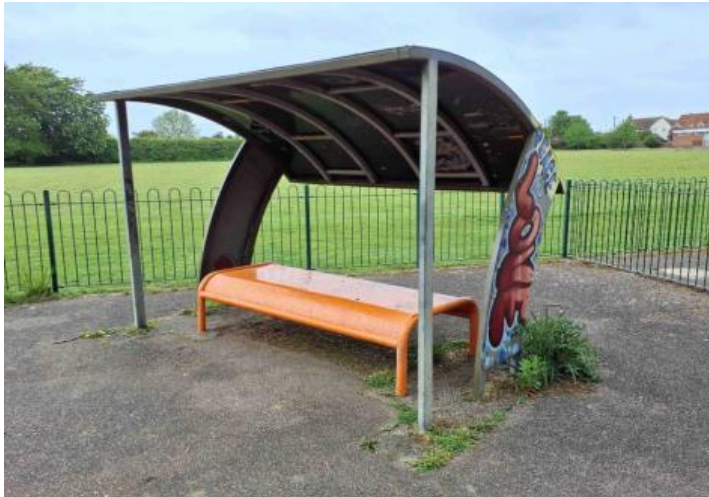
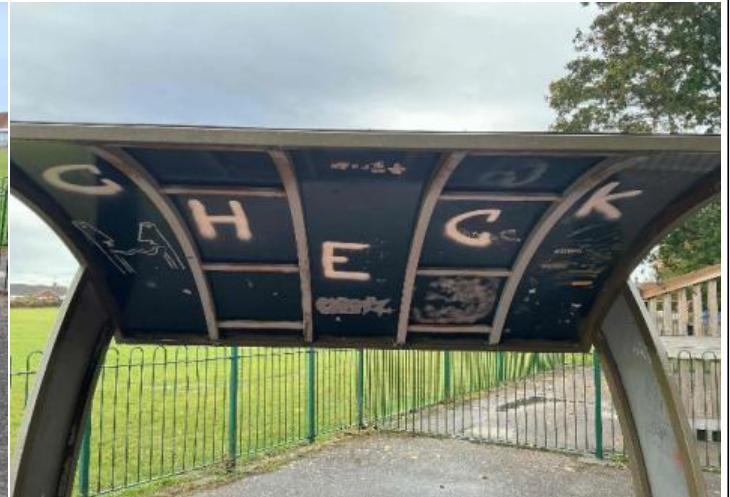
**Finding:** There is some graffiti present **Action:** Remove the graffiti

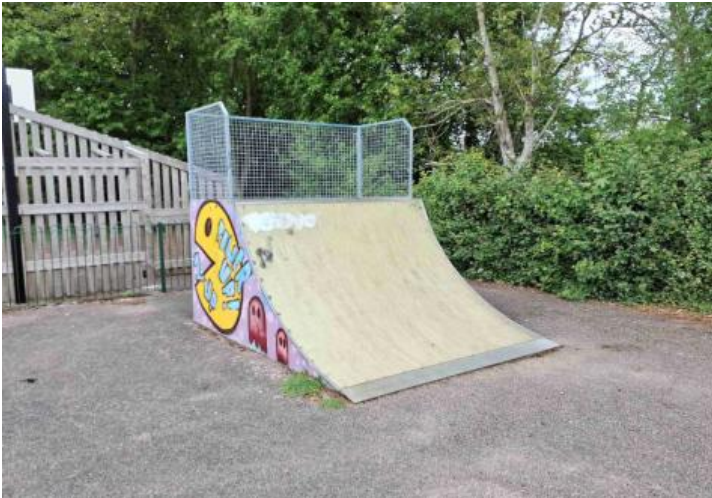
**Finding:** The item has been damaged

**Action:** Monitor for any further deterioration and replace as required

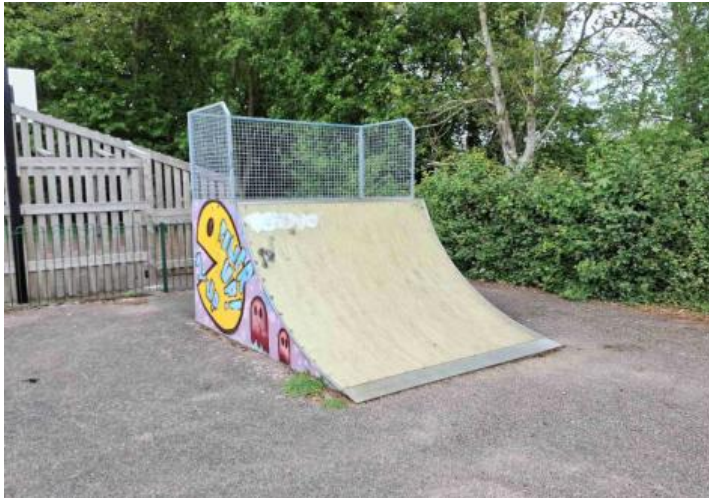
**Finding:** Minor damage to surface

**Action:** Monitor for deterioration

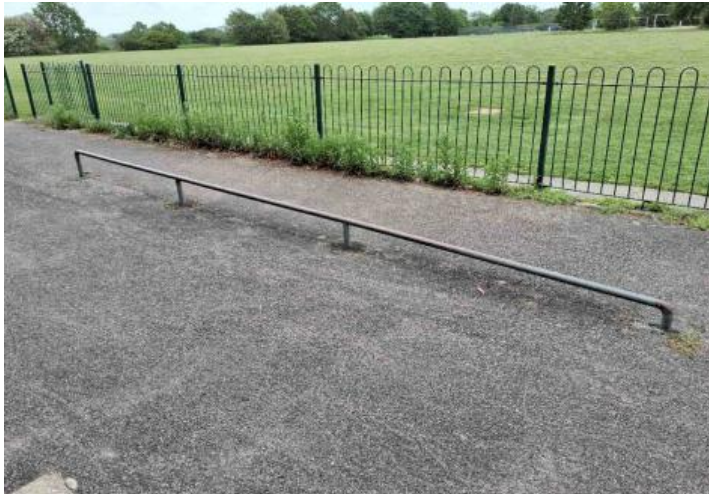
**Finding:** There is surface corrosion / rust present on the item

**Action:** Consider treating the item

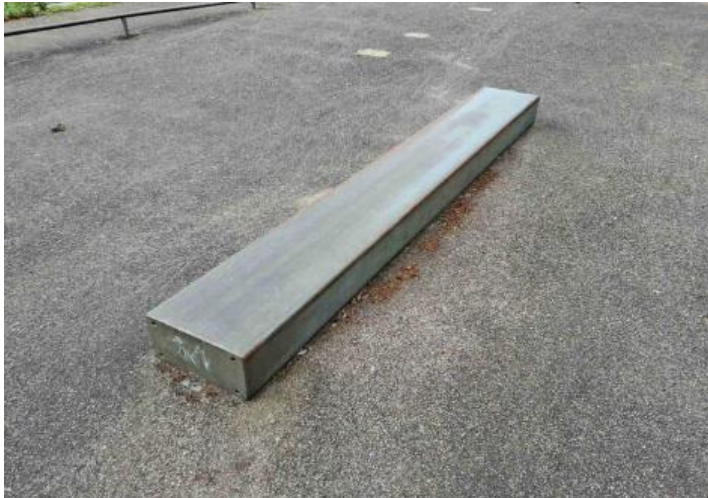
**Finding:** There is surface corrosion / rust present on the item

**Action:** Consider treating the item

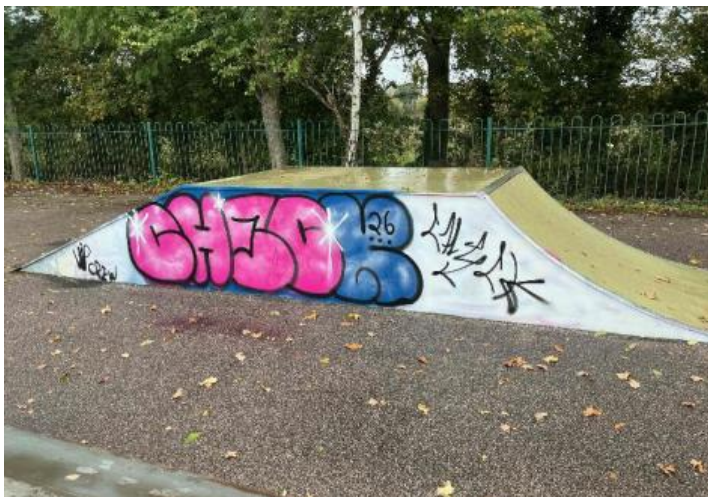
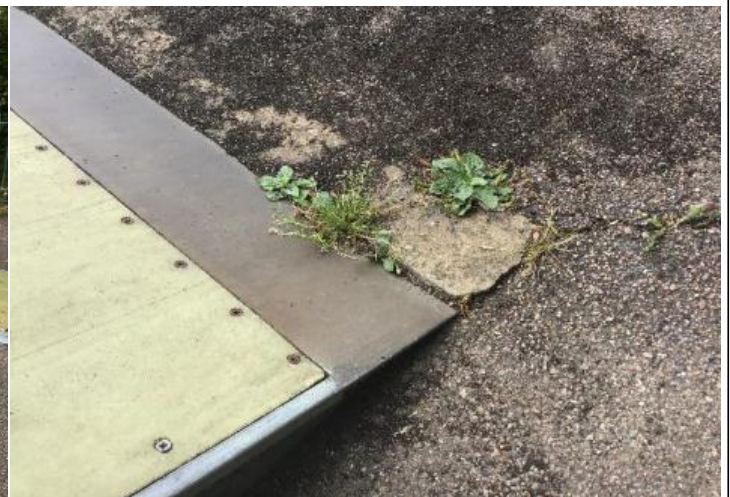
**Finding:** Concrete is lifting at the front of the ramp

**Action:** Remove and reinstate concrete (level)

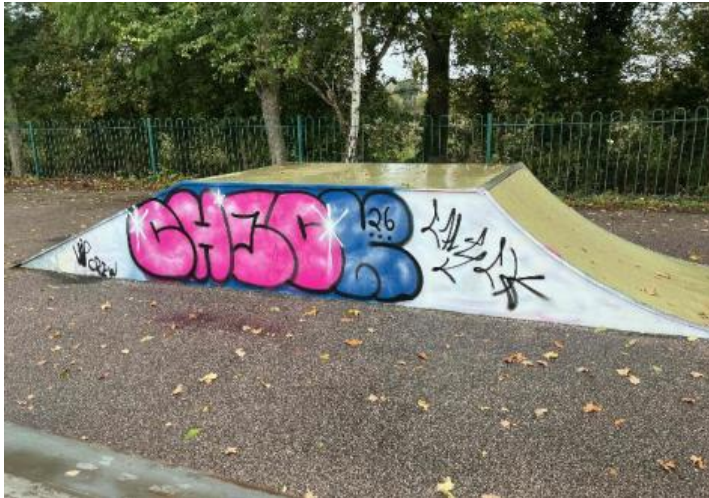
**Finding:** The riding surface has minor damage apparent

**Action:** Monitor for any further deterioration and repair as required

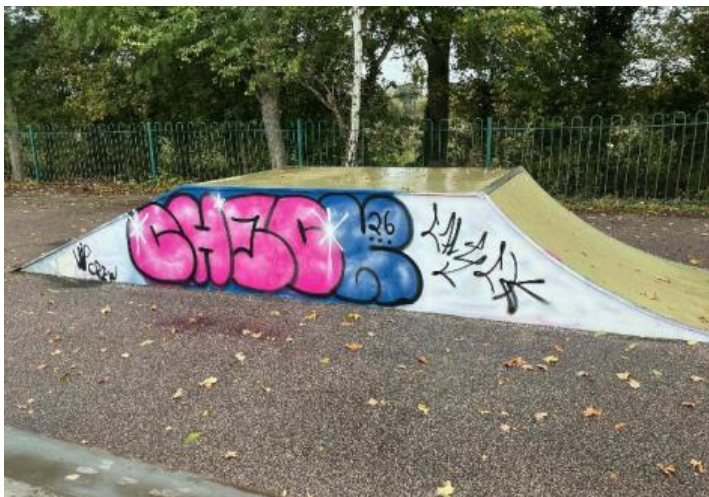
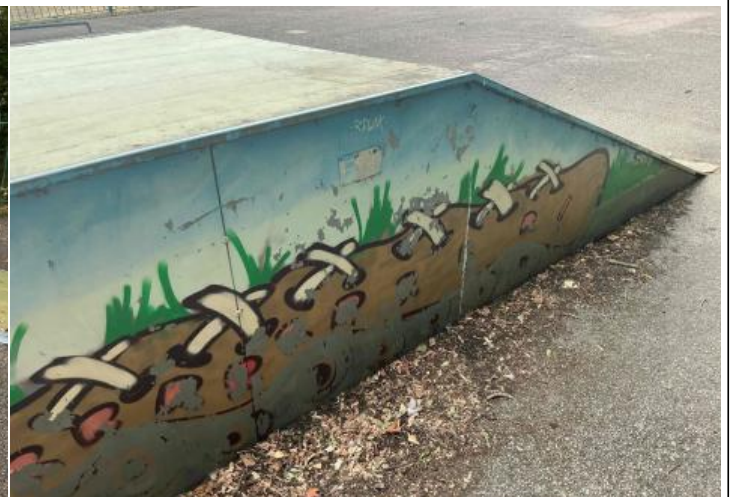
**Finding:** The paint is flaking off the metalwork

**Action:** Rub down and re-paint

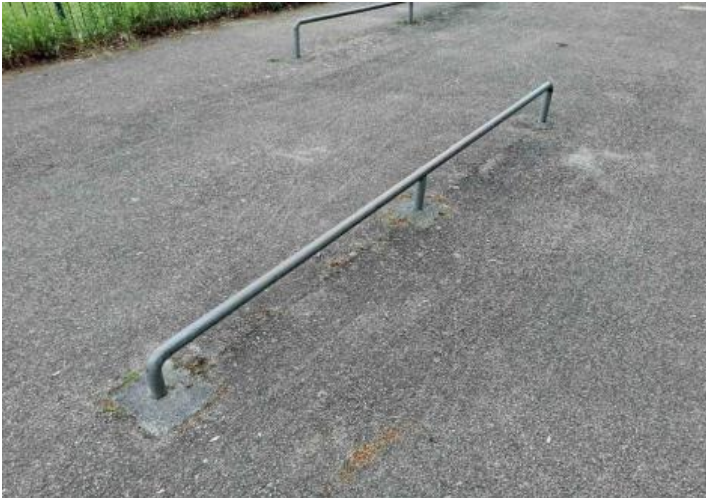
**Finding:** There is surface corrosion / rust present on the item

**Action:** Consider treating the item

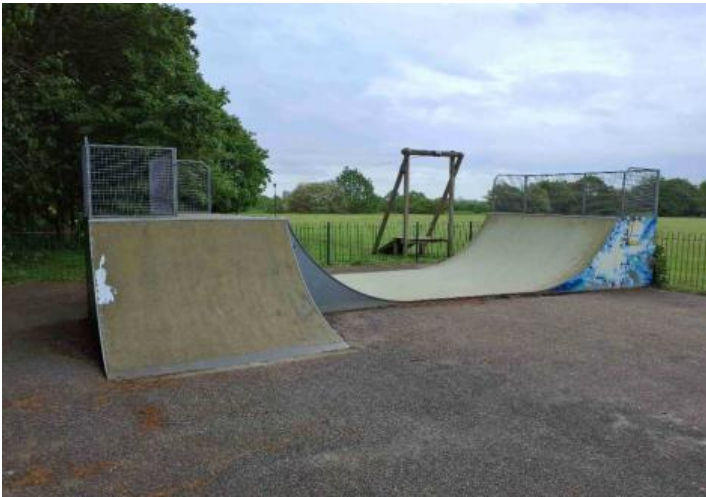
**Finding:** A number of fixing(s) have worked loose

**Action:** Secure all loose fixings

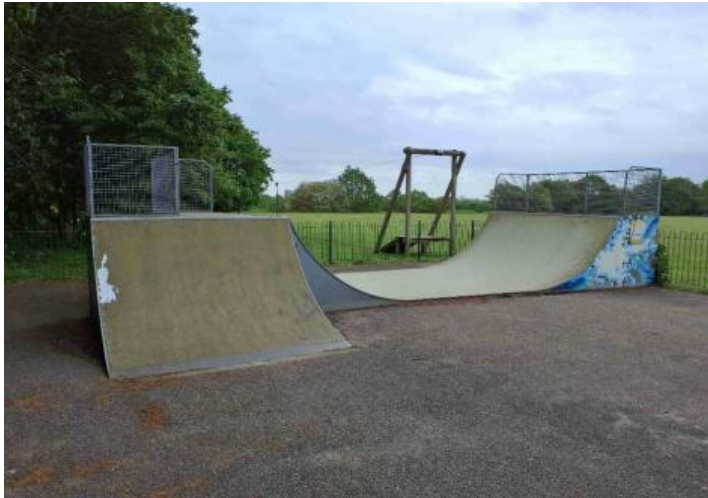
**Finding:** There is some damage to the fence sections

**Action:** Monitor for any further deterioration and repair as required

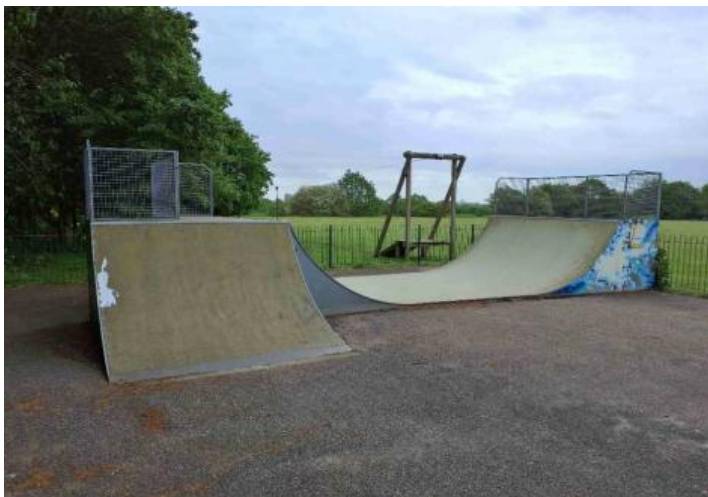
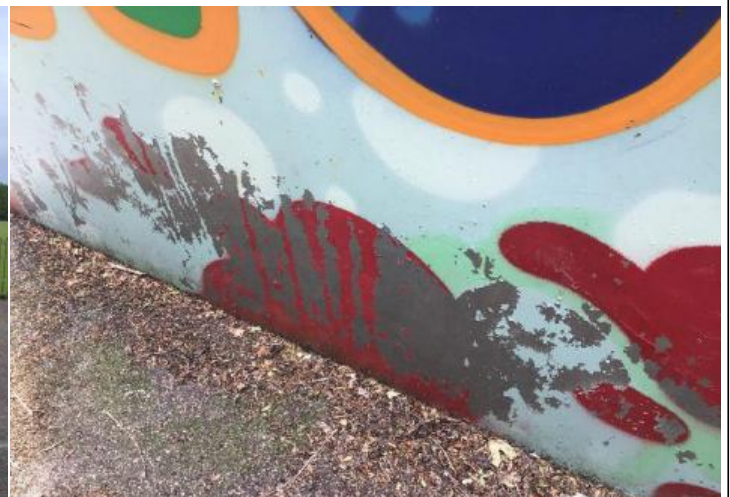
**Finding:** The paint is flaking off the metalwork

**Action:** Rub down and re-paint

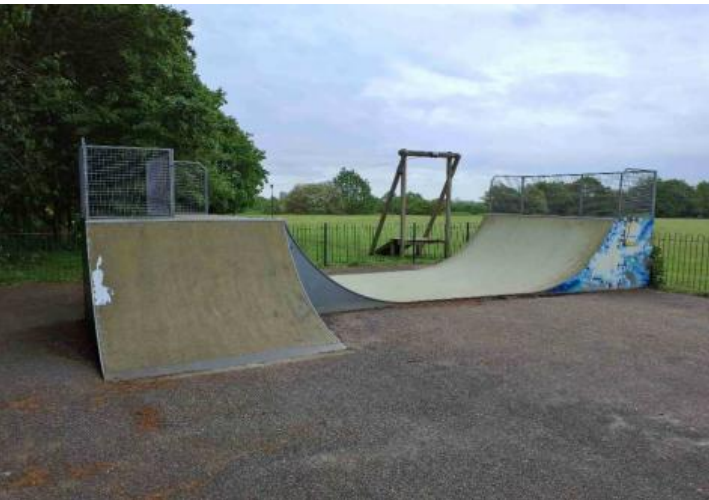
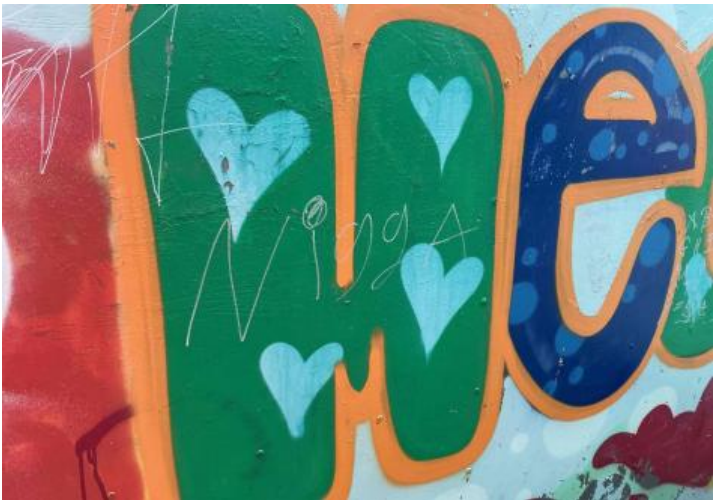
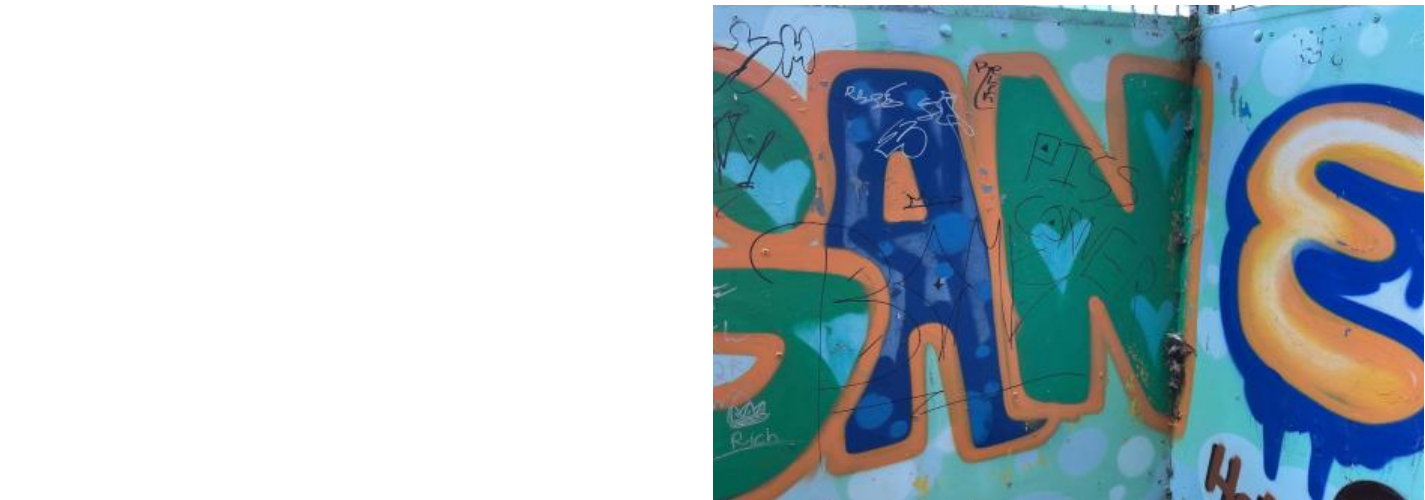
**Finding:** There is offensive graffiti present

**Action:** Remove as soon as practicable

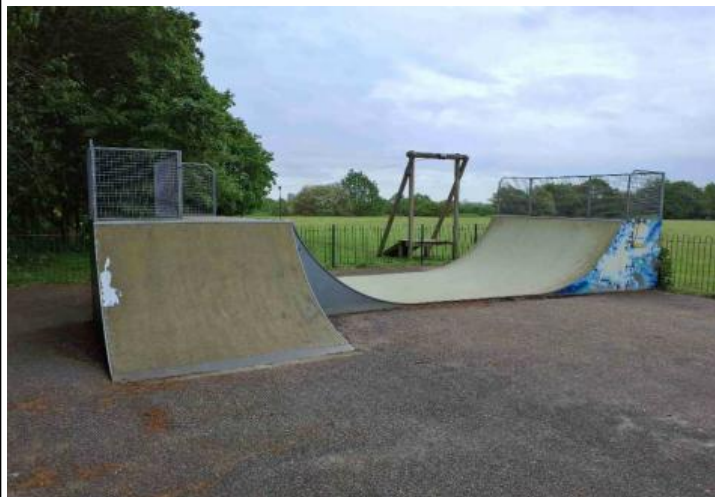
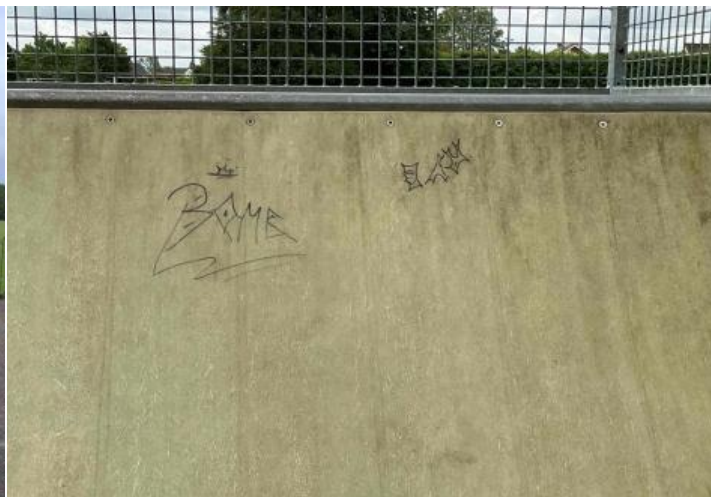
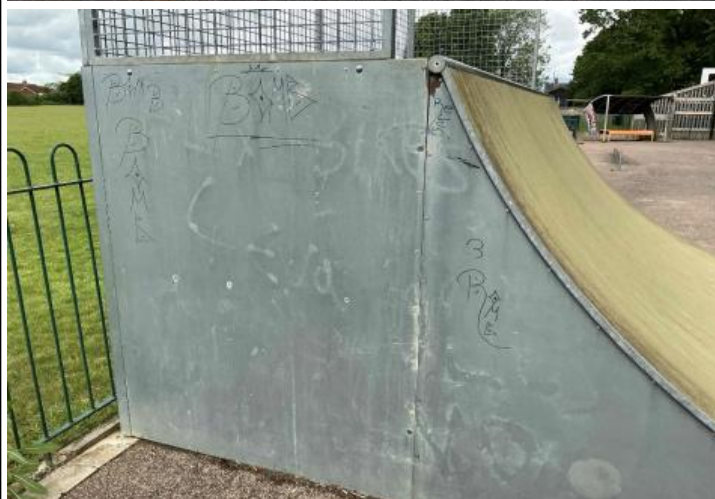
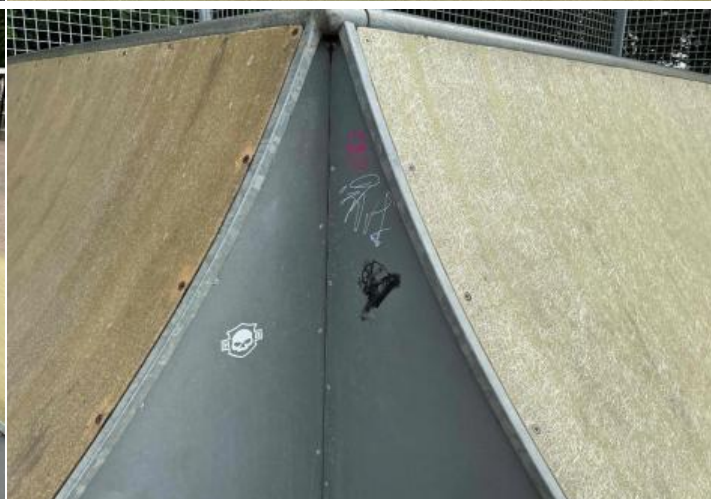
**Finding:** There is some graffiti present

**Action:** Remove the graffiti

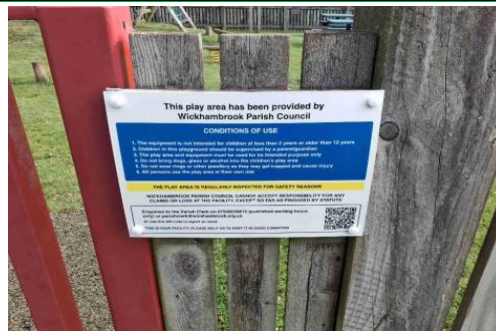
There are projecting bolt thread(s) present - Remove excess thread length and deburr or provide cap

The item has been damaged - Monitor for any further deterioration and replace as required
