## **Play Area Inspection Reports & Remedial Work**

## Wickhambrook. Bury Road

Inspection Ref: 3230454

Operational Inspection - 8-October-2026 - 08:11 Inspector Philip Smith

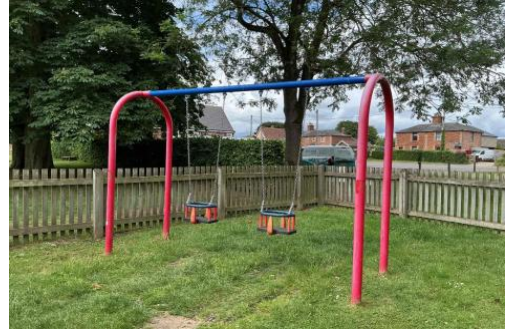
There is moderate damage to the surface - Repair the damaged areas of surfacing

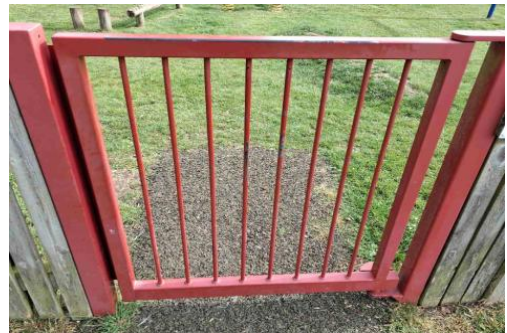
The paint is flaking off the metalwork - Rub down and re-paint

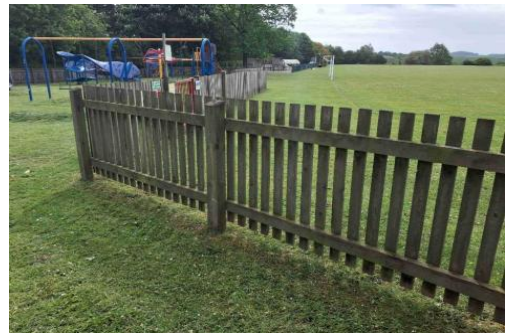
Slats damaged - Replace damaged slat

There is some strimmer / machinery damage apparent on the posts, this can penetrate the preservative applied to the timber and accelerate the rotting process - Monitor for any deterioration (rot) and replace as required

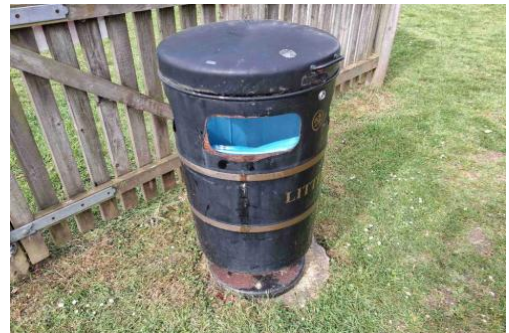
The paintwork on this item has been damaged or worn exposing the metal underneath which is rusting / corroding - Treat affected areas and repaint

The foundation is loose - Reinstate the foundation

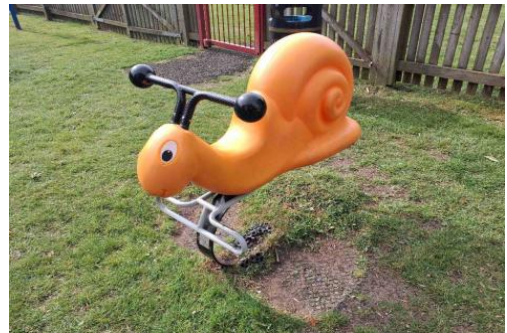
A number of fixing(s) have worked loose - Secure all loose fixings

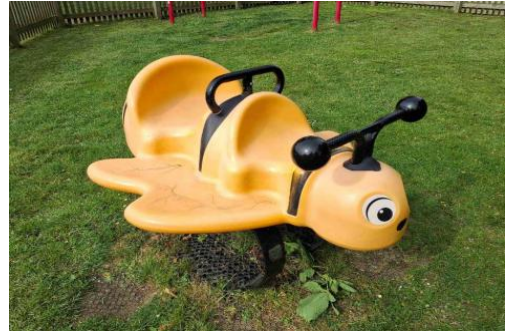
There is or are fixings missing on the item - Replace all missing fixings

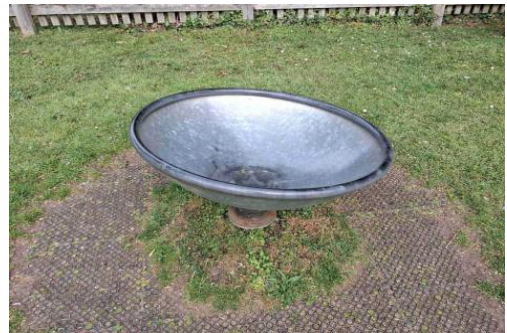
The grass mats are silted up, the soil is compacted and the area will become very slippery when the soil is wet. - Reinstate as required

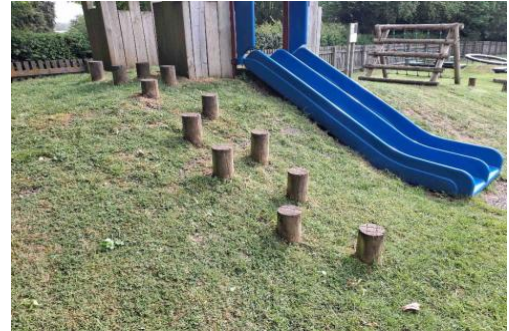
There is some strimmer / machinery damage apparent on the posts, this can penetrate the preservative applied to the timber and accelerate the rotting process - Monitor for any deterioration (rot) and replace as required

The timber has a number of splits/shakes or air cracks and this may affect the stability or allow water ingress which will accelerate the rotting process - Monitor to ensure the splits do not cross through fixing points of the structure and/or cause any instability

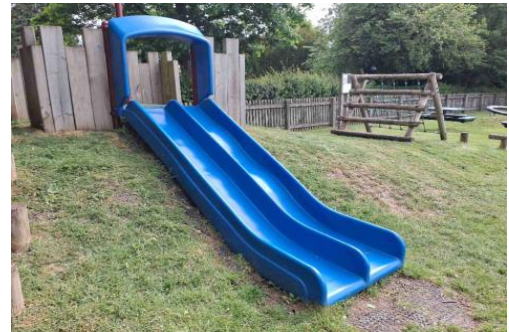
The surface has eroded in some areas and may be slippery in wet conditions - Reinstate the surface

There are trip hazards at the edges of the surface - Reinstate surrounding surface levels to remove the trip points

Some timbers are slightly loose in the foundation - Monitor for deterioration

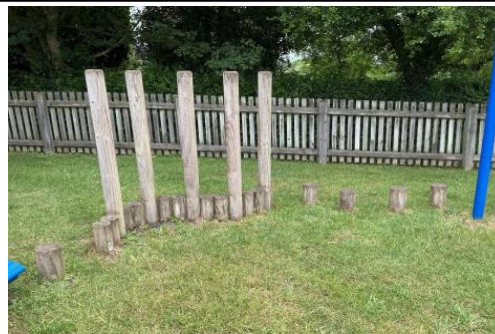
The timber has a number of splits/shakes or air cracks and this may affect the stability or allow water ingress which will accelerate the rotting process - Monitor to ensure the splits do not cross through fixing points of the structure and/or cause any instability

There is some evidence of rot in the timber - Monitor for any further deterioration and replace as required

There is some strimmer / machinery damage apparent on the posts, this can penetrate the preservative applied to the timber and accelerate the rotting process - Monitor for any deterioration (rot) and replace as required

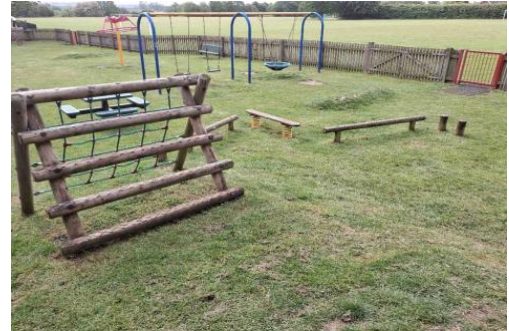
There is some strimmer / machinery damage apparent on the posts, this can penetrate the preservative applied to the timber and accelerate the rotting process - Monitor for any deterioration (rot) and replace as required

There is/are bolt cap covers missing or damaged on the item - Replace missing or damaged bolt cap covers

The timber has a number of splits/shakes or air cracks and this may affect the stability or allow water ingress which will accelerate the rotting process - Monitor to ensure the splits do not cross through fixing points of the structure and/or cause any instability

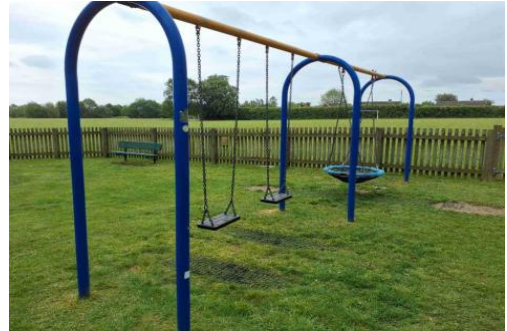
The seat has minor damage or wear - Monitor for any further deterioration and replace as required

There is/are bolt cap covers missing or damaged on the item - Replace missing or damaged bolt cap covers

There is some wear to the shackles - Monitor for any further deterioration and replace when 40% worn

The bushes are showing signs of wear - Monitor for any further deterioration and replace as required

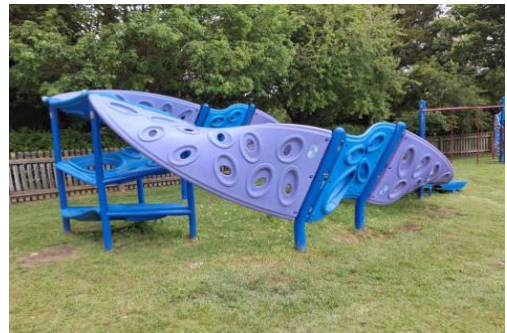
The connecting lugs are showing signs of wear - Monitor for any further deterioration and repair as required

The item has been damaged - Sand down plastic to remove sharp edge

The ropes/nets are worn/damaged in places - Monitor for any further deterioration and repair or replace as required

There is surface corrosion / rust present on the item - Consider treating the item

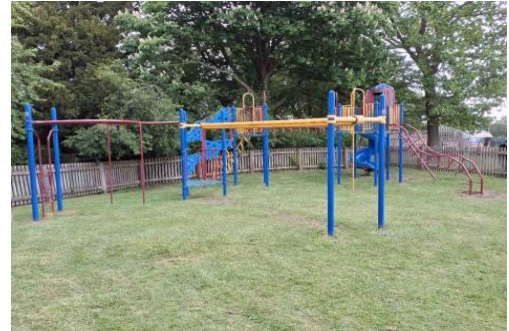
There is algae or moss on the surface of the equipment -  
Clean and treat appropriately

There are a number of dents in the slide surface - Monitor  
for any further deterioration and repair as required

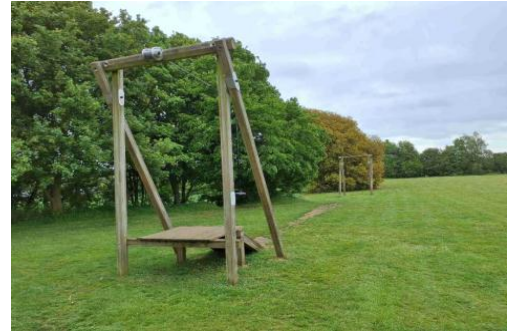
We have completed a visual inspection of the suspension links, cable and fixing points from ground level, however it is not possible to fully inspect these areas without either hiring equipment to gain access or removing the cable and suspension and inspecting at ground level. We recommend that the main cable and fixing security is thoroughly inspected at least in accordance with the manufacturers recommendations to check for wear, damage, security or internal rusting; this will help to ensure the continued safe use of the equipment - Inspect in accordance with the manufacturers recommendations

There is some strimmer / machinery damage apparent on the posts, this can penetrate the preservative applied to the timber and accelerate the rotting process - Monitor for any deterioration (rot) and replace as required

The nylon inserts are worn or missing at the point the cable enters the traveller - Replace worn or missing inserts as required

The seat connection cannot be inspected without dismantling the seat - Dismantle the seat to inspect the seat connection for wear

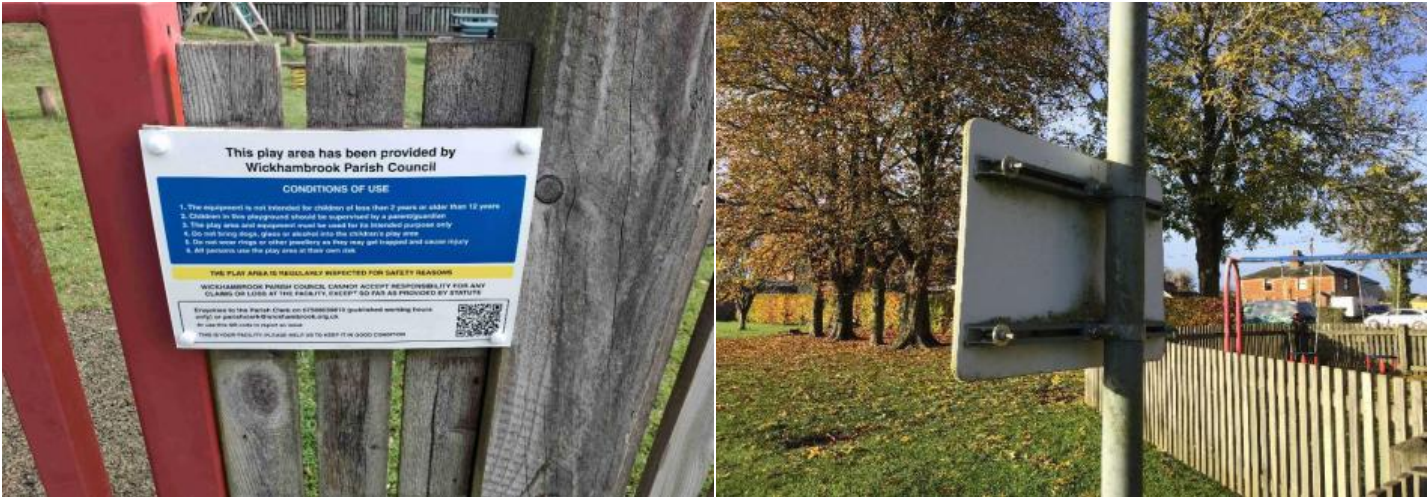
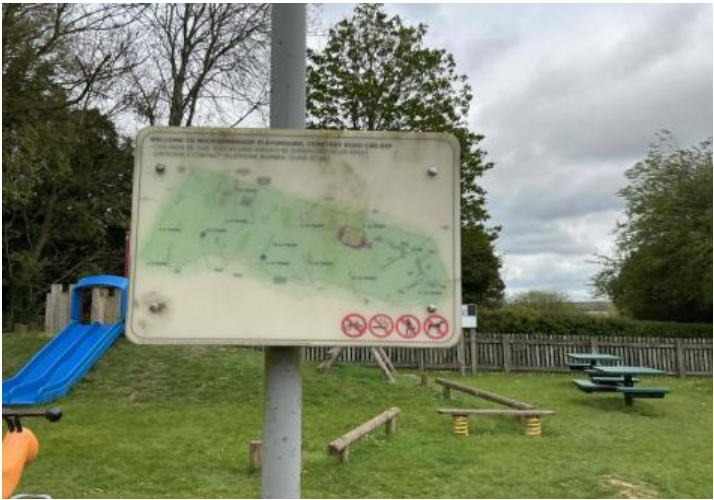
**Finding:** There are projecting bolt thread(s) present

**Action:** Remove excess thread length and deburr or provide cap

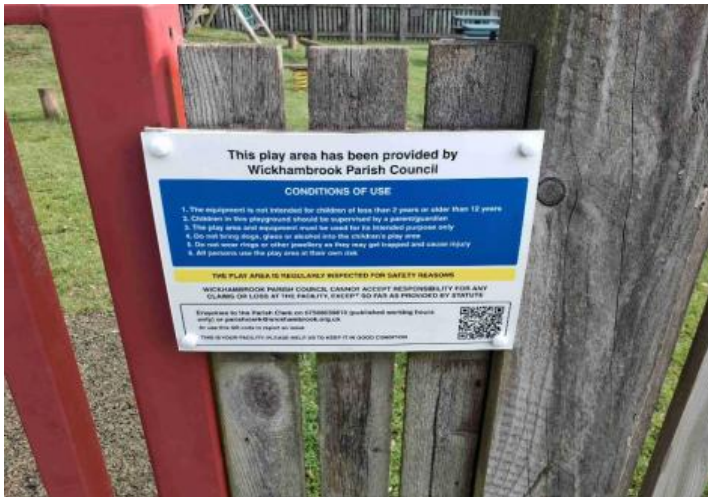
**Finding:** The item has been damaged

**Action:** Monitor for any further deterioration and replace as required

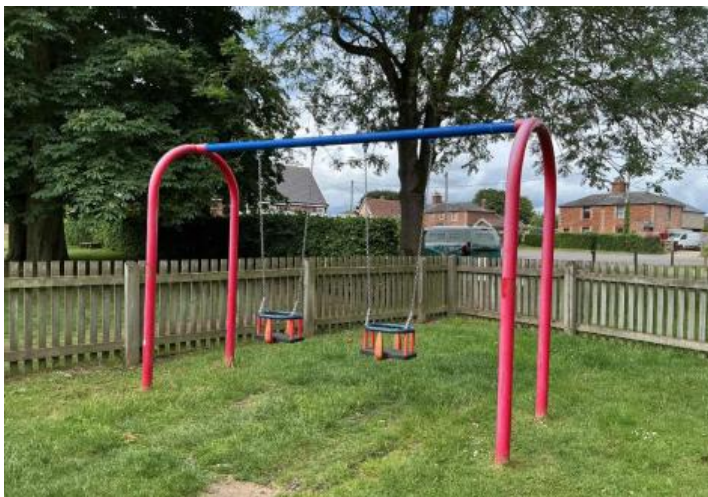
**Finding:** There is moderate damage to the surface

**Action:** Repair the damaged areas of surfacing

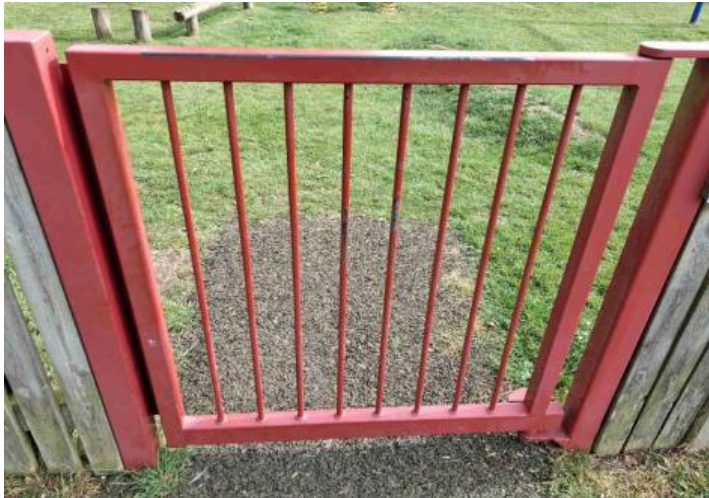
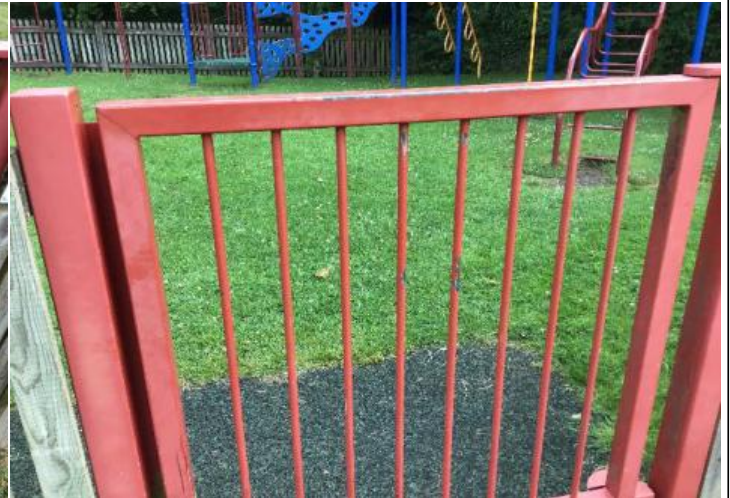
**Finding:** The paint is flaking off the metalwork

**Action:** Rub down and re-paint

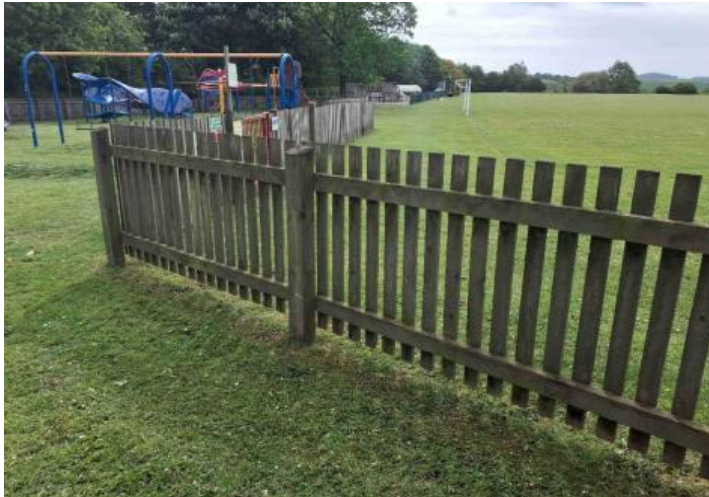
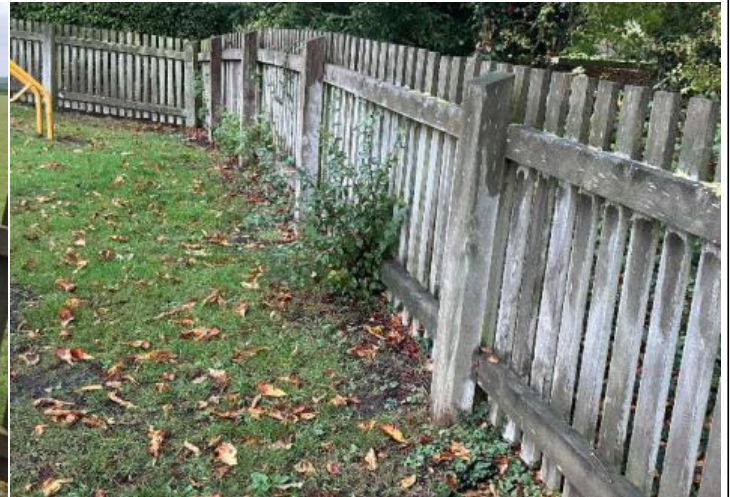
**Finding:** The adjacent foliage is overhanging

**Action:** Cut back and maintain

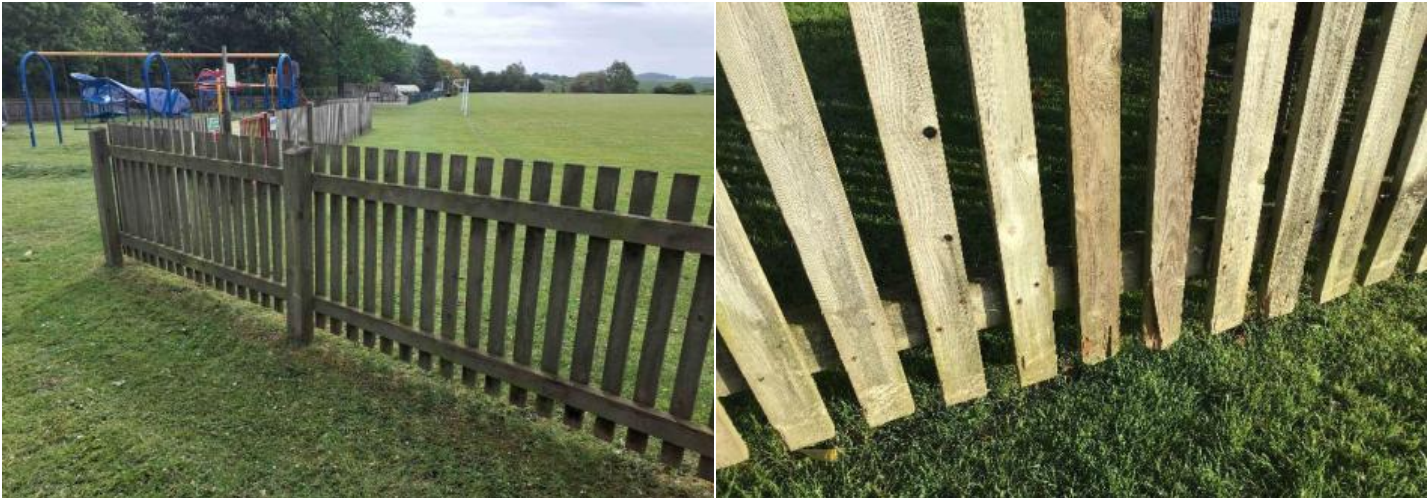
| Item: | Fences - Fencing - Timber | Risk Level: | L - Low Risk |

| Finding: | Parts of the timber are rough or splintered | Action: | Remove all rough or sharp edges |

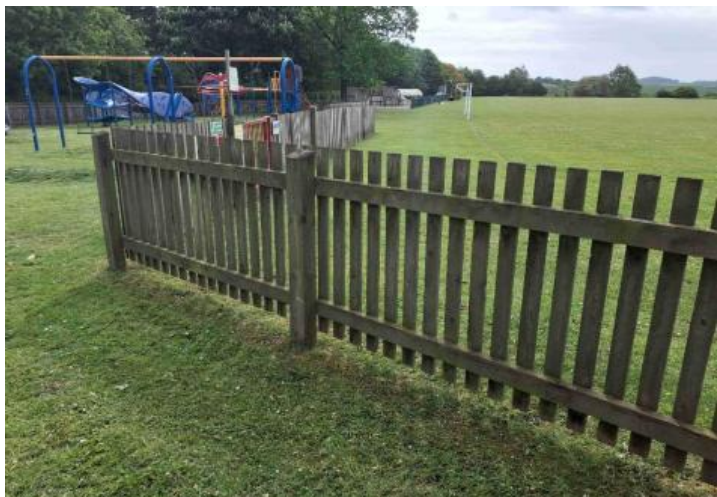
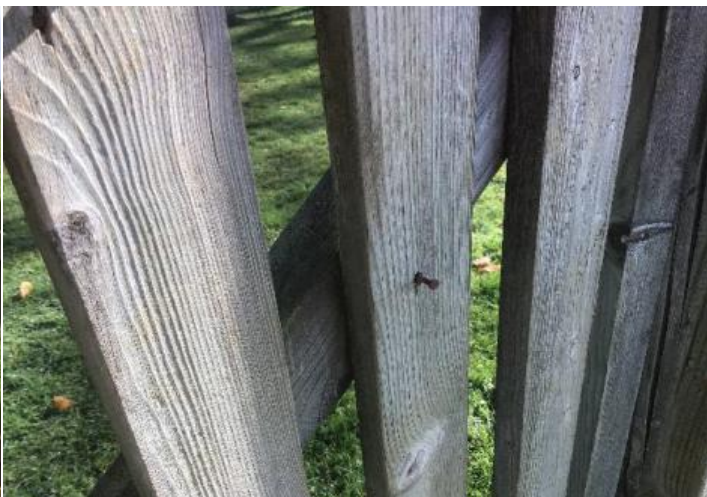
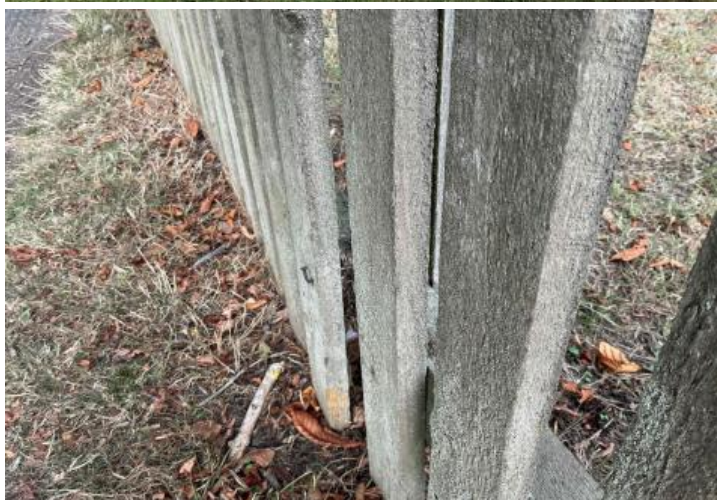
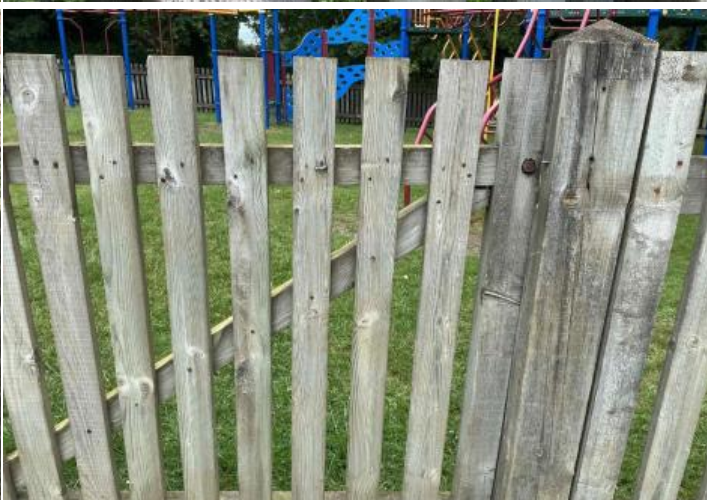
**i** 8 - Low Risk (Finding 5)

**Item:** Fences - Fencing - Timber  
**Manufacturer:** Not Identified

**Finding:** There are projecting nail ends present

**Action:** Remove and provide more appropriate fixings if required

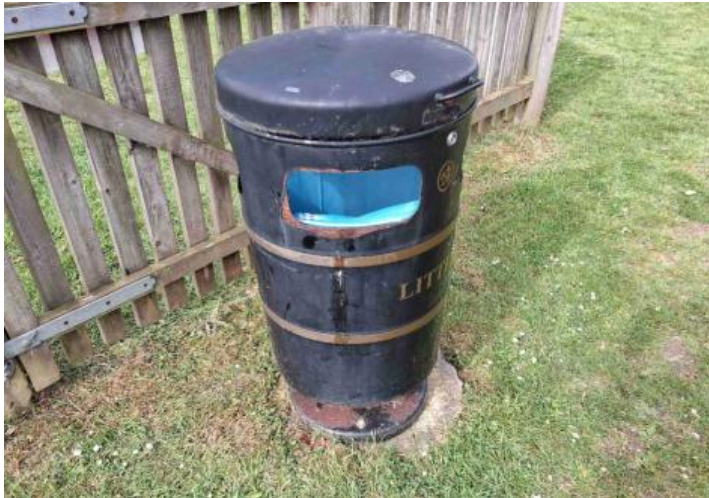
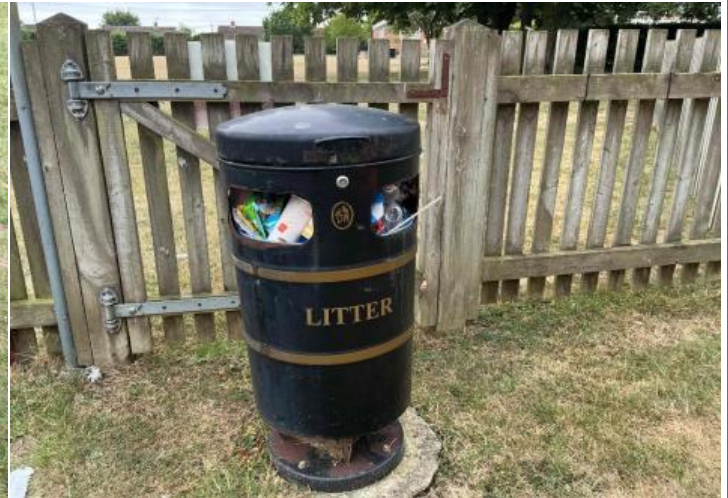
**Item:** Ancillary Items - Litter Bin  
**Manufacturer:** Not Identified

**Finding:** The litter bin is full

**Action:** Empty and review the collection routine

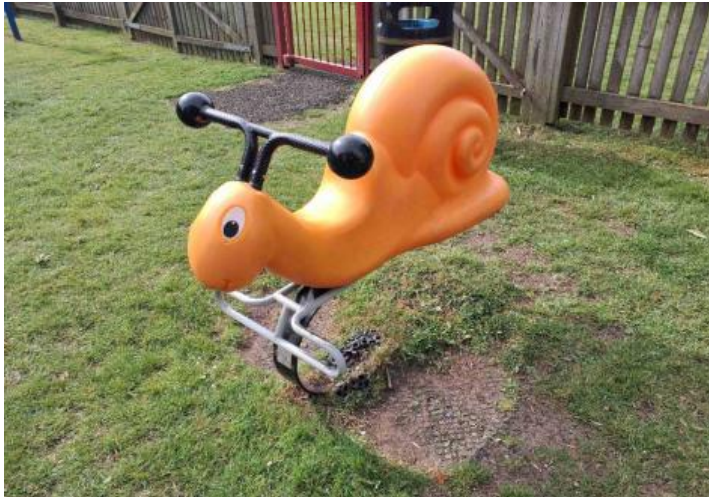
**Item:** Rocking Equipment - Spring Snail  
**Manufacturer:** Miracle Recreation Equipment Company

**Finding:** A number of fixing(s) have worked loose

**Action:** Secure all loose fixings

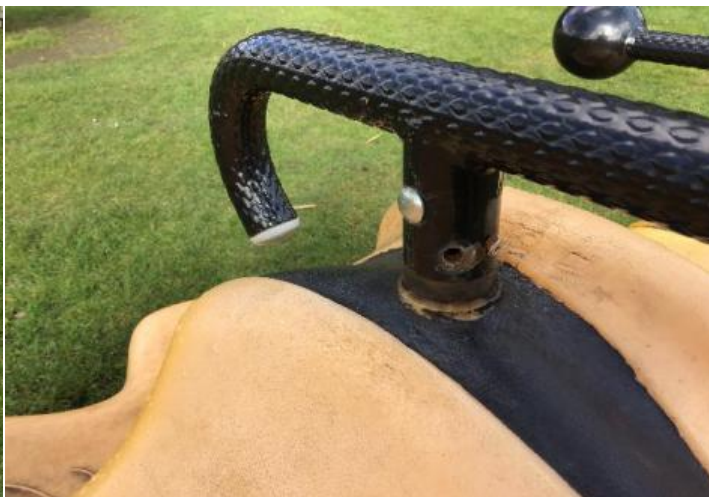
**Item:** Rocking Equipment - Spring Bee  
**Manufacturer:** Miracle Recreation Equipment Company

**Finding:** There is or are fixings missing on the item

**Action:** Replace all missing fixings

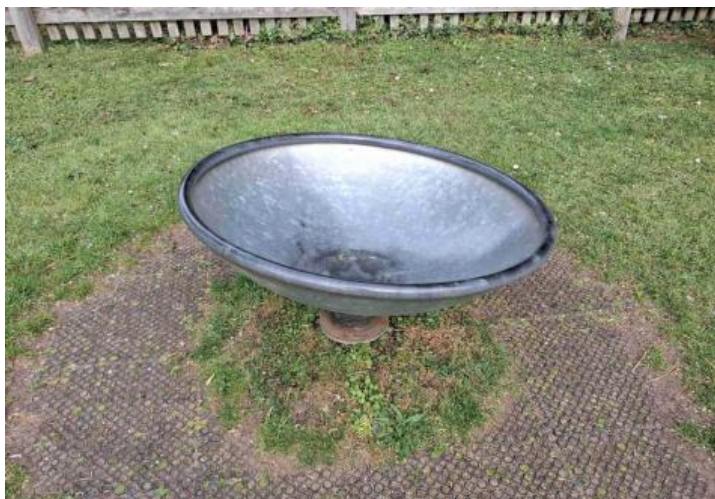
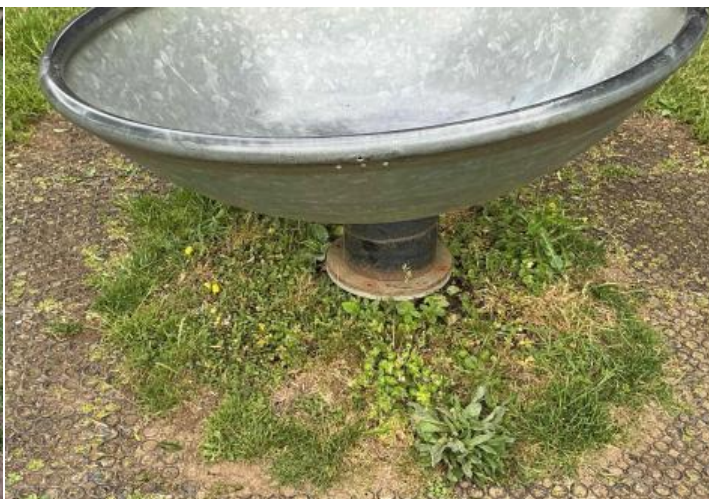
**Item:** Rotor Play - Dish Roundabout  
**Manufacturer:** Sutcliffe Play Limited

**Finding:** The grass mats are silted up, the soil is compacted and the area will become very slippery when the soil is wet.

**Action:** Reinstate as required

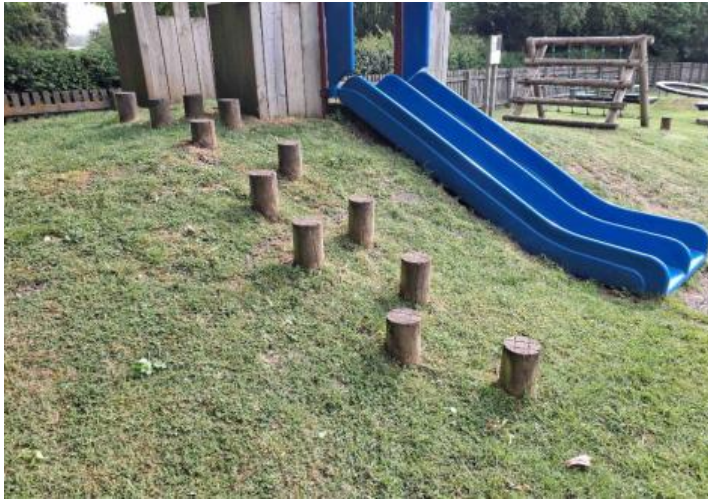
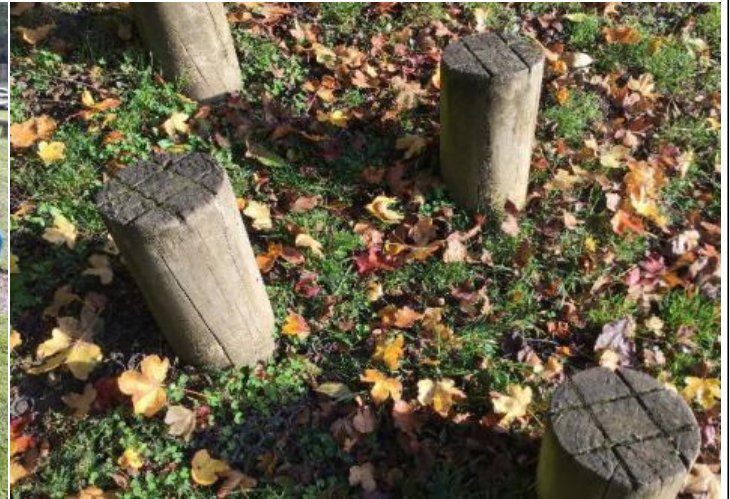
**Item:** Activity Equipment - Stepping Posts  
Timber  
**Manufacturer:** Playworld Systems (Europe) Ltd

**Finding:** There is algae or moss on the surface of the equipment

**Action:** Clean and treat appropriately

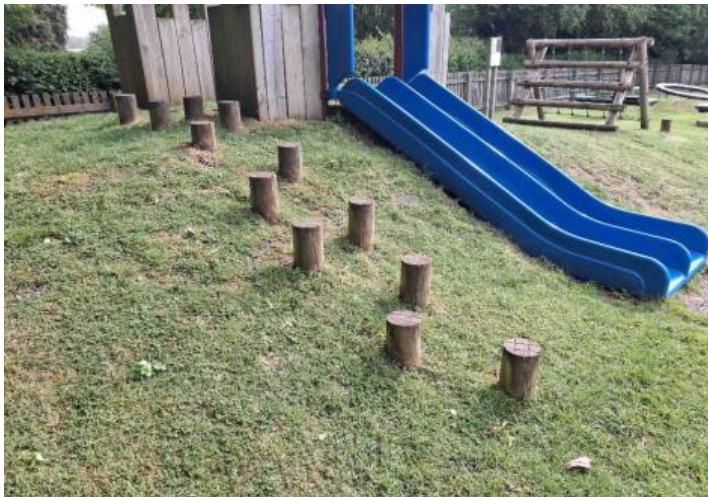
**Item:** Activity Equipment - Stepping Posts  
Timber  
**Manufacturer:** Playworld Systems (Europe) Ltd

**Finding:** There is some strimmer / machinery damage apparent on the posts, this can penetrate the preservative applied to the timber and accelerate the rotting process

**Action:** Monitor for any deterioration (rot) and replace as required

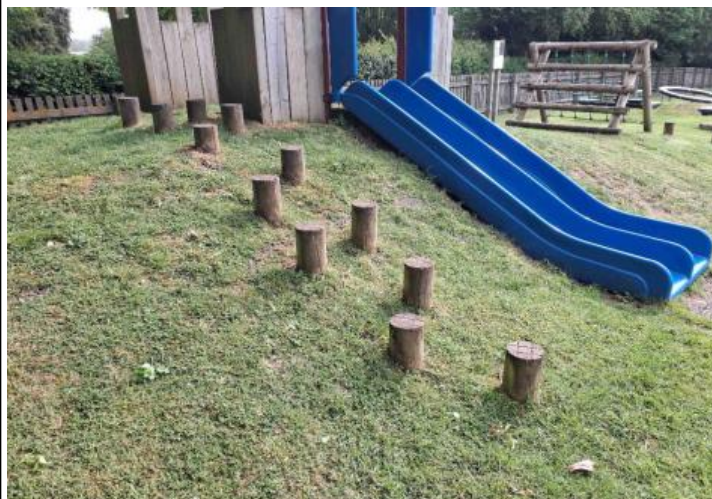
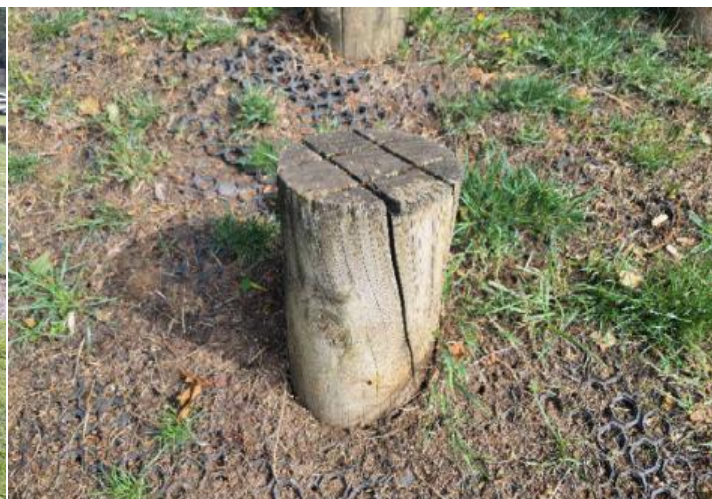
**Finding:** The timber has a number of splits/shakes or air cracks and this may affect the stability or allow water ingress which will accelerate the rotting process

**Action:** Monitor to ensure the splits do not cross through fixing points of the structure and/or cause any instability

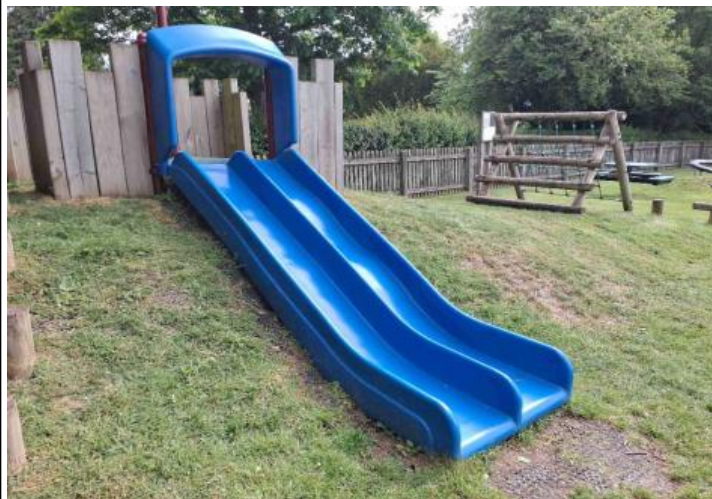
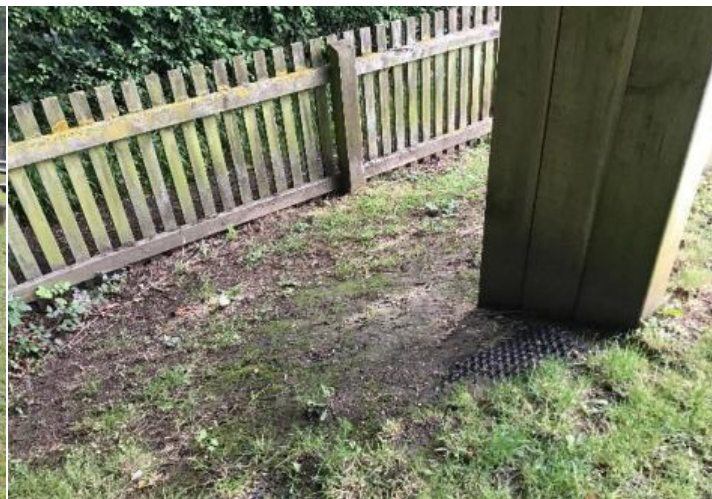
**Finding:** The surface has eroded in some areas and may be slippery in wet conditions

**Action:** Reinststate the surface

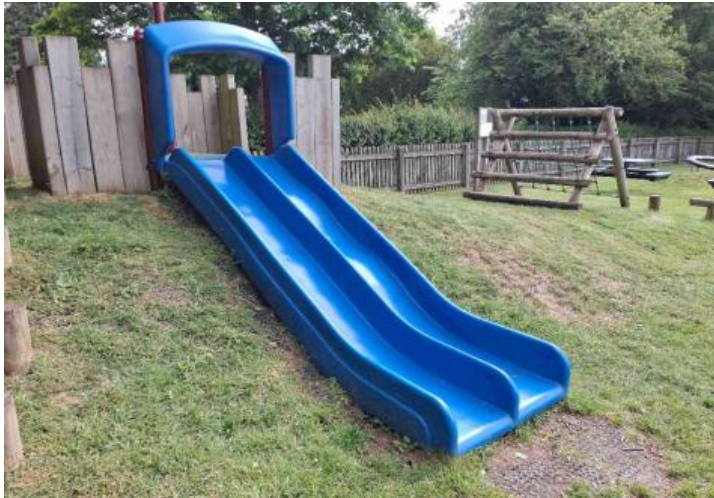
**Item:** Other - Embankment Slide  
**Manufacturer:** Miracle Recreation Equipment Company

**Finding:** There are trip hazards at the edges of the surface

**Action:** Reinstate surrounding surface levels to remove the trip points

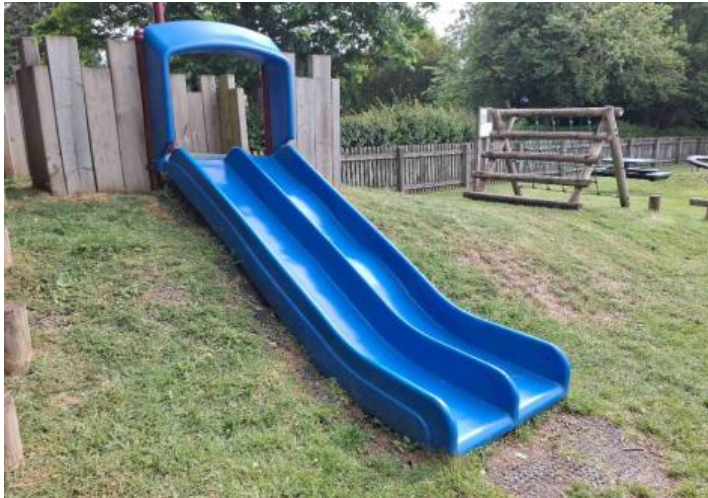
**Item:** Other - Embankment Slide  
**Manufacturer:** Miracle Recreation Equipment Company

**Finding:** Some timbers are slightly loose in the foundation

**Action:** Monitor for deterioration

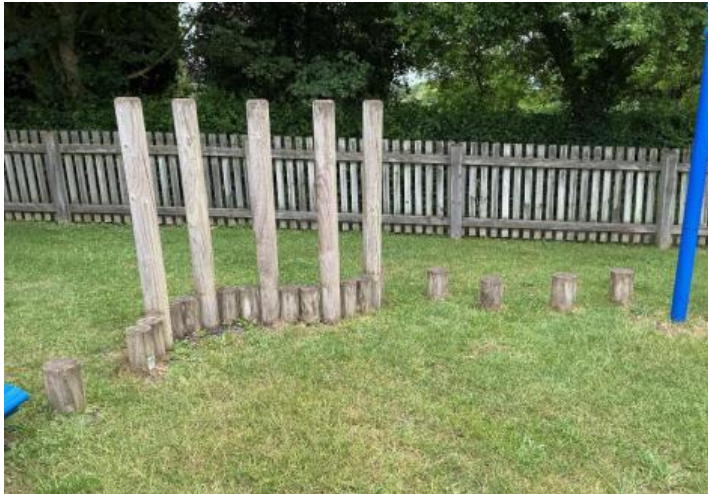
**Item:** Activity Equipment - Log Walk  
**Manufacturer:** Miracle Recreation Equipment Company

**Finding:** The timber has a number of splits/shakes or air cracks and this may affect the stability or allow water ingress which will accelerate the rotting process

**Action:** Monitor to ensure the splits do not cross through fixing points of the structure and/or cause any instability

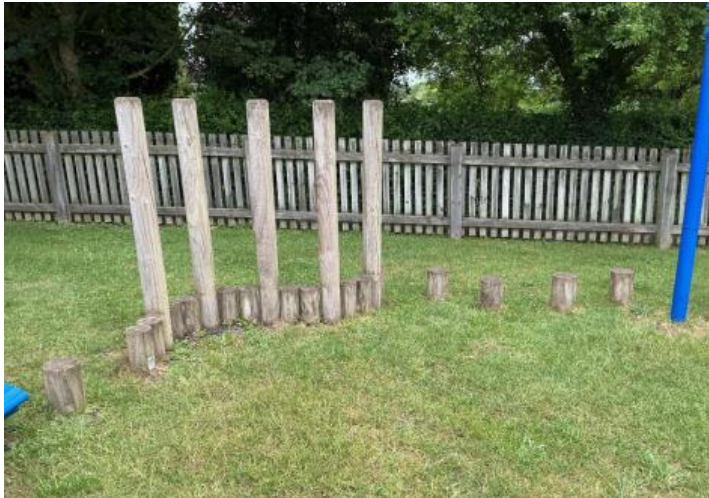
**Item:** Activity Equipment - Log Walk  
**Manufacturer:** Miracle Recreation Equipment Company

**Finding:** There is some strimmer / machinery damage apparent on the posts, this can penetrate the preservative applied to the timber and accelerate the rotting process

**Action:** Monitor for any deterioration (rot) and replace as required

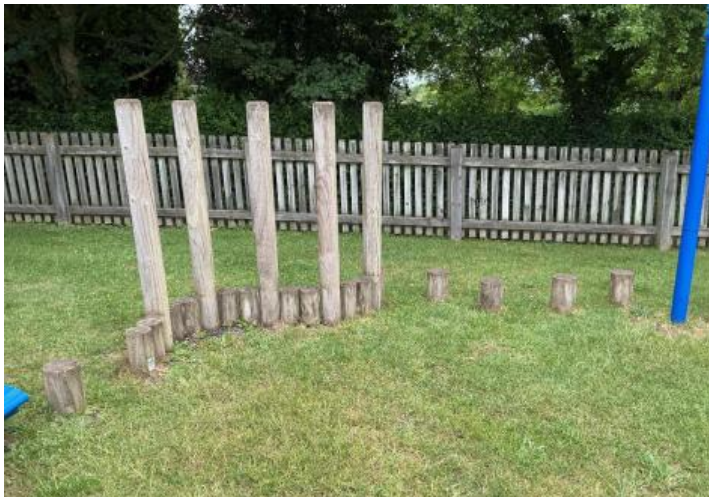
**Item:** Activity Equipment - Log Walk  
**Manufacturer:** Miracle Recreation Equipment Company

**Finding:** There is some evidence of rot in the timber

**Action:** Monitor for any further deterioration and replace as required

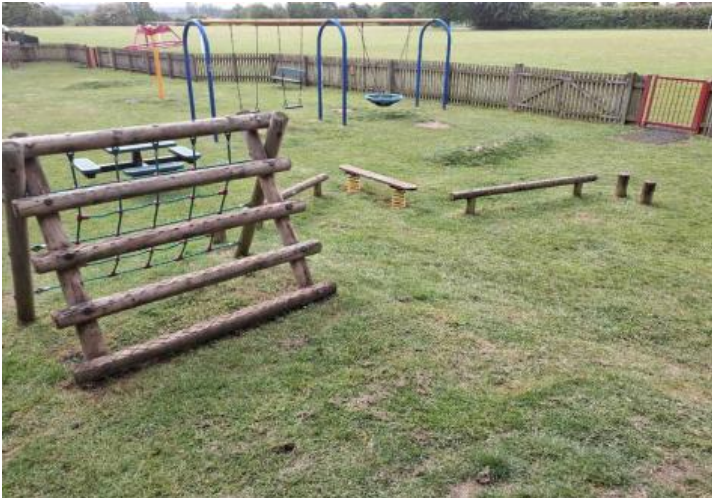
**Item:** Activity Equipment - Activity Trail  
**Manufacturer:** Miracle Recreation Equipment Company

**Finding:** There is some strimmer / machinery damage apparent on the posts, this can penetrate the preservative applied to the timber and accelerate the rotting process

**Action:** Monitor for any deterioration (rot) and replace as required

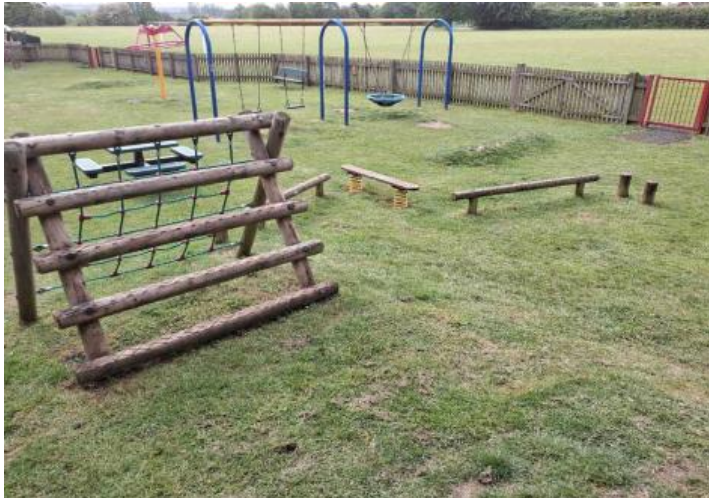
**Item:** Activity Equipment - Activity Trail  
**Manufacturer:** Miracle Recreation Equipment Company

**Finding:** The timber has a number of splits/shakes or air cracks and this may affect the stability or allow water ingress which will accelerate the rotting process

**Action:** Monitor to ensure the splits do not cross through fixing points of the structure and/or cause any instability

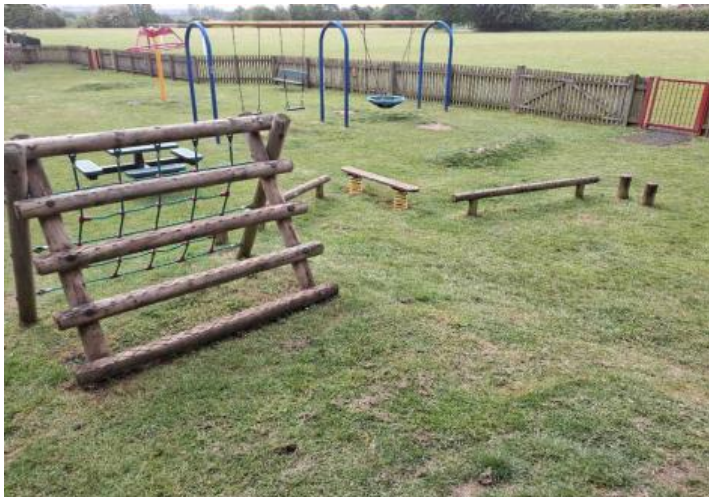
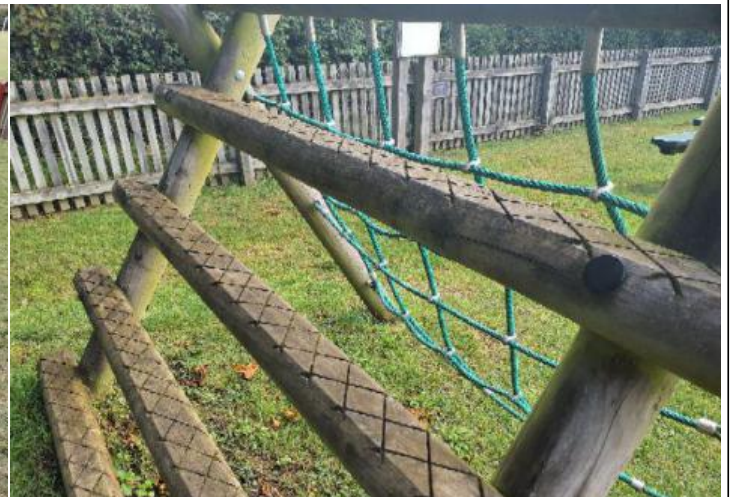
**Item:** Activity Equipment - Activity Trail  
**Manufacturer:** Miracle Recreation Equipment Company

**Finding:** There is algae or moss on the surface of the equipment

**Action:** Clean and treat appropriately

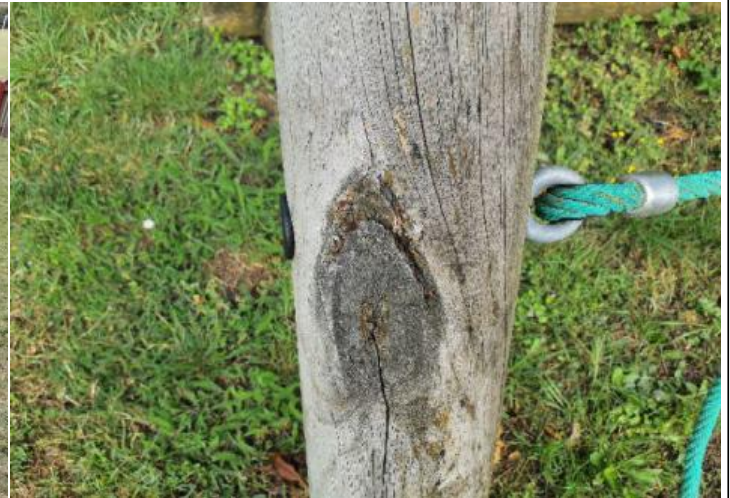
**Item:** Activity Equipment - Activity Trail  
**Manufacturer:** Miracle Recreation Equipment Company

**Finding:** Parts of the timber are rough or splintered

**Action:** Remove all rough or sharp edges

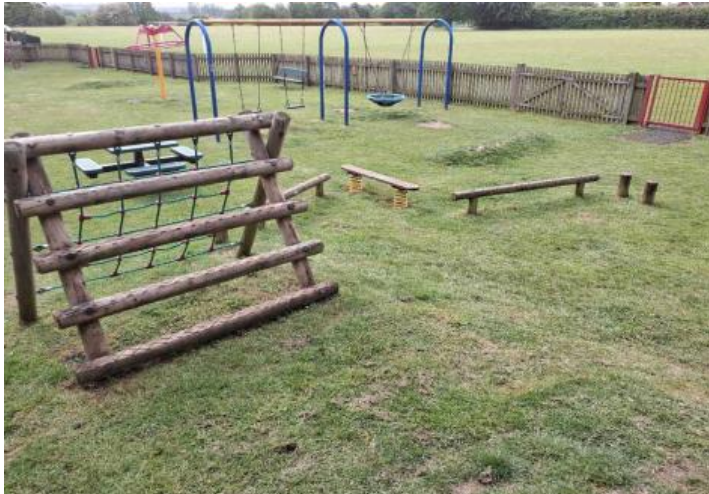
**Item:** Activity Equipment - Activity Trail  
**Manufacturer:** Miracle Recreation Equipment Company

**Finding:** There is/are bolt cap covers missing or damaged on the item

**Action:** Replace missing or damaged bolt cap covers

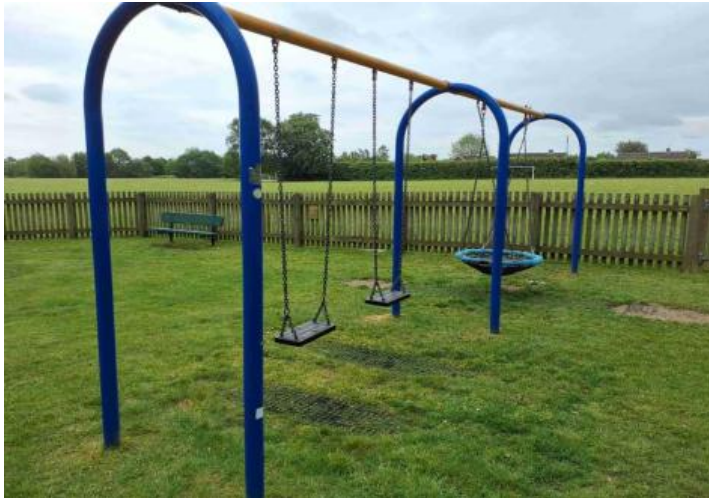
**Item:** Swings - 2 Bay 2 Flat 1 Basket Seat  
**Manufacturer:** Miracle Recreation Equipment Company

**Finding:** The seat has minor damage or wear

**Action:** Monitor for any further deterioration and replace as required

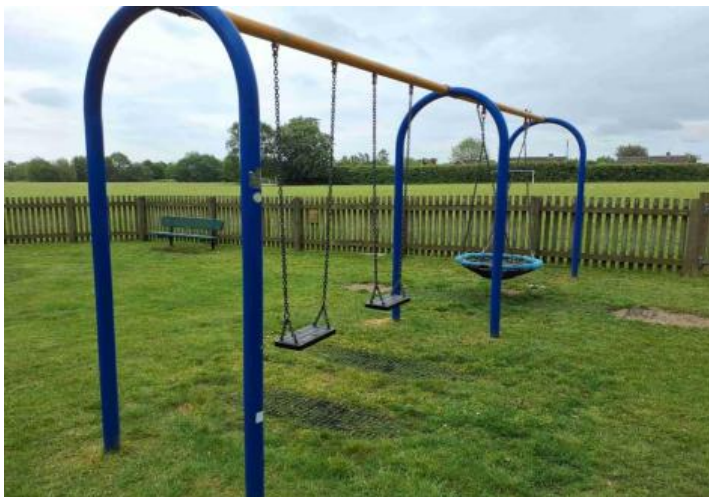
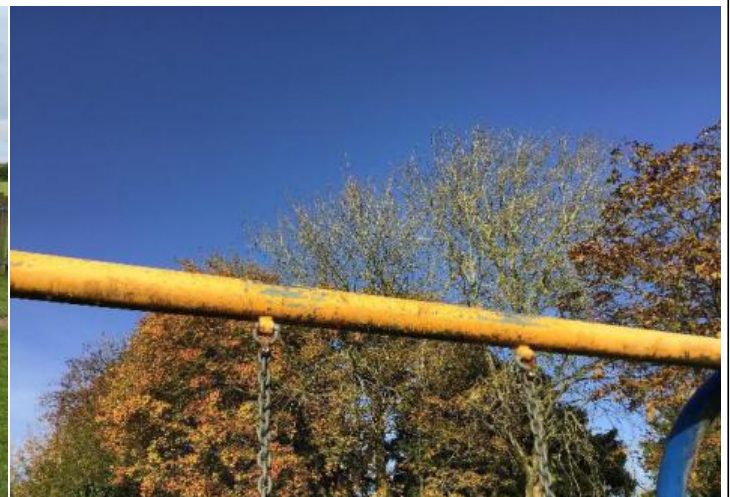
**Item:** Swings - 2 Bay 2 Flat 1 Basket Seat  
**Manufacturer:** Miracle Recreation Equipment Company

**Finding:** The paint is flaking off the metalwork

**Action:** Rub down and re-paint

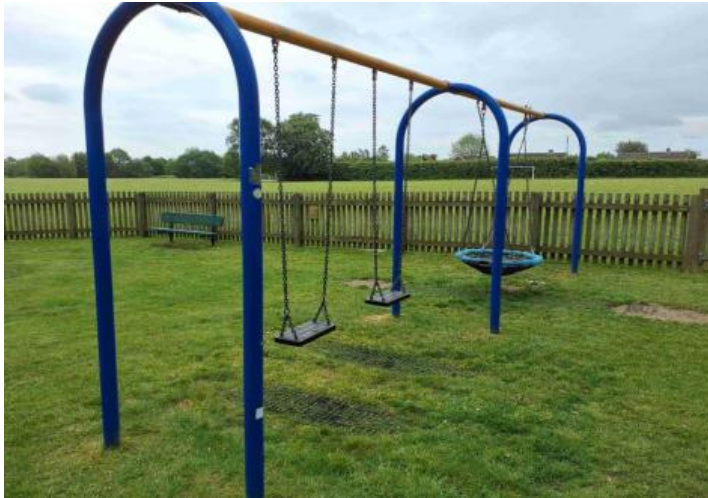
**Item:** Swings - 2 Bay 2 Flat 1 Basket Seat  
**Manufacturer:** Miracle Recreation Equipment Company

**Finding:** There is some wear to the shackles

**Action:** Monitor for any further deterioration and replace when 40% worn

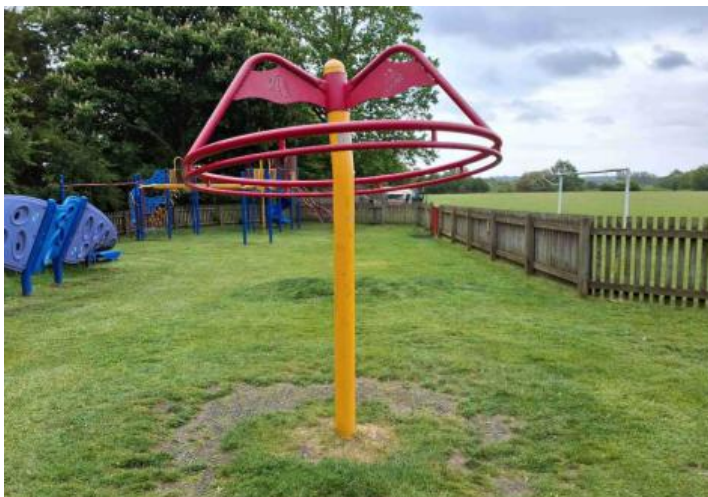
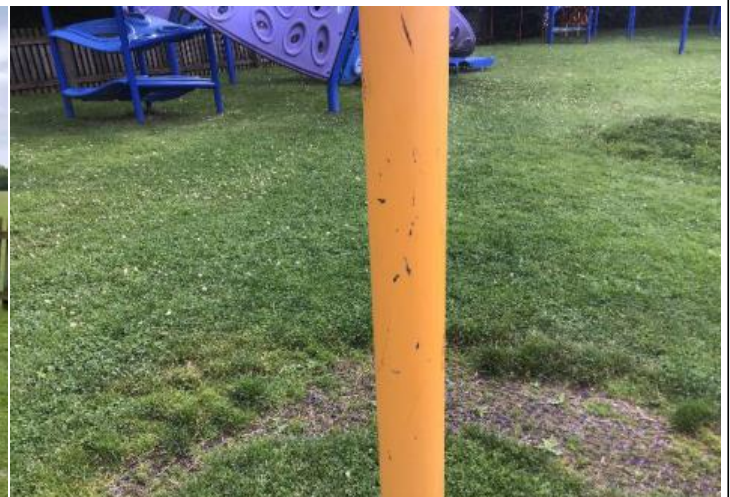
**Item:** Rotor Play - Overhead Rotator  
**Manufacturer:** Miracle Recreation Equipment Company

**Finding:** The paint is flaking off the metalwork

**Action:** Rub down and re-paint

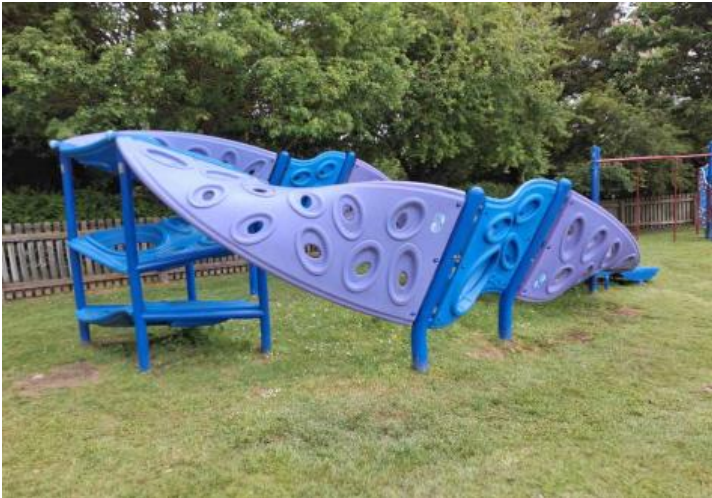
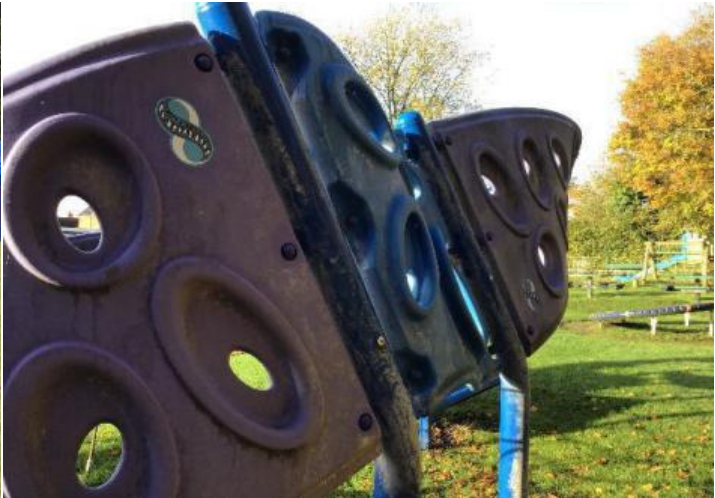
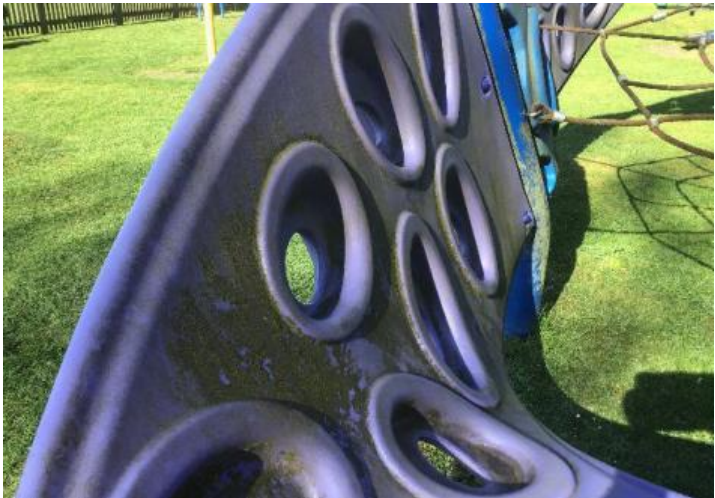
**Item:** Activity Equipment - Climbing Frame  
**Manufacturer:** Not Identified

**Risk Level:** L - Low Risk  
**Surface:** Grass Matrix Tiles

**Finding:** There is algae or moss on the surface of the equipment

**Action:** Clean and treat appropriately
