## **Play Area Inspection Reports & Remedial Work**

## Wickhambrook. Bury Road

Inspection Ref: 3230454

Operational Inspection - 8-October-2026 - 08:11 Inspector Philip Smith

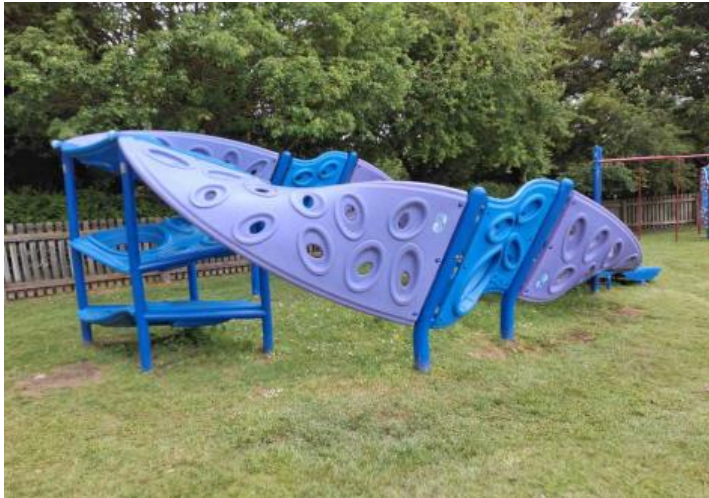
**Item:** Activity Equipment - Climbing Frame  
**Manufacturer:** Not Identified

**Risk Level:** L - Low Risk  
**Surface:** Grass Matrix Tiles

**Finding:** The ropes/nets are worn/damaged in places

**Action:** Monitor for any further deterioration and repair or replace as required

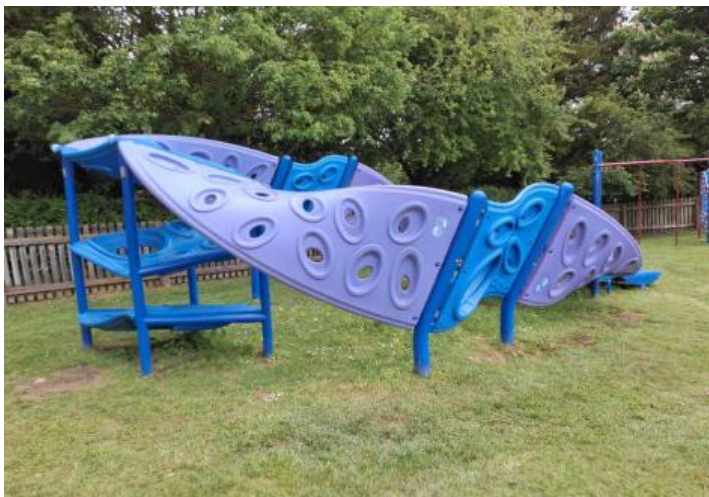
**Item:** Activity Equipment - Climbing Frame  
**Manufacturer:** Not Identified

**Risk Level:** L - Low Risk  
**Surface:** Grass Matrix Tiles

**Finding:** The connecting lugs are showing signs of wear

**Action:** Monitor for any further deterioration and repair as required

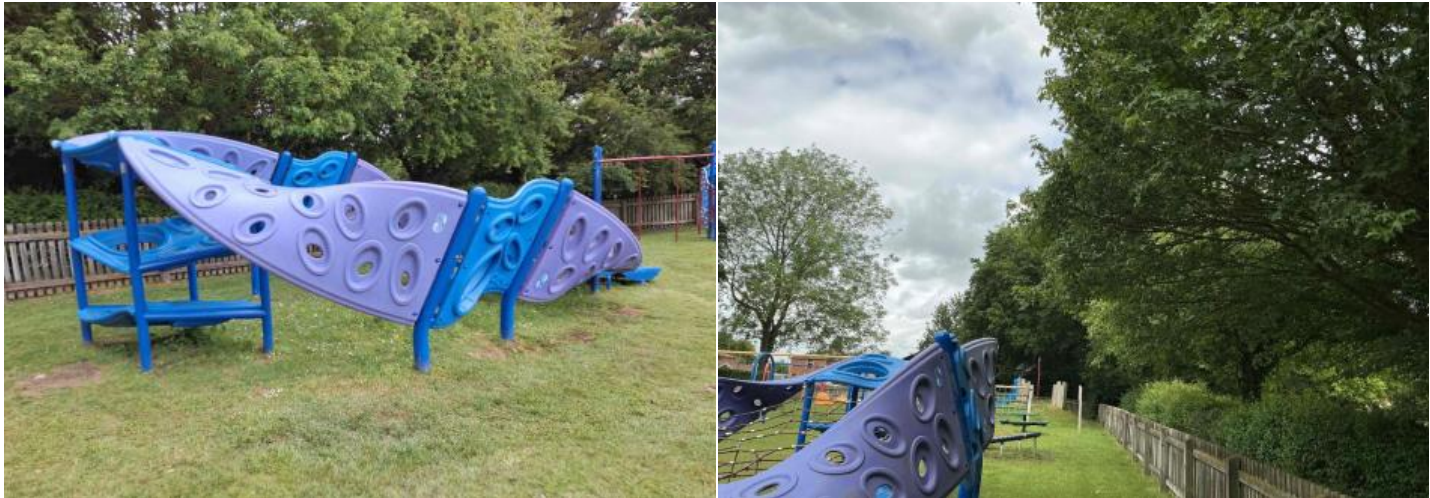
| <b>Item:</b> | Activity Equipment - Climbing Frame | <b>Risk Level:</b> | L - Low Risk |

| <b>Finding:</b> | The tree canopy overhangs the equipment and is less than 2.0m away | <b>Action:</b> | Lift tree canopy to ensure a minimum clearance of 2.0m from the equipment |

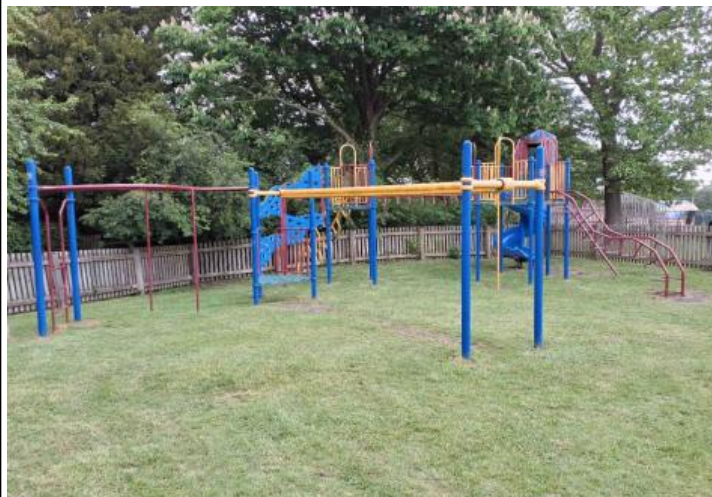
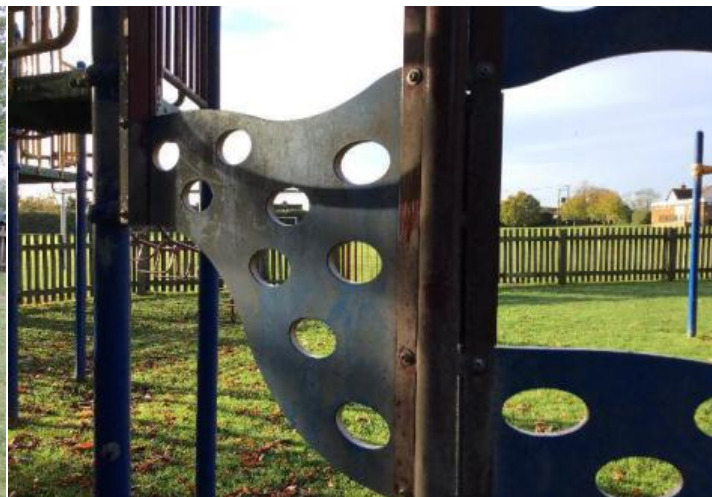
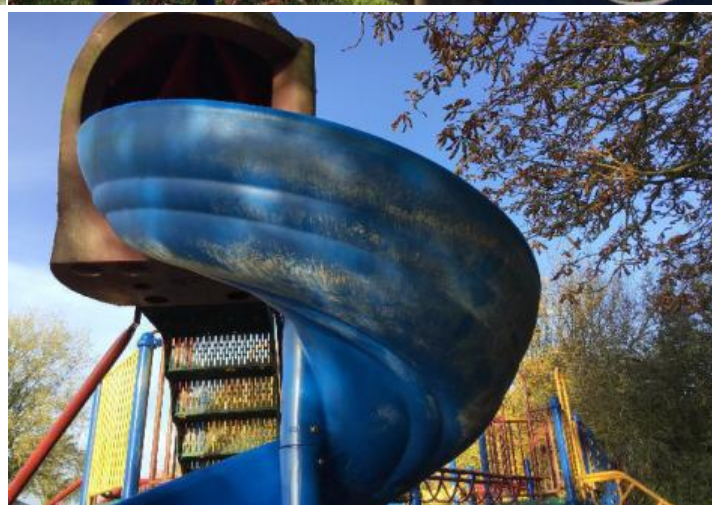
**Item:** Activity Equipment - Multi Play (Senior)  
**Manufacturer:** Miracle Recreation Equipment Company

**Risk Level:** L - Low Risk  
**Surface:** Grass Matrix Tiles

**Finding:** There is algae or moss on the surface of the equipment

**Action:** Clean and treat appropriately

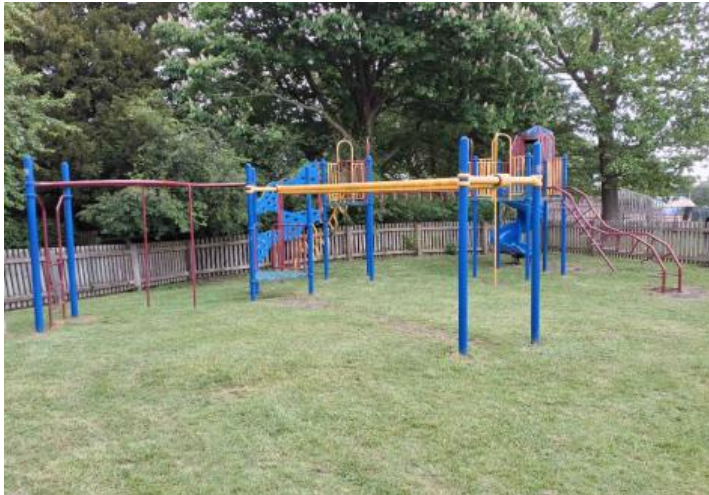
**Item:** Activity Equipment - Multi Play (Senior)  
**Manufacturer:** Miracle Recreation Equipment Company

**Risk Level:** V - Very Low Risk  
**Surface:** Grass Matrix Tiles

**Finding:** There are a number of dents in the slide surface

**Action:** Monitor for any further deterioration and repair as required

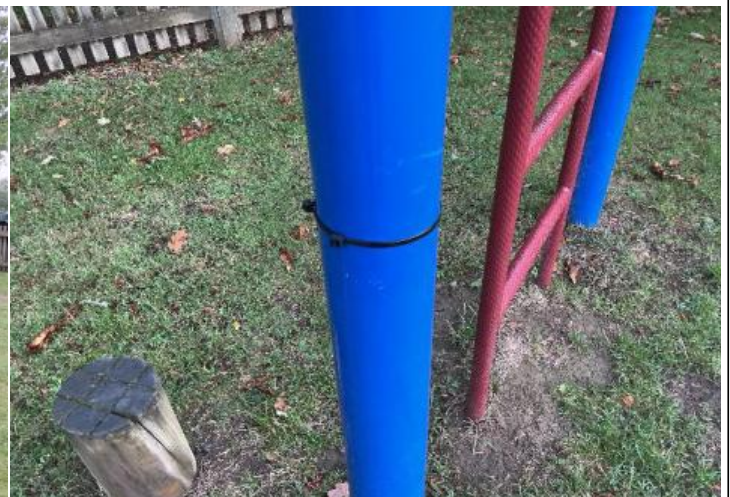
**Item:** Activity Equipment - Multi Play (Senior)  
**Manufacturer:** Miracle Recreation Equipment Company

**Risk Level:** L - Low Risk  
**Surface:** Grass Matrix Tiles

**Finding:** Cable tie around post has been cut leaving sharp edges

**Action:** Remove cable tie

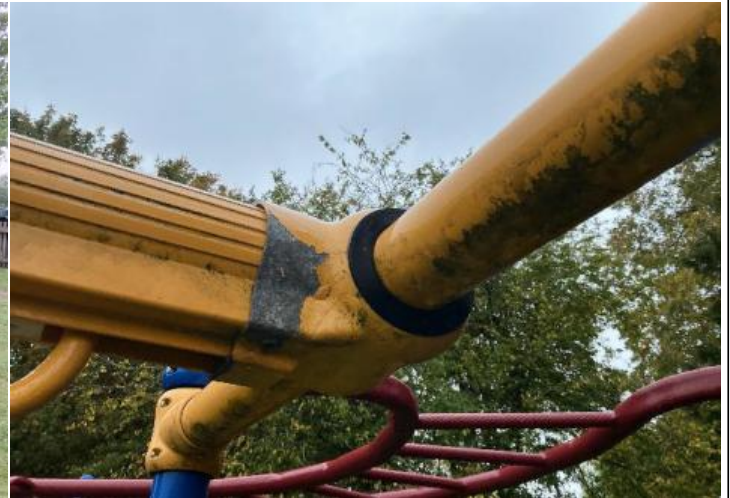
**Item:** Activity Equipment - Multi Play (Senior)  
**Manufacturer:** Miracle Recreation Equipment Company

**Risk Level:** L - Low Risk  
**Surface:** Grass Matrix Tiles

**Finding:** The paint is flaking off the metalwork

**Action:** Rub down and re-paint

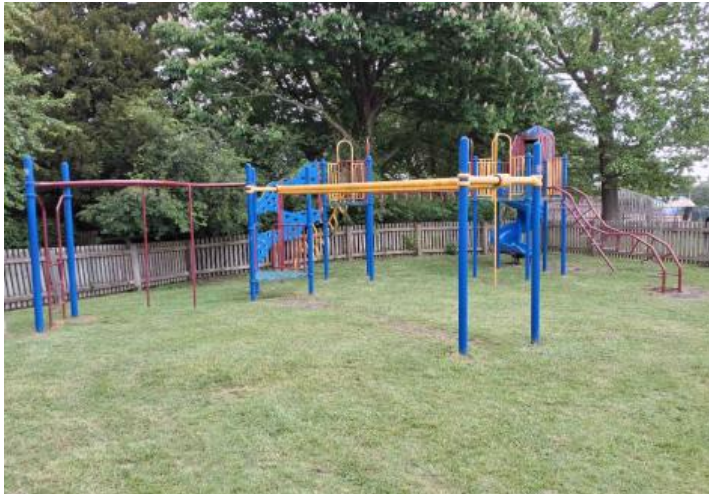
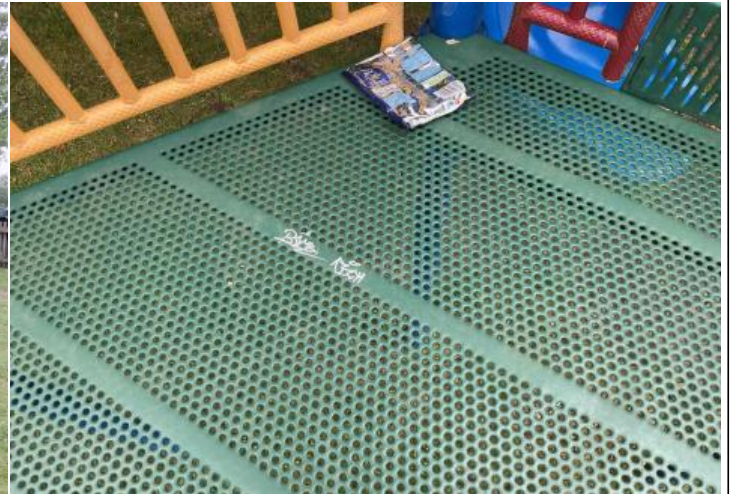
**Item:** Activity Equipment - Multi Play (Senior)  
**Manufacturer:** Miracle Recreation Equipment Company

**Risk Level:** N - Risk Assessment not Undertaken  
**Surface:** Grass Matrix Tiles

**Finding:** There is some graffiti present

**Action:** Remove the graffiti

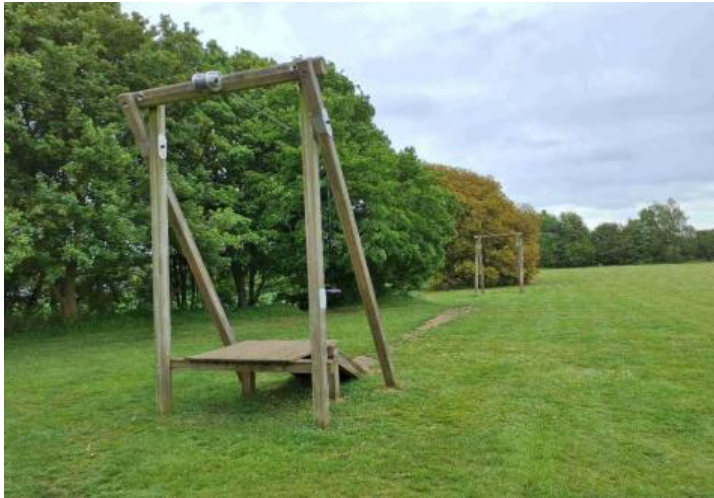
| <b>Item:</b> | Other - Cable Runway | <b>Risk Level:</b> | N - Risk Assessment not Undertaken |
| <b>Finding:</b> We have completed a visual inspection of the suspension links, cable and fixing points from ground level, however it is not possible to fully inspect these areas without either hiring equipment to gain access or removing the cable and suspension and inspecting at ground level. We recommend that the main cable and fixing security is thoroughly inspected at least in accordance with the manufacturers recommendations to check for wear, damage, security or internal rusting; this will help to ensure the continued safe use of the equipment | | <b>Action:</b> Inspect in accordance with the manufacturers recommendations | |

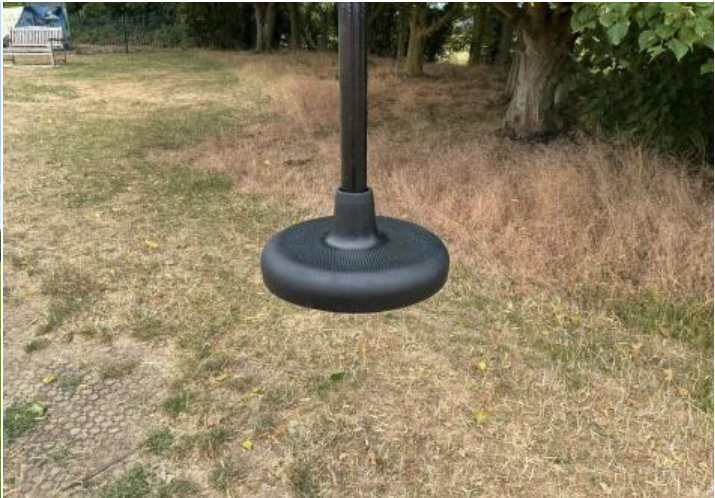
**Item:** Other - Cable Runway  
**Manufacturer:** Fenland Leisure Products

**Risk Level:** N - Risk Assessment not Undertaken  
**Surface:** Grass Matrix Tiles

**Finding:** The seat connection cannot be inspected without dismantling the seat

**Action:** Dismantle the seat to inspect the seat connection for wear

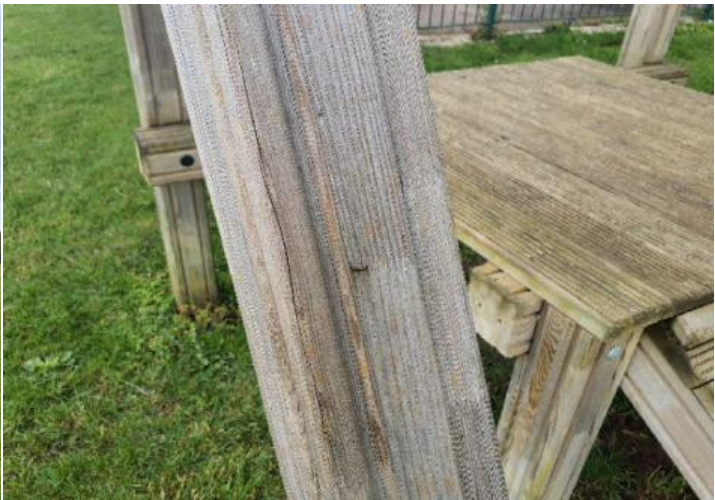
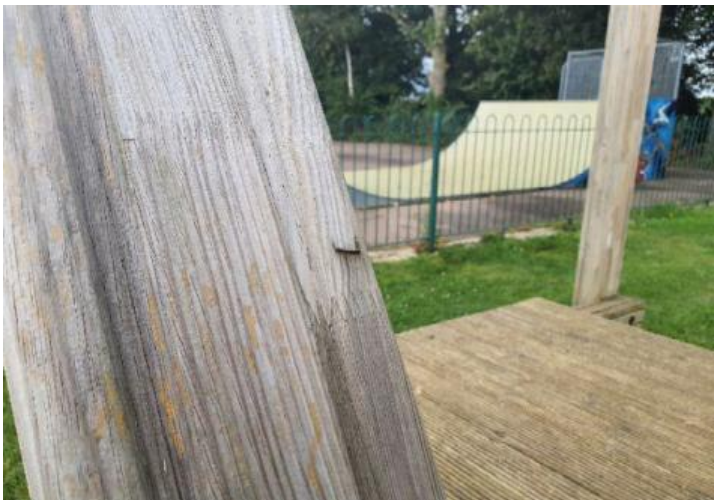
**Item:** Other - Cable Runway  
**Manufacturer:** Fenland Leisure Products

**Risk Level:** L - Low Risk  
**Surface:** Grass Matrix Tiles

**Finding:** There are a number of redundant staples attached to the equipment  
**Action:** Remove redundant staples

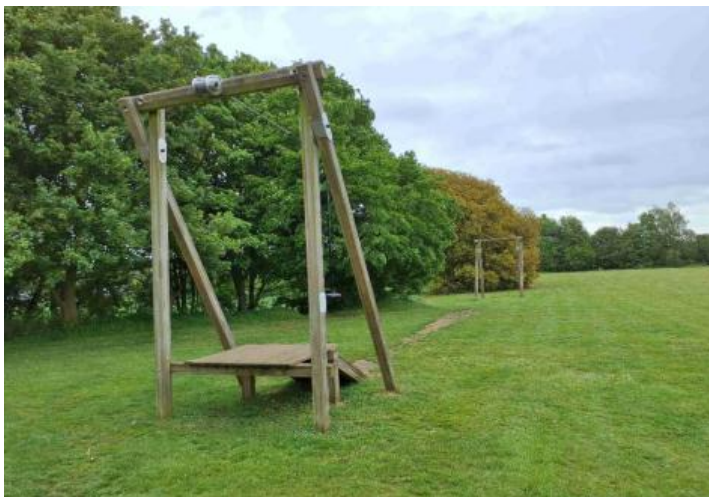
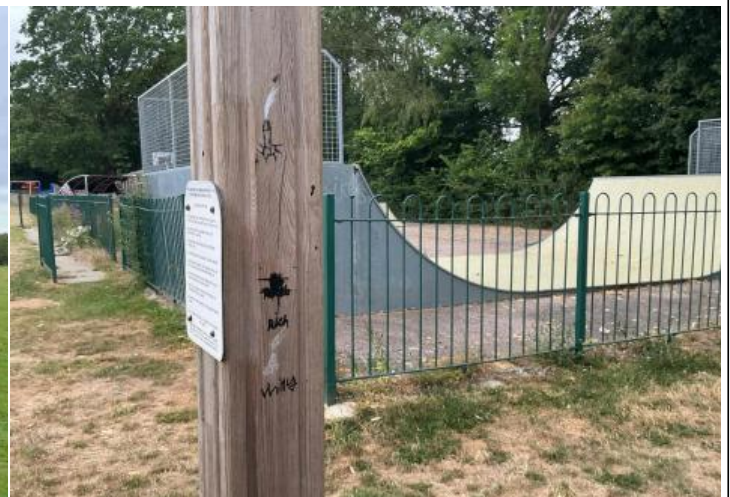
**Item:** Other - Cable Runway  
**Manufacturer:** Fenland Leisure Products

**Risk Level:** N - Risk Assessment not Undertaken  
**Surface:** Grass Matrix Tiles

**Finding:** There is offensive graffiti present

**Action:** Remove as soon as practicable

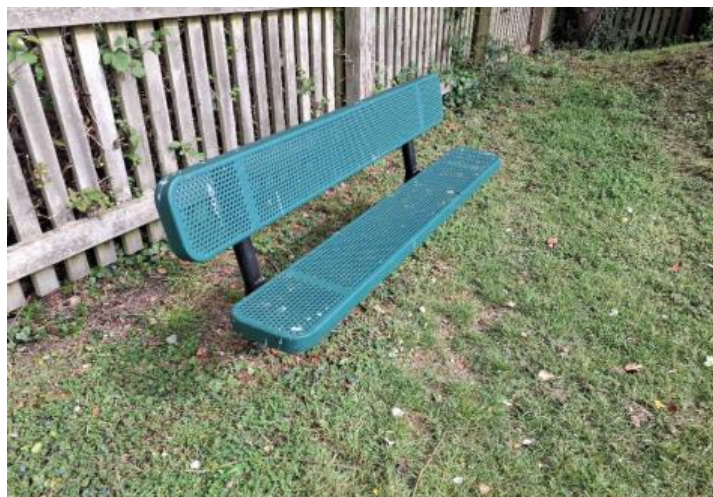
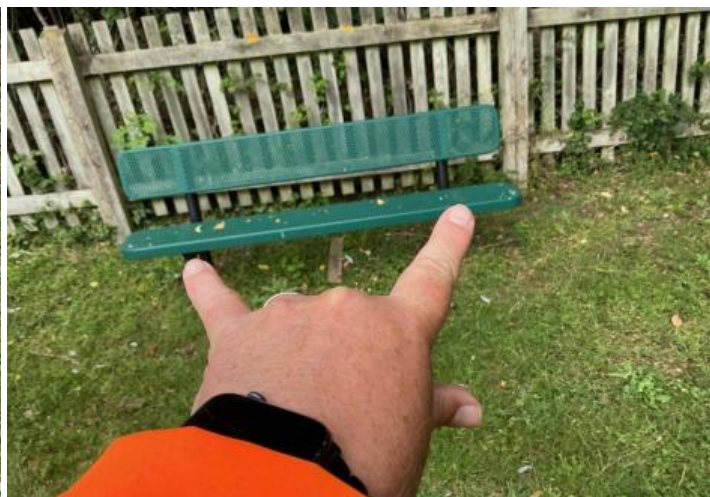
**Item:** Ancillary Items - Bench  
**Manufacturer:** Not Identified

**Risk Level:** L - Low Risk  
**Surface:** Grass

**Finding:** A number of fixing(s) have worked loose

**Action:** Secure all loose fixings

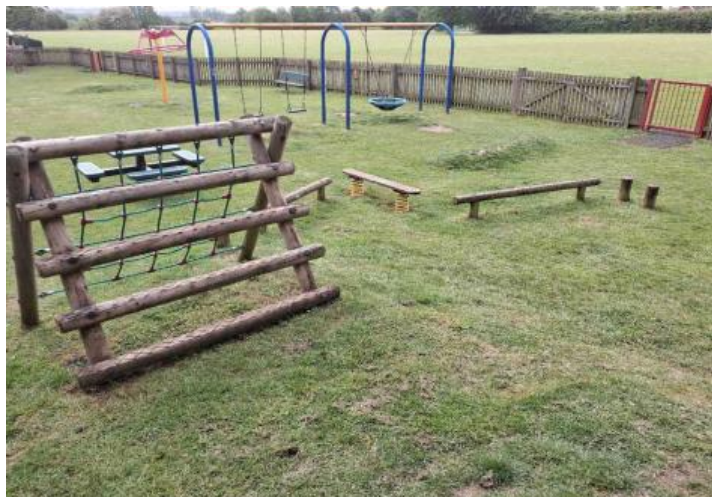
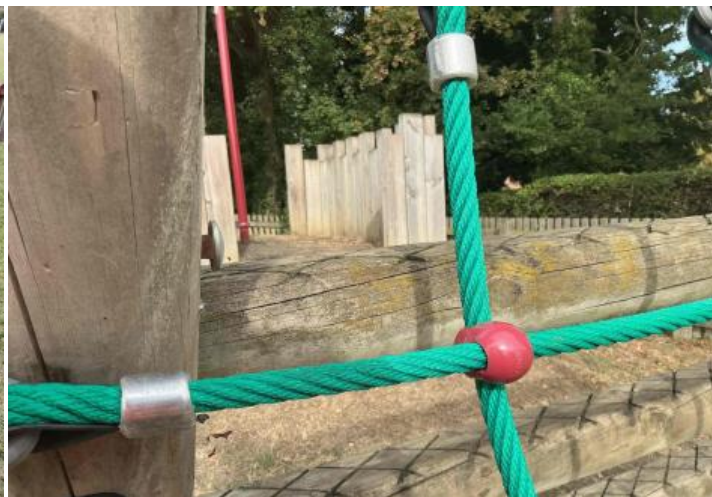
**Item:** Activity Equipment - Activity Trail  
**Manufacturer:** Miracle Recreation Equipment Company

**Risk Level:** L - Low Risk  
**Surface:** Grass Matrix Tiles

**Finding:** A number of fixing(s) have worked loose

**Action:** Secure all loose fixings
