## **Play Area Inspection Reports & Remedial Work**

A copy of the March inspection reports is attached as **Appendix A**, and a summary of work identified is attached as **Appendix B**.

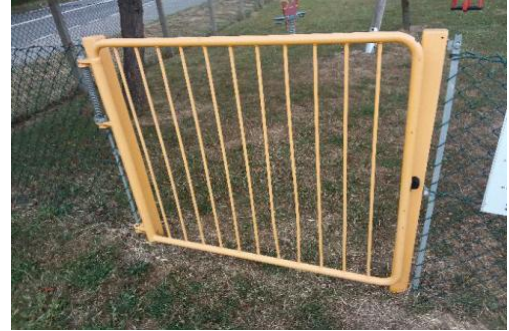
**Item:** Gate - Self Closing  
**Manufacturer:** Not Identified  
**Surface Type:** Grass  
**Item Quantity:** 1

The gate rebounds when opened quickly and could strike the next user entering the area - Monitor use and adjust/replace as required

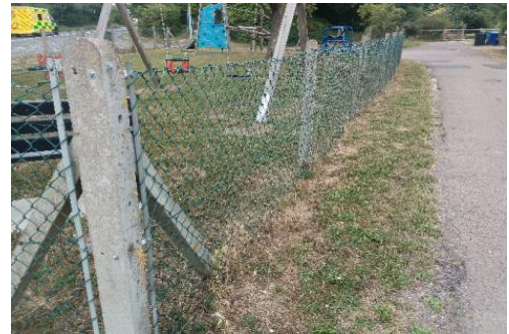
**Item:** Fence - Chainlink  
**Manufacturer:** Not Identified  
**Surface Type:** Grass  
**Item Quantity:** 1

There is some damage to the fence sections - Monitor for any further deterioration and repair as required

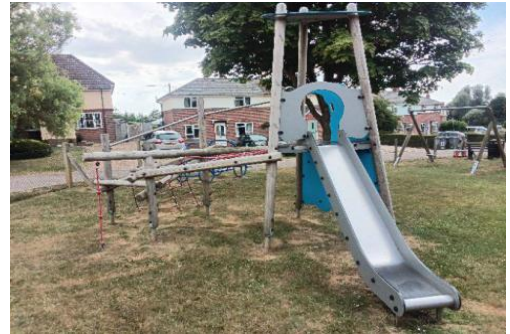
**Item:** Multi Play (Junior)  
**Manufacturer:** Playforce  
**Surface Type:** Grass Matrix Tiles  
**Item Part Number:** Jungle tops  
**Item Quantity:** 1

The ropes/nets are worn/damaged in places - Monitor for any further deterioration and repair or replace as required

The timber has a number of splits/shakes or air cracks and this may affect the stability or allow water ingress which will accelerate the rotting process - Monitor to ensure the splits do not cross through fixing points of the structure and/or cause any instability

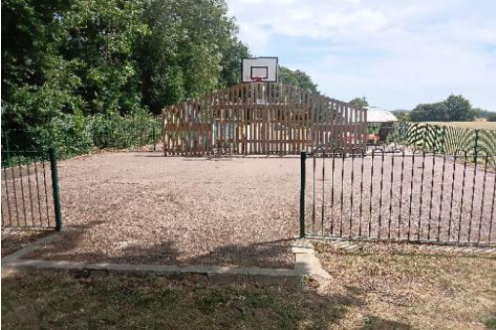
**Item:** Site General  
**Manufacturer:** Owner/Operator  
**Surface Type:** N/A  
**Item Quantity:** 1

There is moderate damage to the surface - Repair the damaged areas of surfacing

The concrete foundation around the goal structure is lifting - Repair

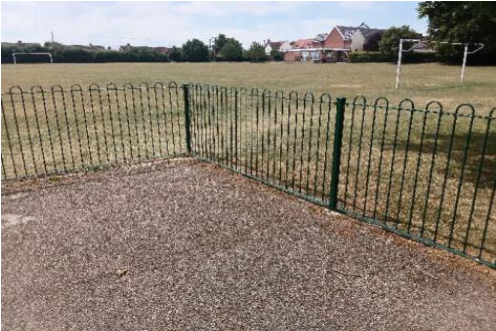
**Item:** Fence - Bow Top  
**Manufacturer:** Not Identified  
**Surface Type:** Bitmac  
**Item Quantity:** 1

There are a number of fixings missing from the fence - Replace missing fixings

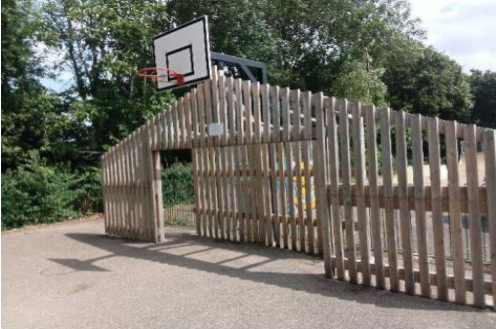
**Item:** Ball Games Area  
**Manufacturer:** Sovereign Leisure  
**Surface Type:** Tarmac  
**Item Quantity:** 1

There is algae, silt or moss growth on the surface resulting in slippery conditions - Clean and treat appropriately

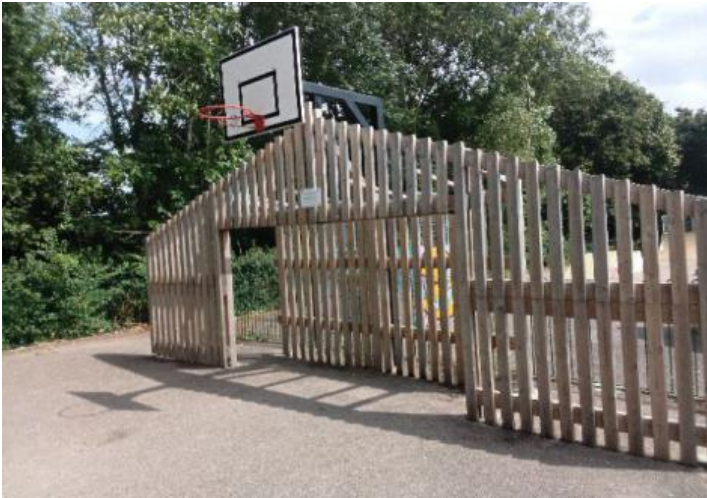
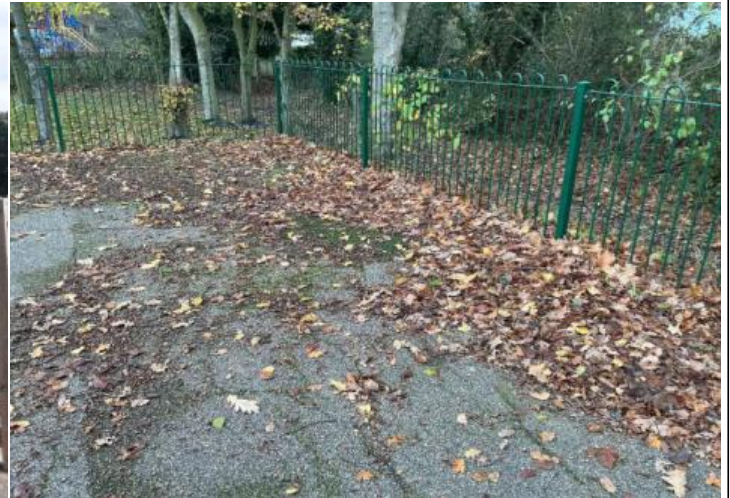
**Finding:** There is some tree debris on the surfacing

**Action:** Remove and maintain

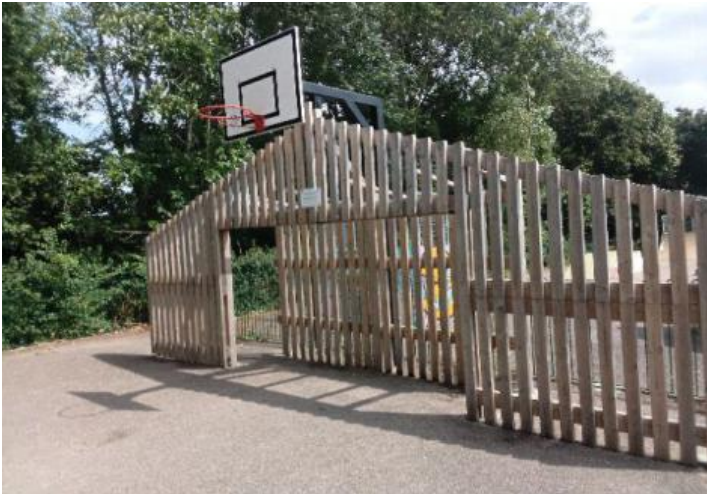
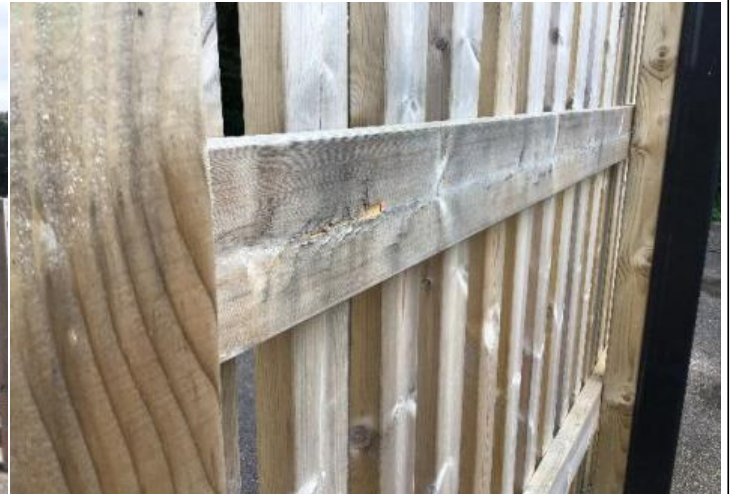
**Finding:** Parts of the timber are rough or splintered

**Action:** Remove all rough or sharp edges

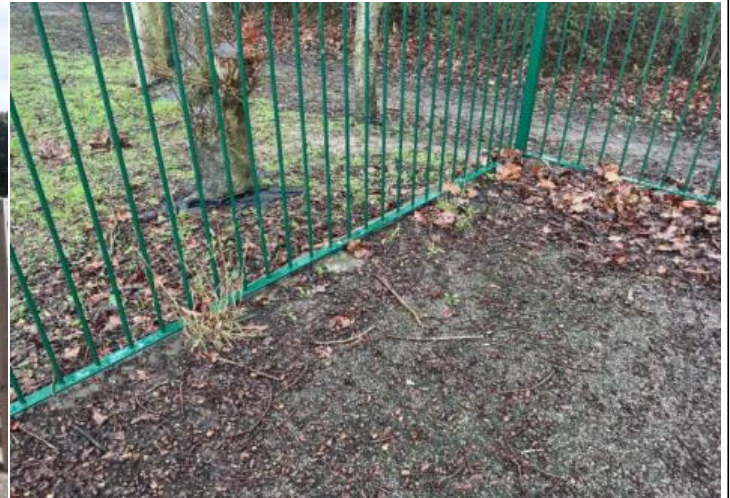
**Finding:** There is weed / vegetation growth on, between, or around the edges of the surfacing

**Action:** Remove weed / vegetation growth

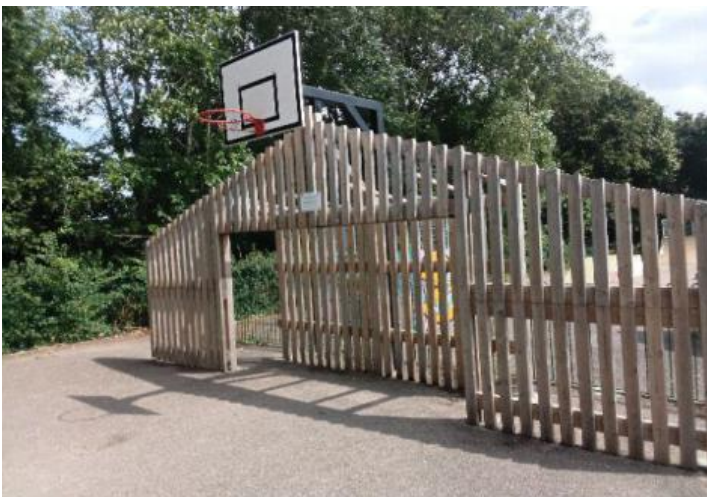
**Finding:** There is algae, silt or moss growth on the surface resulting in slippery conditions

**Action:** Clean and treat appropriately

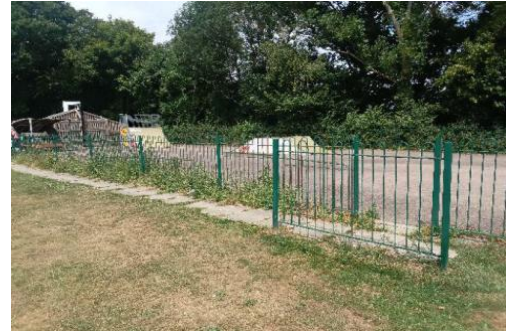
**Item:** Site General  
**Manufacturer:** Owner/Operator  
**Surface Type:** N/A  
**Item Quantity:** 1

There is root damage to the surfacing creating unforeseen changes in levels - Repair the damaged areas of tarmac to provide a uniform surface

There is some damage apparent to the riding surface - Monitor for any further deterioration and repair as required

There is algae, silt or moss growth on the surface resulting in slippery conditions - Clean and treat appropriately

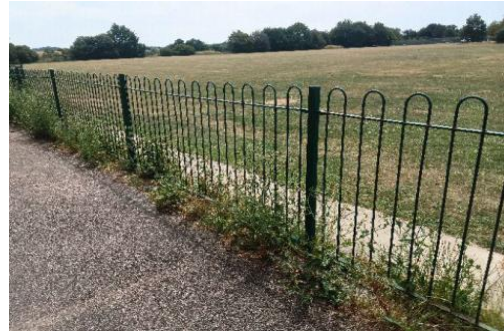
**Item:** Fence - Bow Top  
**Manufacturer:** Not Identified  
**Surface Type:** Bitmac  
**Item Quantity:** 1

There is some damage to the fence sections - Monitor for any further deterioration and repair as required

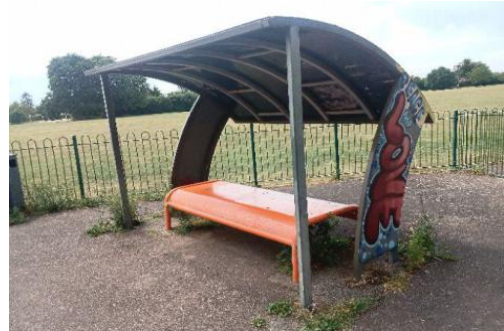
**Item:** Shelter  
**Manufacturer:** Not Identified  
**Surface Type:** Tarmac  
**Item Quantity:** 1

There is some evidence of fire damage to the item - Monitor for any further deterioration and repair as required

Pop rivet fixings have failed on the seat - Replace the failed pop rivets

There is surface corrosion / rust present on the item - Consider treating the item

There is algae, silt or moss growth on the surface resulting in slippery conditions - Clean and treat appropriately

A number of fixing(s) have worked loose - Secure all loose fixings

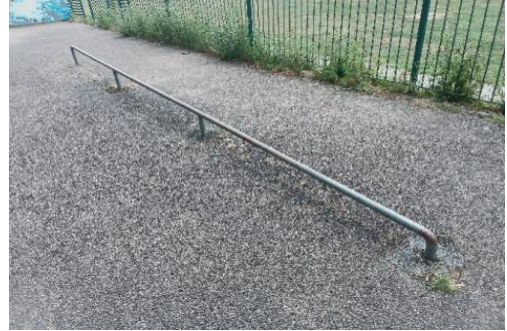
**Item:** Grind Rail  
**Manufacturer:** Eibe Play Ltd  
**Surface Type:** Tarmac  
**Item Quantity:** 1

There is surface corrosion / rust present on the item - Consider treating the item

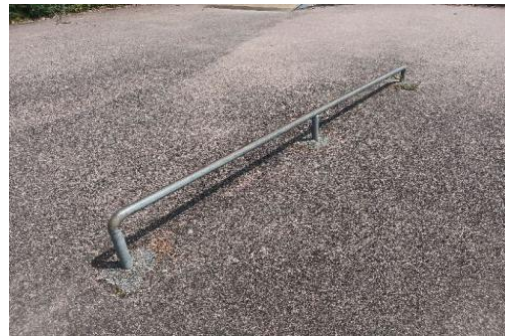
**Item:** Grind Rail  
**Manufacturer:** Eibe Play Ltd  
**Surface Type:** Tarmac  
**Item Quantity:** 1

There is surface corrosion / rust present on the item - Consider treating the item

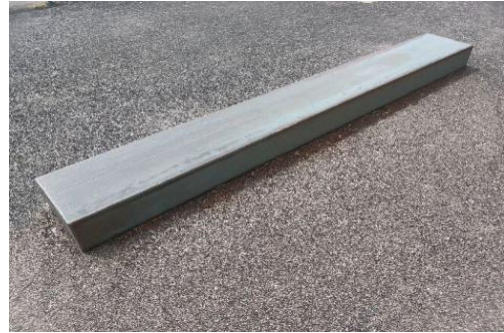
**Item:** Grind Box  
**Manufacturer:** Eibe Play Ltd  
**Surface Type:** Tarmac  
**Item Quantity:** 1

There is surface corrosion / rust present on the item - Consider treating the item

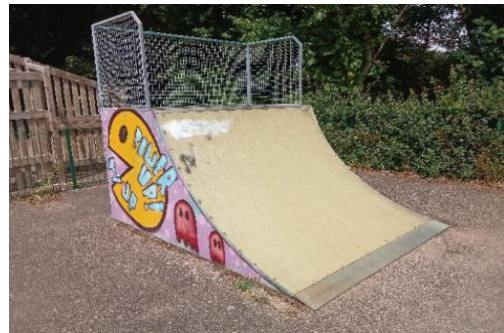
**Item:** Quarter Pipe  
**Manufacturer:** Eibe Play Ltd  
**Surface Type:** Tarmac  
**Item Quantity:** 1

The item has been damaged - Monitor for any further deterioration and replace as required

Minor damage to surface - Monitor for deterioration

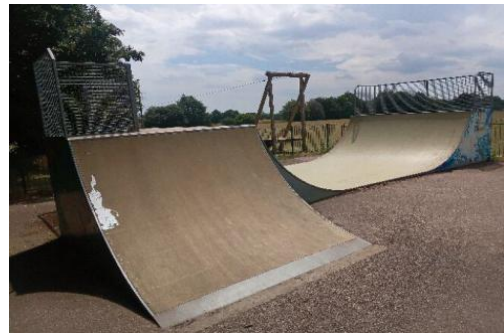
**Item:** Half Pipe  
**Manufacturer:** Eibe Play Ltd  
**Surface Type:** Tarmac  
**Item Quantity:** 1

A number of fixing(s) have worked loose - Secure all loose fixings

There is some damage to the fence sections - Monitor for any further deterioration and repair as required

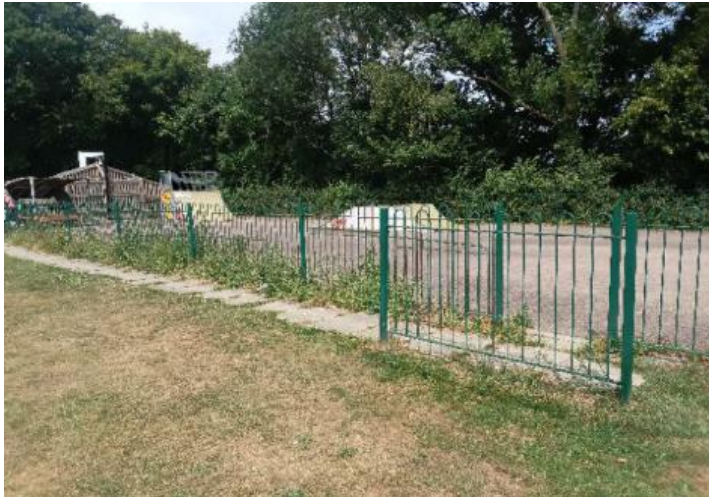
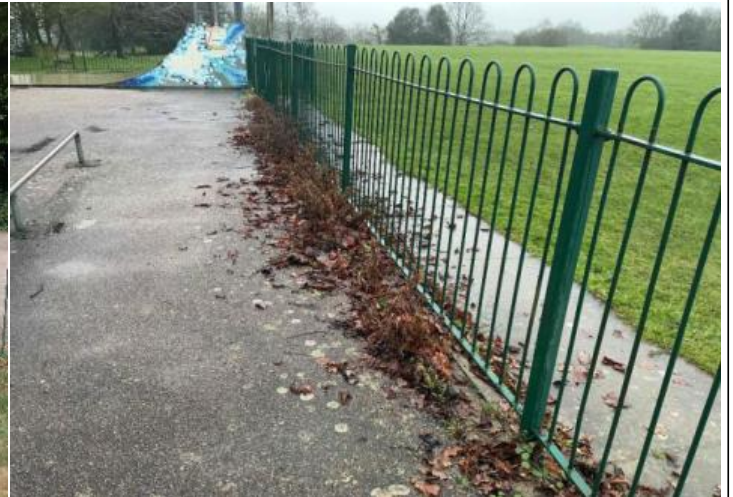
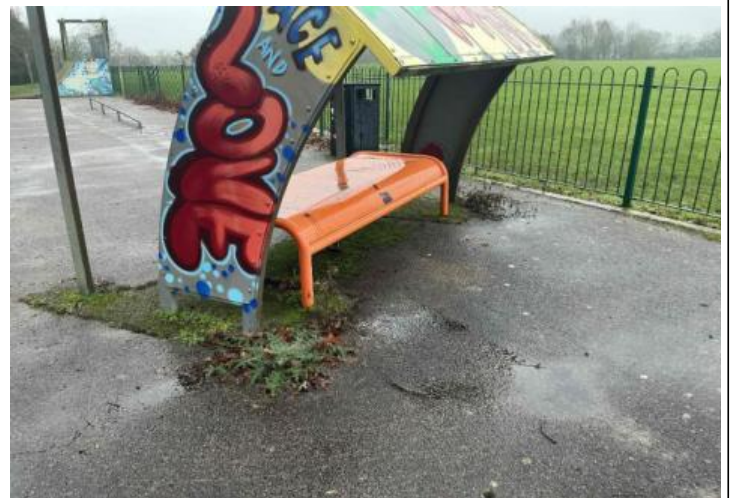
**Finding:** There is weed / vegetation growth on, between, or around the edges of the surfacing **Action:** Remove weed / vegetation growth

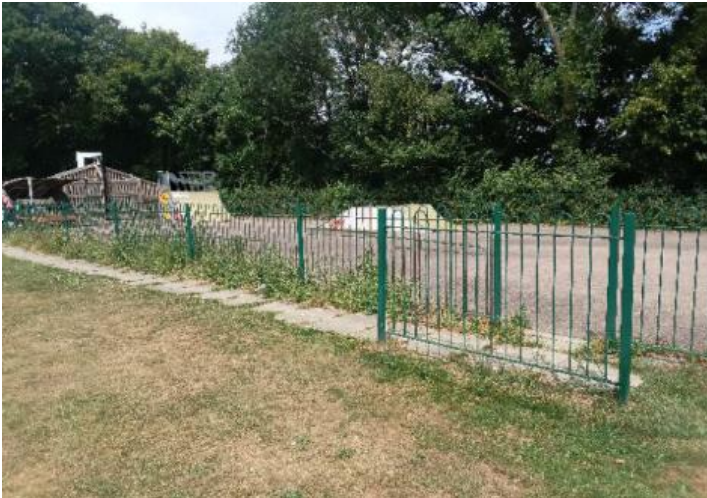
**Finding:** There is root damage to the surfacing creating unforeseen changes in levels

**Action:** Repair the damaged areas of tarmac to provide a uniform surface

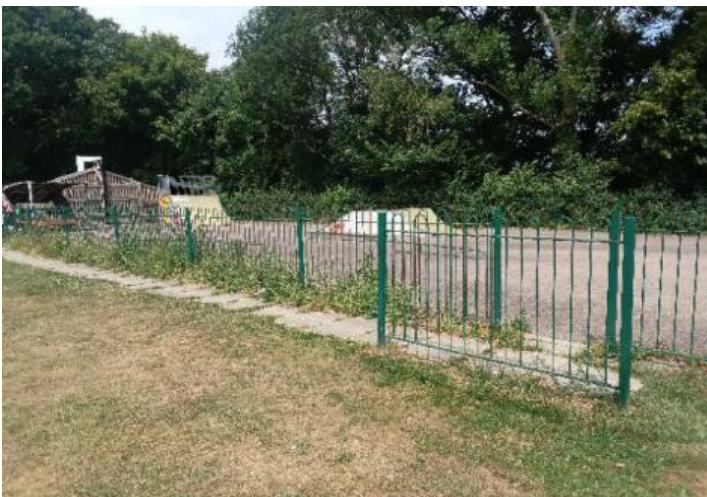
**Finding:** There is some damage apparent to the riding surface

**Action:** Monitor for any further deterioration and repair as required

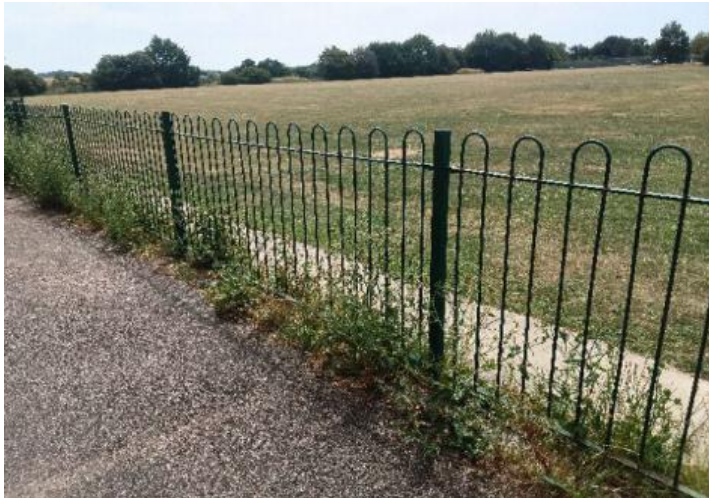
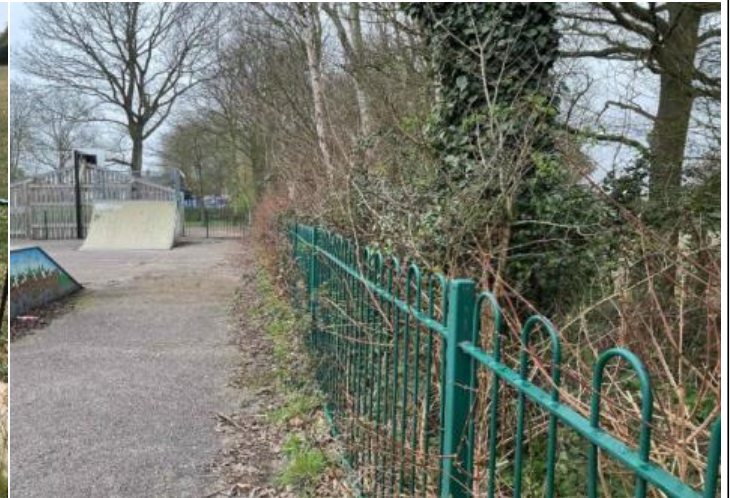
**Finding:** The adjacent foliage is overhanging

**Action:** Cut back and maintain

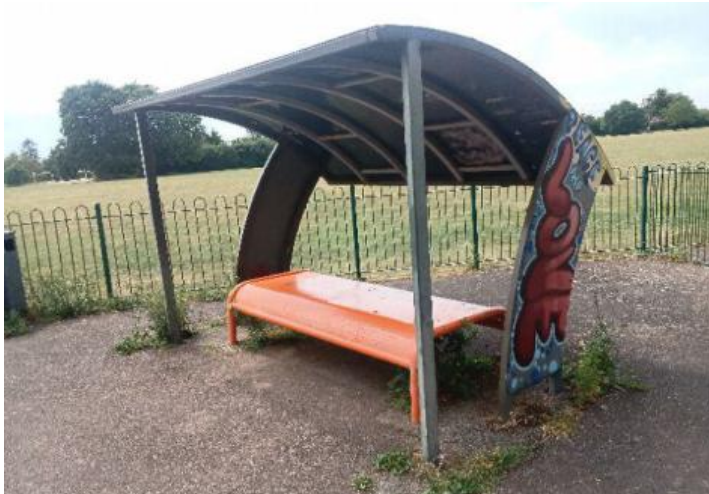
**Finding:** There is some evidence of fire damage to the item

**Action:** Monitor for any further deterioration and repair as required

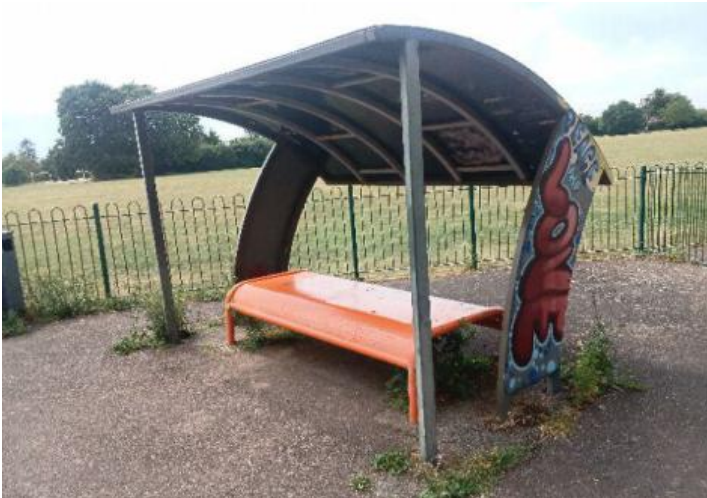
**Finding:** Pop rivet fixings have failed on the seat

**Action:** Replace the failed pop rivets

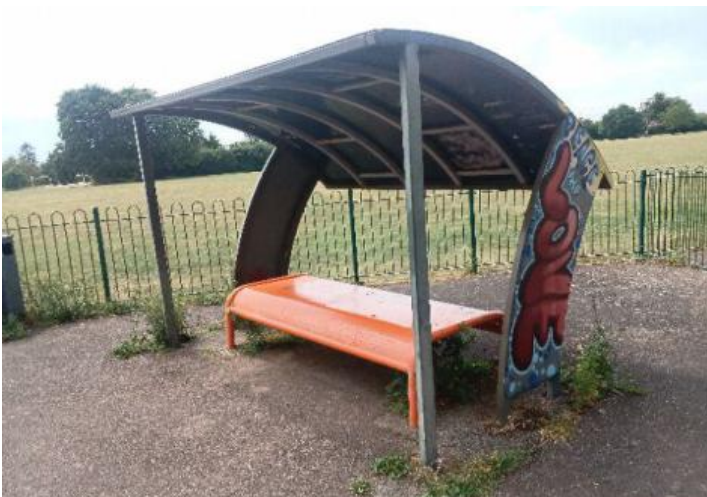
**Finding:** There is algae, silt or moss growth on the surface resulting in slippery conditions

**Action:** Clean and treat appropriately

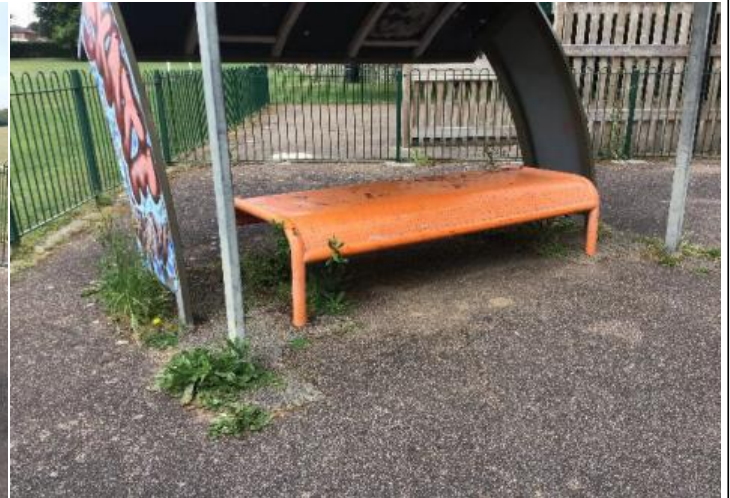
**Finding:** There is weed / vegetation growth within the surface

**Action:** Remove weed / vegetation growth

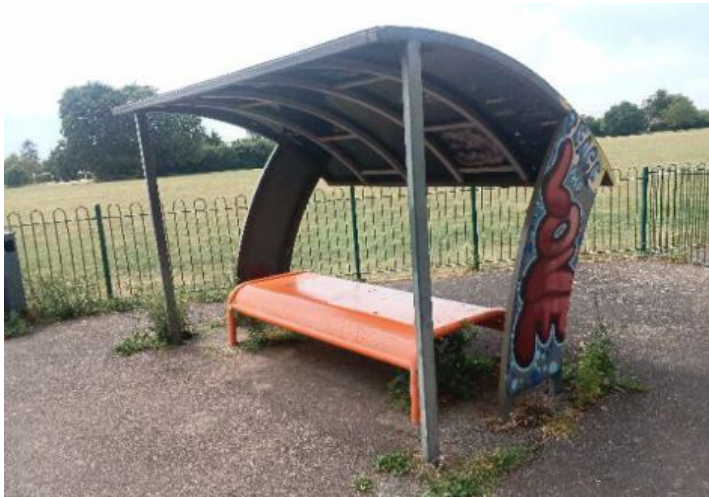
**Finding:** A number of fixing(s) have worked loose

**Action:** Secure all loose fixings

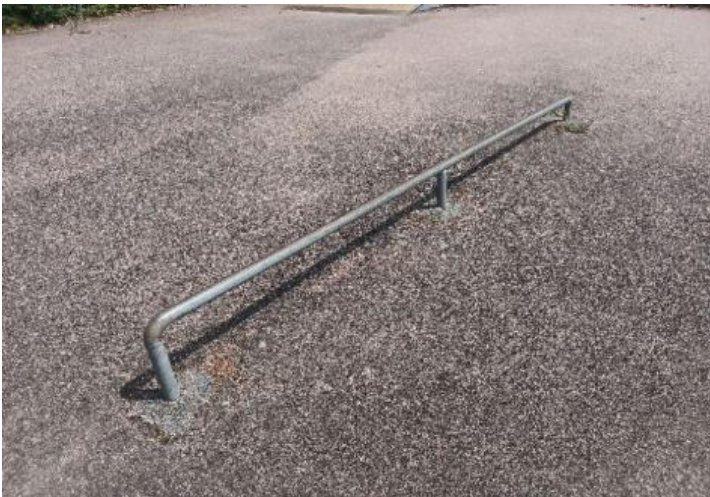
**Finding:** There is surface corrosion / rust present on the item

**Action:** Consider treating the item

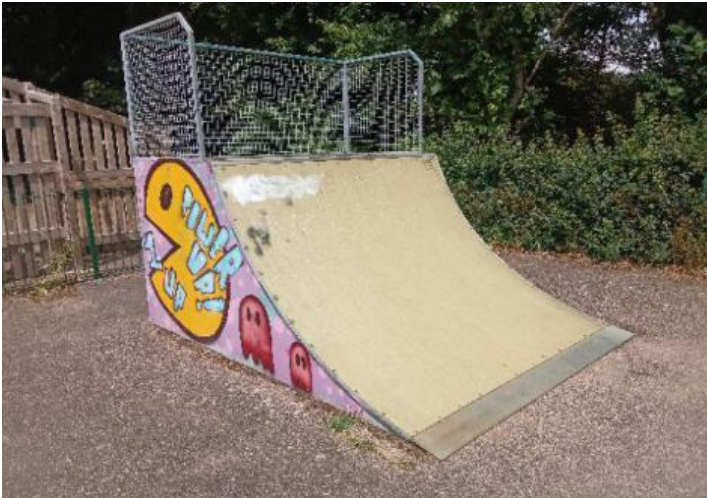
**Finding:** The item has been damaged

**Action:** Monitor for any further deterioration and replace as required

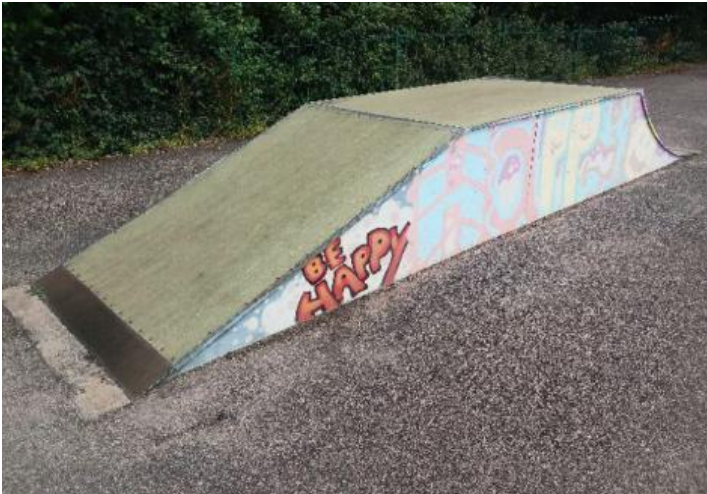
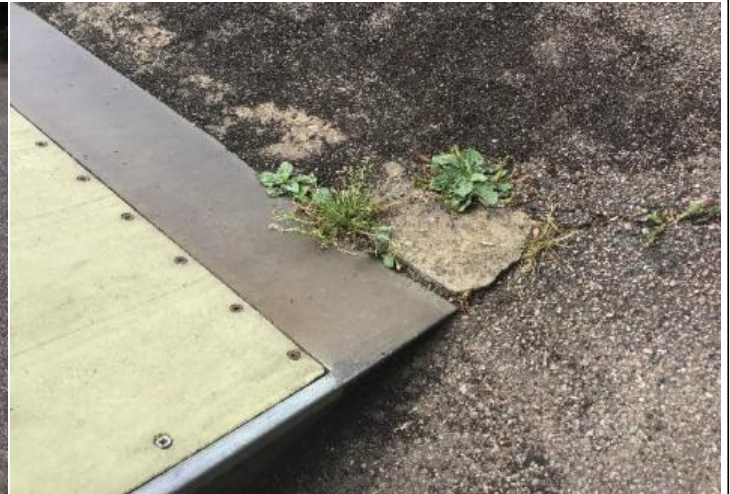
**Finding:** Concrete is lifting at the front of the ramp

**Action:** Remove and reinstate concrete (level)

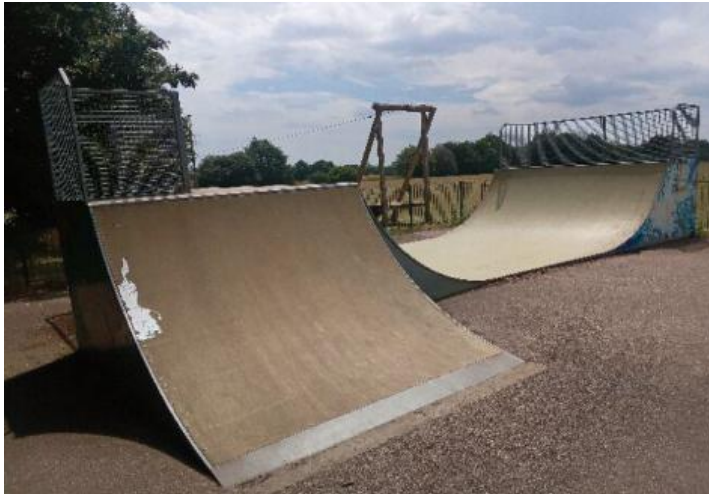
**Finding:** There is some damage to the fence sections

**Action:** Monitor for any further deterioration and repair as required

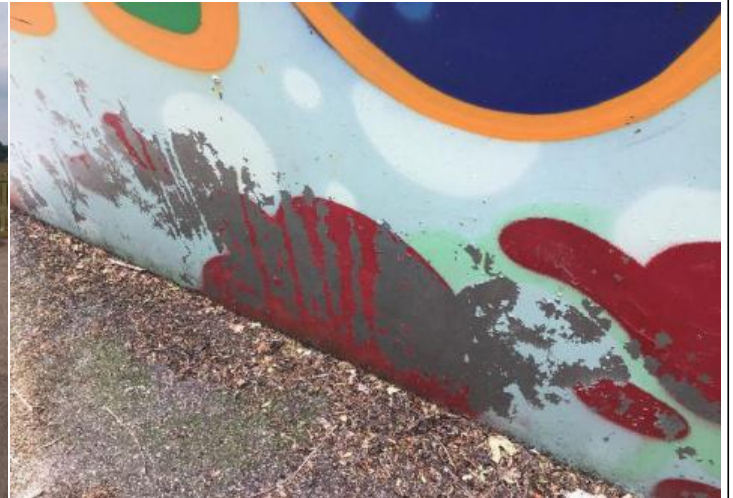
**Finding:** The paint is flaking off the metalwork

**Action:** Rub down and re-paint

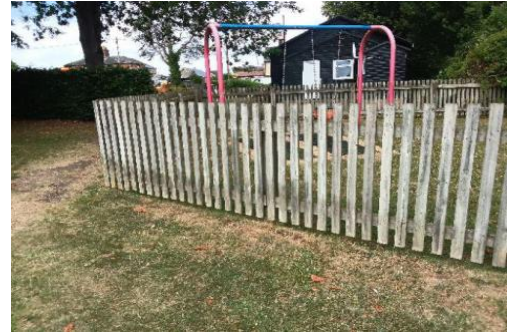
There is some strimmer / machinery damage apparent on the posts, this can penetrate the preservative applied to the timber and accelerate the rotting process - Monitor for any deterioration (rot) and replace as required

Slats damaged - Replace damaged slat

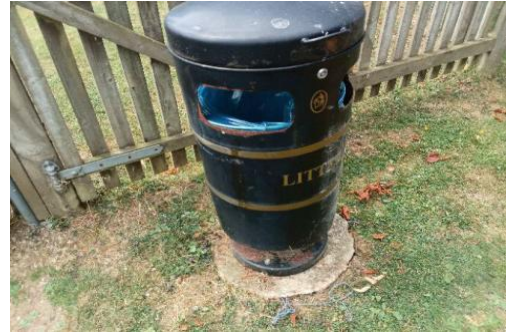
The paintwork on this item has been damaged or worn exposing the metal underneath which is rusting / corroding - Treat affected areas and repaint

The foundation is loose - Reinststate the foundation

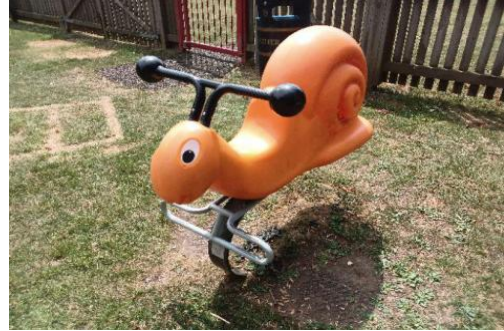
A number of fixing(s) have worked loose - Secure all loose fixings

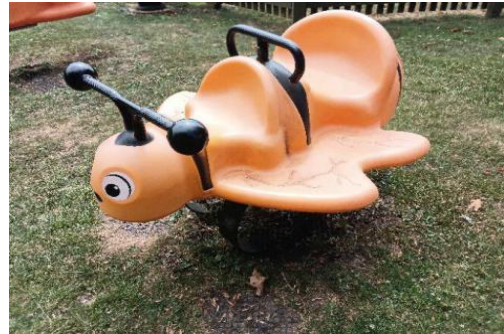
A number of fixing(s) have worked loose - Secure all loose fixings

There is or are fixings missing on the item - Replace all missing fixings

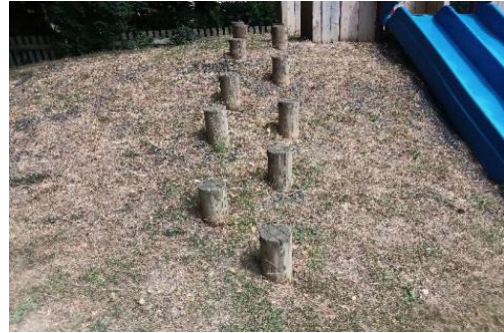
There is some strimmer / machinery damage apparent on the posts, this can penetrate the preservative applied to the timber and accelerate the rotting process - Monitor for any deterioration (rot) and replace as required

The timber has a number of splits/shakes or air cracks and this may affect the stability or allow water ingress which will accelerate the rotting process - Monitor to ensure the splits do not cross through fixing points of the structure and/or cause any instability

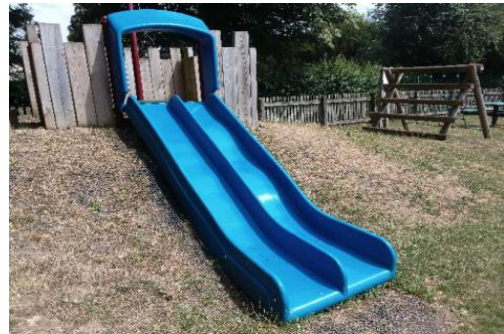
The surface has eroded in some areas and may be slippery in wet conditions - Reinstate the surface

There are trip hazards at the edges of the surface - Reinstate surrounding surface levels to remove the trip points

Some timbers are slightly loose in the foundation - Monitor for deterioration

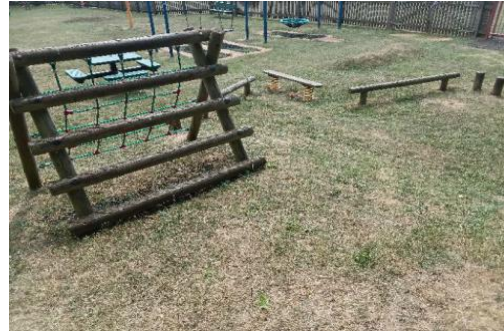
There is/are bolt cap covers missing or damaged on the item - Replace missing or damaged bolt cap covers

A number of fixing(s) have worked loose - Secure all loose fixings

There is some strimmer / machinery damage apparent on the posts, this can penetrate the preservative applied to the timber and accelerate the rotting process - Monitor for any deterioration (rot) and replace as required

The timber has a number of splits/shakes or air cracks and this may affect the stability or allow water ingress which will accelerate the rotting process - Monitor to ensure the splits do not cross through fixing points of the structure and/or cause any instability

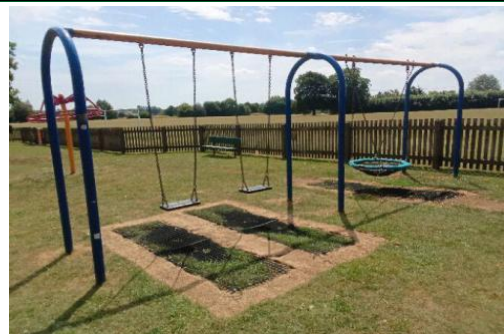
The seat has minor damage or wear - Monitor for any further deterioration and replace as required

There is/are bolt cap covers missing or damaged on the item - Replace missing or damaged bolt cap covers

The bushes are showing signs of wear - Monitor for any further deterioration and replace as required

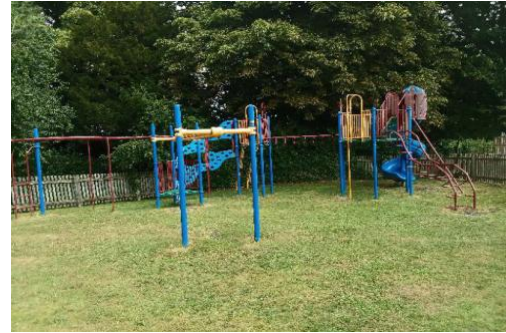
There are a number of dents in the slide surface - Monitor for any further deterioration and repair as required

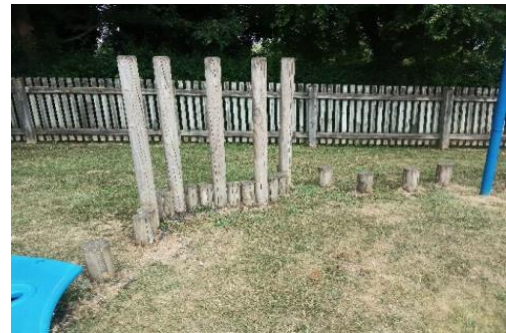
The timber has a number of splits/shakes or air cracks and this may affect the stability or allow water ingress which will accelerate the rotting process - Monitor to ensure the splits do not cross through fixing points of the structure and/or cause any instability

There is some strimmer / machinery damage apparent on the posts, this can penetrate the preservative applied to the timber and accelerate the rotting process - Monitor for any deterioration (rot) and replace as required

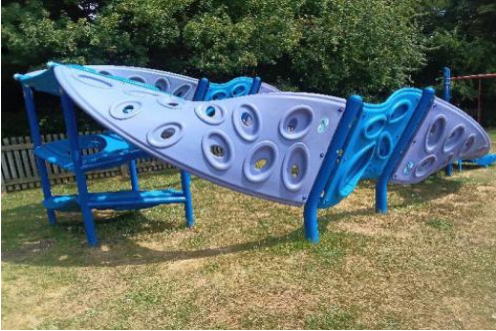
The connecting lugs are showing signs of wear - Monitor for any further deterioration and repair as required

The item has been damaged - Sand down plastic to remove sharp edge

The ropes/nets are worn/damaged in places - Monitor for any further deterioration and repair or replace as required

There is surface corrosion / rust present on the item - Consider treating the item

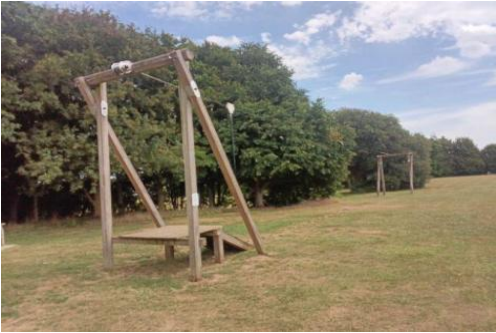
**i** 8 - Low Risk

**Item:** Cable Runway  
**Manufacturer:** Fenland Leisure Products  
**Surface Type:** Grass Matrix Tiles  
**Item Quantity:** 1

We have completed a visual inspection of the suspension links, cable and fixing points from ground level, however it is not possible to fully inspect these areas without either hiring equipment to gain access or removing the cable and suspension and inspecting at ground level. We recommend that the main cable and fixing security is thoroughly inspected at least in accordance with the manufacturers recommendations to check for wear, damage, security or internal rusting; this will help to ensure the continued safe use of the equipment - Inspect in accordance with the manufacturers recommendations

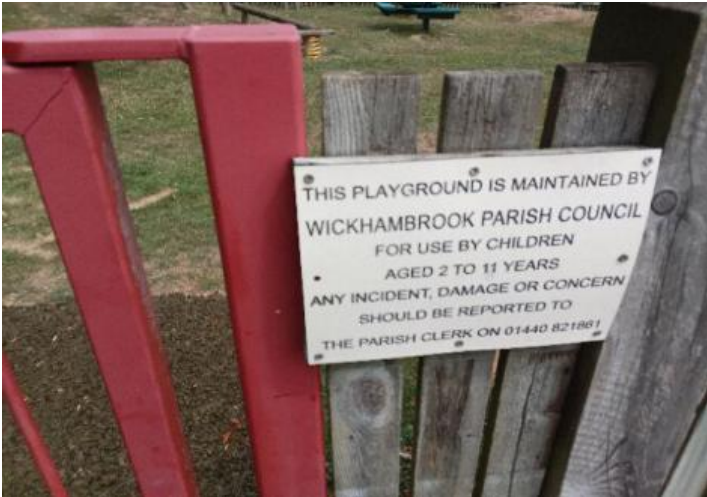
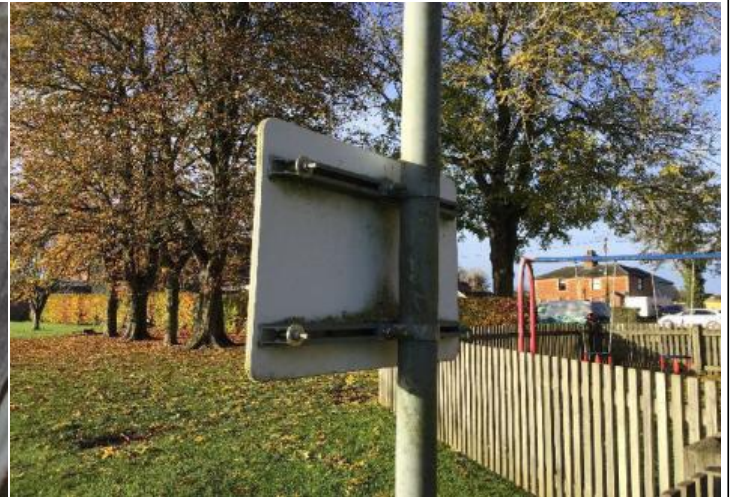
**Item:** Ancillary Items - Sign  
**Manufacturer:** Not Identified

**Finding:** There are projecting bolt thread(s) present

**Action:** Remove excess thread length and deburr or provide cap

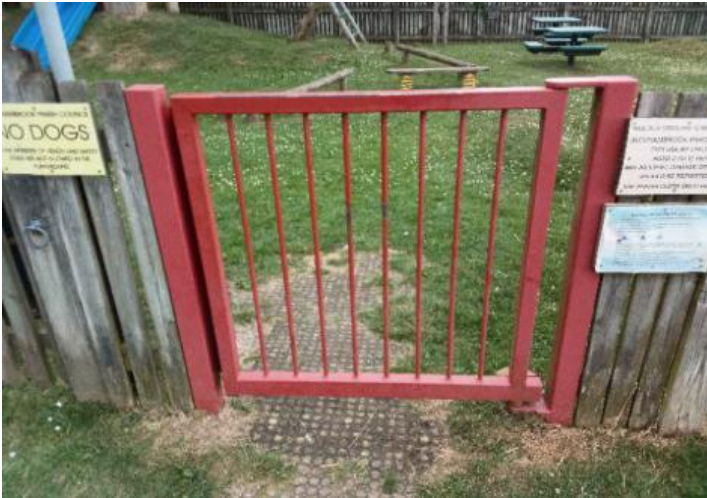
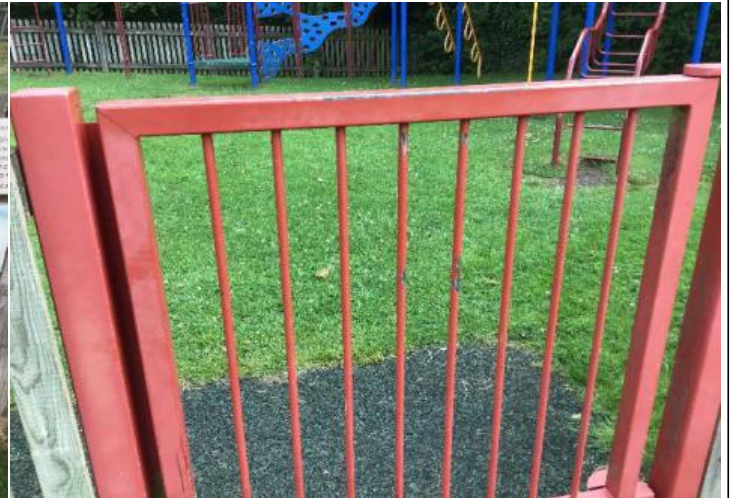
**Item:** Gates - Gate - Self Closing  
**Manufacturer:** Easy Gate Ltd

**Finding:** The paint is flaking off the metalwork

**Action:** Rub down and re-paint

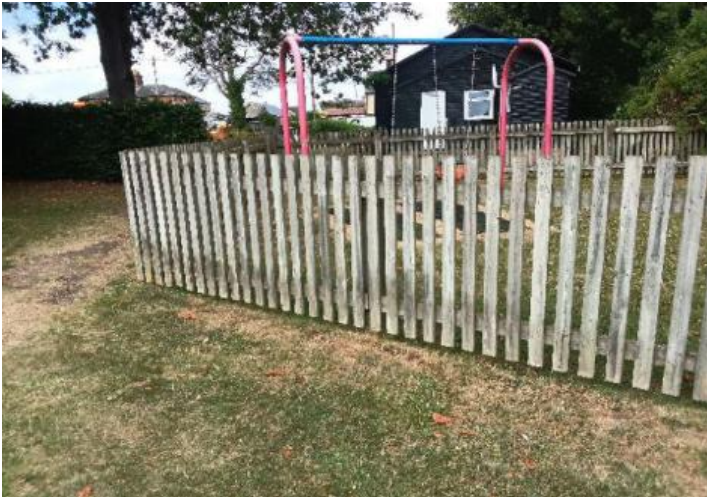
**Item:** Fences - Fencing - Timber  
**Manufacturer:** Not Identified

**Finding:** There is some strimmer / machinery damage apparent on the posts, this can penetrate the preservative applied to the timber and accelerate the rotting process

**Action:** Monitor for any deterioration (rot) and replace as required

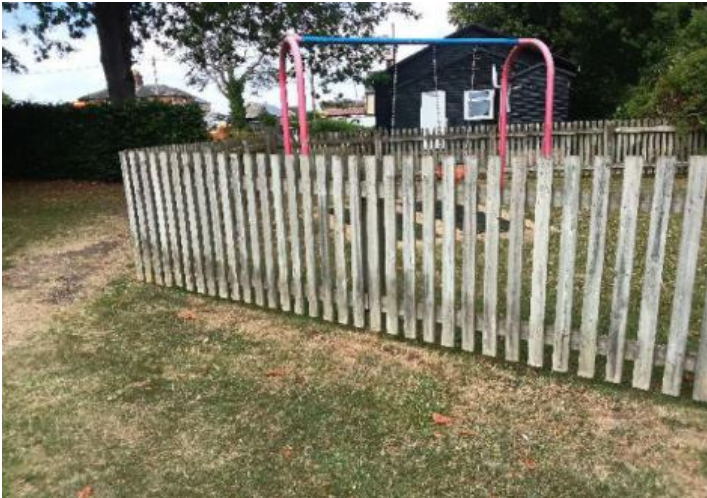
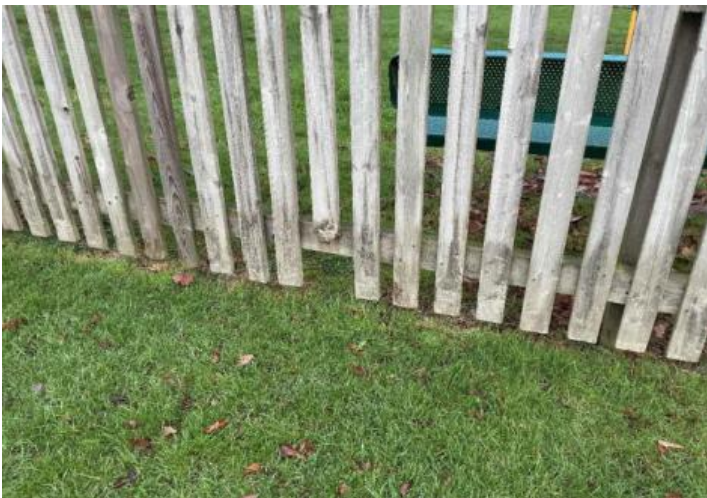
**Item:** Fences - Fencing - Timber  
**Manufacturer:** Not Identified

**Finding:** Slats damaged

**Action:** Replace damaged slat

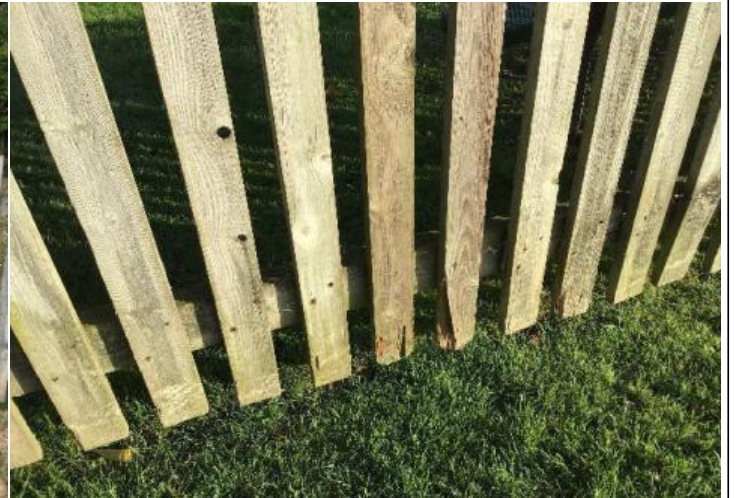
**Item:** Fences - Fencing - Timber  
**Manufacturer:** Not Identified

**Finding:** Parts of the timber are rough or splintered

**Action:** Remove all rough or sharp edges

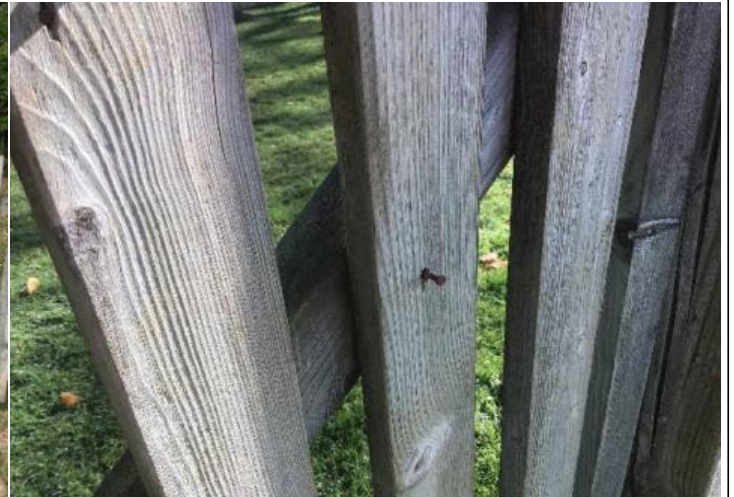
**Item:** Fences - Fencing - Timber  
**Manufacturer:** Not Identified

**Finding:** There are projecting nail ends present

**Action:** Remove and provide more appropriate fixings if required

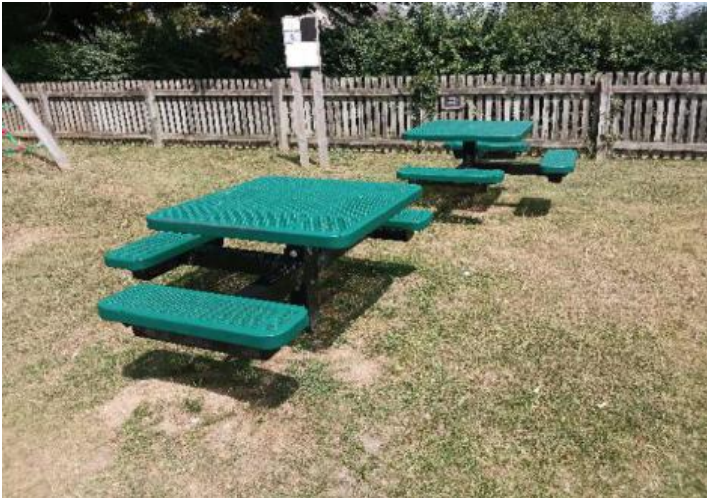
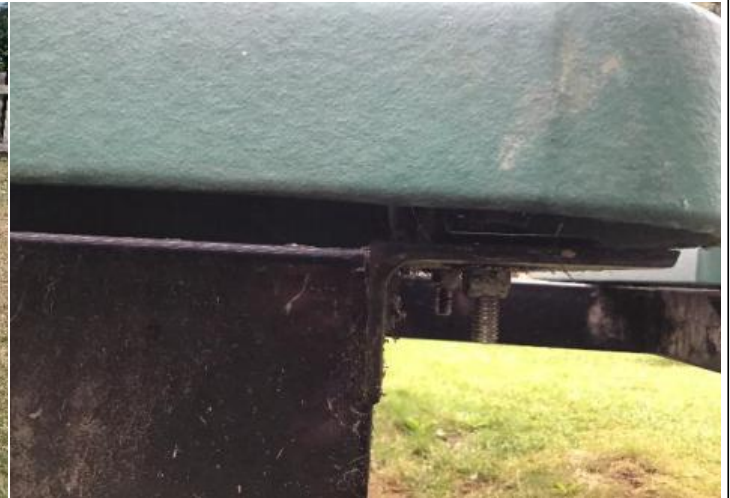
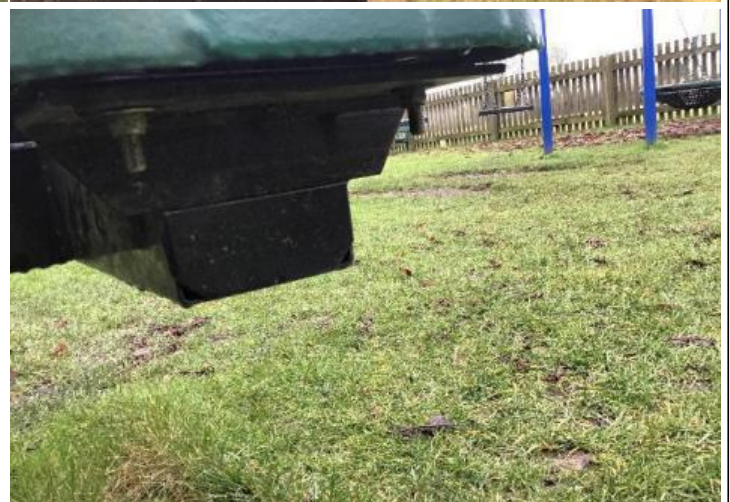
**Item:** Ancillary Items - Picnic Table  
**Manufacturer:** Not Identified

**Finding:** There are projecting bolt thread(s) present

**Action:** Remove excess thread length and deburr or provide cap

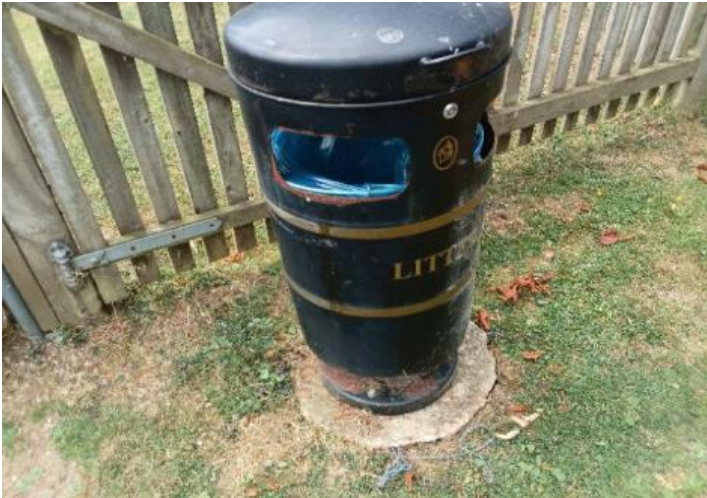
**Item:** Ancillary Items - Litter Bin  
**Manufacturer:** Not Identified

**Finding:** The paintwork on this item has been damaged or worn exposing the metal underneath which is rusting / corroding

**Action:** Treat affected areas and repaint

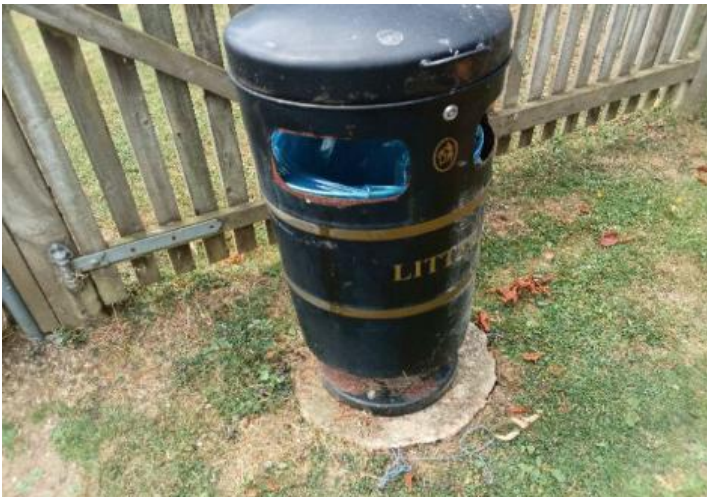
**Item:** Ancillary Items - Litter Bin  
**Manufacturer:** Not Identified

**Finding:** The foundation is loose

**Action:** Reinstate the foundation

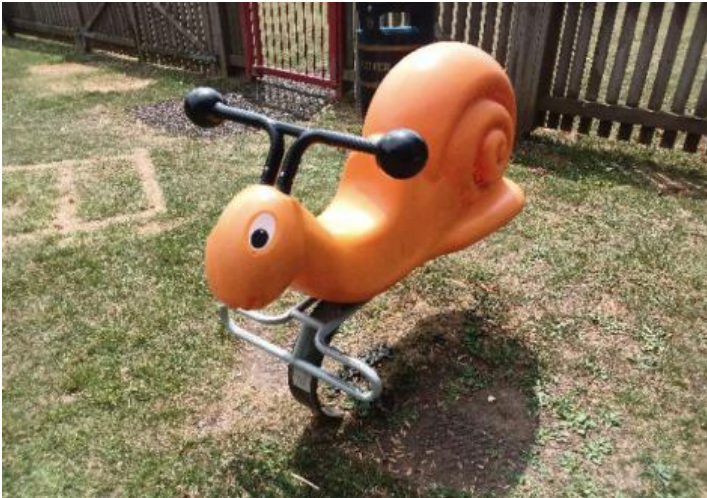
**Item:** Rocking Equipment - Spring Snail  
**Manufacturer:** Miracle Recreation Equipment Company

**Finding:** A number of fixing(s) have worked loose

**Action:** Secure all loose fixings

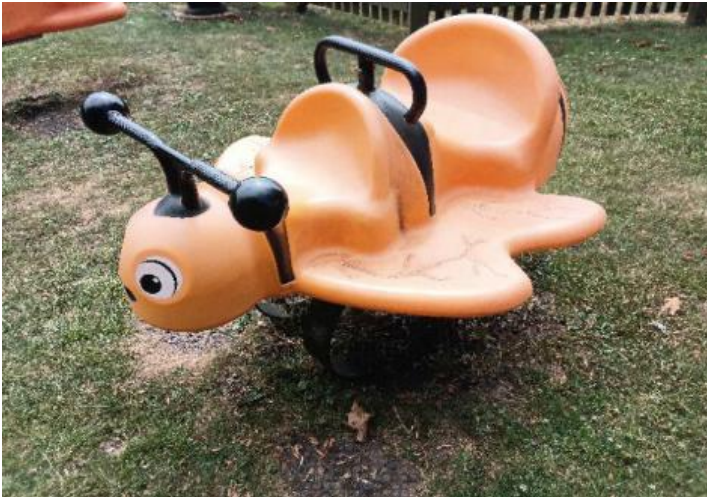
**Item:** Rocking Equipment - Spring Bee  
**Manufacturer:** Miracle Recreation Equipment Company

**Finding:** A number of fixing(s) have worked loose

**Action:** Secure all loose fixings

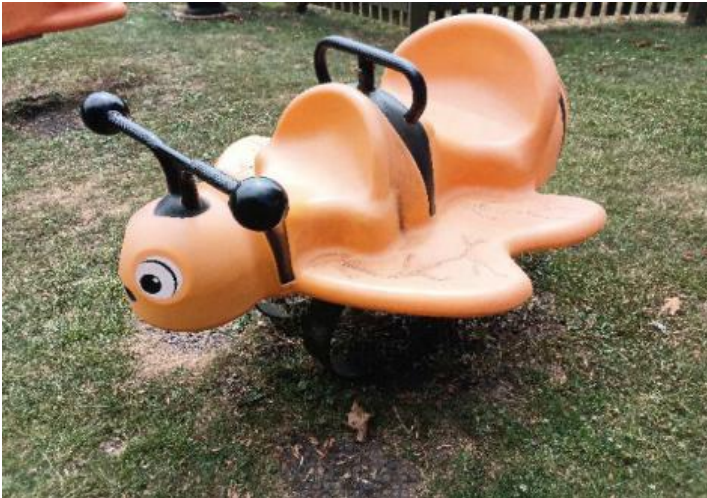
**Item:** Rocking Equipment - Spring Bee  
**Manufacturer:** Miracle Recreation Equipment Company

**Finding:** There is or are fixings missing on the item

**Action:** Replace all missing fixings
