## **Play Area Inspection Reports & Remedial Work**

A copy of the March inspection reports is attached as **Appendix A**, and a summary of work identified is attached as **Appendix B**.

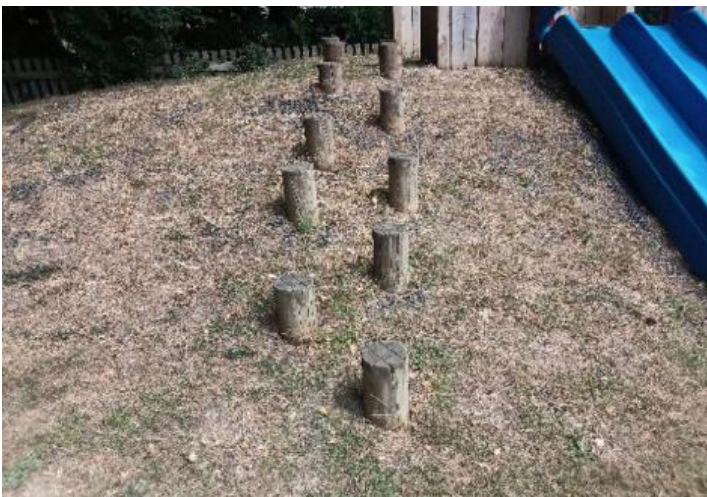
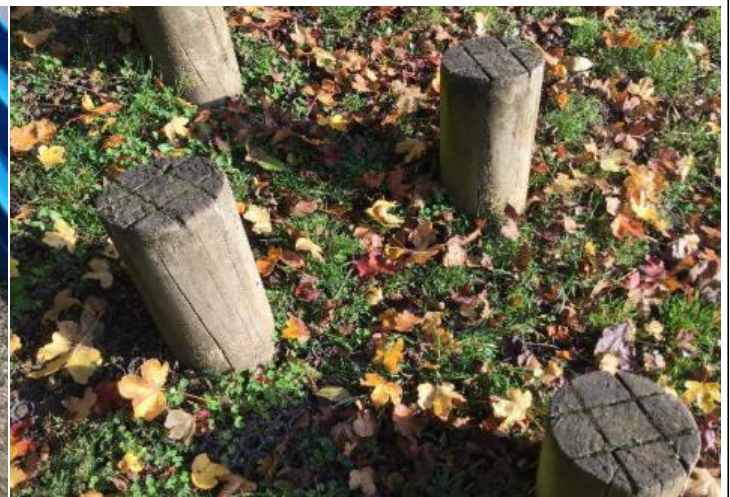
**Manufacturer:** Playworld Systems (Europe) Ltd

**Finding:** There is algae or moss on the surface of the equipment

**Action:** Clean and treat appropriately

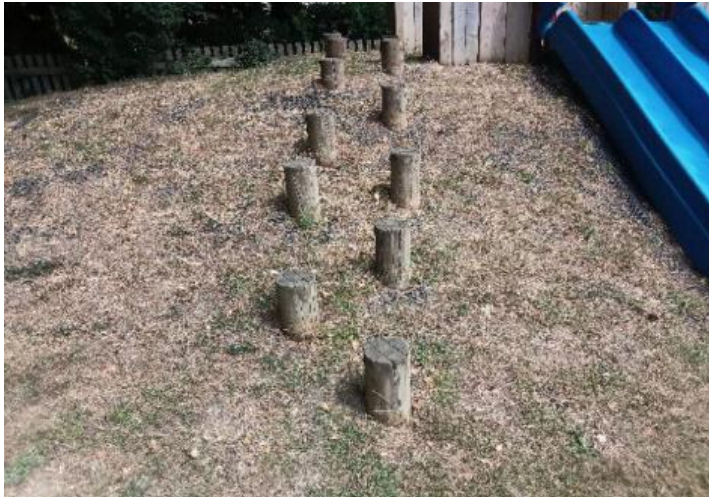
**Item:** Activity Equipment - Stepping Posts  
Timber  
**Manufacturer:** Playworld Systems (Europe) Ltd

**Finding:** There is some strimmer / machinery damage apparent on the posts, this can penetrate the preservative applied to the timber and accelerate the rotting process

**Action:** Monitor for any deterioration (rot) and replace as required

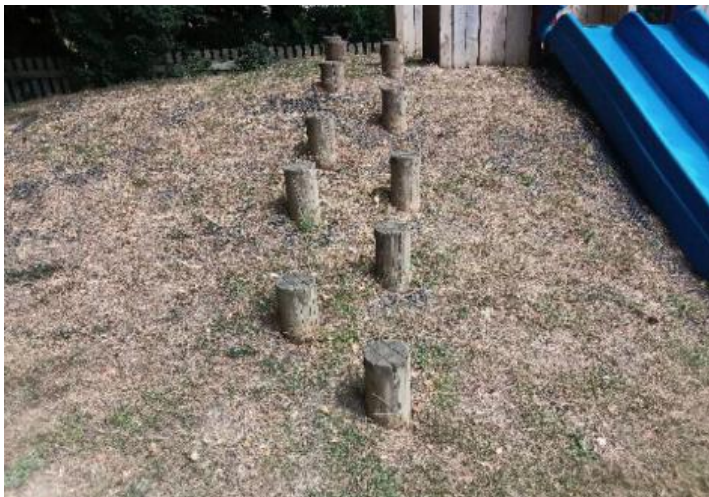
**Item:** Activity Equipment - Stepping Posts  
Timber  
**Manufacturer:** Playworld Systems (Europe) Ltd

**Finding:** The timber has a number of splits/shakes or air cracks and this may affect the stability or allow water ingress which will accelerate the rotting process

**Action:** Monitor to ensure the splits do not cross through fixing points of the structure and/or cause any instability

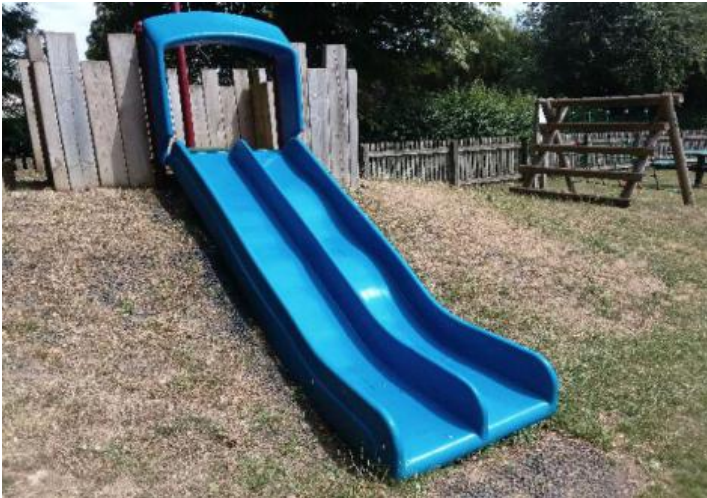
**Item:** Other - Embankment Slide  
**Manufacturer:** Miracle Recreation Equipment Company

**Finding:** There are trip hazards at the edges of the surface

**Action:** Reinststate surrounding surface levels to remove the trip points

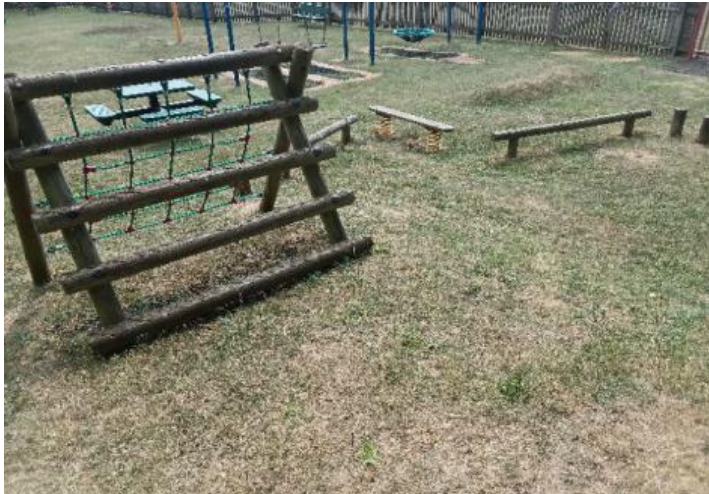
**Item:** Activity Equipment - Activity Trail  
**Manufacturer:** Miracle Recreation Equipment Company

**Finding:** There is/are bolt cap covers missing or damaged on the item

**Action:** Replace missing or damaged bolt cap covers

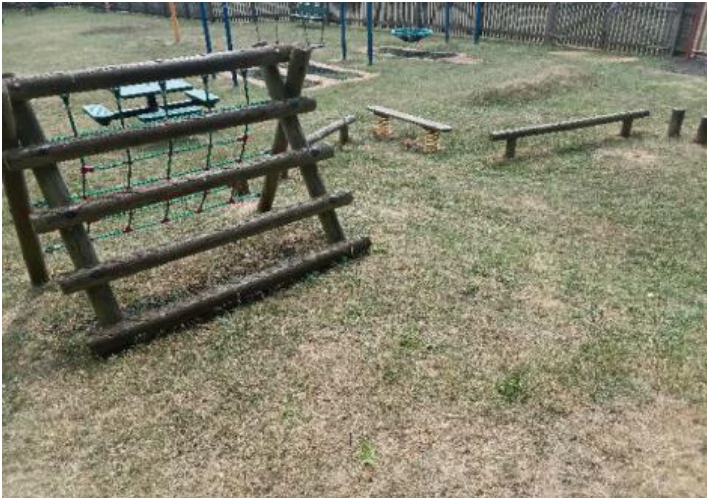
**Item:** Activity Equipment - Activity Trail  
**Manufacturer:** Miracle Recreation Equipment Company

**Finding:** A number of fixing(s) have worked loose

**Action:** Secure all loose fixings

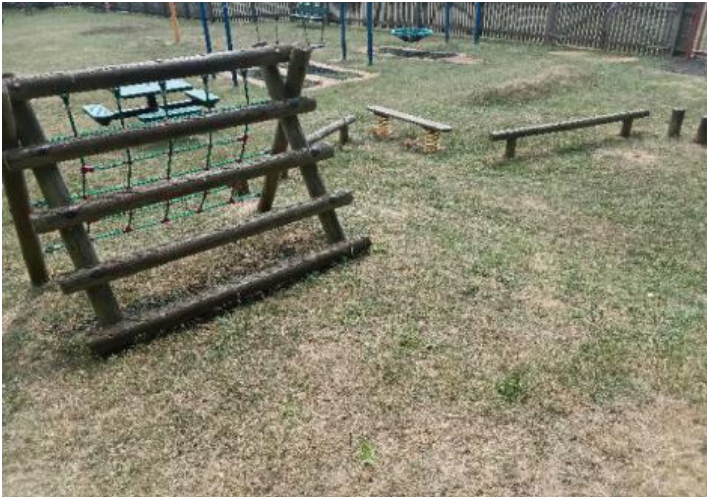
**Item:** Activity Equipment - Activity Trail  
**Manufacturer:** Miracle Recreation Equipment Company

**Finding:** There is some strimmer / machinery damage apparent on the posts, this can penetrate the preservative applied to the timber and accelerate the rotting process

**Action:** Monitor for any deterioration (rot) and replace as required

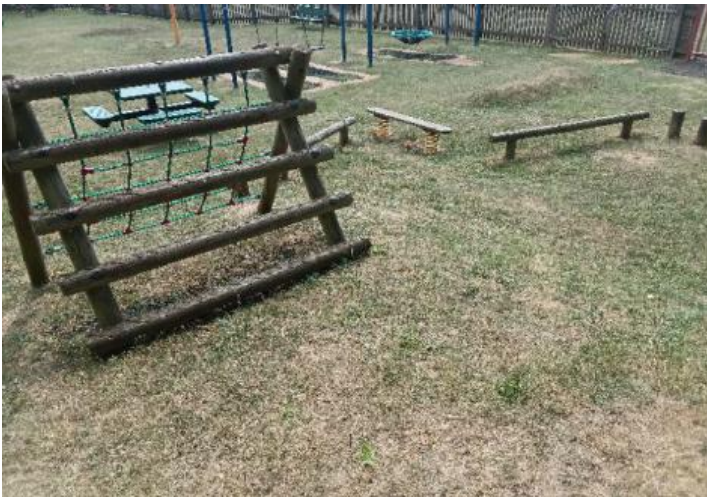
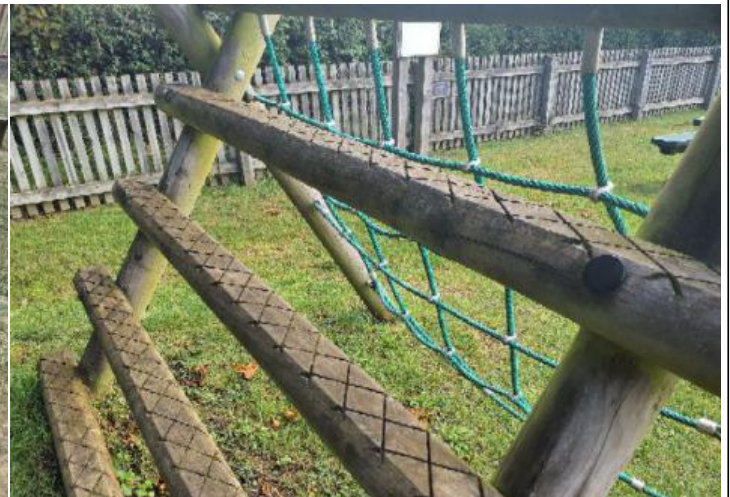
**Item:** Activity Equipment - Activity Trail  
**Manufacturer:** Miracle Recreation Equipment Company

**Finding:** There is algae or moss on the surface of the equipment  
**Action:** Clean and treat appropriately

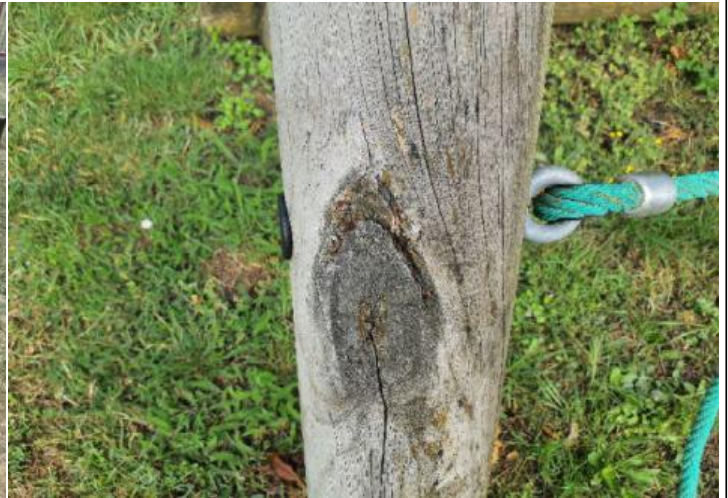
**i** 6 - Low Risk (Finding 6)

**Item:** Activity Equipment - Activity Trail  
**Manufacturer:** Miracle Recreation Equipment Company

**Finding:** Parts of the timber are rough or splintered

**Action:** Remove all rough or sharp edges

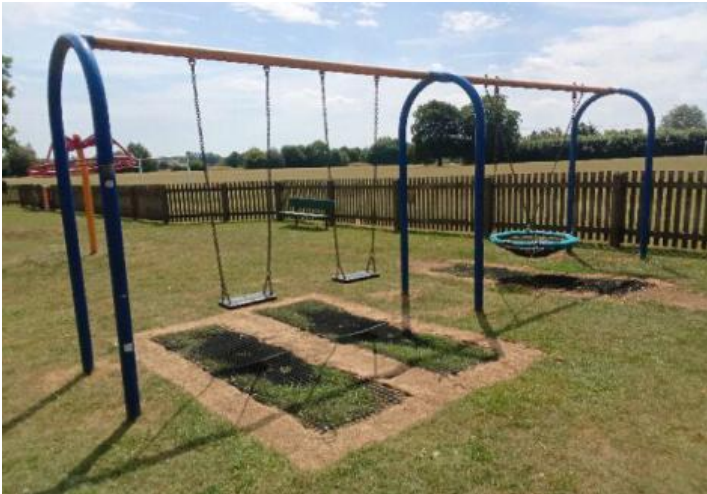
**Item:** Swings - 2 Bay 2 Flat 1 Basket Seat  
**Manufacturer:** Miracle Recreation Equipment Company

**Finding:** The seat has minor damage or wear

**Action:** Monitor for any further deterioration and replace as required

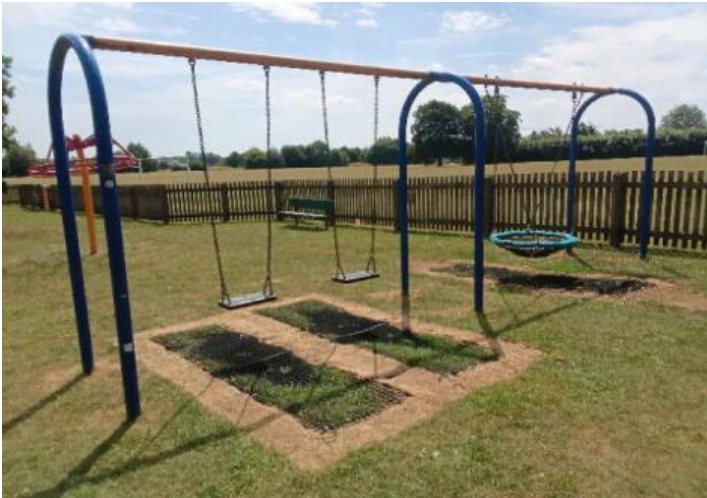
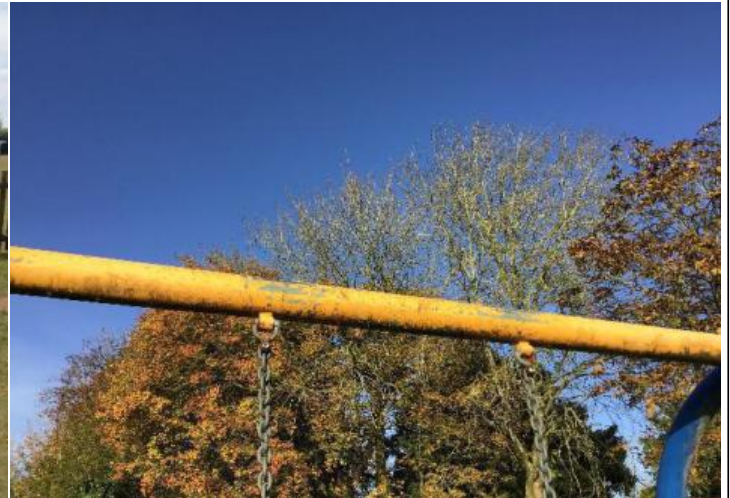
**Item:** Swings - 2 Bay 2 Flat 1 Basket Seat  
**Manufacturer:** Miracle Recreation Equipment Company

**Finding:** The paint is flaking off the metalwork

**Action:** Rub down and re-paint

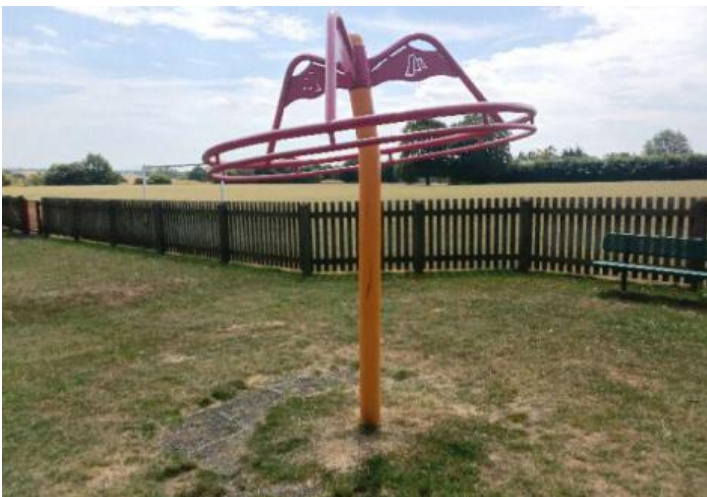
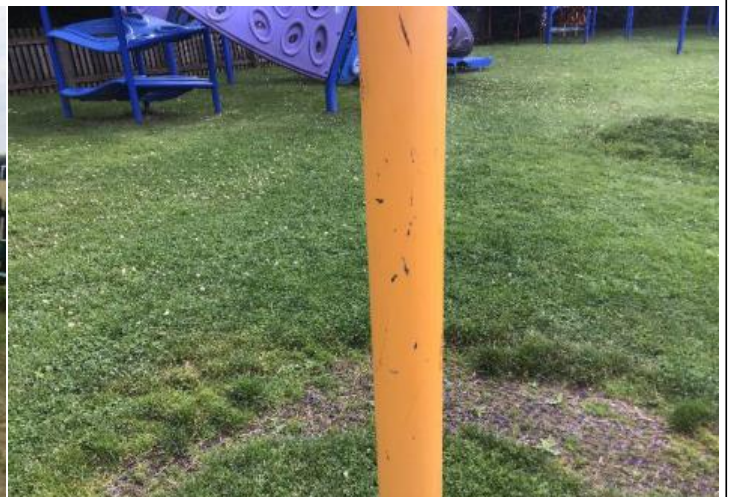
**Item:** Rotor Play - Overhead Rotator  
**Manufacturer:** Miracle Recreation Equipment Company

**Finding:** The paint is flaking off the metalwork

**Action:** Rub down and re-paint

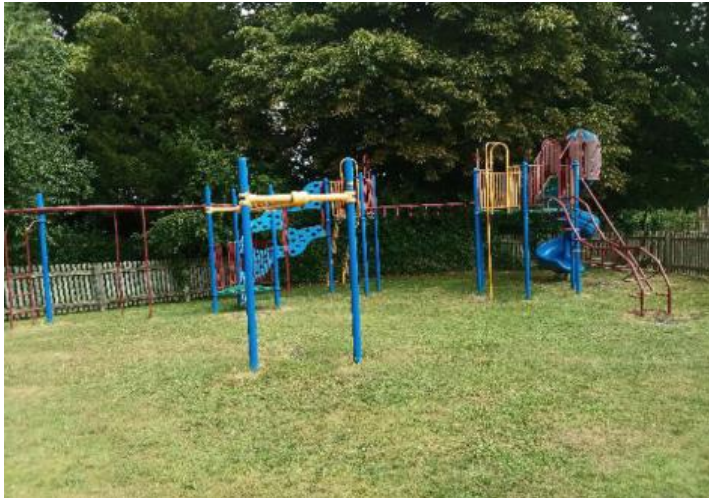
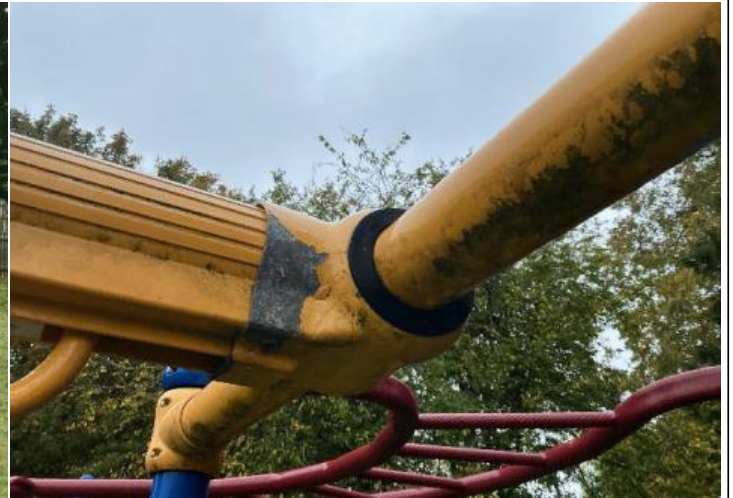
**Item:** Activity Equipment - Multi Play (Senior)  
**Manufacturer:** Miracle Recreation Equipment Company

**Finding:** The paint is flaking off the metalwork

**Action:** Rub down and re-paint

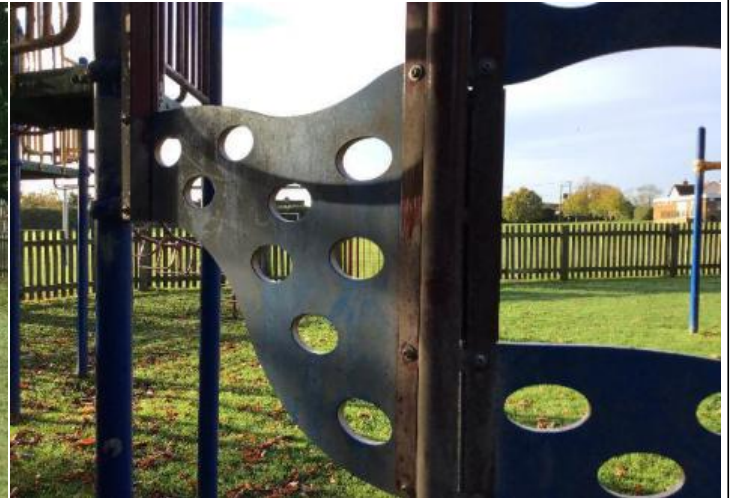
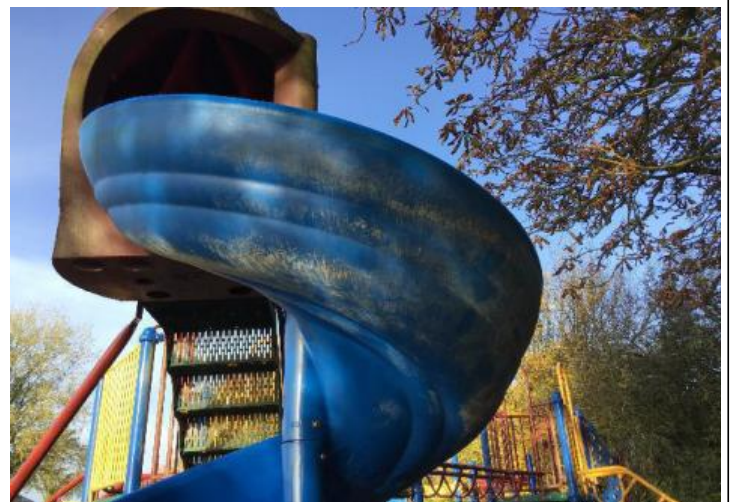
**Item:** Activity Equipment - Multi Play (Senior)  
**Manufacturer:** Miracle Recreation Equipment Company

**Finding:** There is algae or moss on the surface of the equipment

**Action:** Clean and treat appropriately

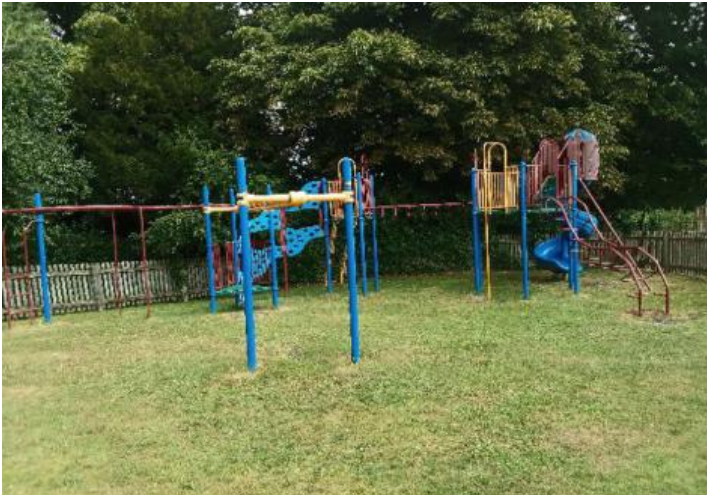
**Item:** Activity Equipment - Multi Play (Senior)  
**Manufacturer:** Miracle Recreation Equipment Company

**Finding:** There are a number of dents in the slide surface

**Action:** Monitor for any further deterioration and repair as required

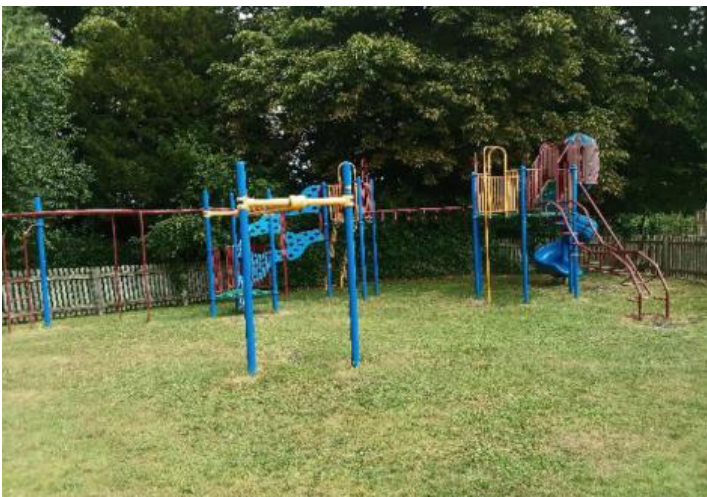
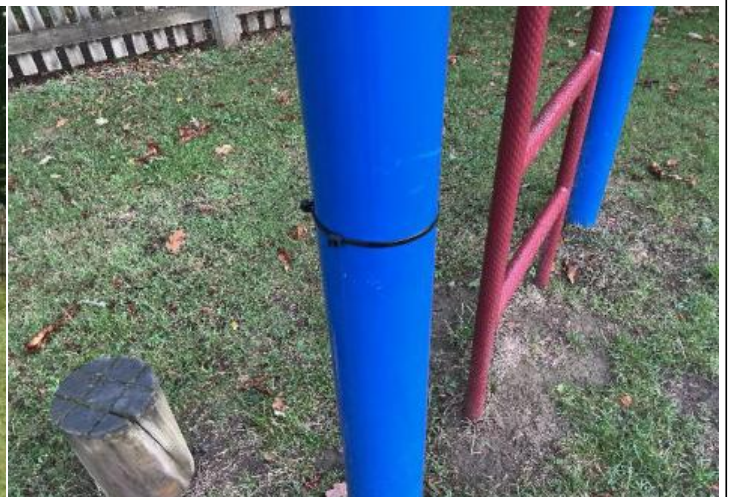
**Item:** Activity Equipment - Multi Play (Senior)  
**Manufacturer:** Miracle Recreation Equipment Company

**Risk Level:** L - Low Risk  
**Surface:** Grass Matrix Tiles

**Finding:** Cable tie around post has been cut leaving sharp edges

**Action:** Remove cable tie

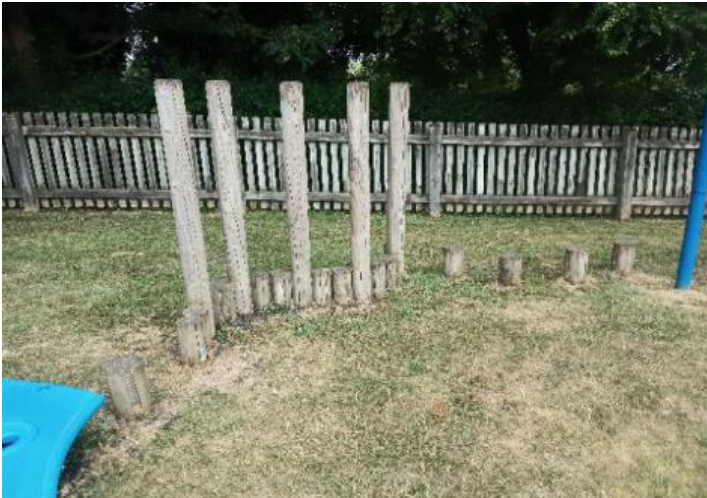
**Item:** Activity Equipment - Log Walk  
**Manufacturer:** Miracle Recreation Equipment Company

**Risk Level:** L - Low Risk  
**Surface:** Grass Matrix Tiles

**Finding:** The timber has a number of splits/shakes or air cracks and this may affect the stability or allow water ingress which will accelerate the rotting process

**Action:** Monitor to ensure the splits do not cross through fixing points of the structure and/or cause any instability

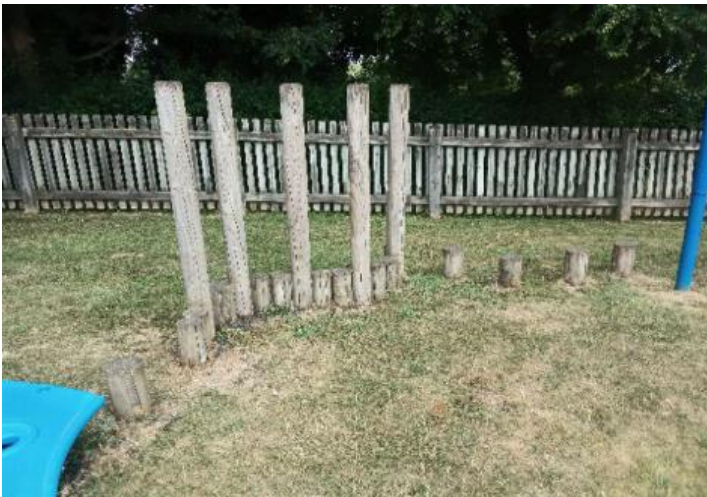
**Item:** Activity Equipment - Log Walk  
**Manufacturer:** Miracle Recreation Equipment Company

**Risk Level:** L - Low Risk  
**Surface:** Grass Matrix Tiles

**Finding:** There is some strimmer / machinery damage apparent on the posts, this can penetrate the preservative applied to the timber and accelerate the rotting process

**Action:** Monitor for any deterioration (rot) and replace as required

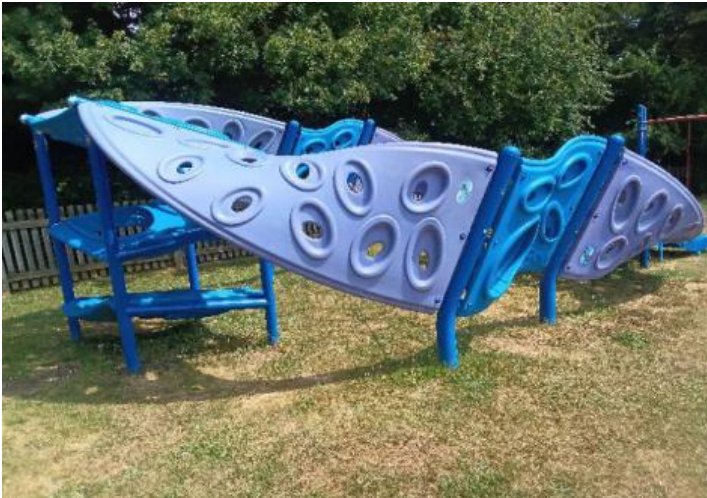
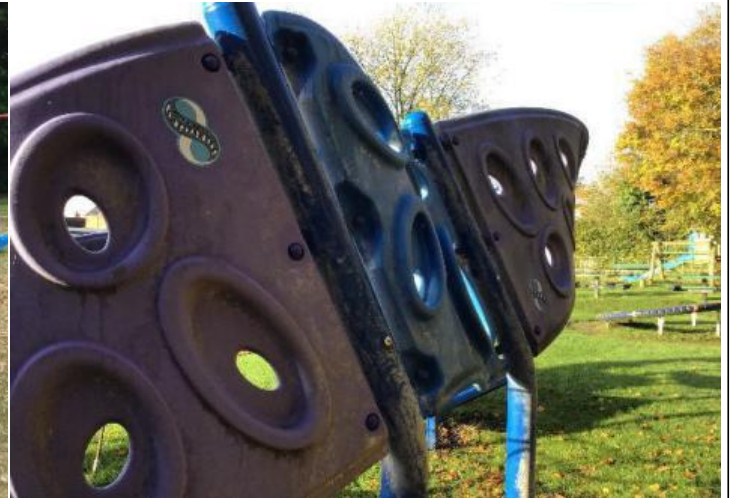
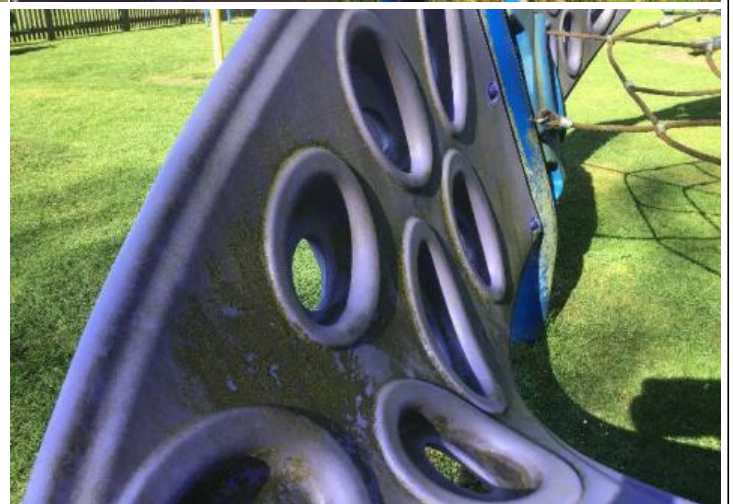
**Item:** Activity Equipment - Climbing Frame  
**Manufacturer:** Not Identified

**Risk Level:** L - Low Risk  
**Surface:** Grass Matrix Tiles

**Finding:** There is algae or moss on the surface of the equipment

**Action:** Clean and treat appropriately

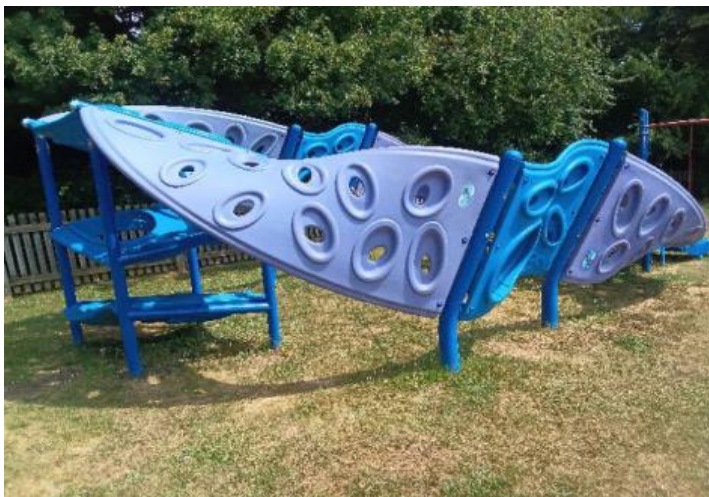
**Item:** Activity Equipment - Climbing Frame  
**Manufacturer:** Not Identified

**Risk Level:** L - Low Risk  
**Surface:** Grass Matrix Tiles

**Finding:** The connecting lugs are showing signs of wear

**Action:** Monitor for any further deterioration and repair as required

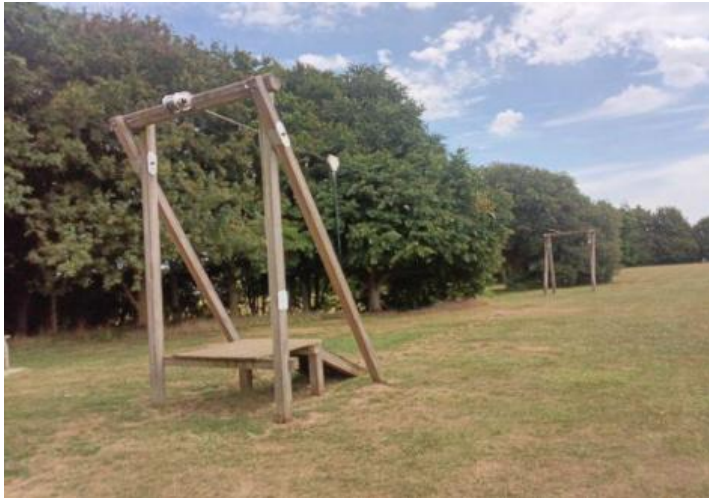
**Item:** Other - Cable Runway  
**Manufacturer:** Fenland Leisure Products

**Risk Level:** N - Risk Assessment not Undertaken  
**Surface:** Grass Matrix Tiles

**Finding:** We have completed a visual inspection of the suspension links, cable and fixing points from ground level, however it is not possible to fully inspect these areas without either hiring equipment to gain access or removing the cable and suspension and inspecting at ground level. We recommend that the main cable and fixing security is thoroughly inspected at least in accordance with the manufacturers recommendations to check for wear, damage, security or internal rusting; this will help to ensure the continued safe use of the equipment

**Action:** Inspect in accordance with the manufacturers recommendations

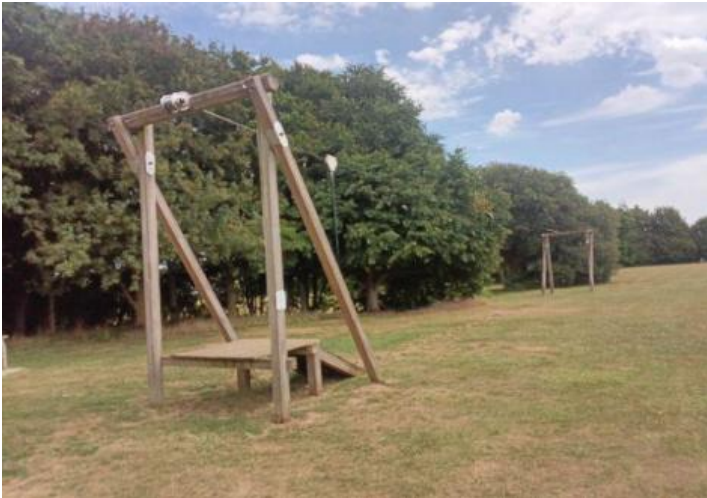
**Item:** Other - Cable Runway  
**Manufacturer:** Fenland Leisure Products

**Risk Level:** L - Low Risk  
**Surface:** Grass Matrix Tiles

**Finding:** There is some strimmer / machinery damage apparent on the posts, this can penetrate the preservative applied to the timber and accelerate the rotting process

**Action:** Monitor for any deterioration (rot) and replace as required

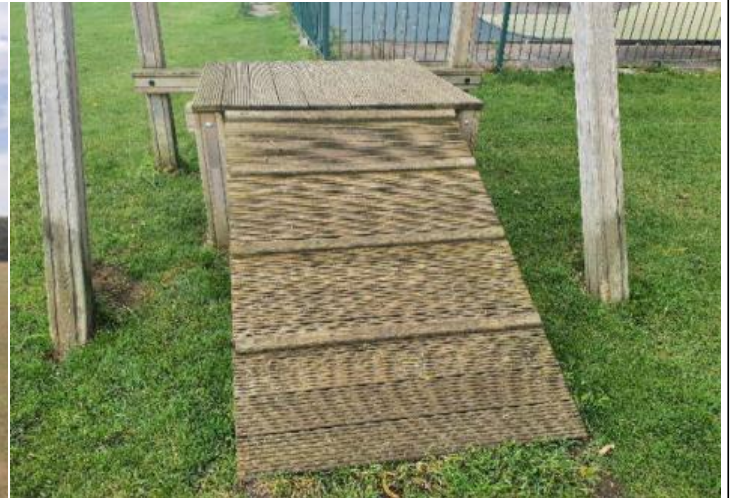
**Item:** Other - Cable Runway  
**Manufacturer:** Fenland Leisure Products

**Risk Level:** L - Low Risk  
**Surface:** Grass Matrix Tiles

**Finding:** There is algae or moss on the surface of the equipment

**Action:** Clean and treat appropriately

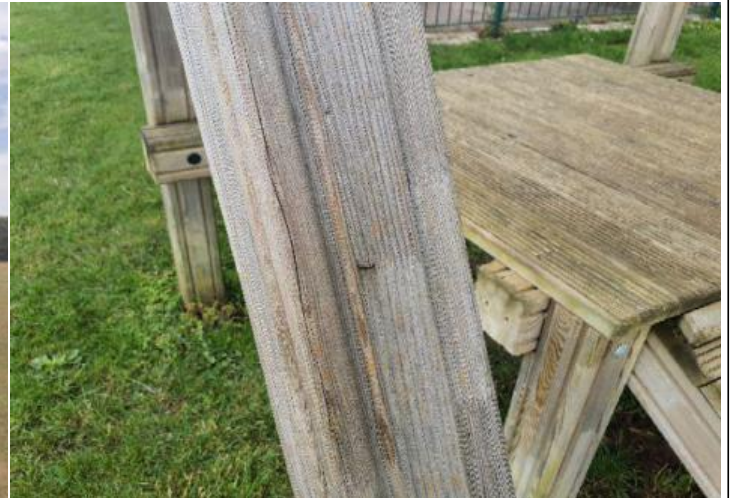
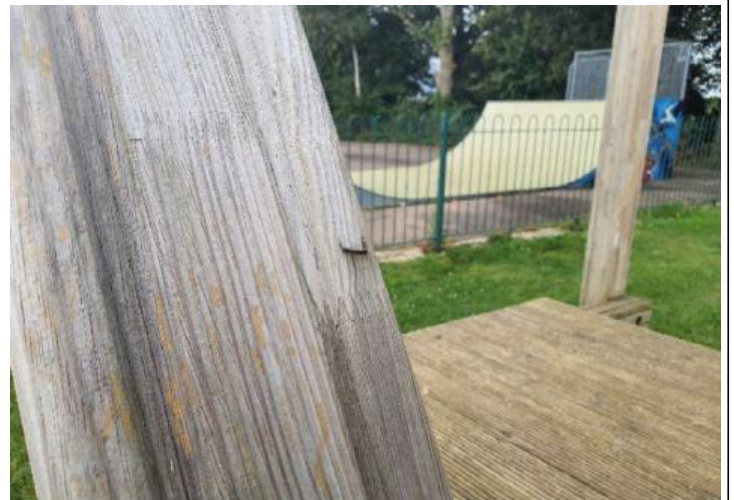
**Item:** Other - Cable Runway  
**Manufacturer:** Fenland Leisure Products

**Risk Level:** L - Low Risk  
**Surface:** Grass Matrix Tiles

**Finding:** There are a number of redundant staples attached to the equipment **Action:** Remove redundant staples
